AMBIENT BIOAEROSOLS MONITORING

Cribbs Causeway
Prepared for: Advetec Holdings Ltd

SLR Ref: 416.11977.00001
Version No: 1
October 2021

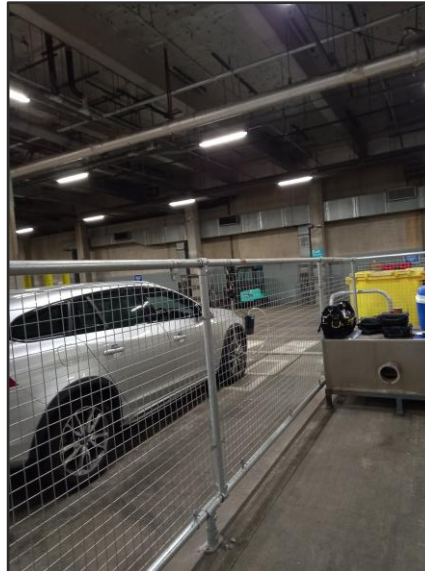
General/food waste
build up

- A high level of site cleanliness will be maintained (i.e. spillages are to be cleared on an ad-hoc basis and not left in situ).
- The level of raw waste build-up (i.e. waste that has not been inputted into the shredder for treatment) will be kept to a minimum at all times.
- A proactive approach to carbon media replacement. Carbon media should be tested to establish an appropriate replacement frequency. Media should then be replaced before saturation occurs.

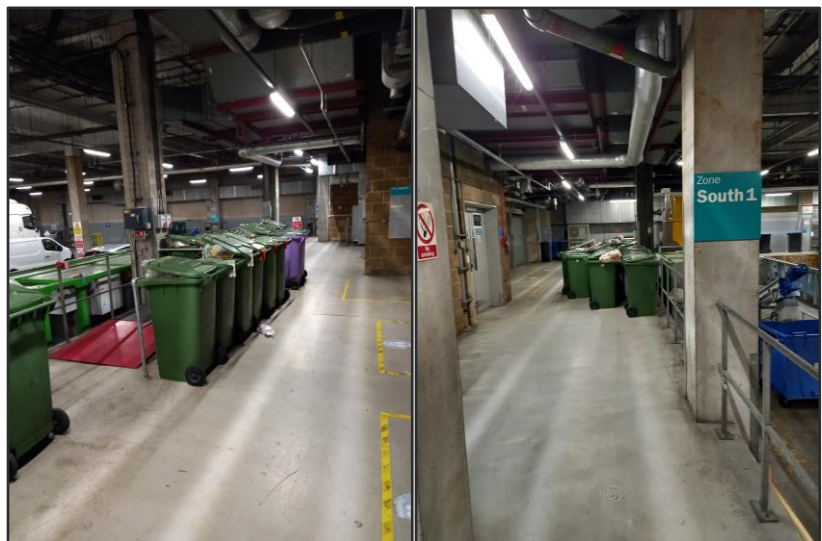
- The AD unit was loaded approximately 1 hour prior to commencement on the monitoring and was fully operational throughout the duration of the monitoring period. The unit was loaded once during the monitoring period.
- There is currently a build up of raw, general waste and food waste. This may have impacted the results for both analytes from Location 5, 7 and 8. Photo examples of the build up can be found in Annex B.
- The LEV system was not operational during the monitoring period due to maintenance of the fire alarm system.
- The carbon filter media was replaced approximately 3 months prior to the monitoring date.
