**Trees in relation to design, demolition and construction –
Recommendations**

**Naburn Weir,
3 The Walles Garden,
Naburn Hall,
Naburn,
YORK,
YO19 4RU.**

Tree Survey Report

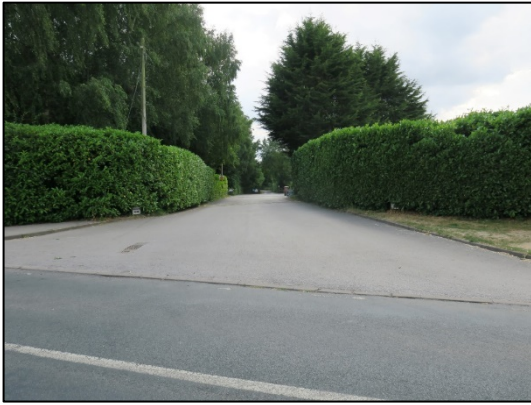
Photograph 1: Representative image of site entrance at NGR SE 59702 44622

- 3.8 Access to site is via a private road leading off the B1222, initially passing through a caravan site before following a tarmac track for approximately 300 metres. At the end of the track there is an area of tarmac hardstanding used for vehicle parking. At the site entrance and around the caravan park there is ornamental planting including leylandii *Cupressus × leylandii* and laurel *Laurus spp.*. The remainder of the track is predominantly edged with hawthorn hedgerow *Crataegus monogyna* with occasional blackthorn *Prunus spinosa*, elder *Sambucus nigra*, bramble *Rubus fruticosus*, common oak *Quercus robur*, ash *Fraxinus excelsior* and sycamore *Acer pseudoplatanus*.

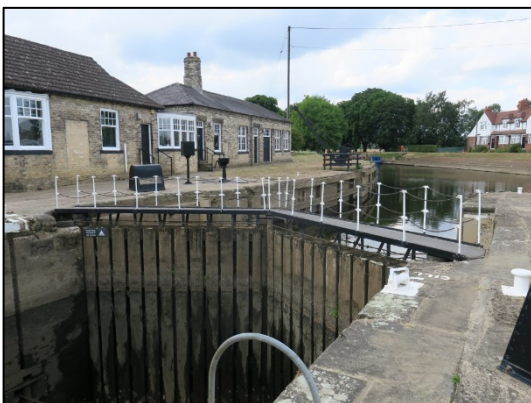
Photograph 5: Representative image of lock and buildings

- 3.9 The survey site is located within an island dominated by amenity grassland. To enter the survey area there is a leading pathway across a lock allowing access to the island.

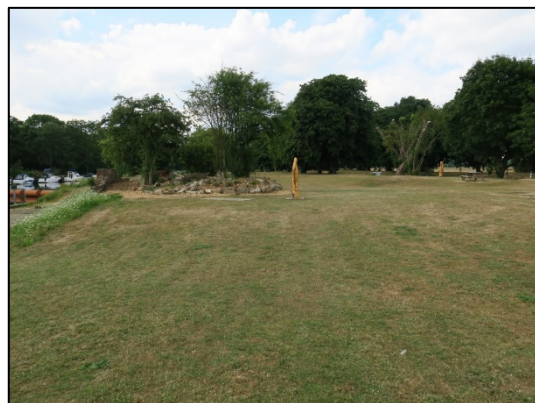
Photograph 6: Representative image amenity grassland around impact site

- 3.10 The survey area is surrounded by amenity grassland which is short and regularly mown throughout the growing season and comprises grasses such as perennial rye-grass *Lolium perenne* and red fescue *Festuca rubra* with occasional broadleaved herbaceous species such as dandelion *Taraxacum officinale agg.*, ribwort plantain *Plantago lanceolata* and greater plantain *Plantago major*.

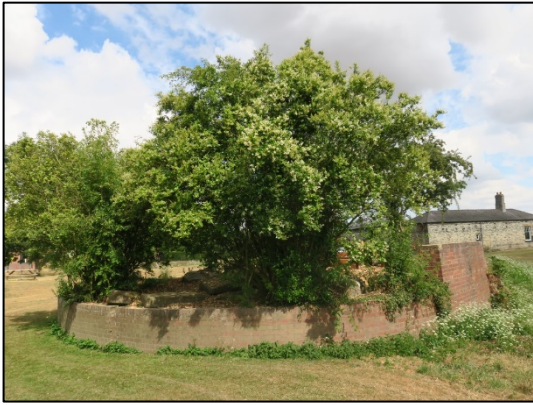
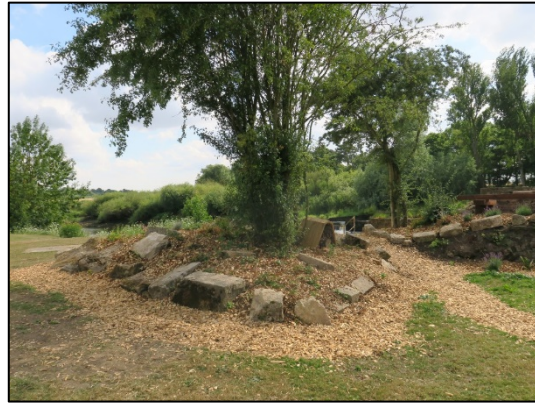
- 3.12 This area comprises ornamental planting contained within a brick retaining wall. There are a small number of mature hawthorns surrounded by ornamental plantings with woodchipping around the base of the trees.

Photograph 9: Representative image of ornamental plantings [B]

Photograph 10: Representative image of ornamental plantings [B]

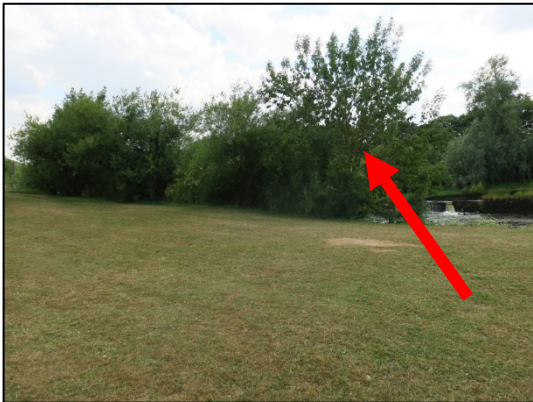
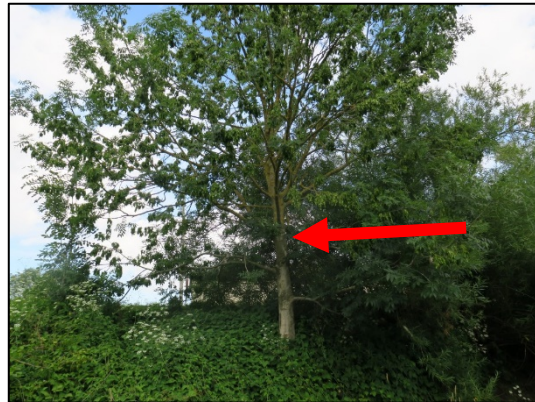
Photograph 11: Representative image of the ash tree at SE 59357 44549 [C]

- 3.13 Within this area of impact is a single semi-mature ash tree located on a top of a steep embankment. The area around the base of the tree is unmanaged, largely surrounded by coarse grasses and rank perennial herbs.

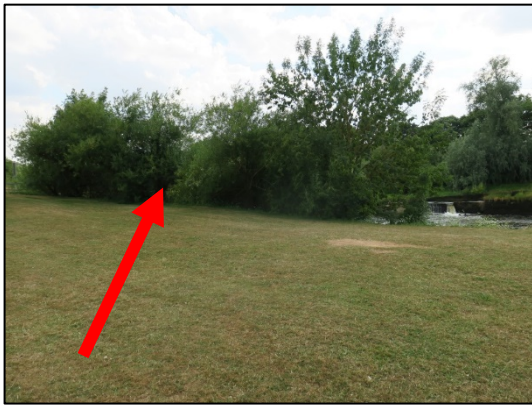
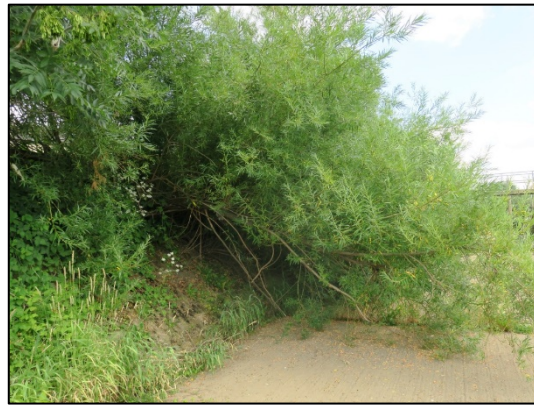
Photograph 13: Representative image of the willow trees [D]

- 3.14 Proposed works will impact on a row of c10 mature willow *Salix spp.* trees which have in the past been managed. The trees are approximately 5m tall and are located along an embankment. Habitats at the base of these trees are unmanaged, consisting mostly of coarse grasses and rank perennial herbs.

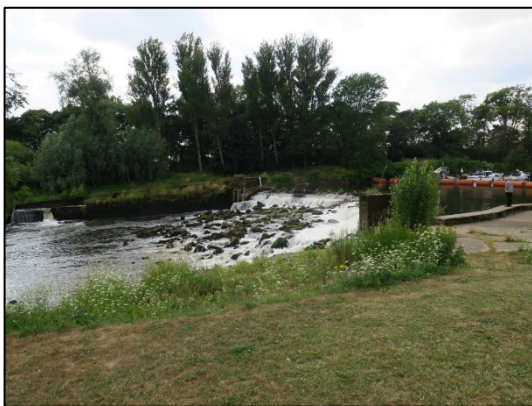
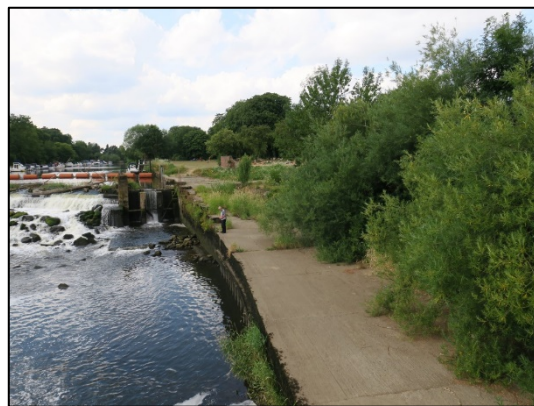
3.15 The location in which the turbine will be installed is dominated by amenity grassland with concrete hard standing. At the edge of the river there is occasional rough grassland with rank perennial herbs.

Photograph 15: Representative image of ornamental plantings [B]

Photograph 16: Representative image of ornamental plantings [B]

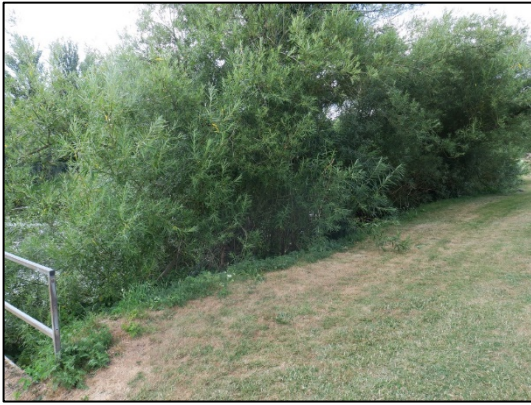
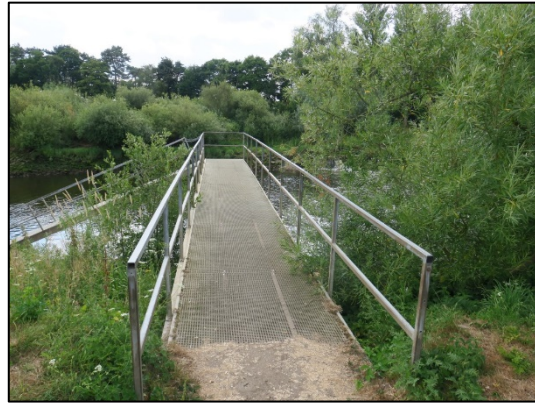
3.16 At the southern end of the impact area there are additional willows and a metal pontoon structure for pedestrian access to moorings.

Photograph 17: Representative image of ornamental plantings [B]

Photograph 18: Representative image of ornamental plantings [B]

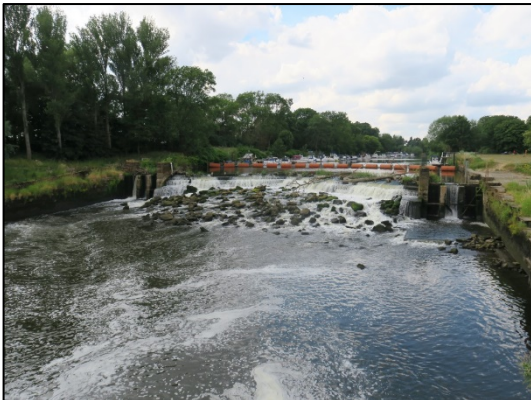
Photograph 19: Representative image of the stone work [J]

3.17 The weir consists of stone boulder with the remain of stonework where it meets the riverbank.

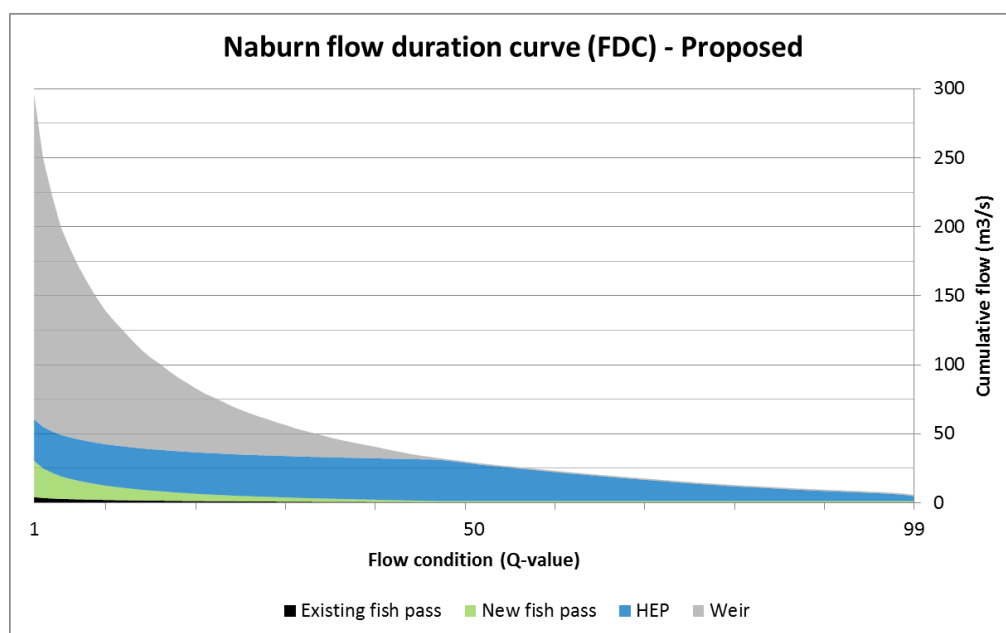
- 3.13. The flow duration curve for the site and hydropower scheme is shown below. During low flow conditions, the majority of flow currently passing over the weir will be diverted through the hydropower scheme. Once the hydropower scheme satiates at Q46, the weir flow quickly returns to being the dominant flow at the site.
- 3.14. Short sections of bank will be removed to create the new hydraulic channels, which will have an invert that is slightly raised above the bed level of the main channel.

- 3.15. At present during low to moderate flow conditions, the majority of flow passes over the weir, with a small proportion passing through the existing pool and weir fish pass. The average flow speed within the river is likely to be in the region of up to 5-30 cm/s, reducing to zero at the bed and bank edge. Immediately downstream of the weir is a sloped bank of rock protection, where the flow is faster and more turbulent.

- 3.16. In the proposed scenario, the majority of flow would pass through the hydropower scheme; flow through the existing fish pass would be slightly reduced and a flow of around 1 m³/s would pass through the new fish pass. The flow speed upstream of the intake will increase marginally due to the slightly lower water level, however this effect will not be significant. At the hydropower intake and outfall locations, the flow speed will be in the region of 10-40 cm/s. Immediately upstream of the weir and immediately downstream of the rock protection, and particularly near the right bank, average flow speeds may reduce to 1-5 cm/s.

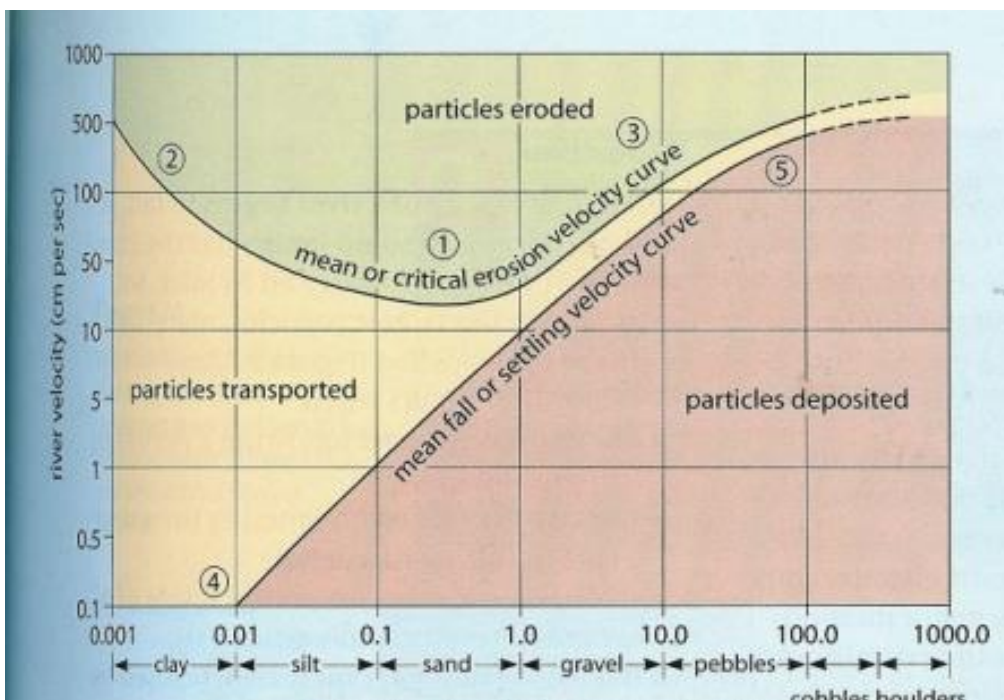
Fig. 3: Hjulstrom curve

- 3.18. With reference to the Hjulstrom curve, shown below, the change from 5-30 cm/s to 1-5 cm/s in areas close to the weir and right bank may result in some increased deposition of sands and fine gravels, along with reduced erosion of sands. There may also be a slight increase in deposition of coarse silts.

- 3.19. At the intake and outfall locations, the change will be approximately from 0-10 cm/s to 10-40 cm/s. This may result in reduced deposition of silts and sands along with increased erosion of sands. However the physical extent of this effect will be very limited.

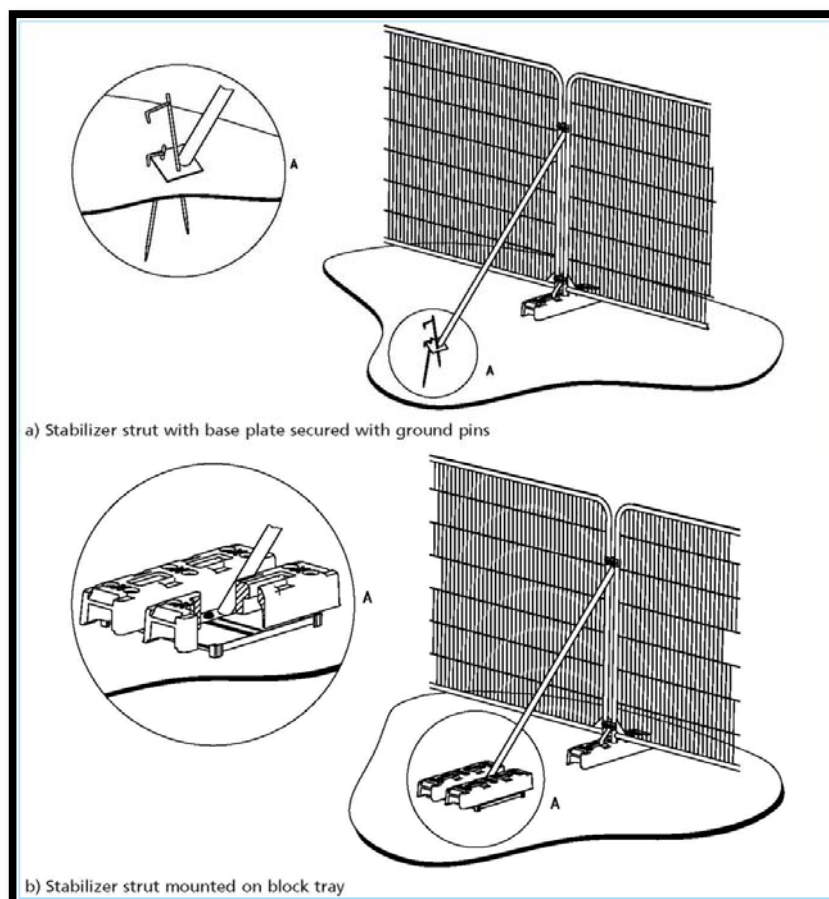
Specification: To comprise of 2m tall welded mesh panels on rubber or concrete feet. Panels are to be joined together using a minimum of two anti-tamper couplers, installed so that they can only be removed from inside the fence. The panels should be supported on the inner side by stabiliser struts, which should be attached to a base plate and secured with ground pins.

Signage denoting the words “*tree protection area*” at 5.0m intervals should be fixed to the protective barrier fencing (See Appended file).
