SALMON HARVESTER PROPERTIES LTD
DALES MANOR BUSINESS PARK, SAWSTON,
CAMBRIDGESHIRE
SUPPLEMENTARY GEOENVIRONMENTAL
ASSESSMENT REPORT

Document Ref: DMB/721750/R2/F
Date: August 2008
Revision: 0

Dales Manor Business Park, Sawston Supplementary Geoenvironmental Assessment Report

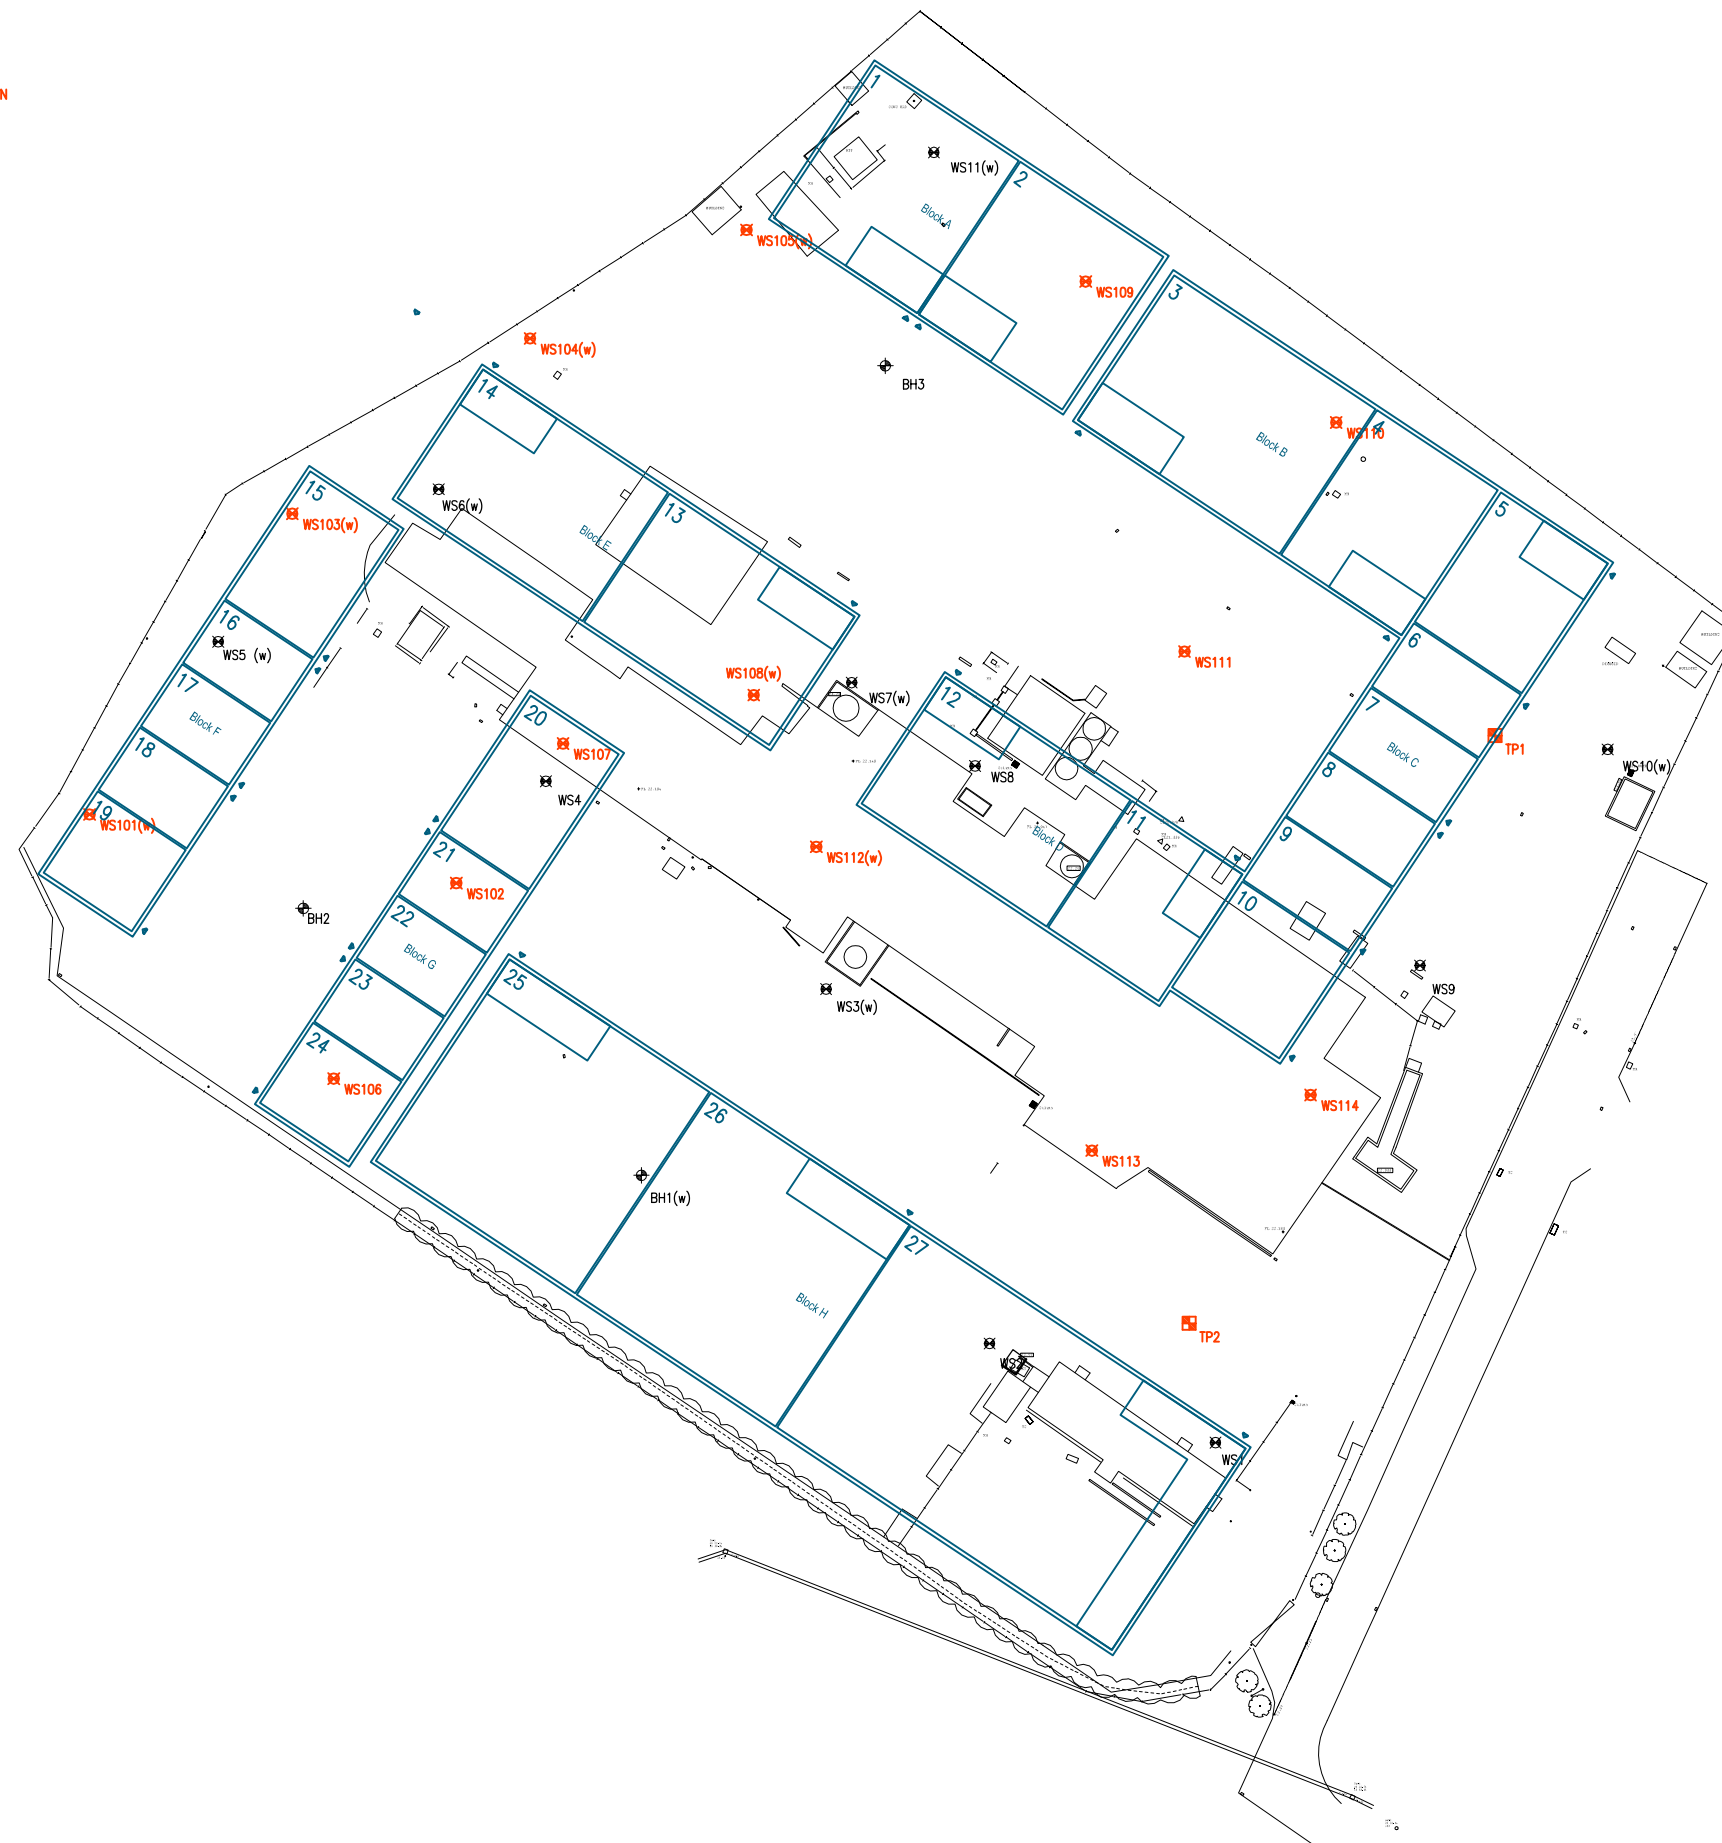
WS1 WINDOW SAMPLE BOREHOLE LOCATION

PROPOSED_S1
TP1 TRIAL PIT LOCATION

The locations of all exploratory holes were positioned by a MLME engineer to provide coverage of the site taking into account previous report findings, and the requirements of this supplementary investigation. The existing buildings, observed features, and underground services were also considered when positioning exploratory holes. The number of locations and sampling points are considered sufficient to identify potential site problems and provide an overview of site conditions.

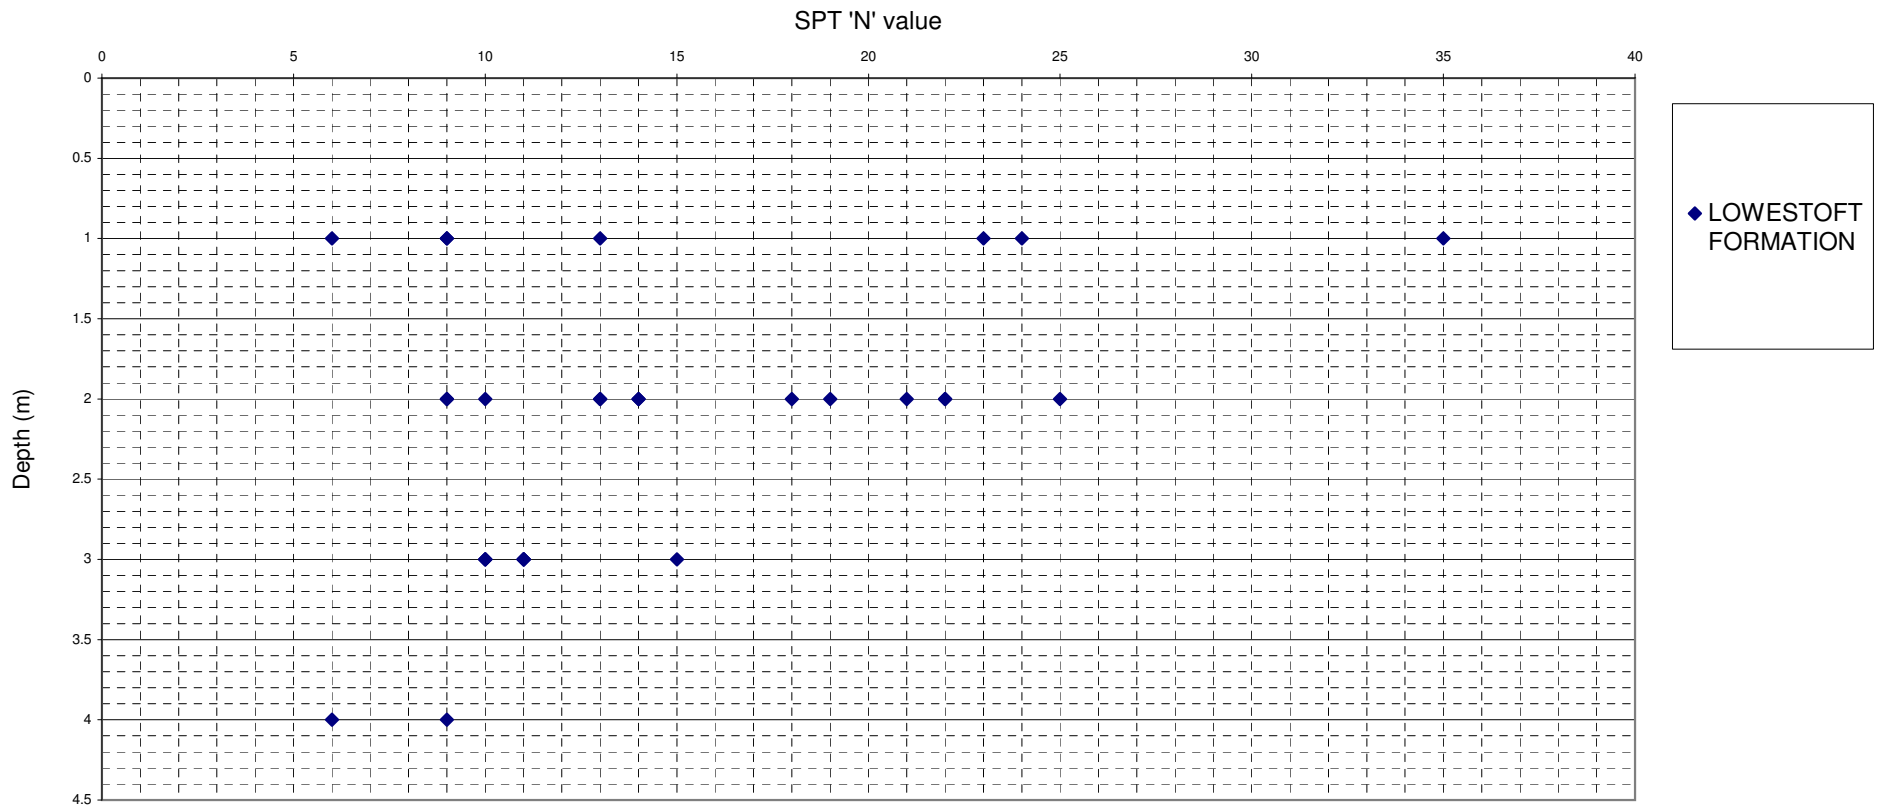
Figure: 5
Site: Dales Manor Business Park
Location: Sawston, Cambridgeshire
Job No. 721750

SPT 'N' VALUE vs DEPTH PLOT

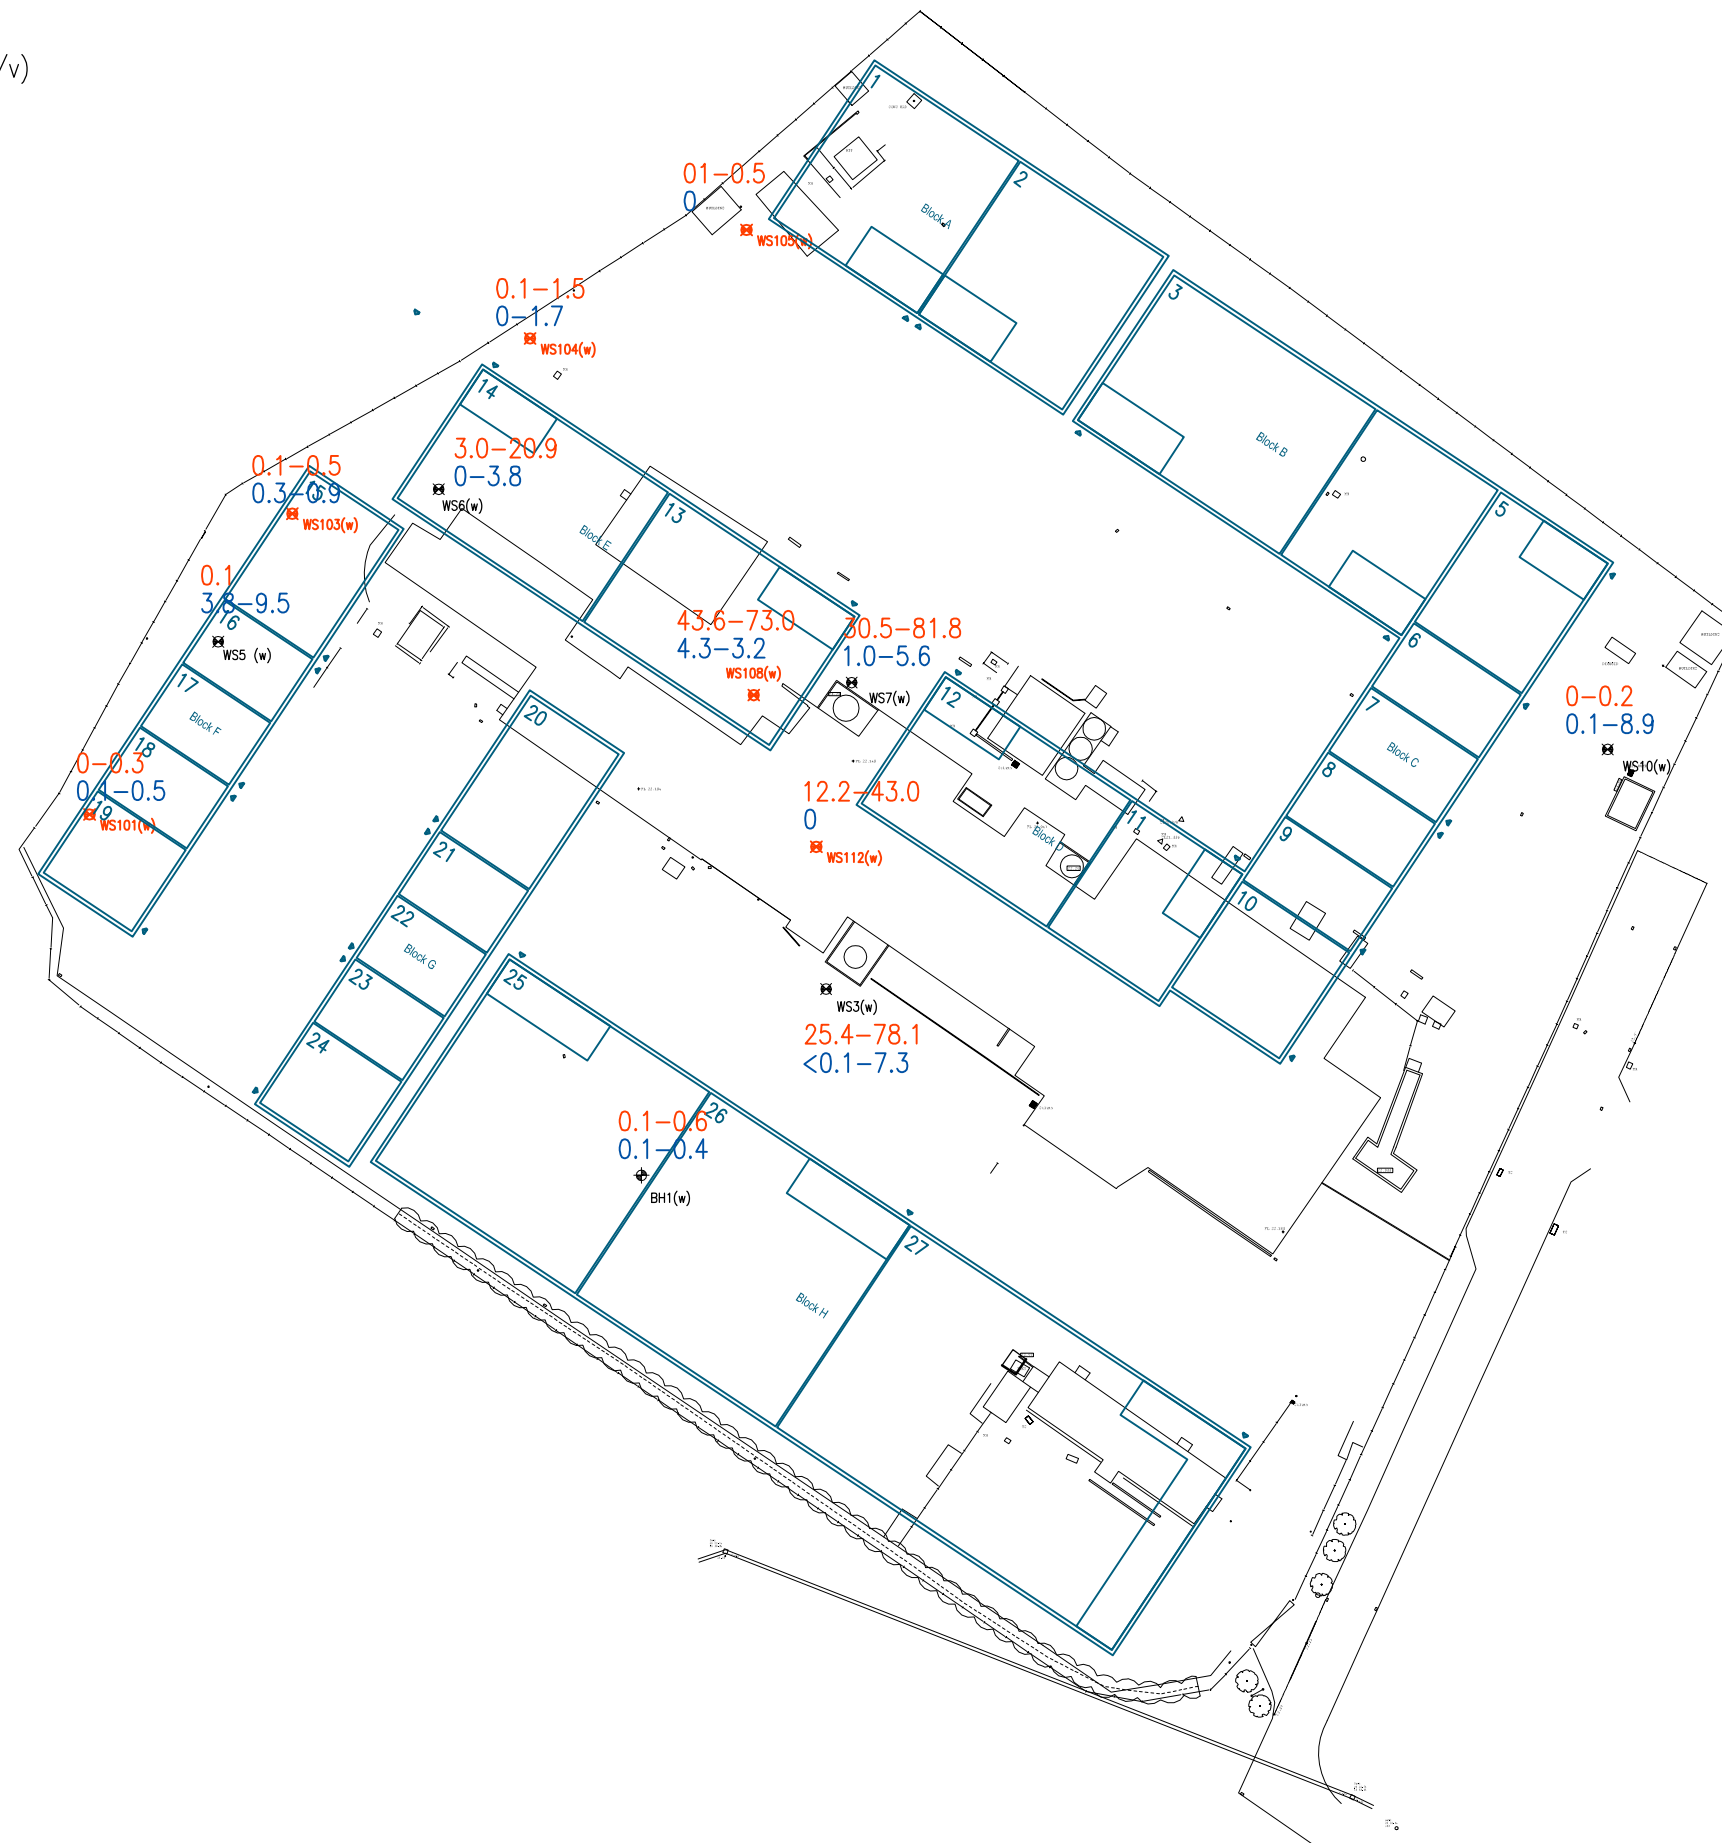
METHANE

CARBON DIOXIDE

- Following the removal of below-ground sumps, excavations should be validated to prove no significant contamination has occurred from past leakage.
- Gas monitoring during the investigation recorded elevated methane (maximum 81%) and carbon dioxide. Gas protection measures will be required within each building and over external areas of the site.

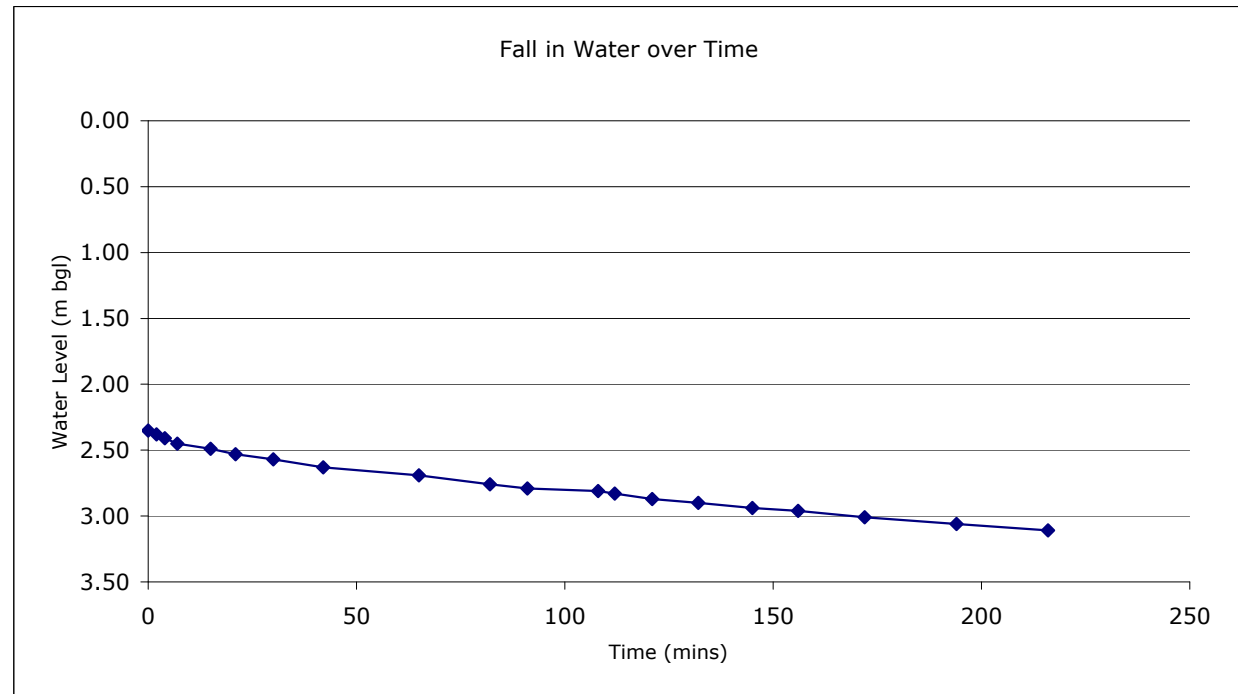
Test Location: **SA1**

Time (mins)	Water Level (m bgl)
0	2.35
2	2.38
4	2.41
7	2.45
15	2.49
21	2.53
30	2.57
42	2.63
65	2.69
82	2.76
91	2.79
108	2.81
112	2.83
121	2.87
132	2.9
145	2.94
156	2.96
172	3.01
194	3.06
216	3.11

Soil Infiltration Rate
1.6x10⁻⁵m/s

Remarks
1. Test Undertaken in general accordance with BRE Digest 365.
2. Trial pit was not filled with aggregate.
3. Stability was variable
4. Results were extrapolated to ensure water level reached 75% effective depth.

Location	Depth Range (m bgl)	Ground Conditions	Soil Infiltration Rate (m/s)
TP1	2.35 – 3.35	1.85 – 2.50 Silty, gravelly to very gravelly SAND 2.50 – 3.35 Structureless Chalk of Gravel fragments in a sandy silt matrix	1.6×10^{-5}
TP2	1.66 – 2.65	Structureless Chalk of Gravel fragments in a sandy silt matrix	1.0×10^{-5}
