R008 - Drainage Works Addendum

2513 - Drovers Way

Drainage Improvement Works – Addendum

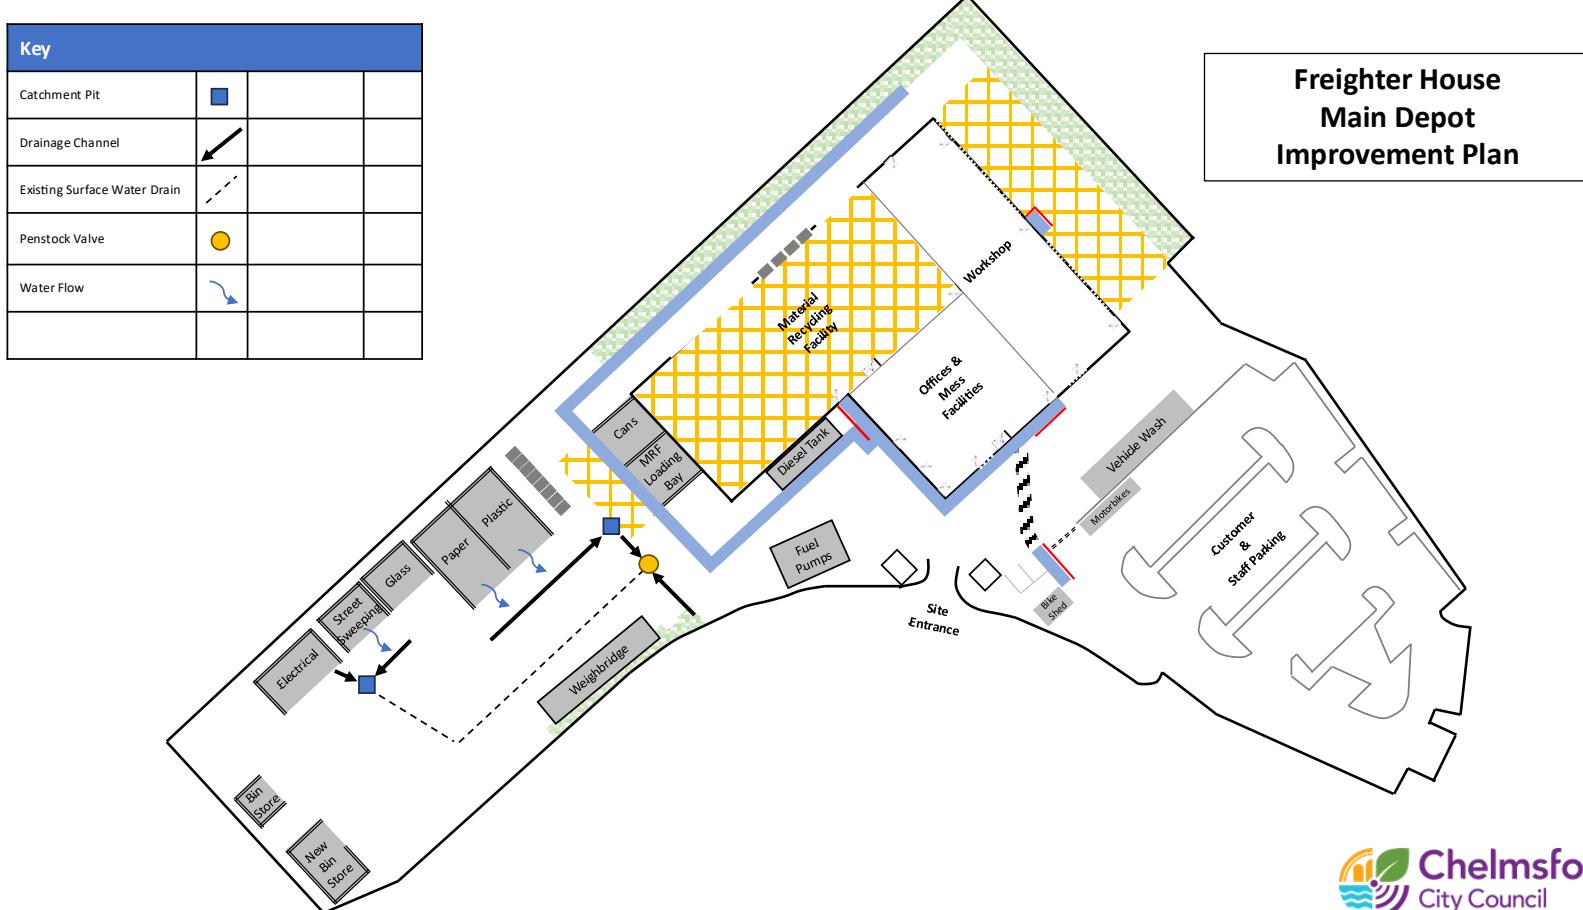
Appendix 1

Following a visit to site with representatives from AardvarkEM Ltd (environmental consultants) and the regulatory officer (28 May 2025) it was discussed that improvements to the sites drainage were required. A visual representation of the Improvement Plan for the drainage network is presented in Appendix 1. Improvements to the site drainage were carried out by a contractor, works commenced on the 1st September and were completed on 15th September 2025. A summary of the improvements carried out are outlined below

- Removal of the existing Aco drainage adjacent to road sweepings and electrical bay and replaced with a concrete lined trench dug to a depth of 700mm with a settlement chamber.
- Reinstatement of the drainage channel and installation of a catch pit in front off the paper and plastics bays
- Installation drainage at the entrance to the waste storage areas along with a penstock valve.

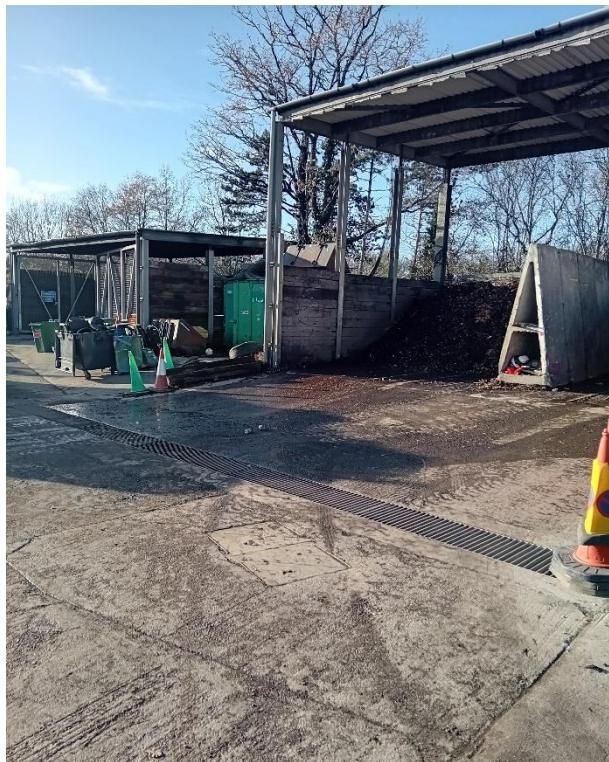
Figure 1. Street sweeping bay post- improvements

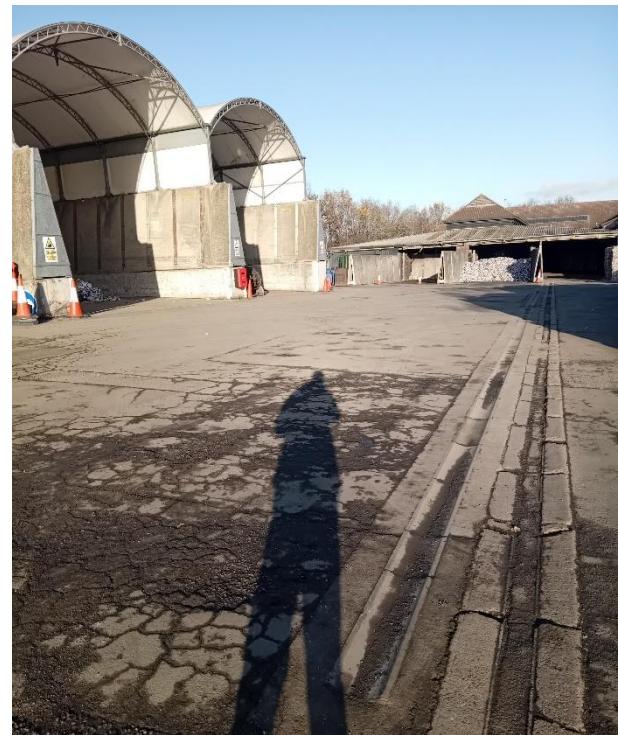
Figure 2. Reinstituted drainage channels along length of the site

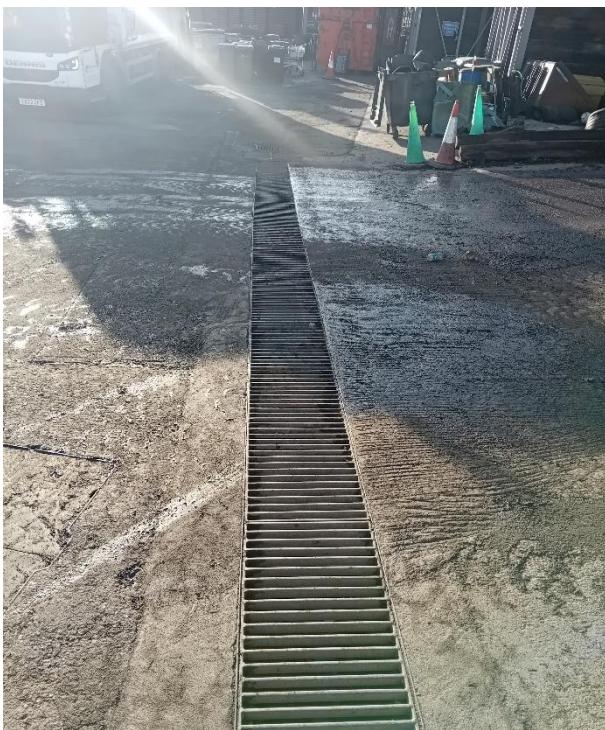
Figure 3. improved drainage channel adjacent to the street sweeping area

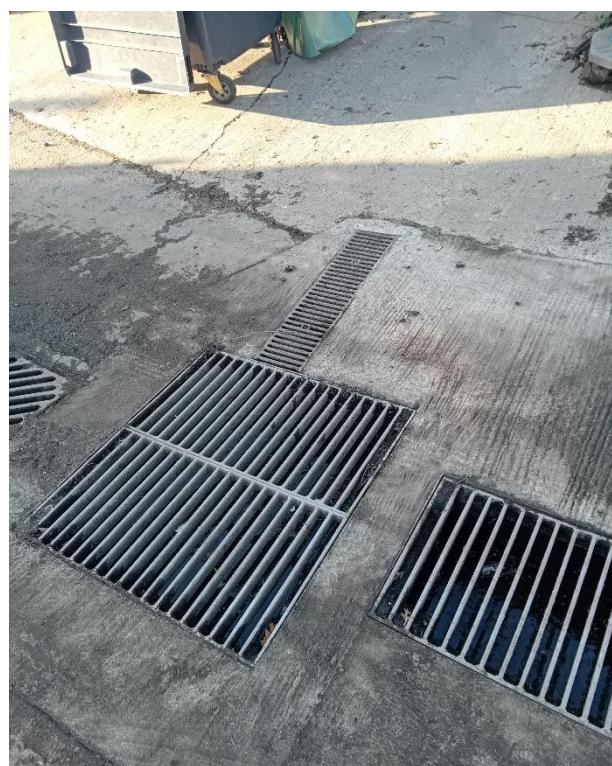
Figure 4. New drains that have been installed at the site

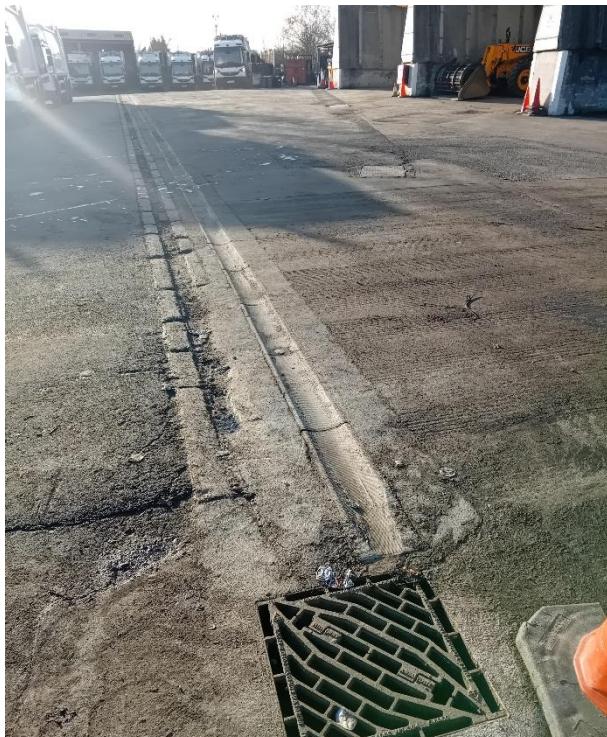
Figure 5. Reinstated drainage channels looking up the site

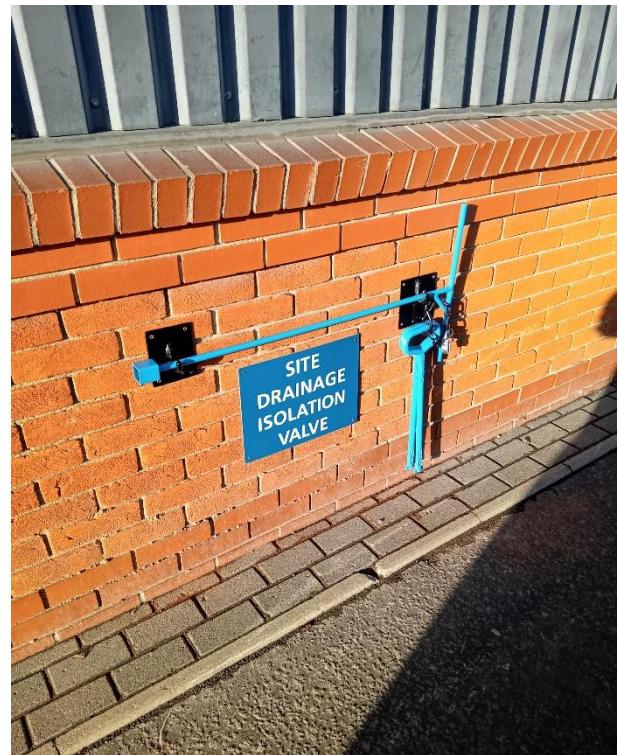
Figure 6. Installation of new penstock valve
