Freighter House
Chelmsford City Council
Environmental Permit Application
Site Condition Report

June 2025

Report Number: 2513-R003

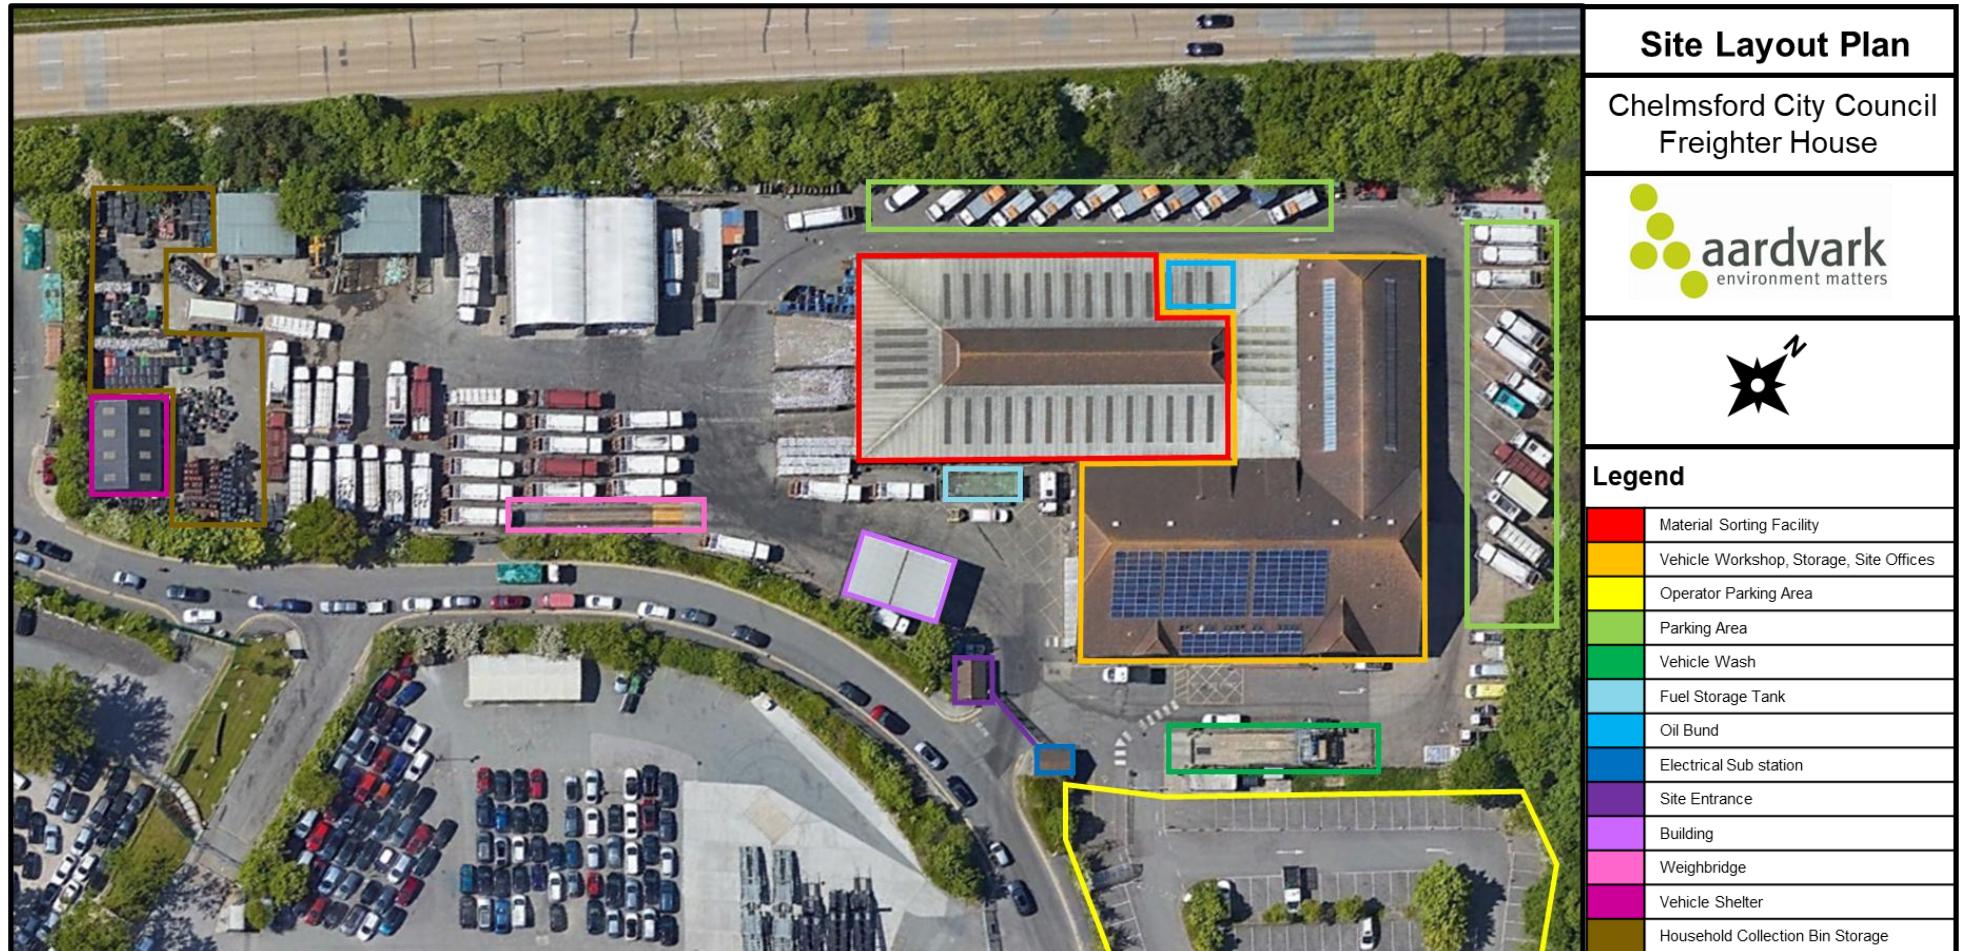
Figure 2: Site Layout Plan

Materials enter the site via the site entrance, controlled by an automatic number plate recognition (ANPR) barrier system, so only permitted vehicles may enter. Entrance to site is recorded and vehicles are cleaned, if necessary, using the onsite vehicle wash. Waste is weighed on its entrance and exit to the site, through use of the site weighbridge. Waste will then be sorted and transferred into the appropriate containment area ready to be processed and dispatched.

The large building to the north of the site contains the Material Sorting Facility (MSF) where metal cans/tins and also plastics can be compacted to form commercial bales. Materials pre and post compaction can also be stored in the building. This building also contains the vehicle workshop where all vehicles are inspected every 8 weeks, to maintain safety standards and ensure accordance with the Vehicle Operators License. Site storage in addition to the site offices and staff common areas are also housed in this building. Within the MSF area is a bunded oil storage area for waste oil from the facility.

The storage area to the south-west of the main building is an area of temporary storage, the area is usually empty however can be utilised to house excess waste. Alongside the main site building are multiple storage bays including the MSF infeed bay and baled waste bay for waste pre and post treatment in the MSF.

Storage bays for gas cylinders are positioned around the site. These include bays for orphan gas bottles, non-LPG and LPG bottles which are housed in separate locked cages at the top western corner of the site. Locked storage cages housing oxygen bottles and acetylene bottles are stored along the north-western perimeter of the site.

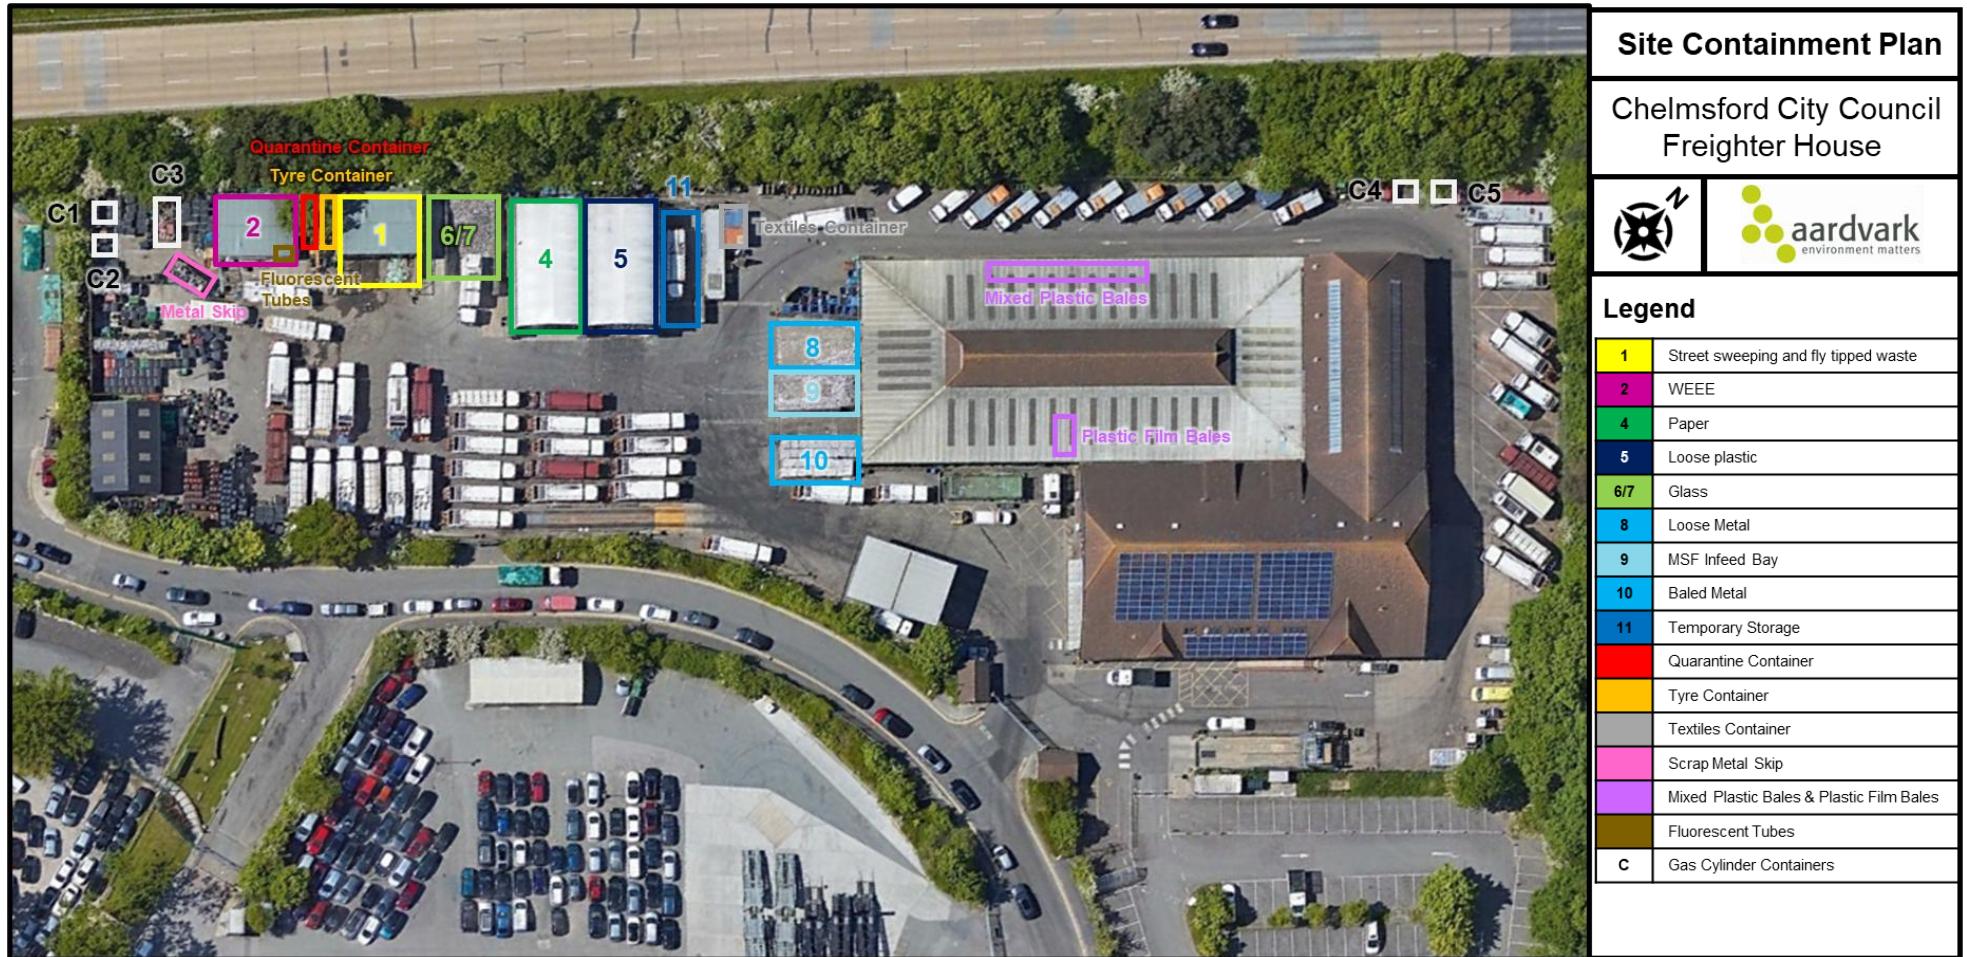
Figure 3: Site Containment Plan

The entire site is underlain by an impermeable surface. The main site area acts as a form of containment, the perimeter of the site being slightly raised in comparison to the main site area in the form of a perimeter kerb. A drainage system forms part of the containment, collecting in drains throughout the site before running towards the eastern corner of the site, on the boundary with the car park. Wastewater passes through a 3-stage interceptor before reaching the flow controlled discharge point.

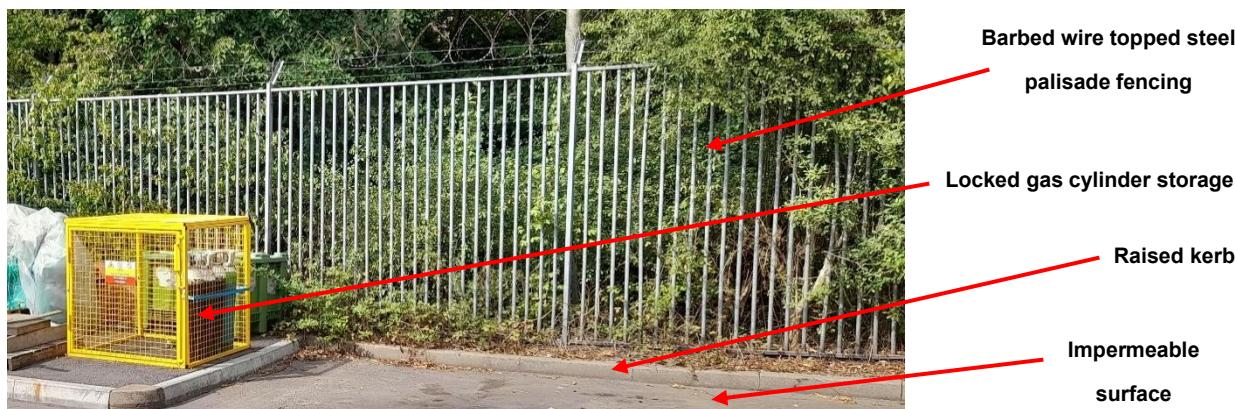
Figure 4: Key site features

Steel palisade fencing marks the boundary of the site, allowing any fugitive waste to remain within the site boundaries. Such litter can then be collected during site spot checks. The site is secured by a gated entrance off Drover's Way. CCTV covers the site entrance, perimeter and key points around the site. The steel fencing, CCTV and gated entrance is designed to deter trespassers.

Below we can see some of these features pictured in Figure 3.

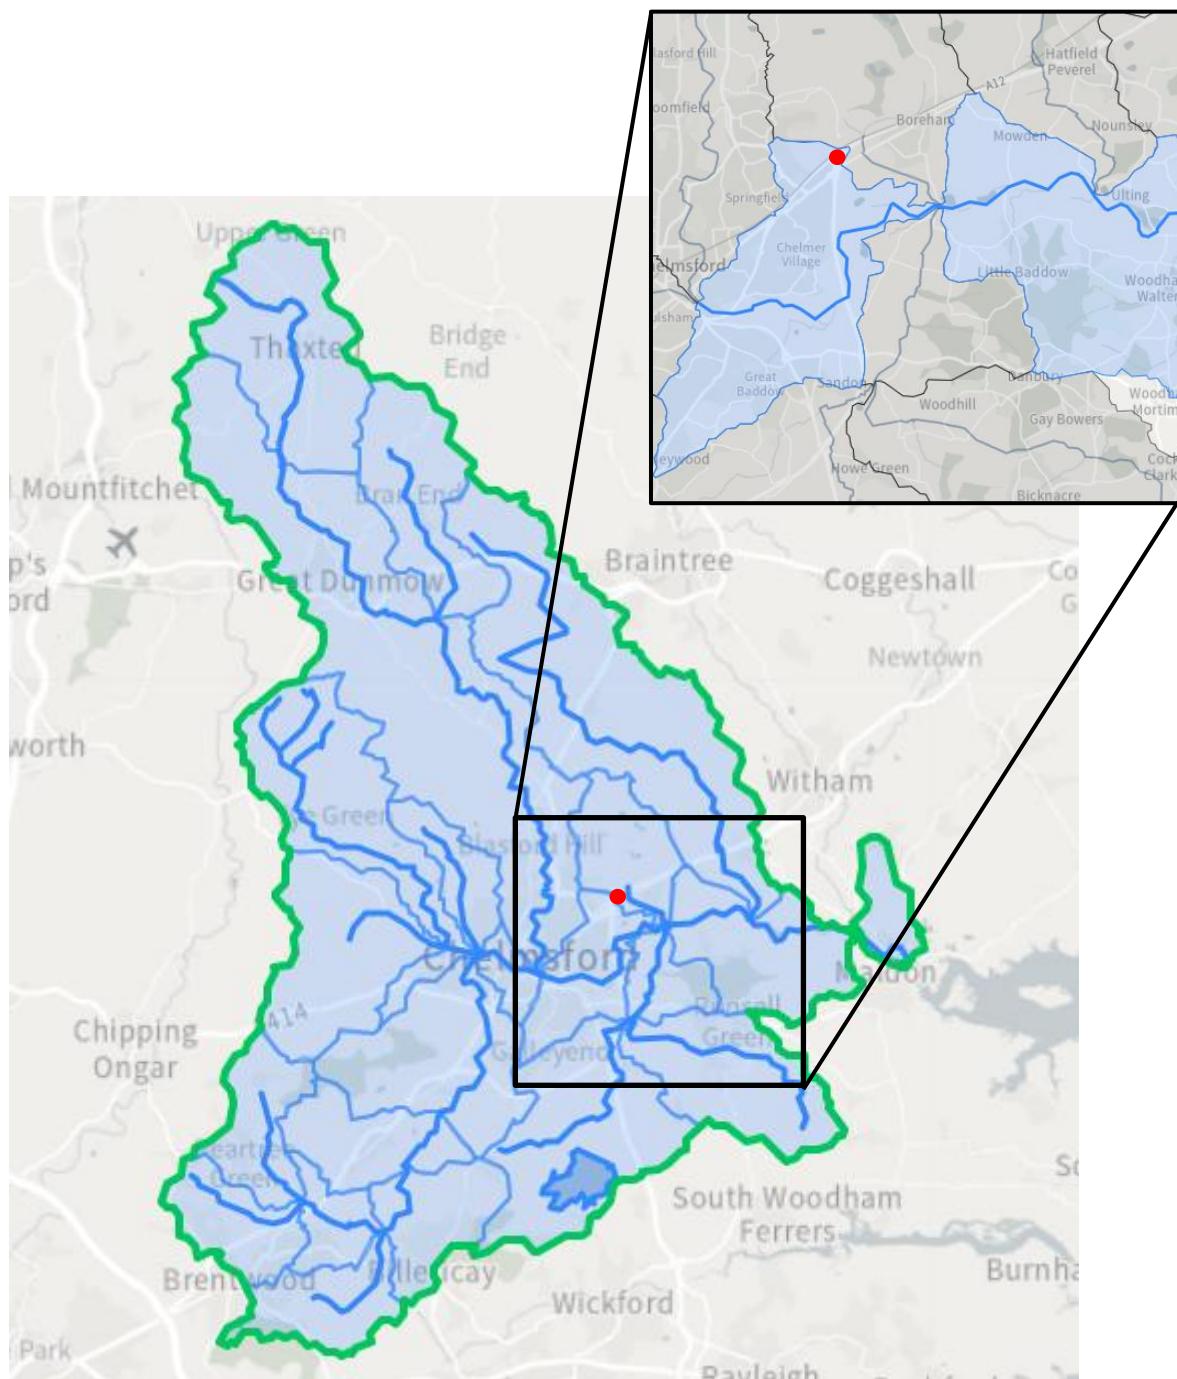
Appendix 1 – Catchment Map

Located within the Chelmer operational catchment, within the Chelmer (d/s confluence with Can) water body (A map of the catchment is provided in Appendix 1). Soilscape soil typing mapping indicates soil type to be freely draining (please see Appendix 2 for the map data).
