## Q95 Estimate

As stated in the H1 tool, there is no publically available Q95 data on the unnamed tributary of the River Chelmer that EMR Boreham discharges into and no sampling points on this waterway listed on the Water Quality Archive (<https://environment.data.gov.uk/water-quality/view/explore?search=&area=1-2&samplingPointType.group=&samplingPointStatus%5B%5D=open&loc=&limit=500>). Therefore, two nearby waterways of an apparent similar size were investigated (Sandon Brook at Sandon Bridge (<https://nrfa.ceh.ac.uk/data/station/meanflow/37013>) and the River Ter at Crabbs Bridge (<https://nrfa.ceh.ac.uk/data/station/meanflow/37003>) and were found to have Q95 flow rates of 0.034 m<sup>3</sup>/s and 0.035 m<sup>3</sup>/s respectively. Upon examining photos of the two nearby waterways (see below) and photos of the unnamed tributary that EMR Boreham discharges into, it appears that the unnamed tributary that EMR Boreham discharges into is less than half the size of the Sandon Brook at Sandon Bridge and the River Ter at Crabbs Bridge. Therefore, the Q95 for this unnamed tributary, when flowing, has been conservatively estimated as 30% of the known Q95 of Sandon Brook at Sandon Bri

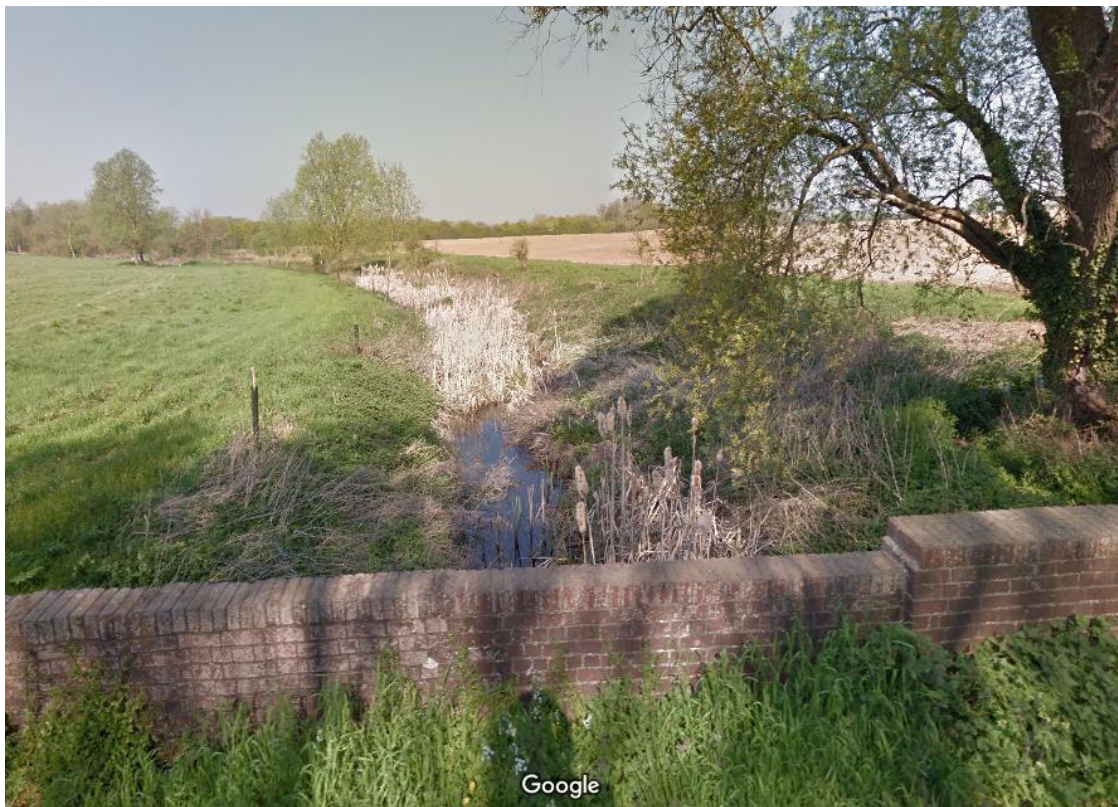
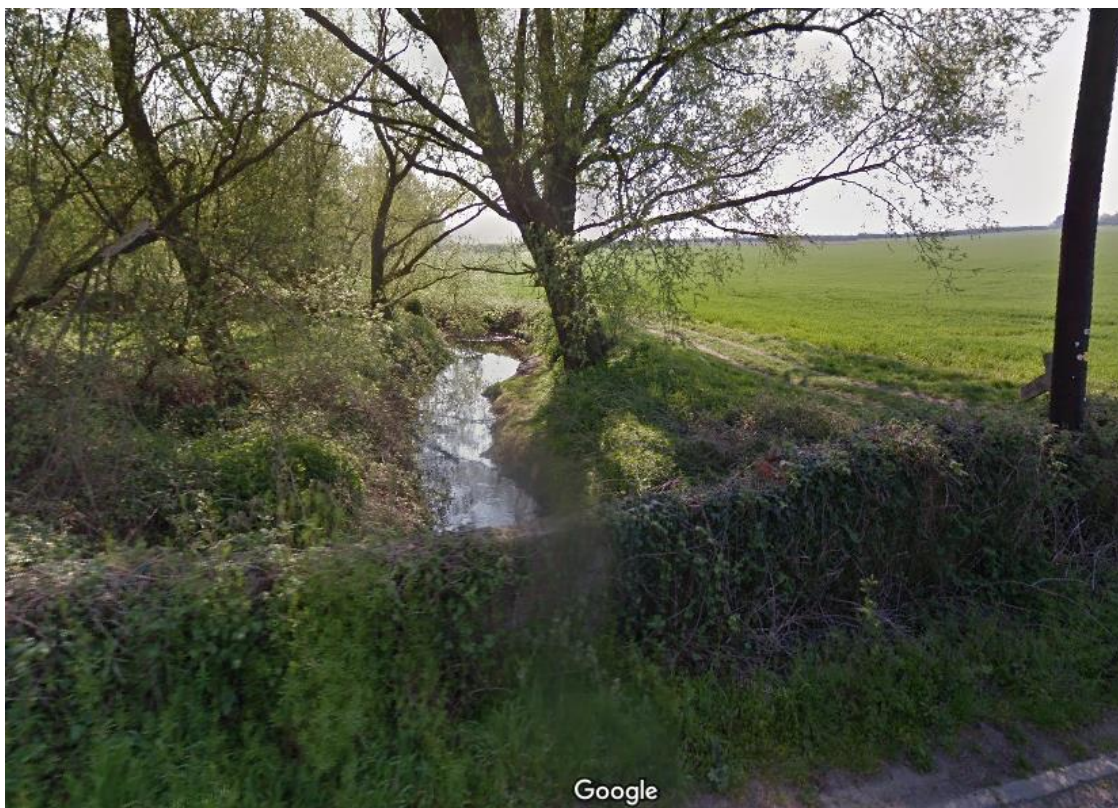
Google Images of River Ter at Crabbs Bridge (month and weather unknown):

As seen, the unnamed tributary of the River Chelmer that EMR Boreham discharges generally into looks smaller than the Sandon Brook at Sandon Bridge and River Ter at Crabbs Bridge, both of which look to be a similar size and is reflected in their similar Q95's.

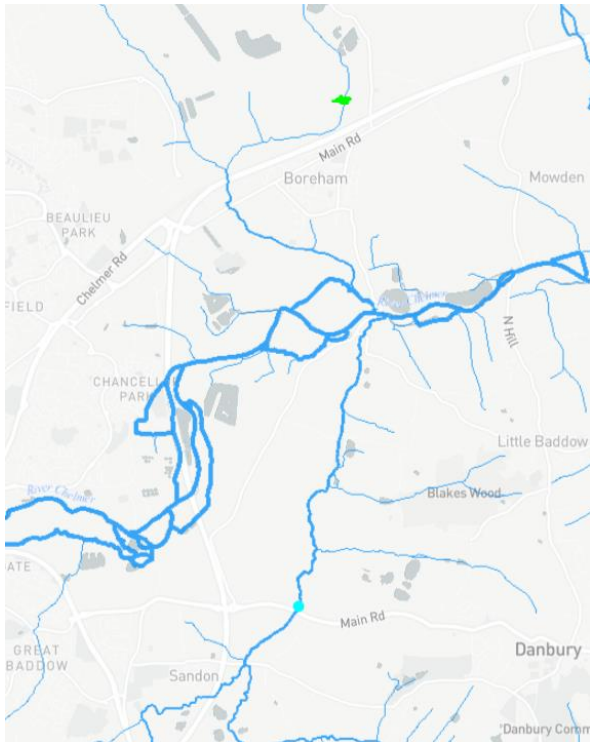
Map 2. Green dot showing EMR Boreham discharge point, blue dot showing Sandon Bridge sampling station on the Sandon Brook.

Approx. 5.4 km away from EMR Boreham discharge point (see Map 2.) is the river gauging point on another similar tributary of the River Chelmer. See Google images of the river below

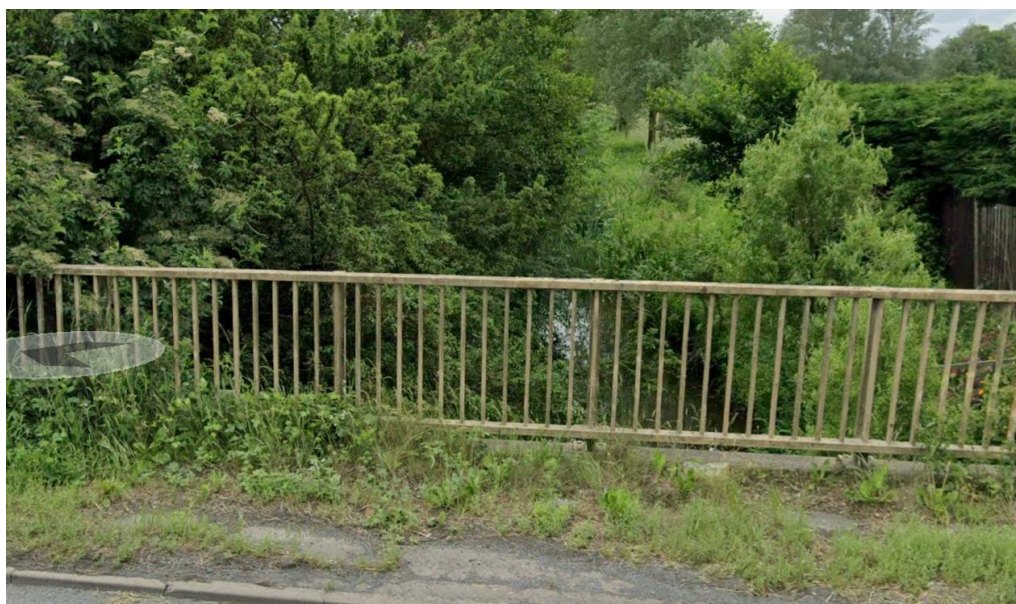
Google Image of Sandon Brook at Sandon Bridge (month and weather unknown):

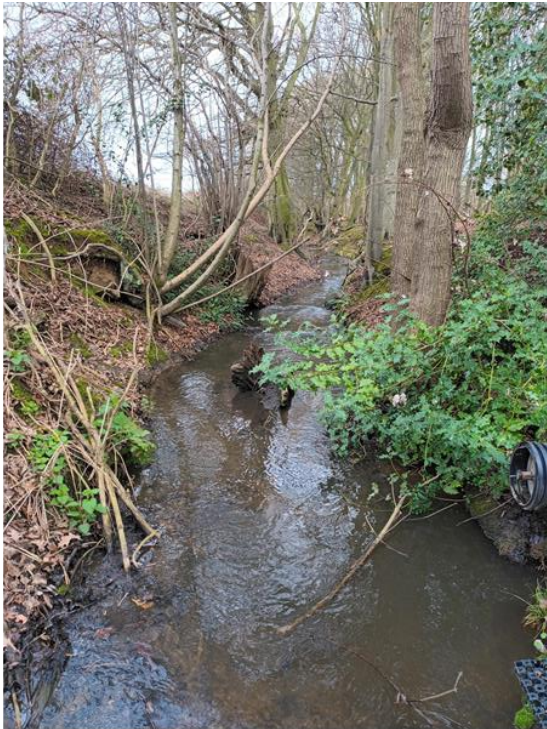
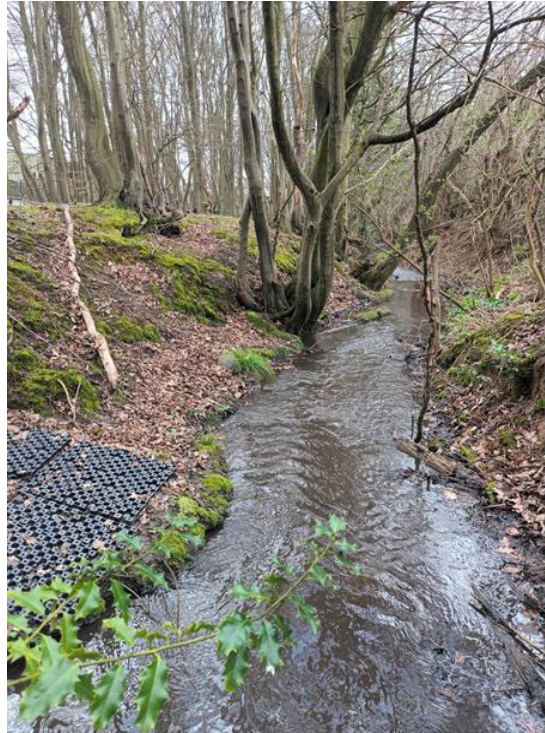
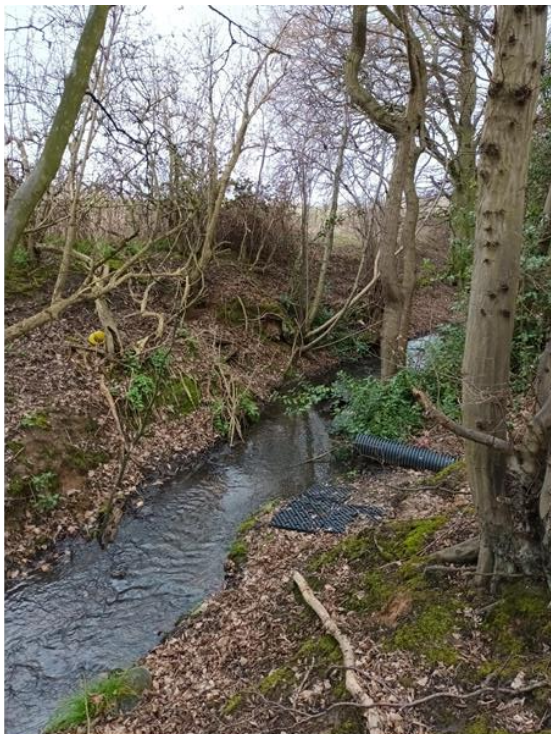
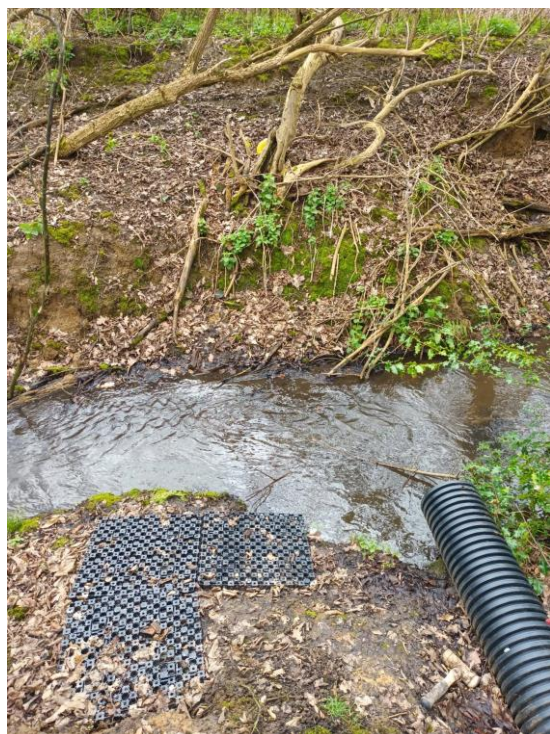
Photograph of discharge point in March following rain.

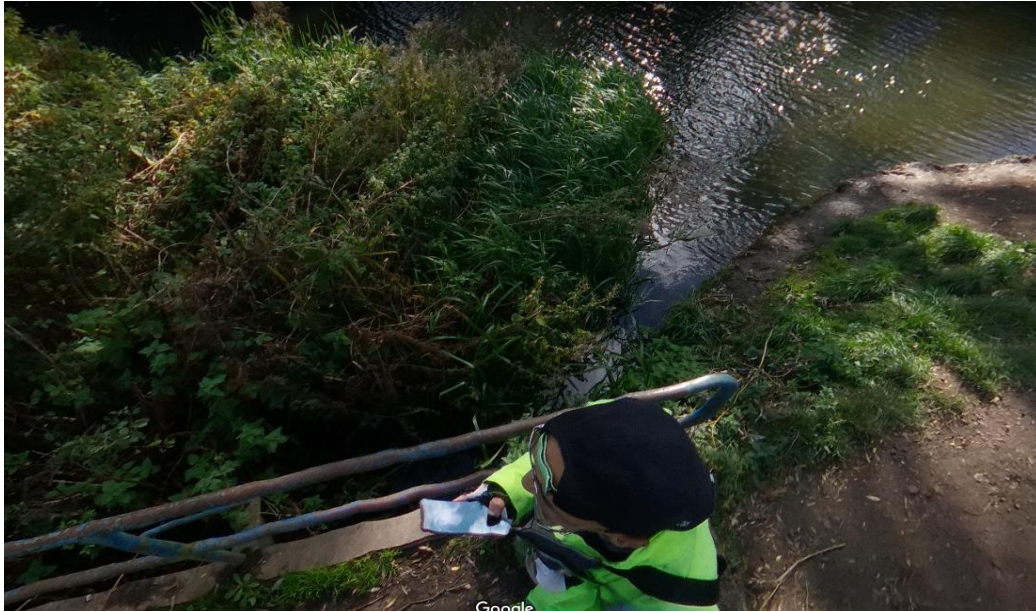
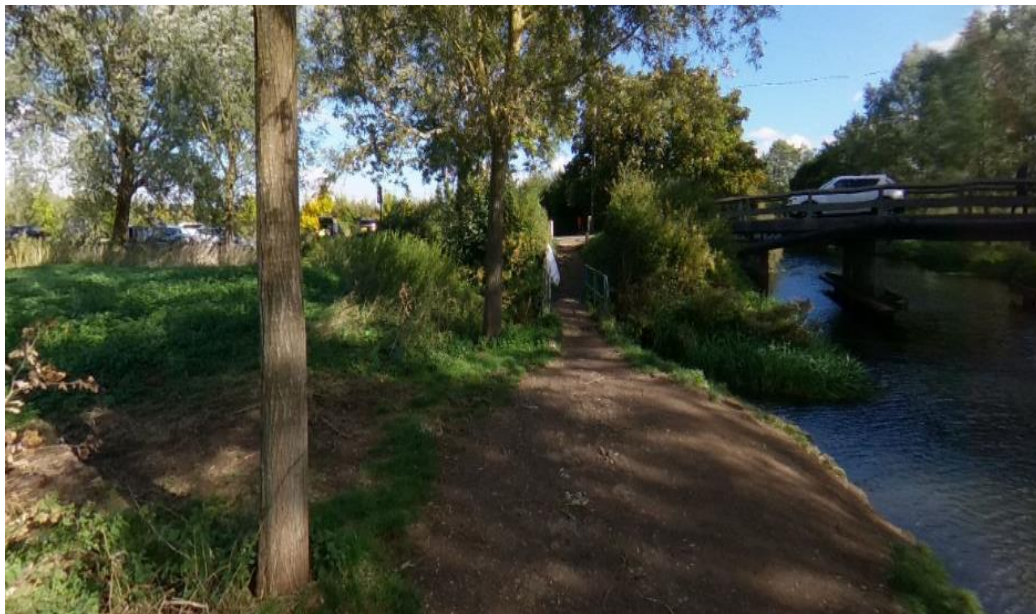
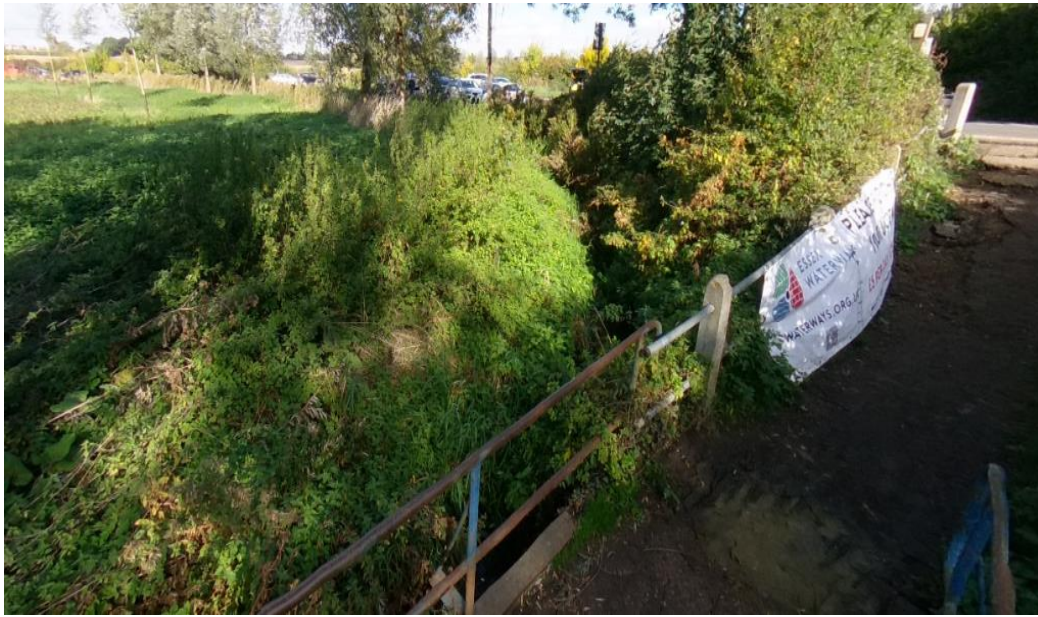
Google images where the unnamed tributary (that EMR Boreham discharges into) enters the River Chelmer (month and weather unknown).

Therefore, the Q95 for this unnamed tributary, when flowing, has been conservatively estimated as 30% of the known Q95 of Sandon Brook at Sandon Bridge. 30% of 0.034 m<sup>3</sup>/s is 0.0102 m<sup>3</sup>/s (10.02 l/s).
