Stage 1: Tier 2 Site Investigation GQRA

Project Reference: P25.114.GQRA
KAO Data Centre – KLON-03

JCA

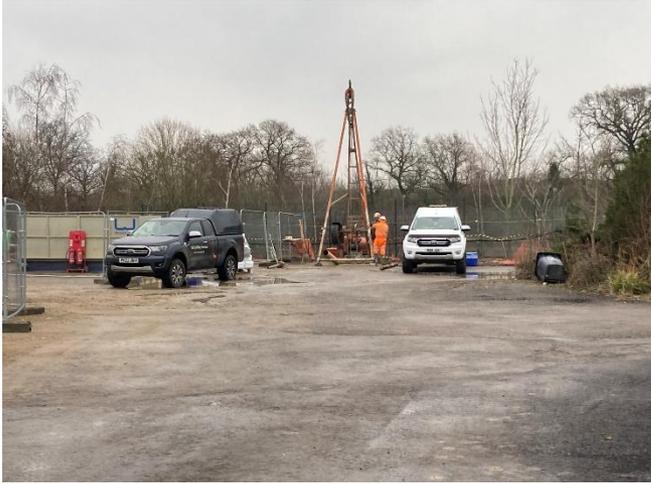
Project:	KAO Data Centre	Title:	Site Photographs
Job Number:	P25.114	<ol style="list-style-type: none"> 1. BH1 2. BH1 starter pit 3. BH1 arisings 4. BH2

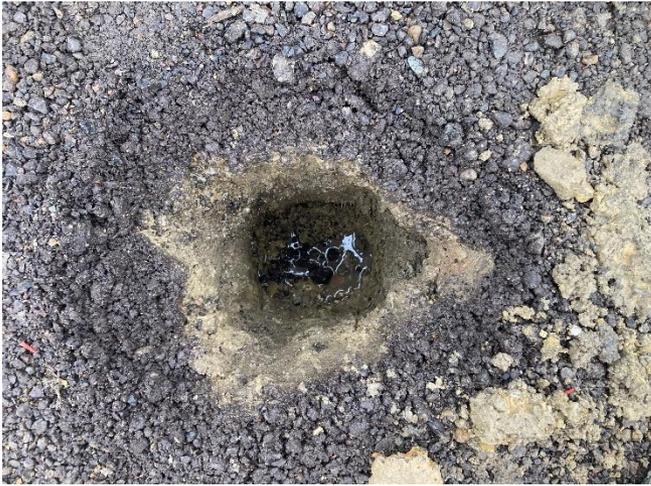
Project:	KAO Data Centre	Title:	Site Photographs
Job Number:	P25.114	5. BH2 starter pit 6. BH3 7. BH1 monitoring standpipe 8. BH2 monitoring standpipe

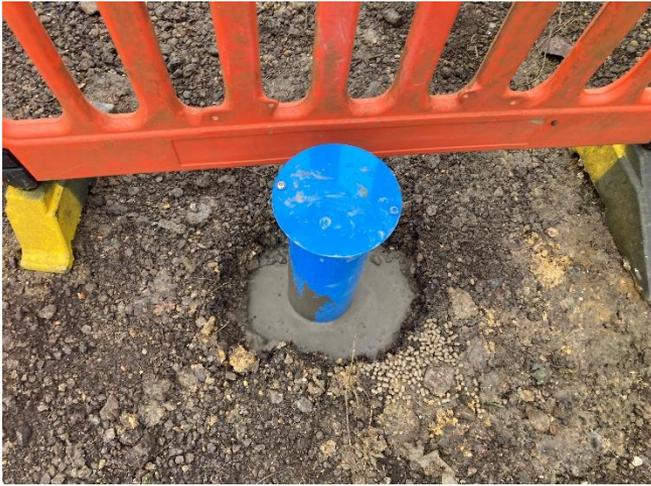
Project:	KAO Data Centre	Title:	Site Photographs
Job Number:	P25.114	9. BH3 monitoring standpipe 10. WS1 11. WS1 arisings 12. WS1 GL to 3.00mbgl

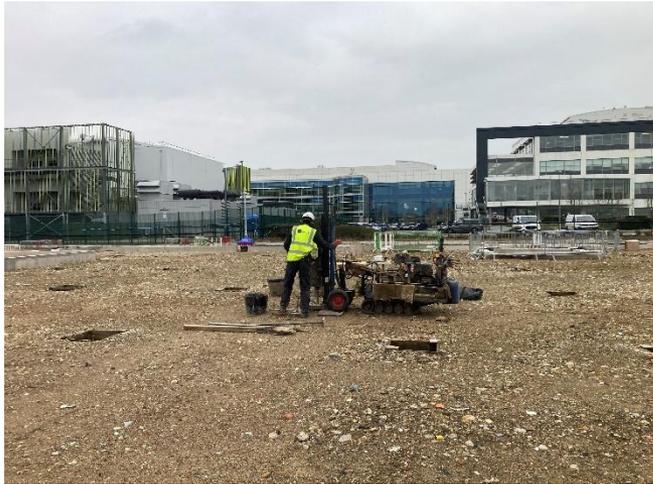
Project:	KAO Data Centre	Title:	Site Photographs
Job Number:	P25.114	13. WS2 14. WS2 arisings 15. WS2 GL to 3.00mbgl 16. WS3

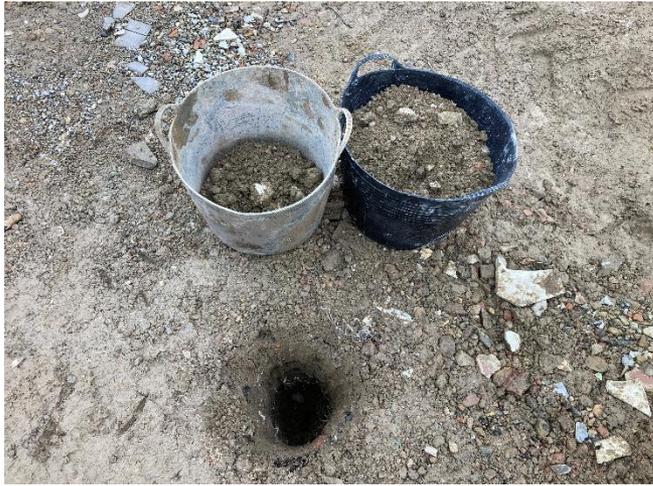
Project:	KAO Data Centre	Title:	Site Photographs
Job Number:	P25.114	17. WS3 arisings 18. WS3 GL to 3.00mbgl 19. WS4 20. WS4 arisings
