# Interim Baseline Report

Project Reference: P25.114.BLR  
**KAO Data Centre**

**JCA**

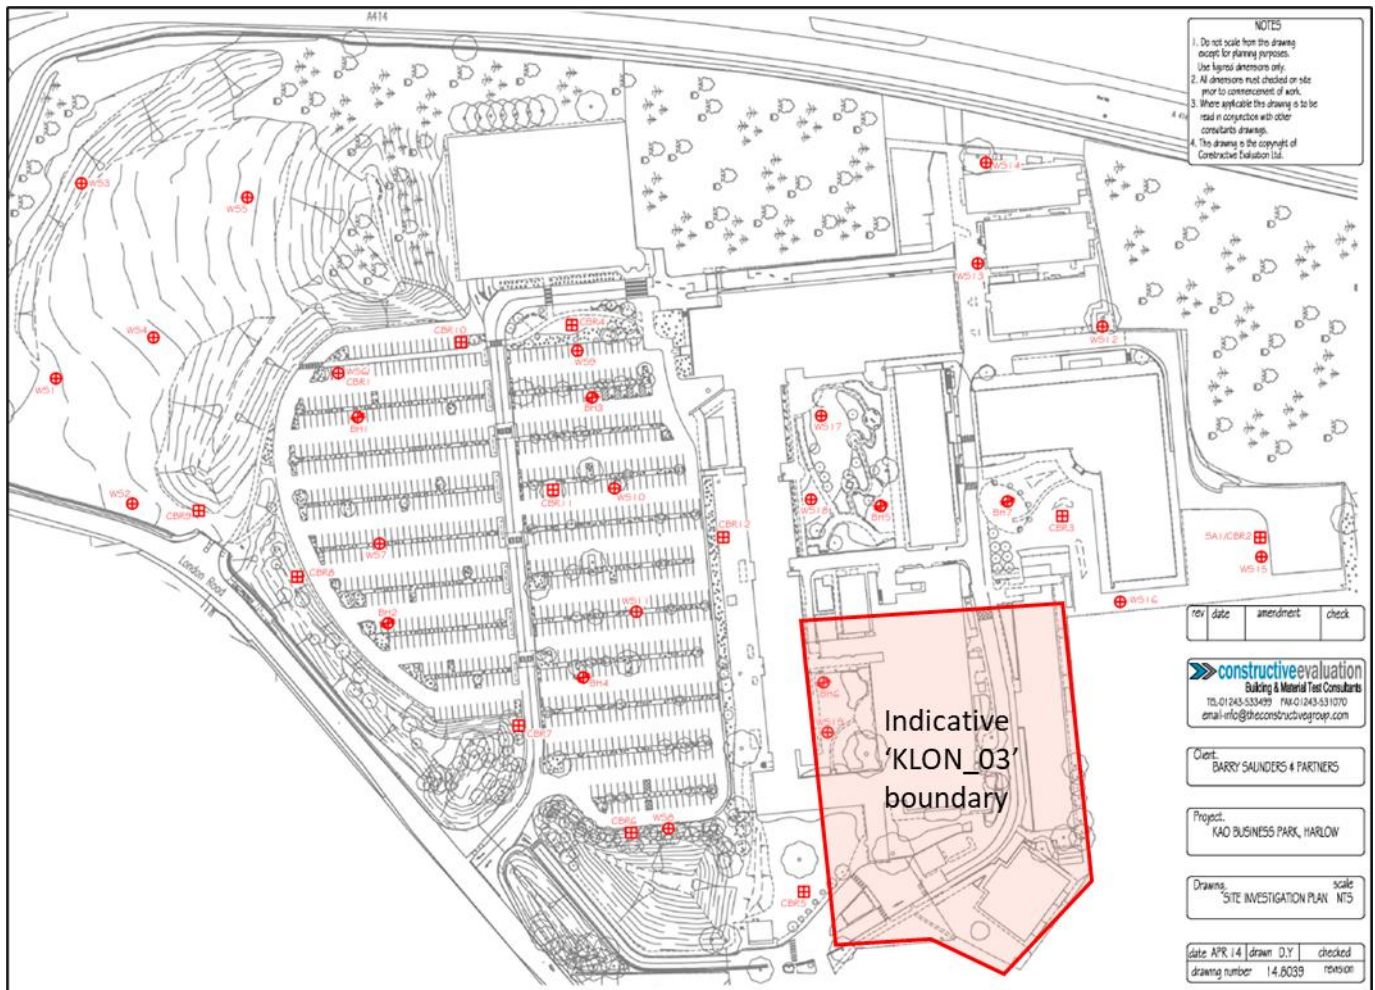
Image 6.2: Hole Location Plan for CE 2014 Intrusive Investigation (Ref: 14.8039, Dated: May 2014) (with KLON\_03 outlined)

- 7no. cable percussive boreholes (BH1-BH7) to a maximum depth of 20.00mbgl.
- 19no. lightweight window sample boreholes across the site (WS1-WS19).
- 22no. Clegg Impact tests were completed within twelve trial pits (CBR1-CBR12) to enable the calculation of CBR values.
- 2no. bespoke soakage tests.
- All locations were logged, groundwater conditions and visual or olfactory evidence of contamination noted and representative soil samples removed in accordance with current protocol for contamination and geotechnical parameters.

A hole location plan for the aforementioned investigation is presented below (overleaf).
