Worms Heath Restoration Limpsfield Road

Hydrogeological Risk Assessment

**CES557 LIMPSFIELD FLOOD
MODELLING REPORT**

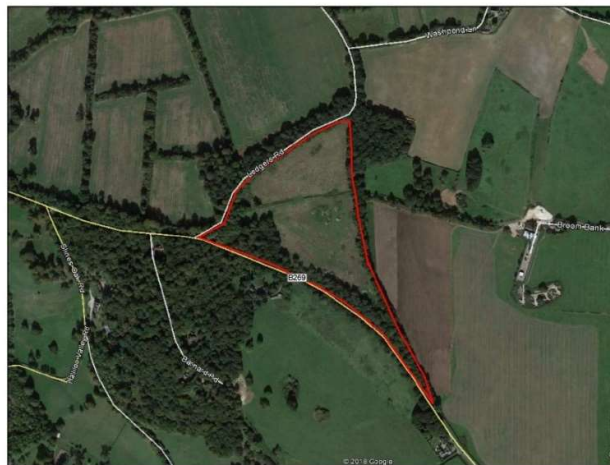
Figure 1: Google Earth site boundary

The site is approximately 9.5ha and includes 3.0ha of woodland, mainly along the southern boundary, but also along the other boundaries. The remainder of the site is an open field that gently slopes down towards the north-west. There is a public bridleway that runs east to west across the site.

The site is shown by the red boundary in Figure 1 above.

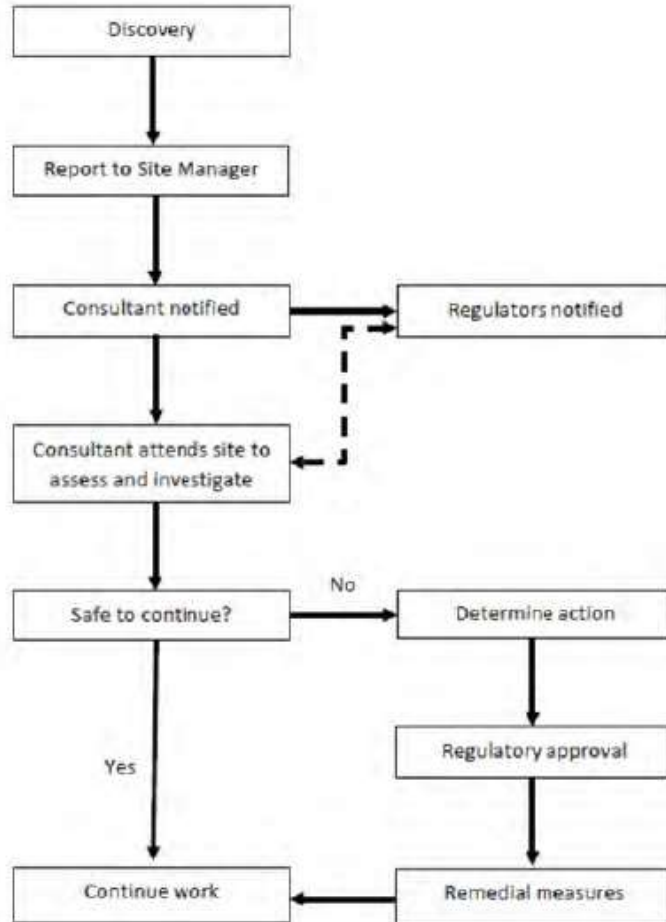
Chart 1 Discovery Strategy Process

- A record will be produced by the Consultant and held on site (with copies held by the Consultant, Client and Local Authority/other relevant organisation), detailing the discovery, assessment works undertaken, findings thereof, confirmation either of no action required or detailing the remedial action taken and validation thereof.

The process is shown below.

A copy of this discovery strategy will be provided on site (within the EMS) and provisions made to ensure that all site personnel are made aware of their responsibility to observe, report, and act on any potentially suspicious, abnormal unforeseen or contaminated soils/ground they may encounter.

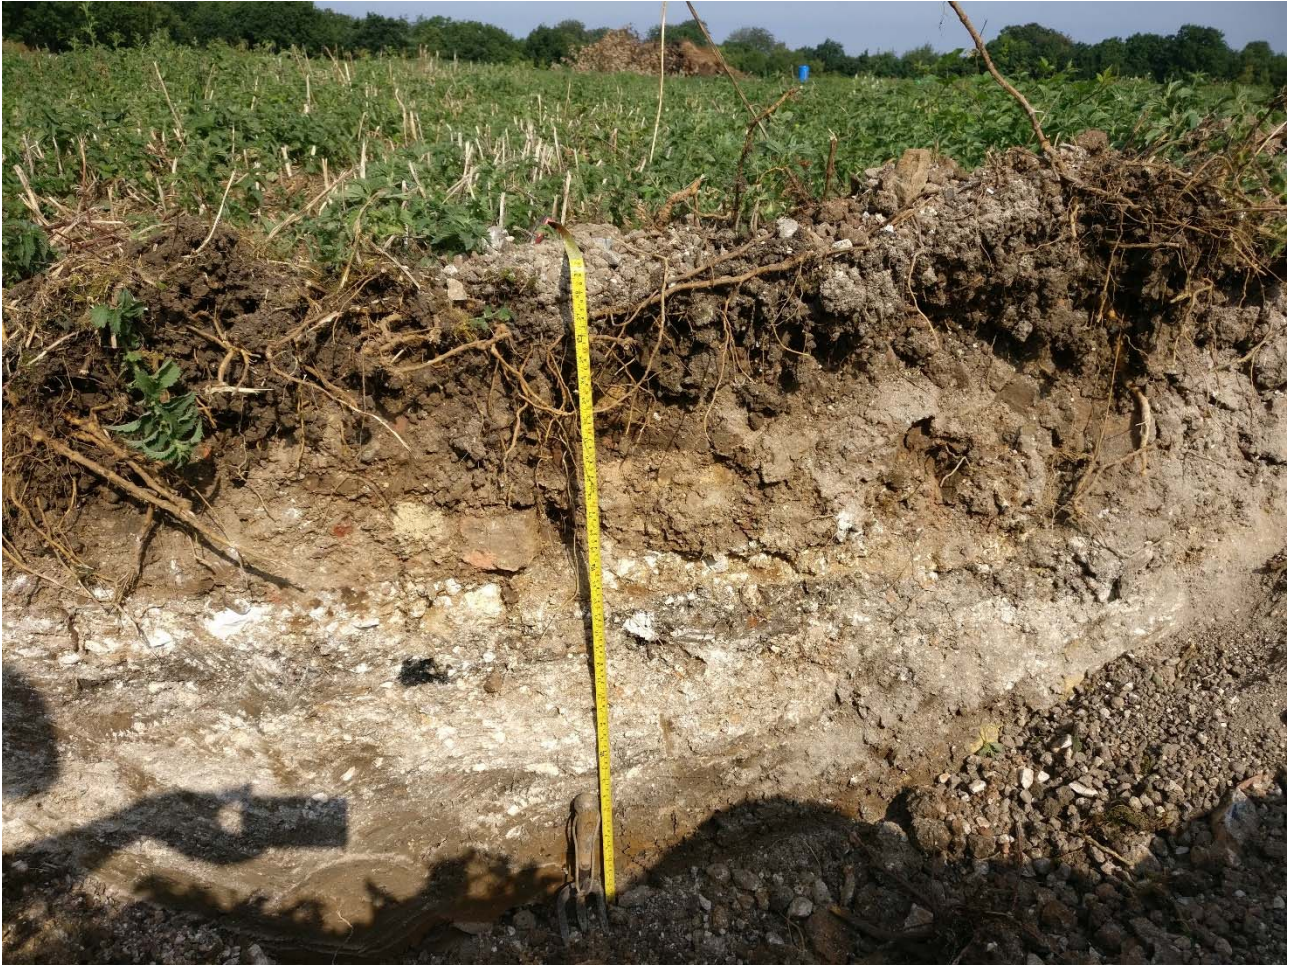
Appendix 2

- 2.10 Pit 1 was excavated in the south of the site. A photograph of pit 1 is shown at Appendix 2. Topsoil-like material observed from 0-40cm was variable in texture, including medium clay loams and clays which were brown in colour. The structure varied from granular and friable to coarse subangular blocky, some pores were present. The structure was poor from 30-120cm. The profile was observed to be contaminated with brick, metal (including a 500mm bar), glass and other materials. The brick content was observed up to 50%. Some roots were observed to 50cm.

- 2.11 The material from 40-90cm was observed as mixed chalk spoil. The lower profile contained asphalt, brick and other contaminants. The consistency of the material was compacted from 30cm. The structure was poor. Few roots were penetrating the compacted material below 30cm. This material should not be considered as a subsoil but as imported excavated parent material.

- 2.12 Imported clay was observed from 90cm to depth. This material was firm and had a poor structure.

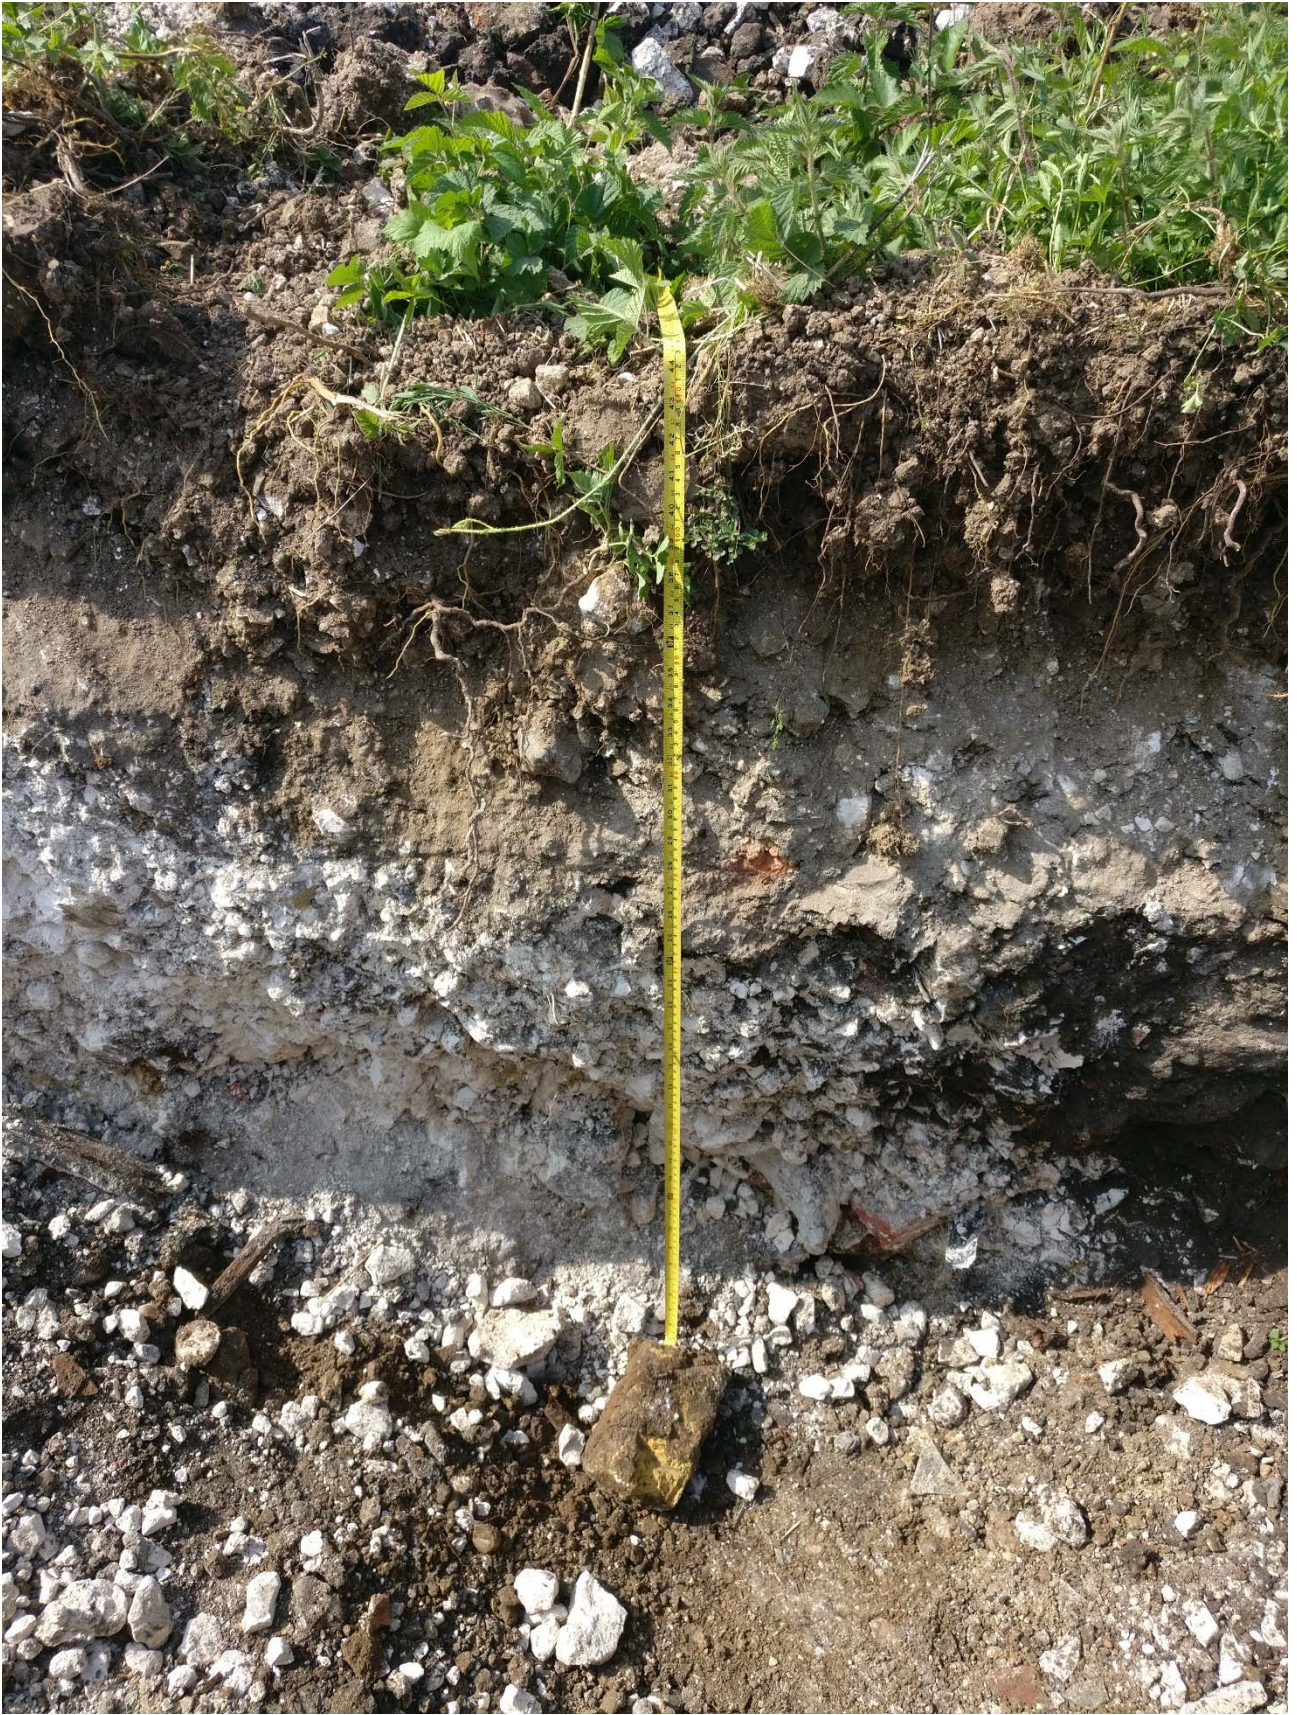
Appendix 3

- 2.13 Pit 2 was excavated in the centre of the site. A photograph of the exposed soil profile is shown at Appendix 3. Topsoil material was present at 0-20cm and was variable in texture and contaminated as per pit 1. The underlying soil material was observed to be medium silty clay loam and medium clay loam.
- 2.14 Subsoil was observed from 30-60cm in depth as dark brown to black, with a medium sandy clay loam texture. The soil material was contaminated with brick at a rate of about 10% by volume. The consistency was recorded as very firm, with a poor subsoil structure. Roots were observed to 60cm in depth. The horizon was recorded as slowly permeable.
- 2.15 Chalk spoil material was observed from 60cm to depth.

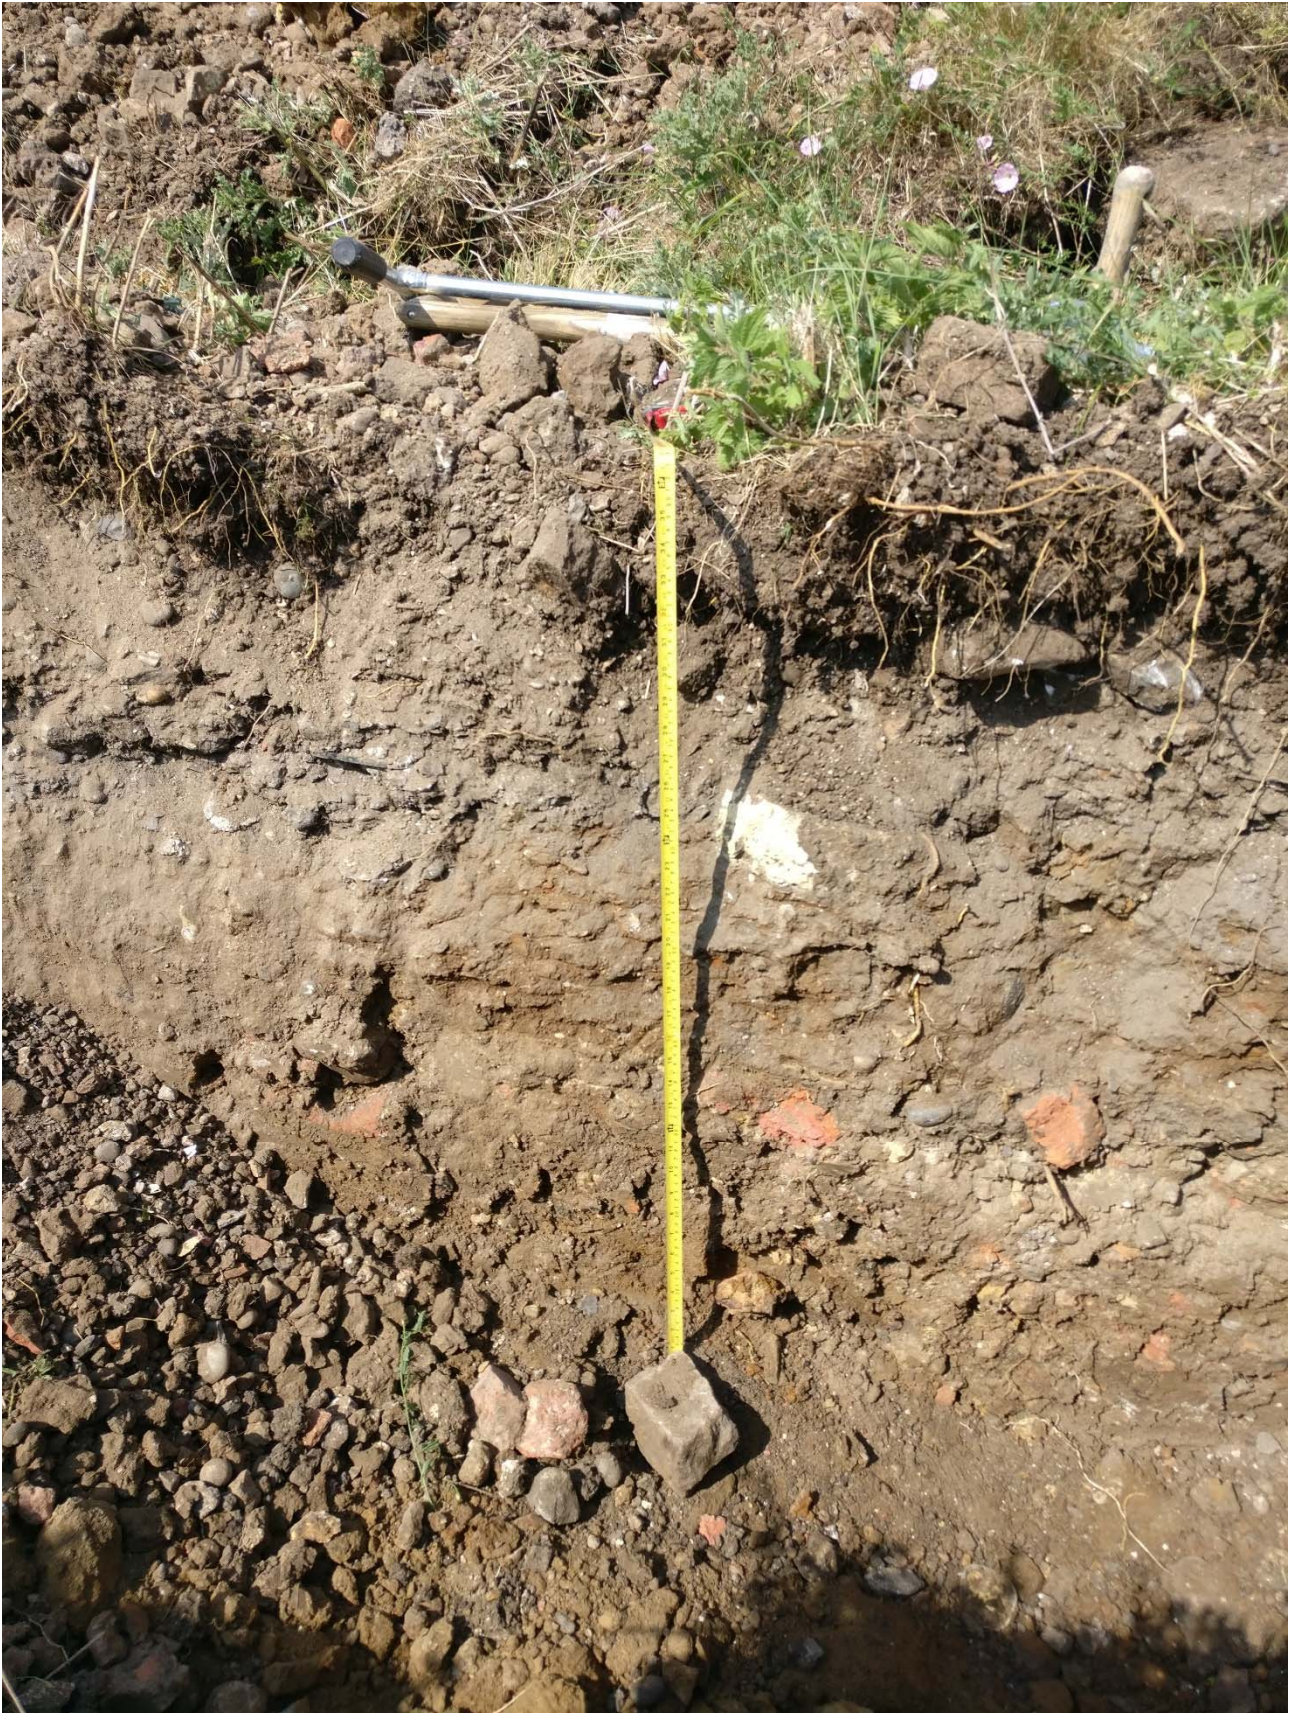
Appendix 4

- 2.16 Pit 3 was excavated in the north of the site and a photograph of the soil profile is shown at Appendix 4. Topsoil material was similar to those observed at Pit 1 and Pit 2. Contamination such as brick and large lumps of concrete <350mm were observed. A photograph of the contamination is shown at Appendix 5.
- 2.17 The subsoil was observed to be sandy loam, with large lumps of clay, up to 400mm in diameter. About 30% brick content was observed.
- 2.18 Orange sandy clay was observed from 70cm to depth, which was very firm in consistency, poor in structure and slowly permeable.

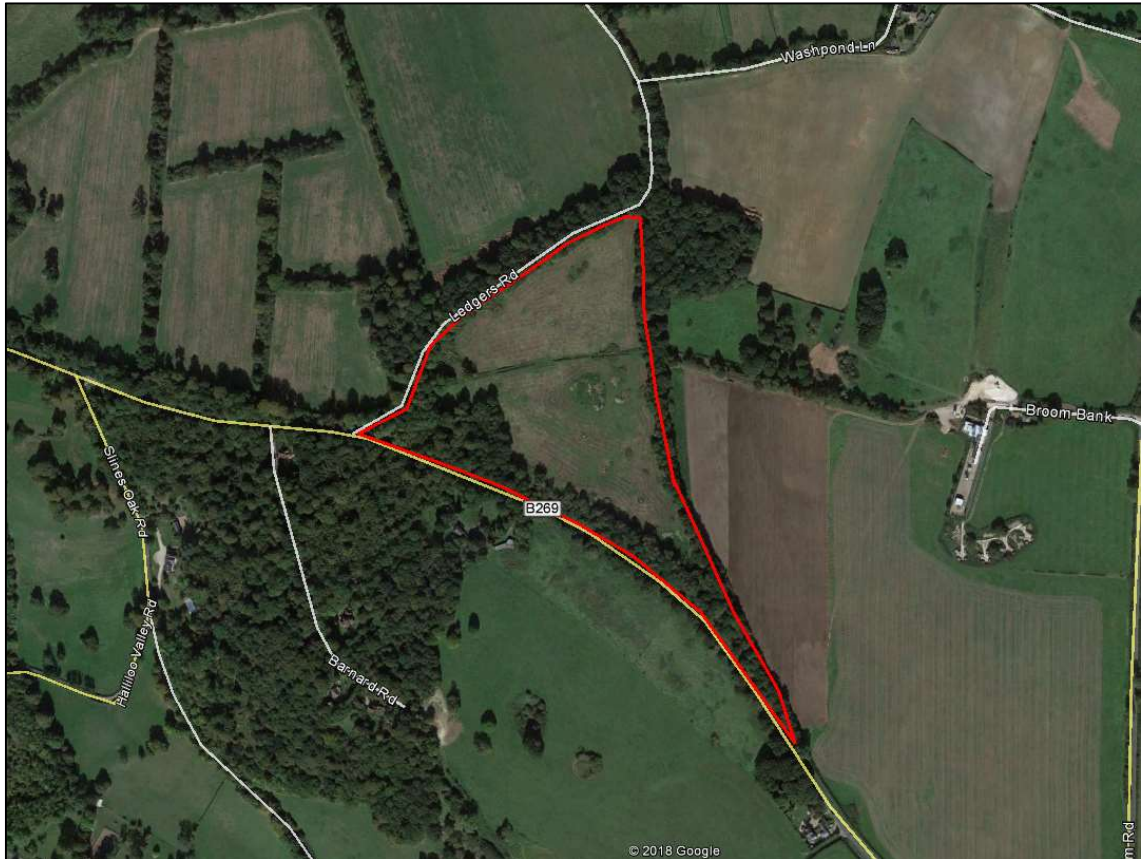
Figure 1: Google Earth site boundary

Civil Engineering Solutions have been commissioned to prepare flood modelling outputs for a potential development site near Slines Oak, Limpsfield Road, Chelsham and Farleigh, Tandridge, Surrey, CR6 9QL. The site is centred at NGR: 537859, 157935 and measures some 9Ha. As outlined in red in Figure 1 below.

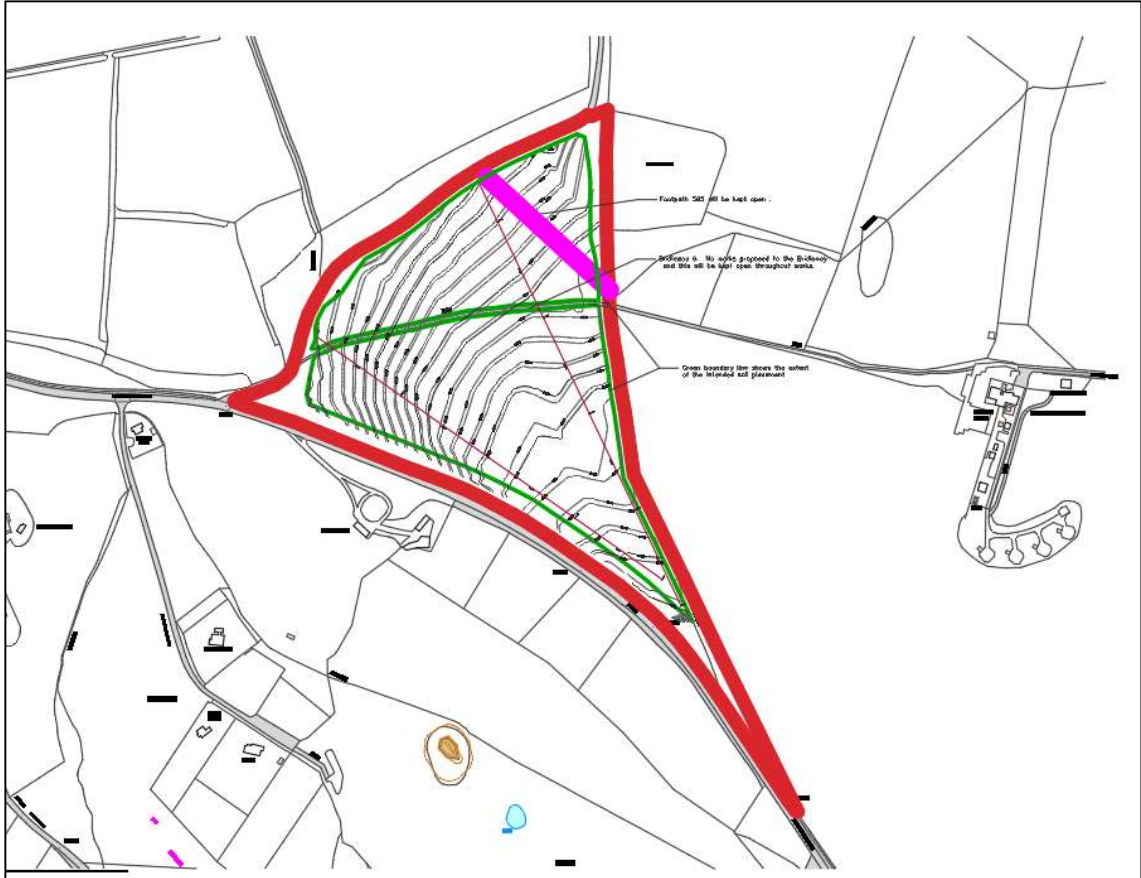
Figure 2: Provided Site GA

Auto CAD file '0140 Land north of Limpsfield Road (CES 12.06.2019).dwg'. The file details the 'Existing' site topographic surface and the 'Proposed' site topographic surface. The CAD file also identifies the red line boundary for the scope of works. A screenshot of the CAD file can be seen below:

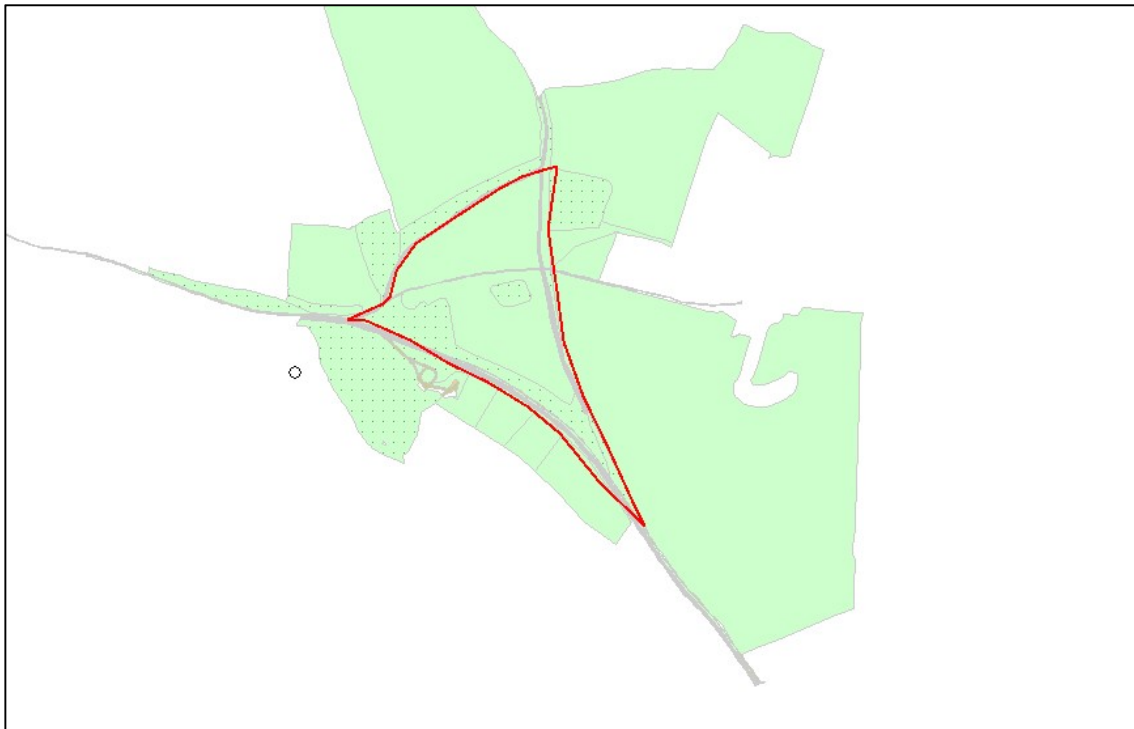
Figure 7: CES557 Limpsfield OS Mastermap Data

Ordnance survey Mastermap data was purchased for the immediate catchment and downloaded as *.GML format. The OS Topographic Land Area table data was imported into MapInfo and the table structure edited to move the land use feature code to be the first attribute in the table. This table was then saved and exported to MID/MIF format to assist with the 2D flood modelling. This is particularly useful in defining manning's roughness and soil permeability factors for the study area based on OS land use classifications.

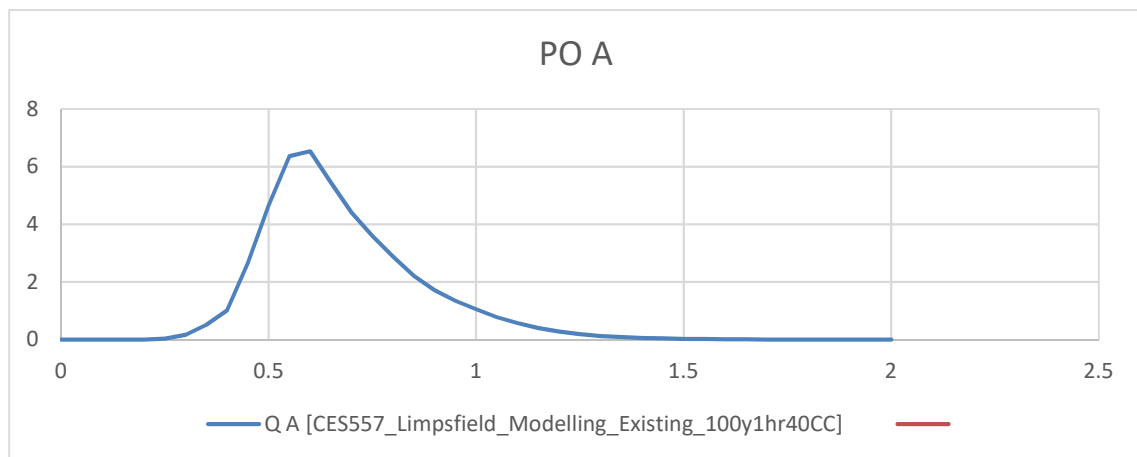
Figure 14: PO A

Of note, the X axis' units are time (hours) and the Y axis is flow in m³/s
