Worms Heath Restoration Limpsfield Road

ENVIRONMENTAL SETTING AND SITE DESIGN (including Conceptual Site Model)

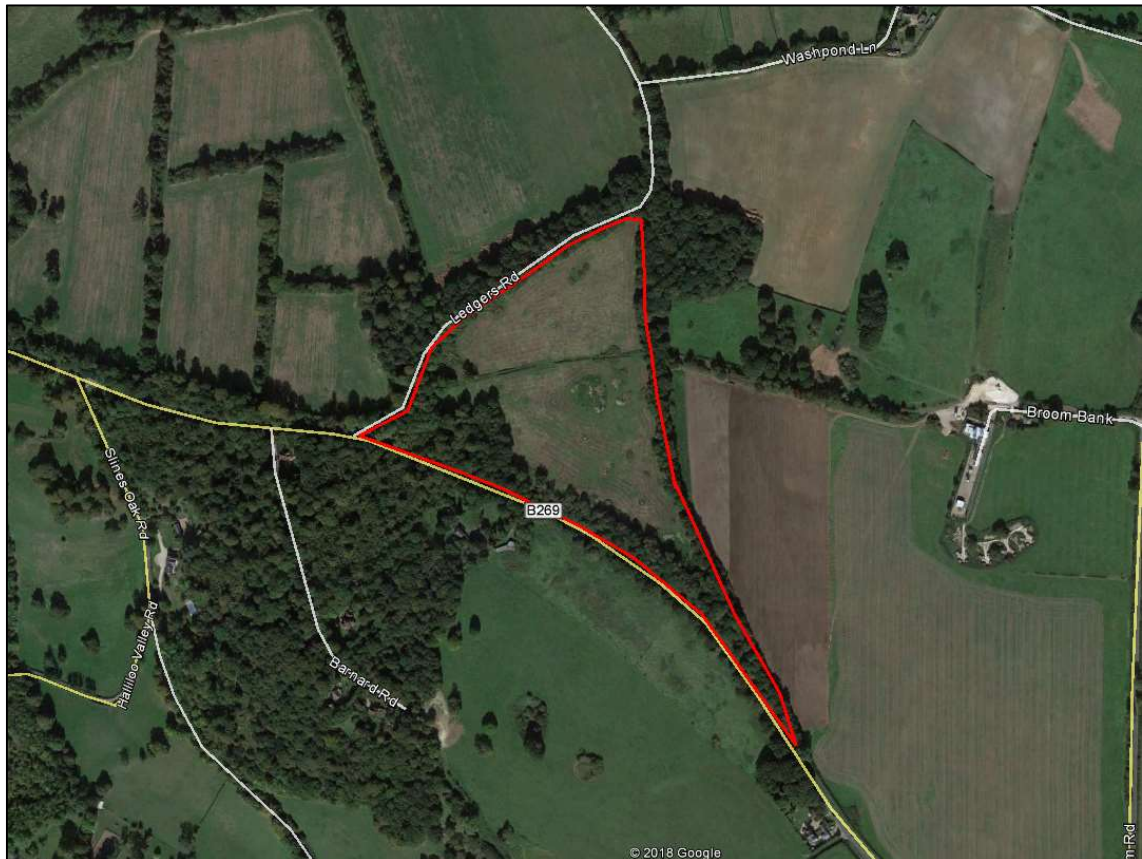
Figure 1: Google Earth site boundary

Civil Engineering Solutions have been commissioned to prepare flood modelling outputs for a potential development site near Slines Oak, Limpsfield Road, Chelsham and Farleigh, Tandridge, Surrey, CR6 9QL. The site is centred at NGR: 537859, 157935 and measures some 9Ha. As outlined in red in Figure 1 below.

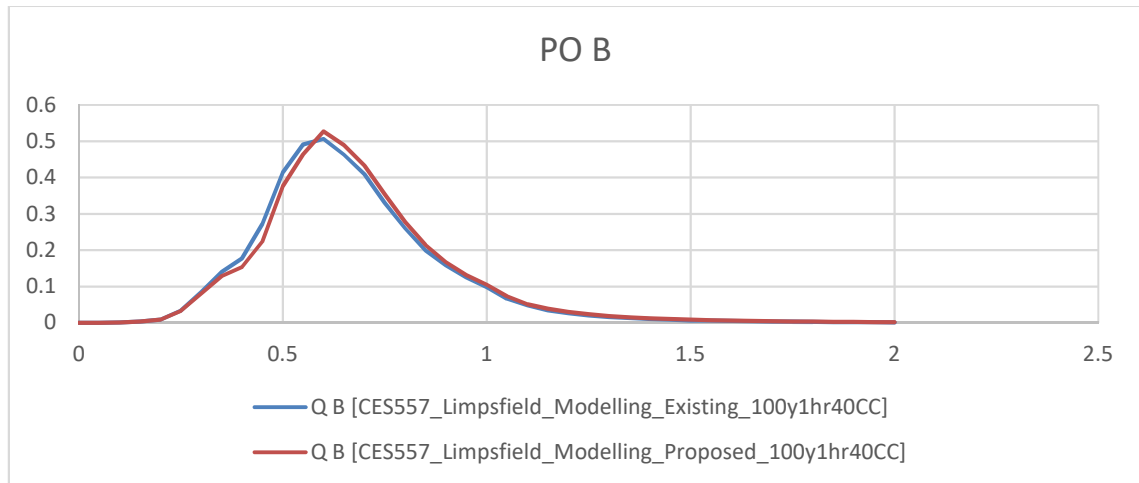
Figure 15: PO B

Of note, the X axis' units are time (hours) and the Y axis is flow in m³/s

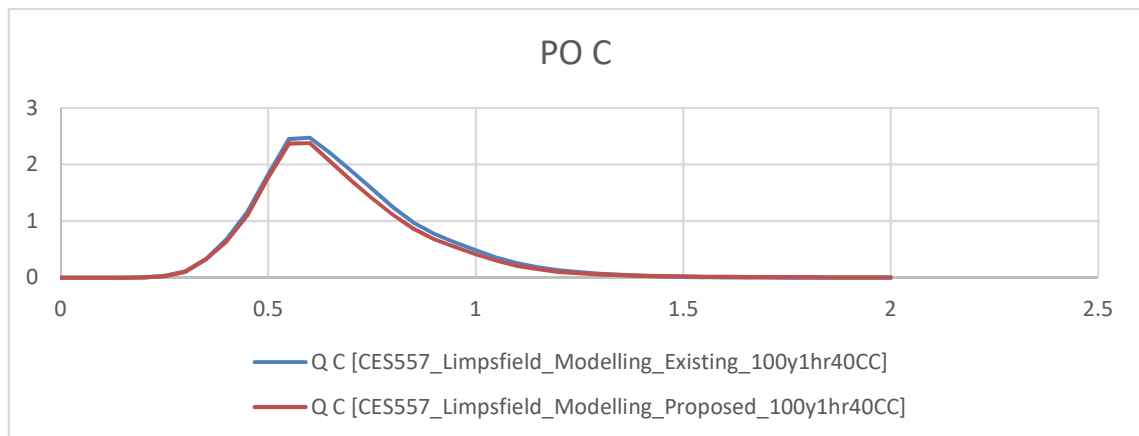
Figure 16: PO C

Of note, the X axis' units are time (hours) and the Y axis is flow in m³/s
