## **GEO-ENVIRONMENTAL INVESTIGATION AND ASSESSMENT**

**STURRY ROAD,  
CANTERBURY**

**SS016679-PE-08-266-R**

**SEPTEMBER 2008**

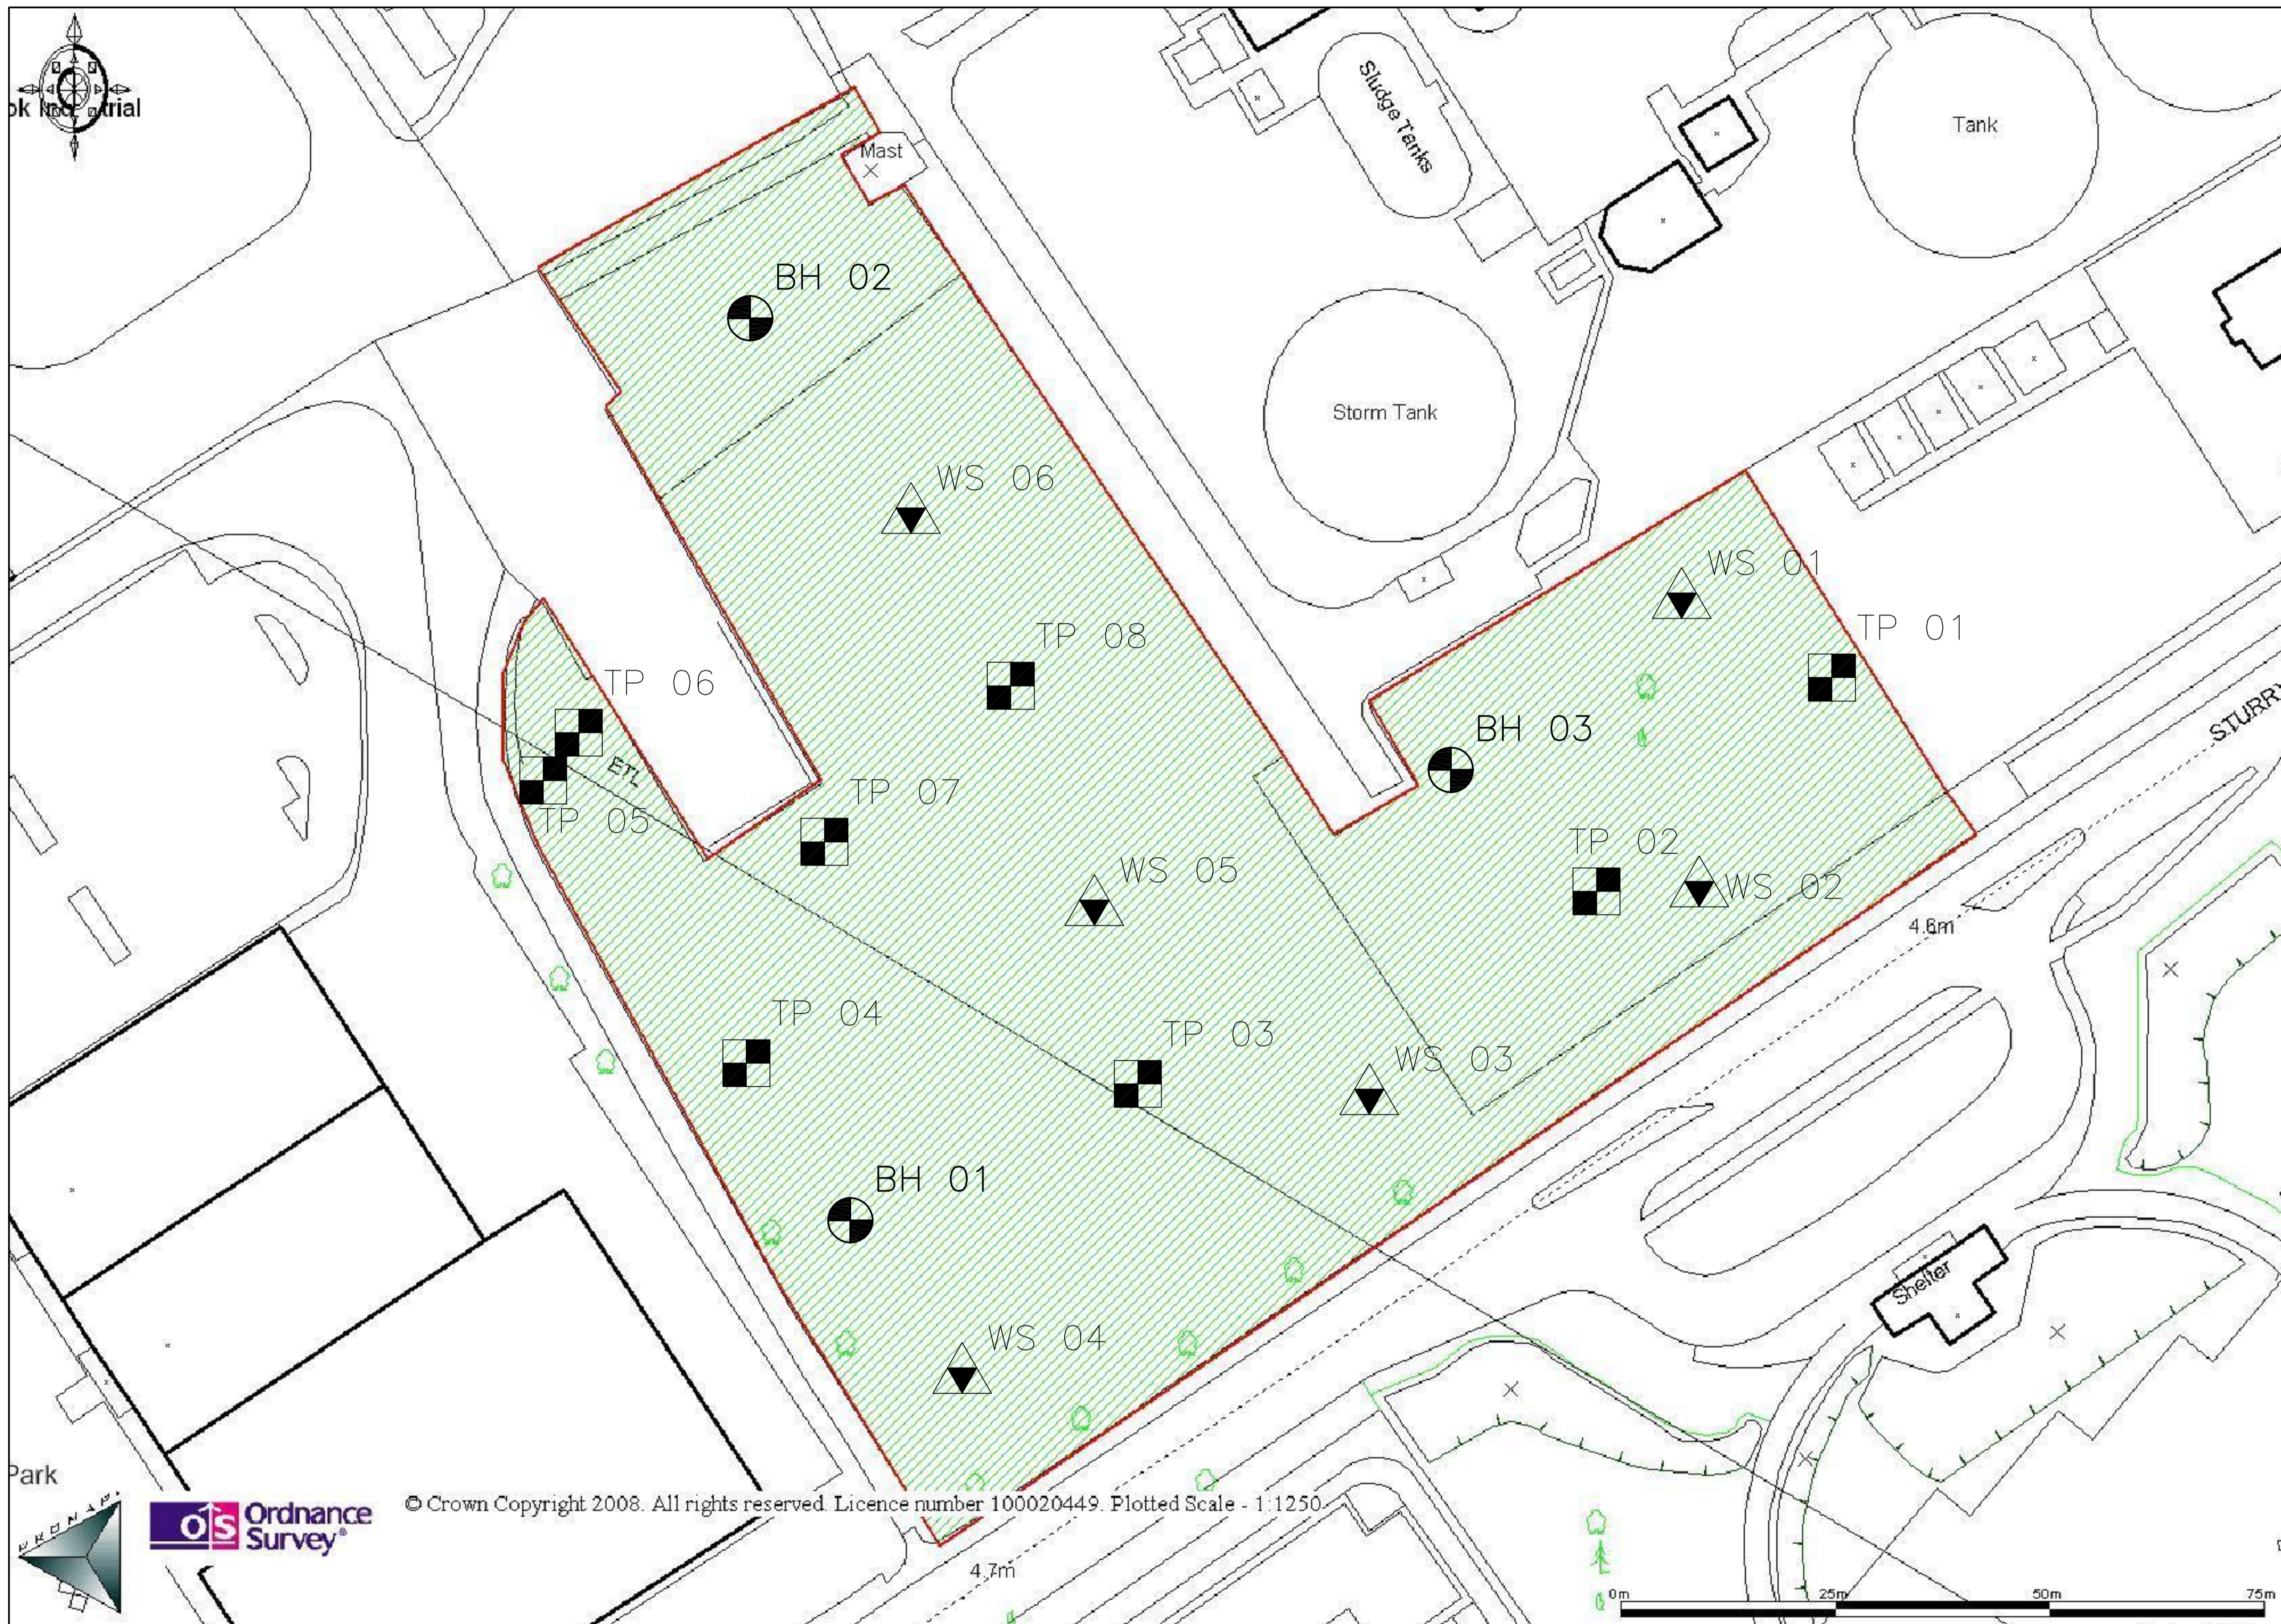
**FIGURE 502**

**Exploratory Hole Location Plan**

- WS XX Window Sample.
- BH XX Borehole.
- TP XX Trial Pit.

- 6no windowless sample boreholes (WS1 to WS6) to investigate near surface deposits. All window sample boreholes were installed with standpipes for subsequent monitoring of ground gas concentrations.
- 3no cable percussion boreholes (BH1 and BH3) to investigate deeper geological conditions and provide geotechnical information for construction purposes. All boreholes were installed with ground gas and groundwater monitoring standpipes.
- 8no mechanically excavated trial pits (TP1 to TP8) to provide further coverage of shallow ground conditions.
- Collection of representative soil samples and subsequent laboratory testing for ground contamination and geotechnical assessment.

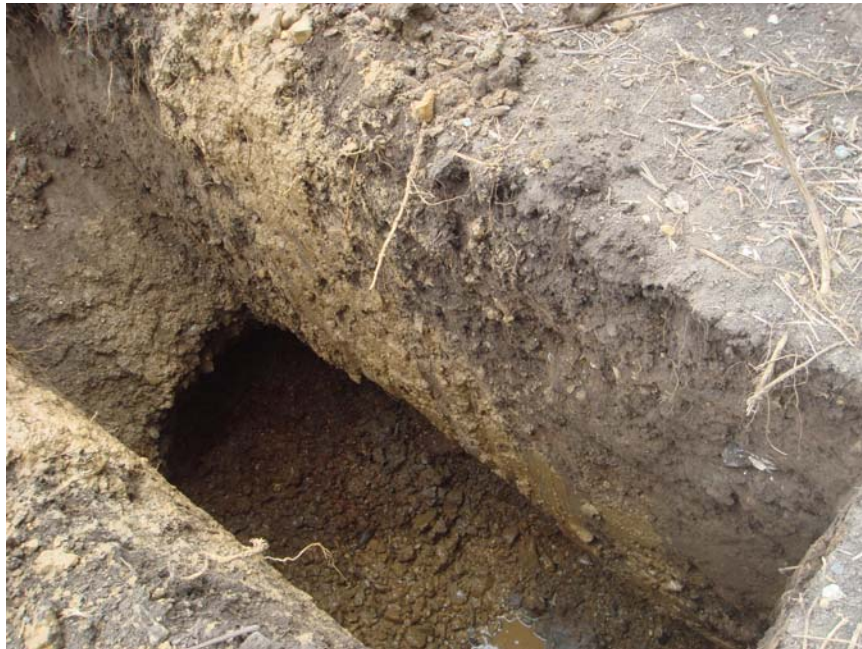
Depth (m)	Type	Test Results / Remarks	Legend	Level	Description	Depth (m)	Water
0.50	D1			4.05	Soft dark brown gravelly silt/clay TOPSOIL with some roots and rootlets. Occasional gravel size concrete fragments.	0.55	
				3.50	Soft dark brown becoming orange-grey slightly gravelly silty sandy CLAY (BRICKEARTH)	1.10	
1.40	D2			3.10	Firm orange-brown and grey mottled SILT/CLAY. (BRICKEARTH)	1.50	
				1.80	Medium dense orange-brown clayey silty sandy GRAVEL of fine to coarse flint. (RIVER TERRACE GRAVELS)	2.80	
2.50	D3				End of Trial Pit at 2.80 m

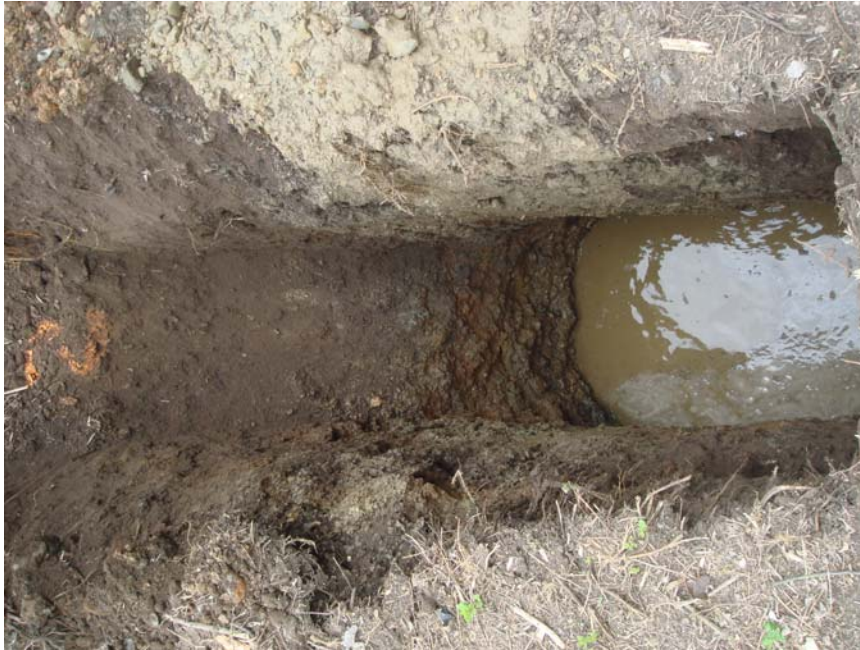
Depth (m)	Type	Test Results / Remarks	Legend	Level	Description	Depth (m)	Water
0.50	D1			4.13	Soft dark brown sandy silt/clay TOPSOIL with some roots and rootlets. Some brick fragments.	0.60	
1.00	D2			3.78 3.63	Soft to firm brown and grey silty sandy slightly gravelly clay. Occasional brick fragments. (MADE GROUND)	0.95 1.10	
2.00	D3			2.03	Medium dense orange-brown silty sandy GRAVEL of fine to coarse flint. (RIVER TERRACE GRAVELS)		
				2.03	End of Trial Pit at 2.70 m	2.70	▽

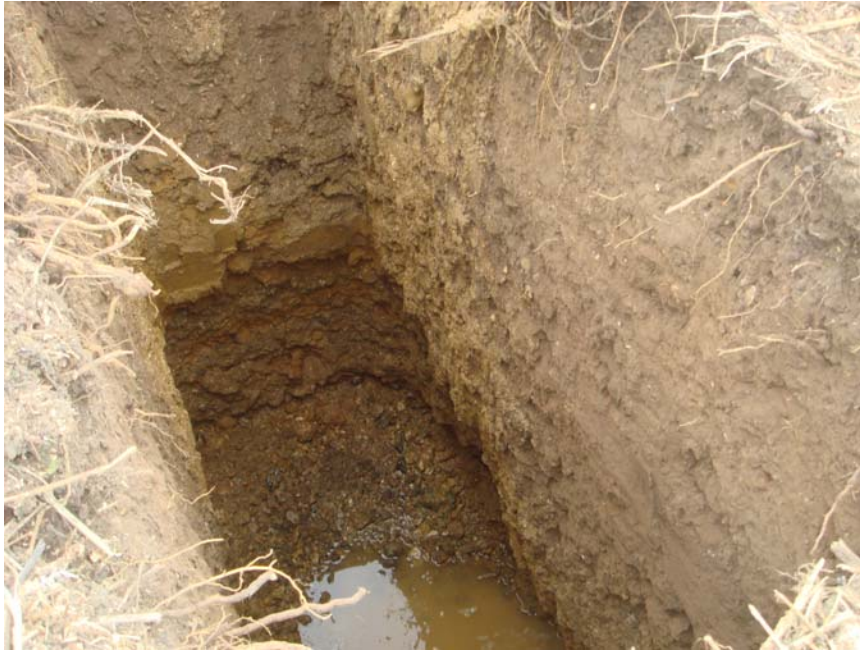
Depth (m)	Type	Test Results / Remarks	Legend	Level	Description	Depth (m)	Water
1.00	D2			4.30	Soft dry and friable brown slightly gravelly silt/clay TOPSOIL with some roots and rootlets.	0.60	
				4.00	Soft dark brown silty sandy gravelly CLAY. (BRICKEARTH)	0.90	
				3.80	Soft to firm orange-brown and grey very gravelly SILT/CLAY. (BRICKEARTH)	1.10	
2.00	D3			2.20	Medium dense orange-brown locally grey silty clayey sandy GRAVEL of fine to coarse flint. (RIVER TERRACE GRAVELS)		
					End of Trial Pit at 2.70 m	2.70

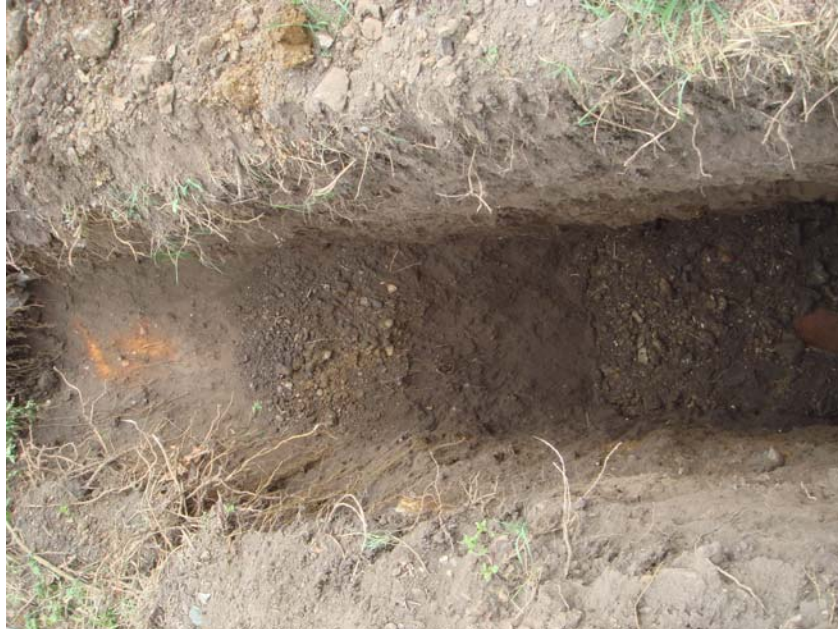
Depth (m)	Type	Test Results / Remarks	Legend	Level	Description	Depth (m)	Water
0.50	D1			4.31	Soft dry and friable brown slightly gravelly silt/clay TOPSOIL with some roots and rootlets.	0.60	
1.30	D2			3.81	Firm dark brown silty sandy gravelly CLAY. (BRICKEARTH)	1.10	
2.00	D3			3.51	Soft orange-brown and grey very gravelly SILT/CLAY. (BRICKEARTH)	1.40	
				2.41	Medium dense orange-brown locally grey silty clayey sandy GRAVEL of fine to coarse flint. (RIVER TERRACE GRAVELS)	2.50	
					End of Trial Pit at 2.50 m

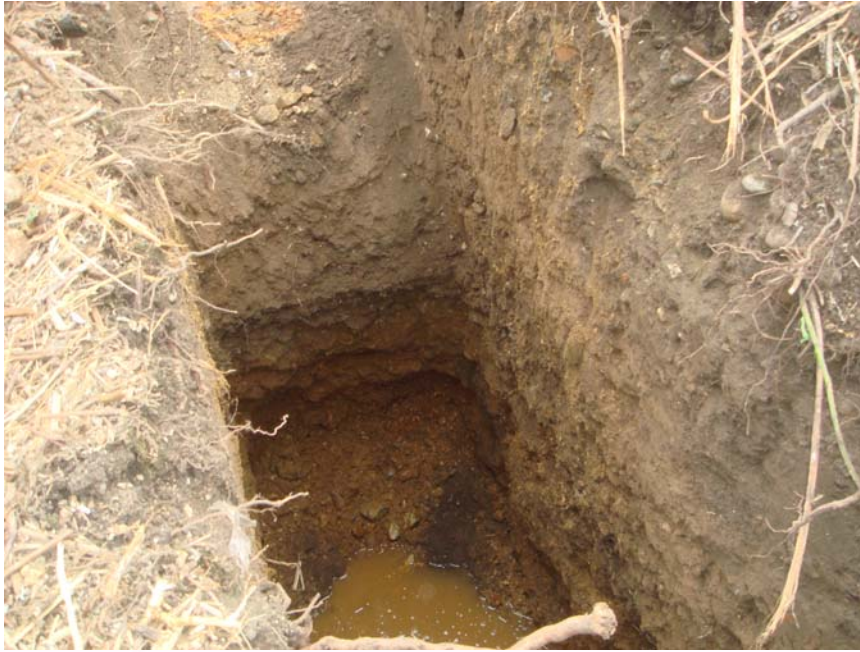
Depth (m)	Type	Test Results / Remarks	Legend	Level	Description	Depth (m)	Water
0.50	D1			4.28	Soft brown gravelly silt/clay TOPSOIL with roots and rootlets.	0.45	
					Firm brown dry and friable very gravelly SILT/CLAY. (BRICKEARTH)		
2.00	D3			3.03	Medium dense orange-brown locally grey silty clayey sandy GRAVEL of fine to coarse flint.	1.70	
				2.73	Pocket of dark grey very gravelly silt/clay at 2.0m with strong hydrocarbon odour and oily sheen. (RIVER TERRACE GRAVELS)	2.00	
					End of Trial Pit at 2.00 m

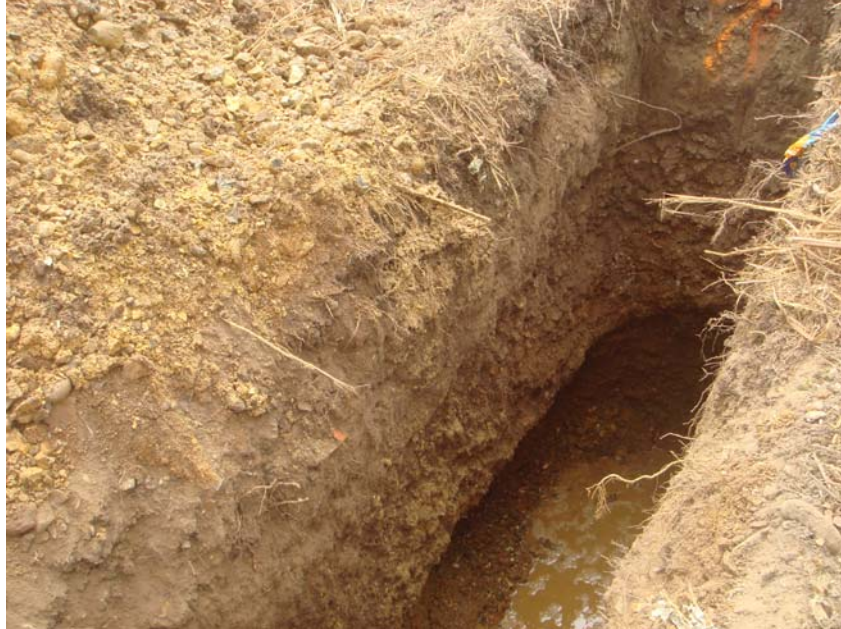
Depth (m)	Type	Test Results / Remarks	Legend	Level	Description	Depth (m)	Water
0.25	D1			4.28	Soft brown gravelly silt/clay TOPSOIL.	0.55	
				3.73	Firm dark brown silty sandy gravelly CLAY (BRICKEARTH)	1.10	
				2.33	Medium dense orange-brown silty sandy cobbly GRAVEL of fine to coarse flint (RIVER TERRACE GRAVELS)	2.50	▽
2.50	D2			2.33	End of Trial Pit at 2.50 m

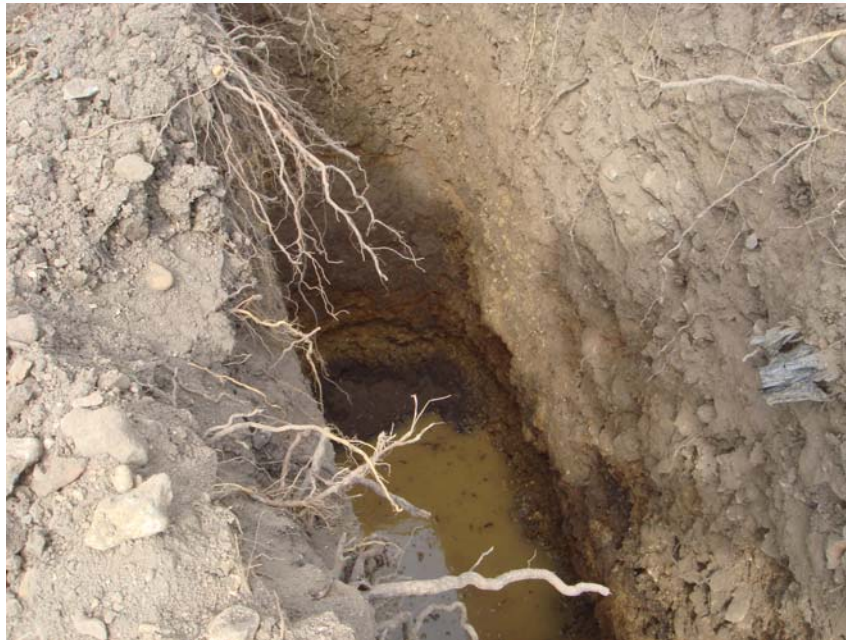
Depth (m)	Type	Test Results / Remarks	Legend	Level	Description	Depth (m)	Water
0.50	D1			4.18	Soft brown dry and friable very gravelly silt/clay TOPSOIL with many roots and rootlets.	0.65	
				3.63	Soft brown silty sandy gravelly CLAY (BRICKEARTH)	1.20	
				2.63	Firm very gravelly SILT/CLAY (BRICKEARTH)	2.20	
2.00	D2			2.03	Medium dense orange-brown silty sandy cobbly GRAVEL (RIVER TERRACE GRAVELS)	2.80	▽
				2.03	End of Trial Pit at 2.80 m
