**Banana Field, Meriden Quarry**

**Stability Risk Assessment  
(May 2026)**

**Prepared for NRS Meriden Aggregates Limited**

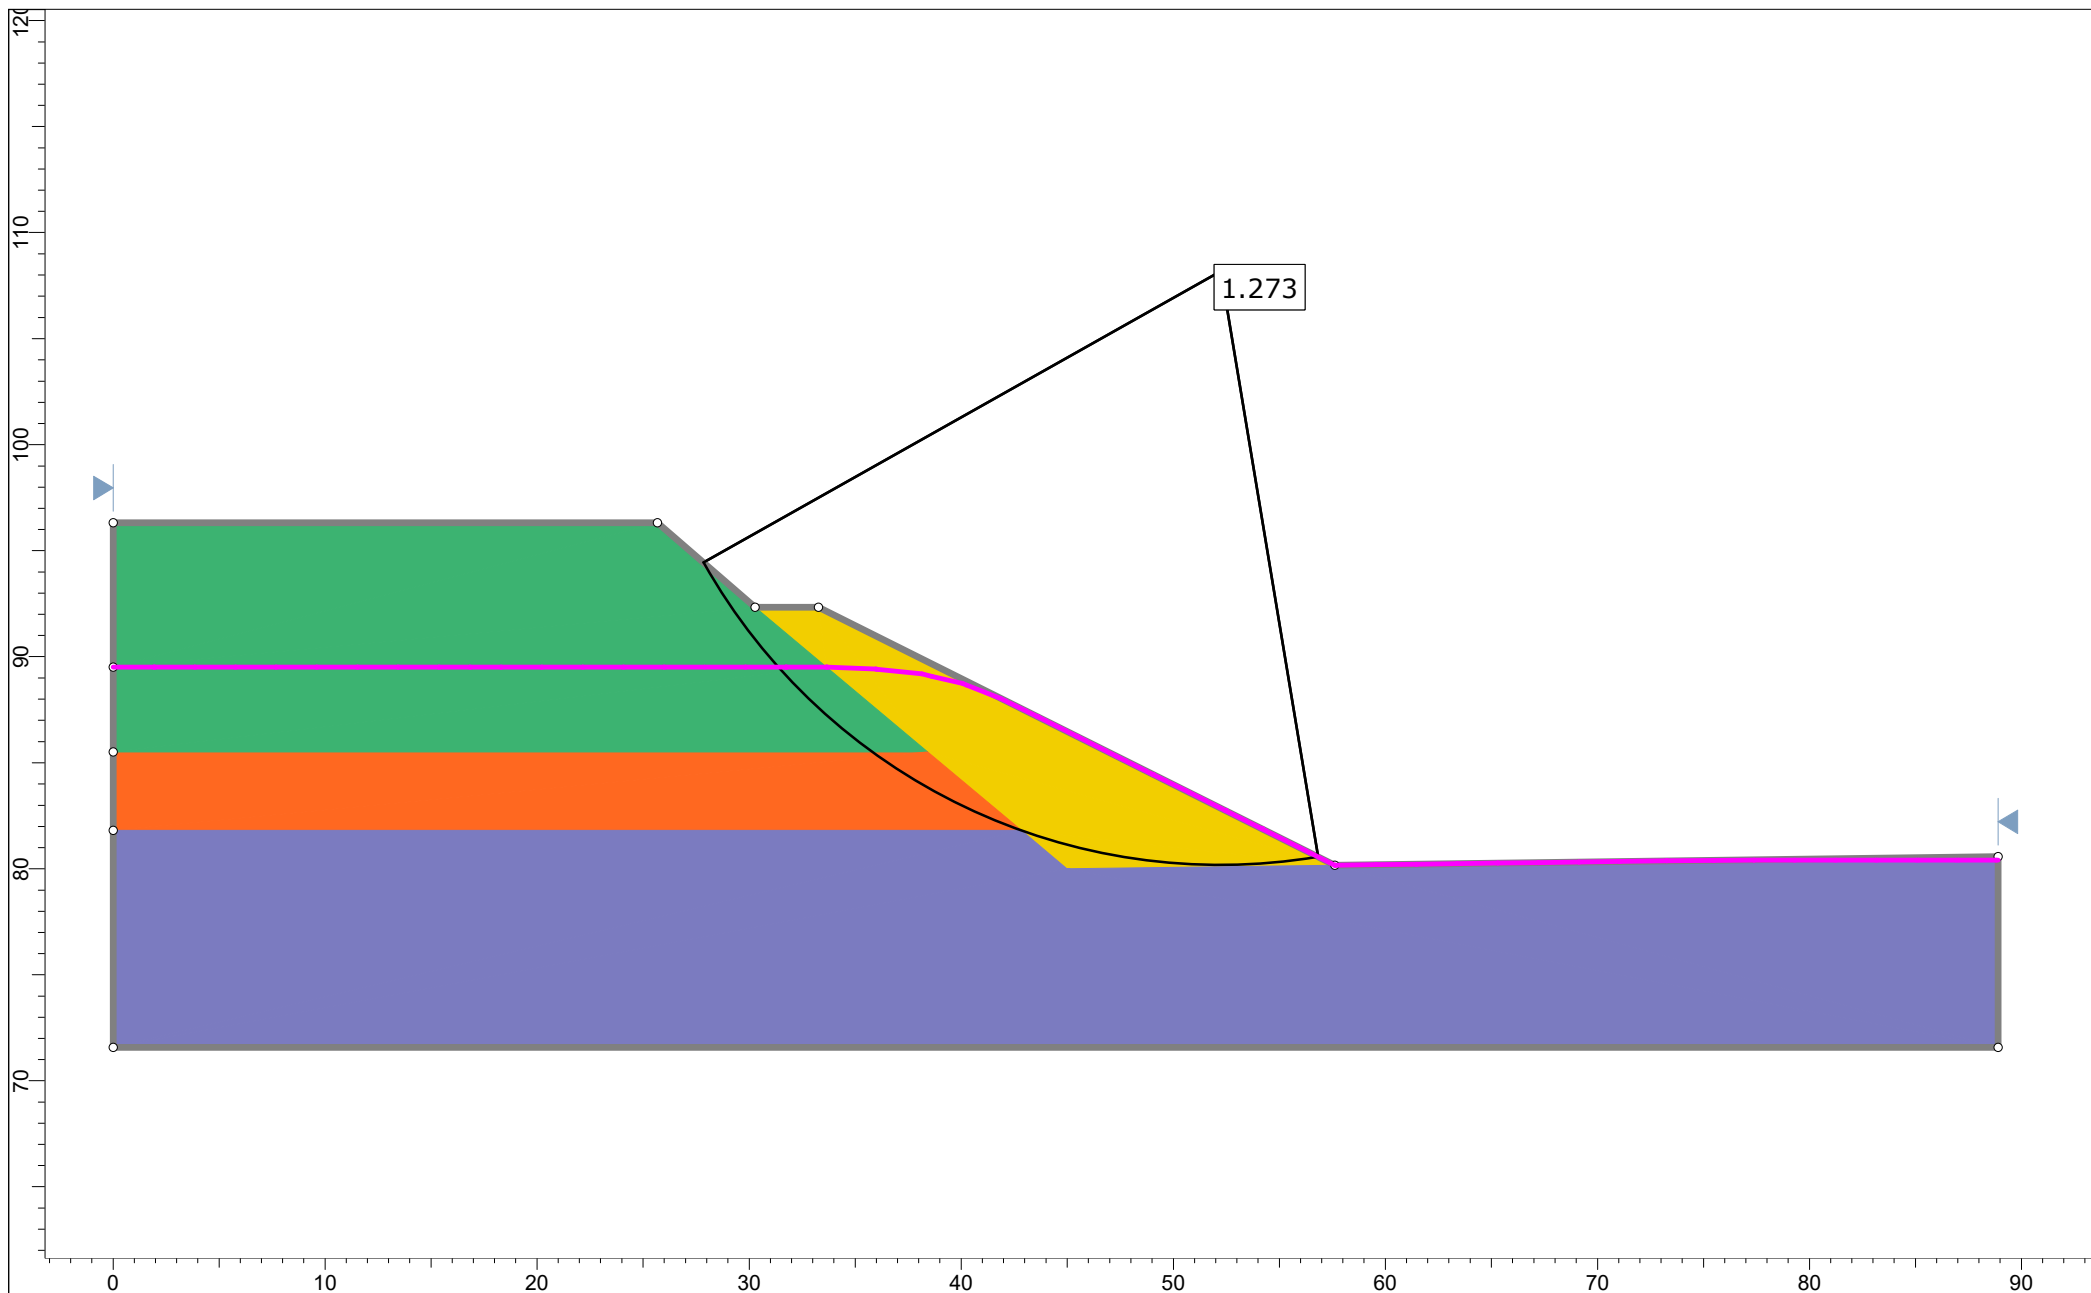
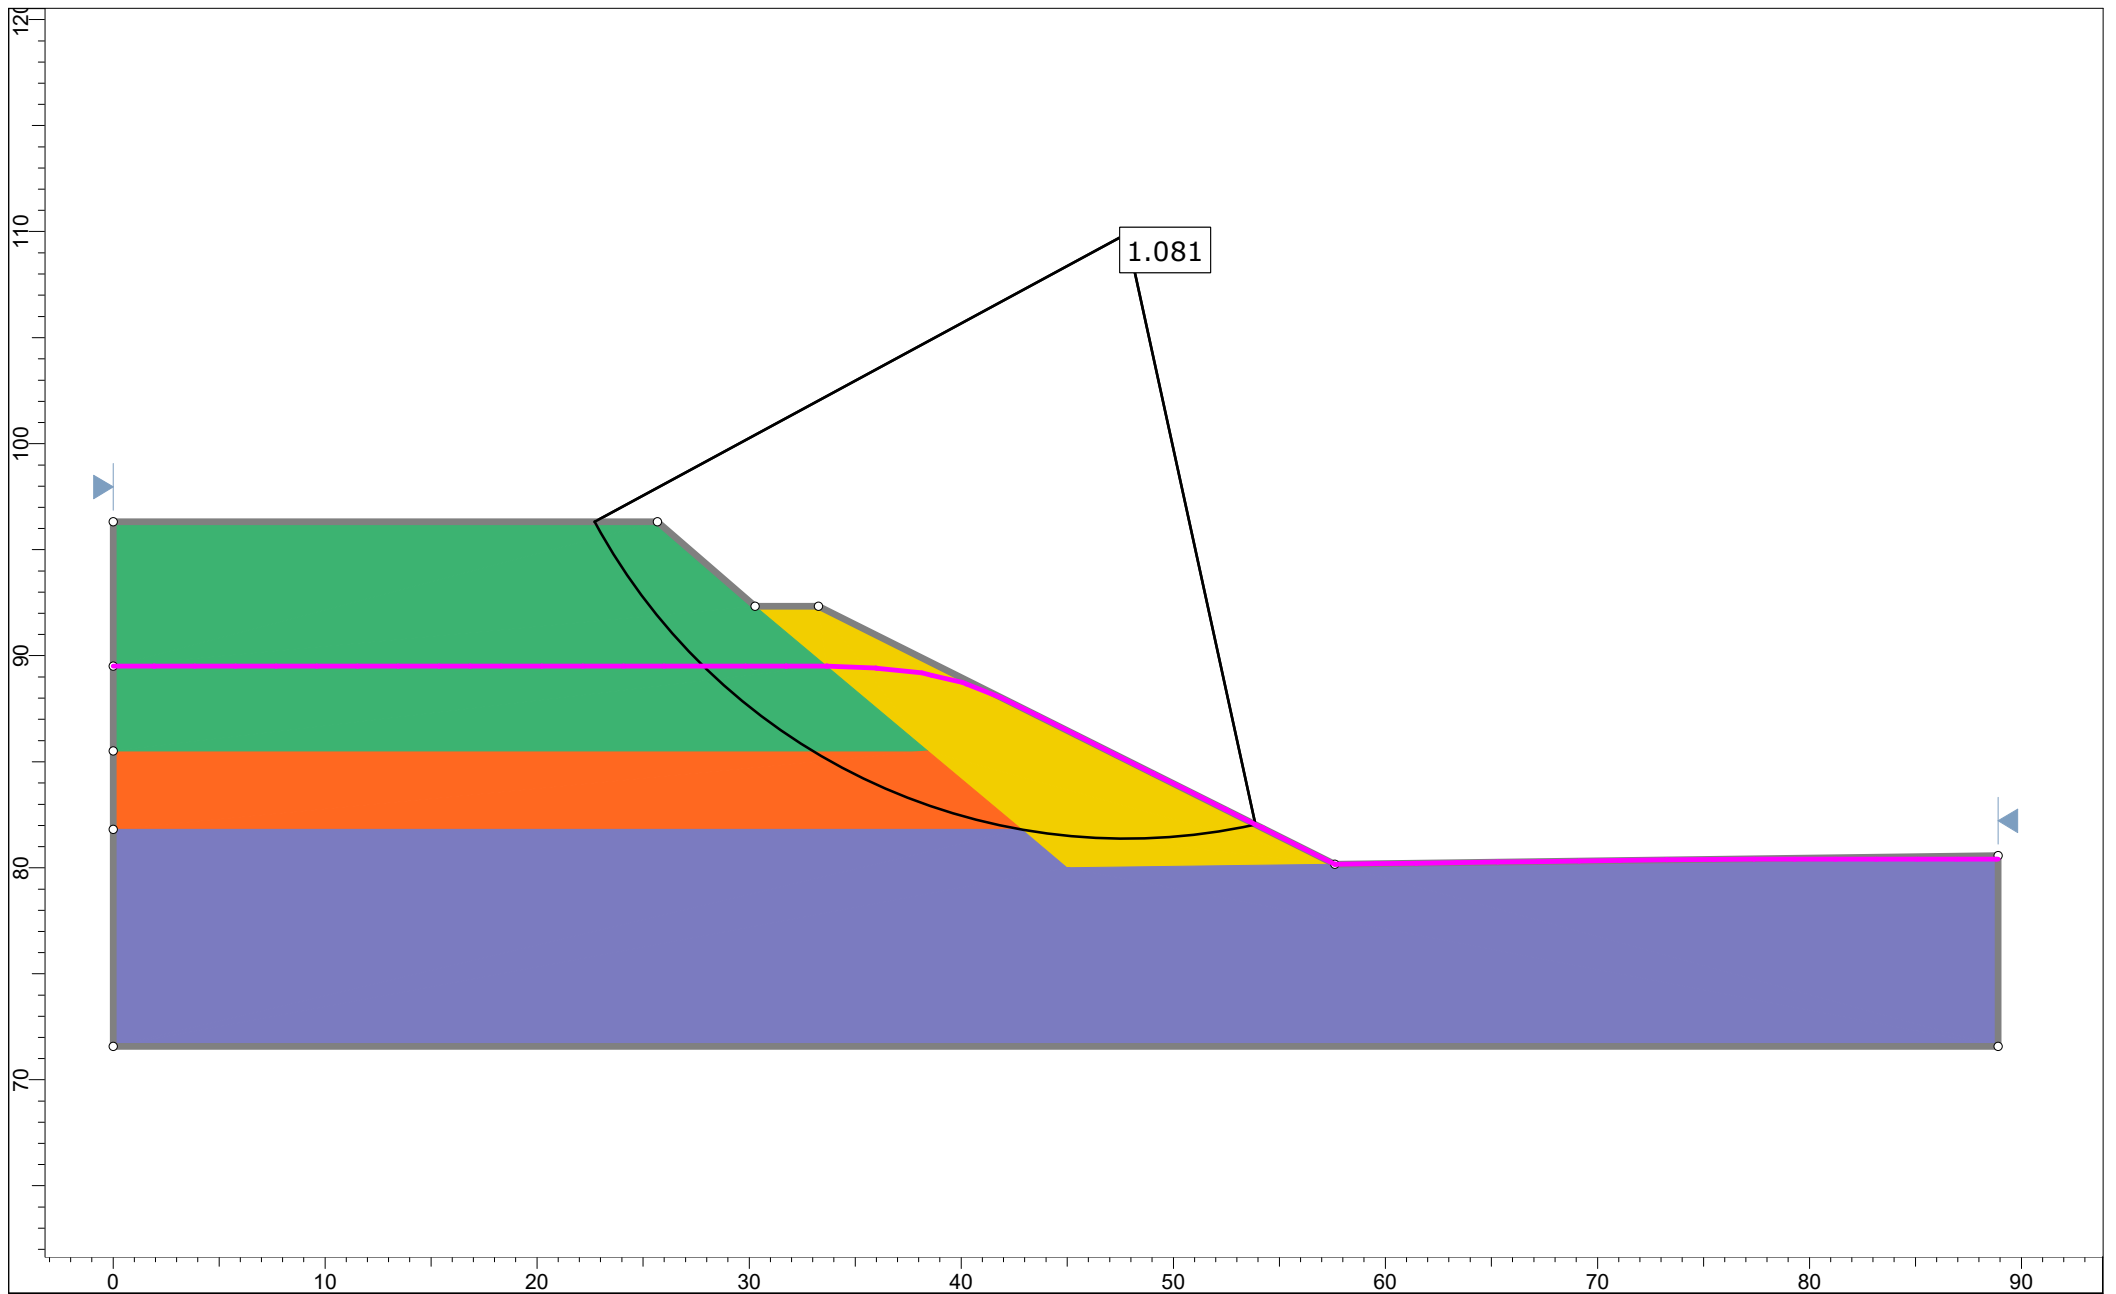
The stability analyses program SLIDE has been used to analyse the section using Bishop's circular analysis. As the side slope liner is constructed under temporary conditions, undrained parameters have been applied.

| Combination | Failure Mechanism Analysed | Overdesign Factor | Comments |
|---|---|---|---|
| 1 | Circular | 1.273 | Failure through Geological Barrier |

| 2 | Circular | 1.081 | Failure through Geological Barrier |

The stability of the side slope liner has been assessed and is considered to be acceptable.

The groundwater profile within the glaciofluvial deposits has been calculated by the software based on the assumed steady-state seepage conditions. The analysis confirms that the constructed 1v:2h side slopes provide an adequate level of stability for the side slope liner.

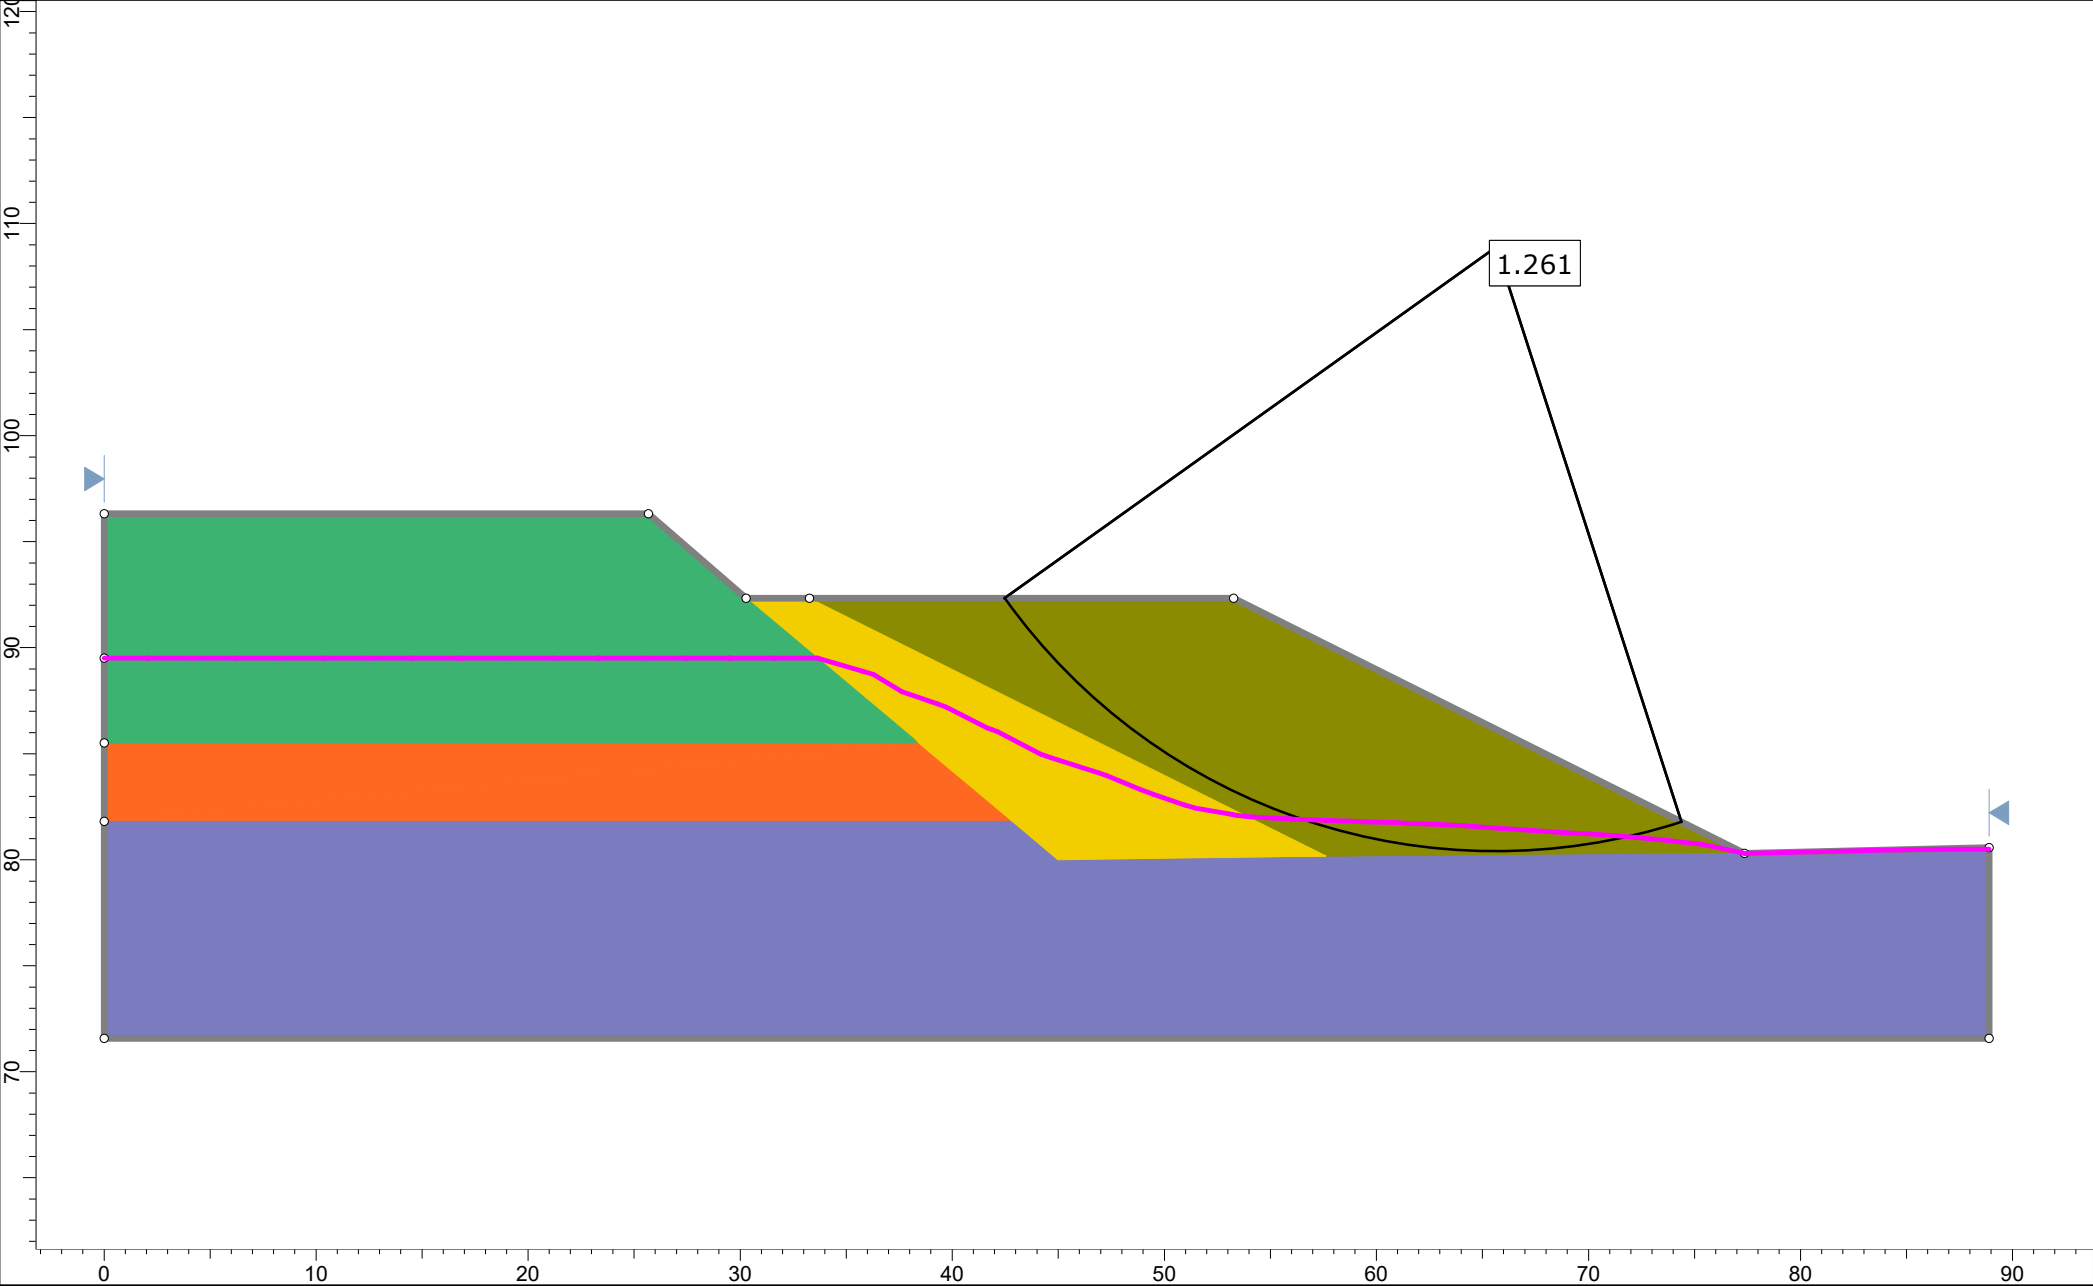
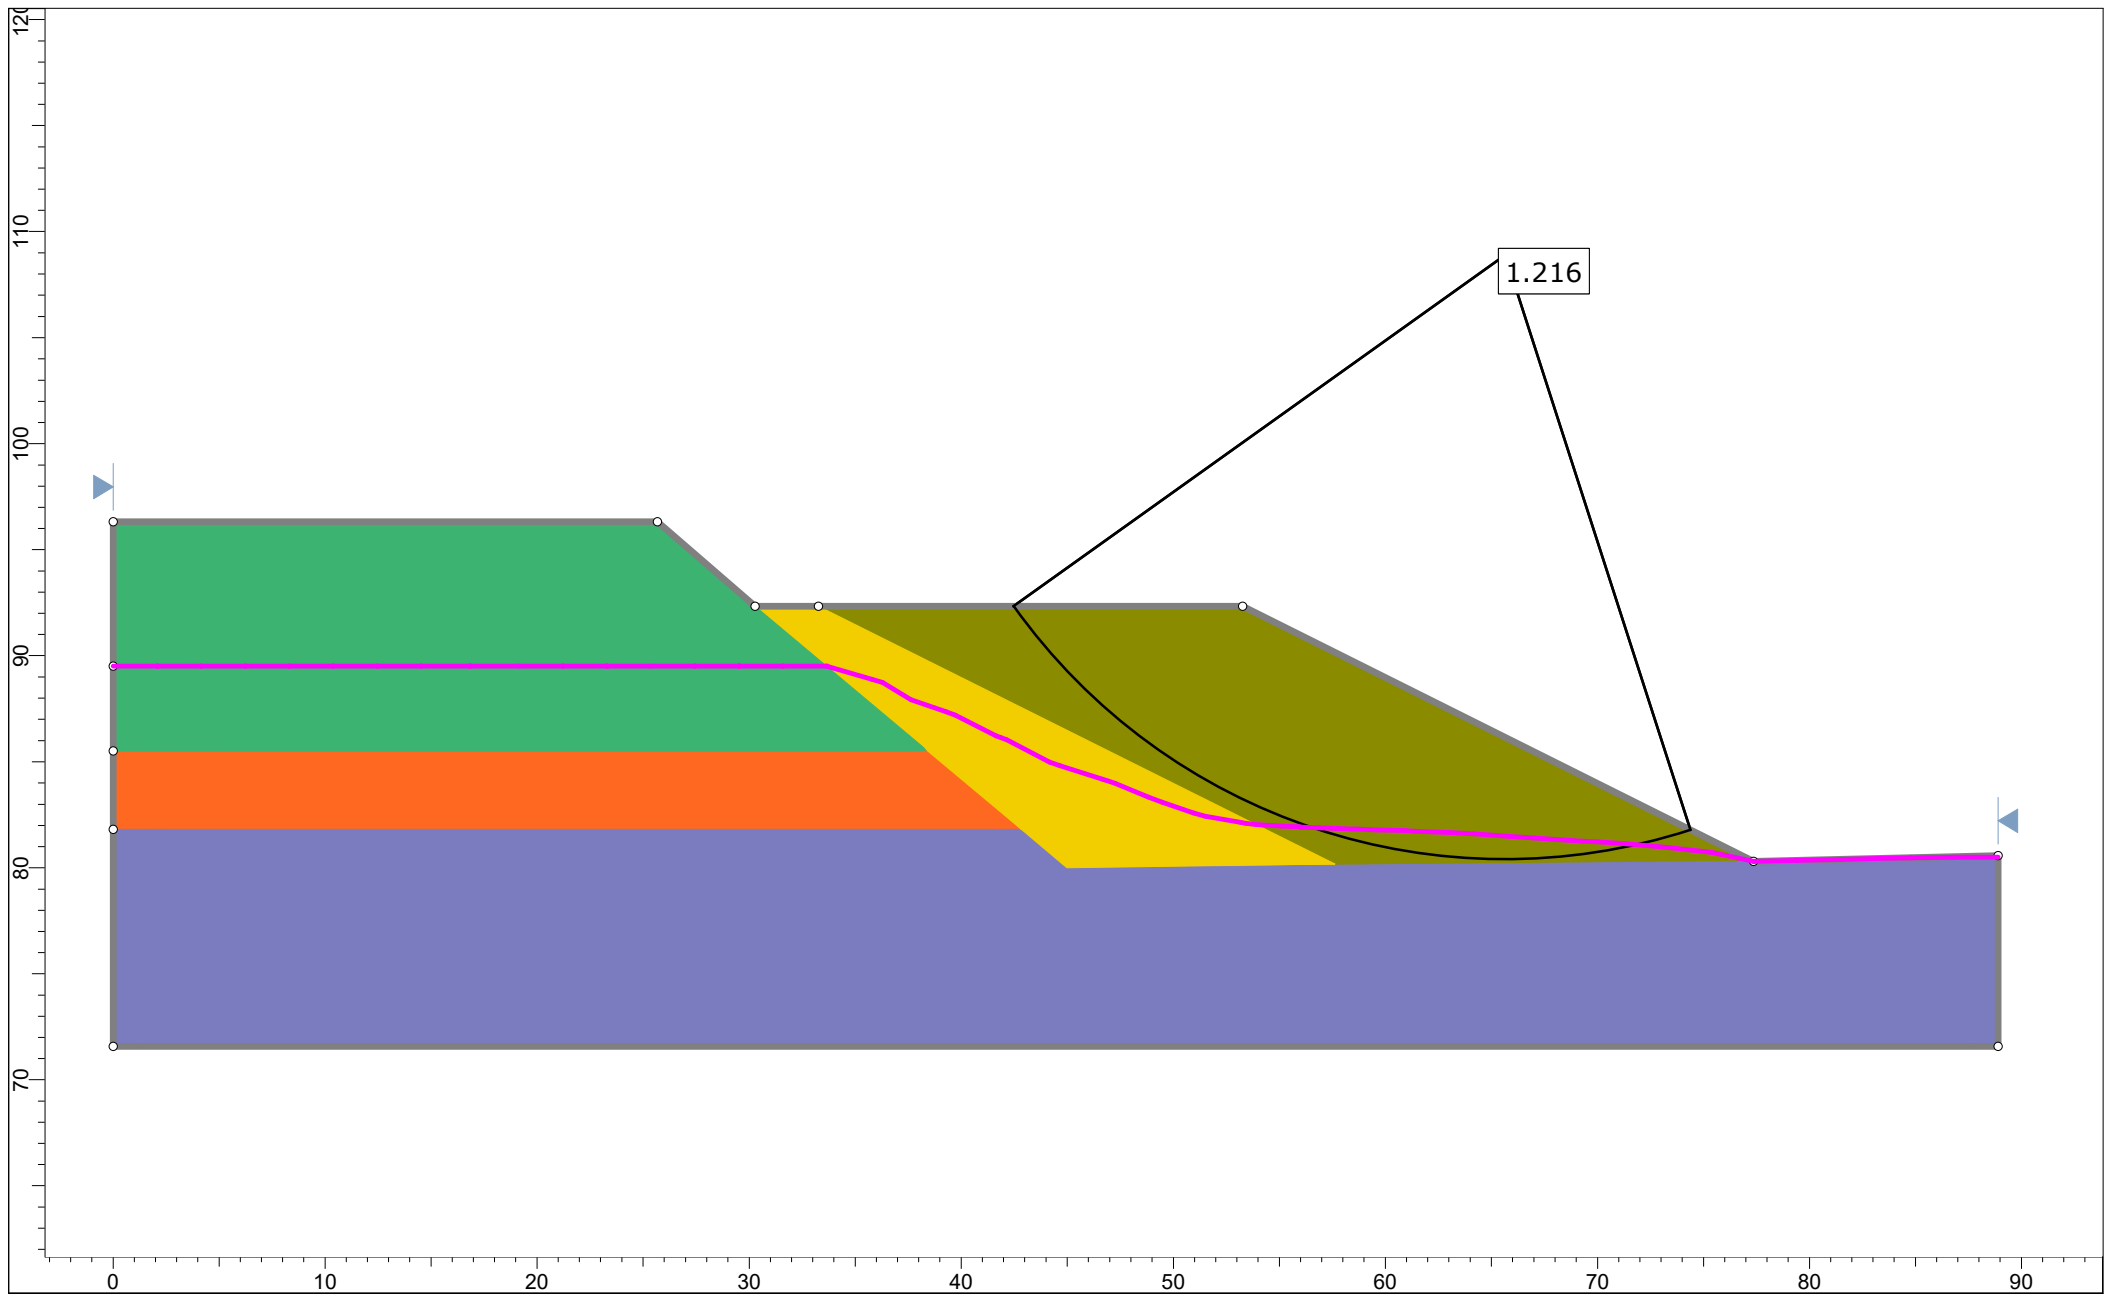
The stability analyses program SLIDE has been used to analyse the section using Bishop's circular analysis. Undrained parameters have been applied to the inert waste and side slope liner. Details of the analysis are summarised below in Table 8.1-2 and analysis outputs are presented in Appendix 1.

| Combination | Failure Mechanism Analysed | Overdesign Factor | Comments |
|---|---|---|---|
| 1 | Circular | 1.261 | Failure through waste mass |
| 2 | Circular | 1.216 | Failure through waste mass |

An acceptable overdraft factor against a failure through the waste mass has been determined; these results demonstrate that a 1v:2h overall slope within the backfilled inert waste will remain stable during infilling. The worst-case condition, with inert waste placed at the same level as the geological barrier, has been assessed and is considered acceptable. Ultimately the whole void of the excavated void will be filled with waste and no slopes will remain.

The waste mass analysis incorporates analyses of the side slope liner since this component will play a role in waste mass stability.

Hence it is considered that the calculated overdraft factor for the temporary slopes in the waste mass are adequate and that any minor surface instability can be dealt with through appropriate management of the site.
