CREWE WwTW

**FACTUAL REPORT ON
GROUND INVESTIGATION**

Contract: 42187

Date: June 2018

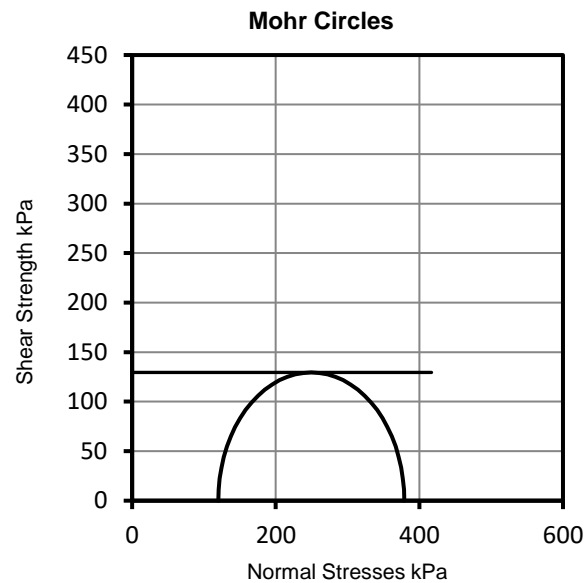
Borehole / Trial Pit	Depth (m)	Sample	Description
BH01	3.00	U8	Brown slightly gravelly, slightly clayey SILT

Initial Sample	Test Number	1
	Original Length (mm)	340.00
	Depth from Top (mm)	110.00
	Condition	Undisturbed
	Orientation	Vertical
Length (mm)		210.00
Diameter (mm)		102.85
Moisture Content (%)		12.00
Bulk Density (Mg/m ³)		2.18
Dry Density (Mg/m ³)		1.94
Membrane Thickness (mm)		0.34
Membrane Type		Latex
Rate of Strain (%/min)		1.9
Test Results	Cell Pressure (kPa)	120
	Axial Strain (%)	20
	Membrane Corr. (kPa)	1.27
	Deviator Stress, $(\sigma_1 - \sigma_3) f$ (kPa)	259
	Undrained Shear Strength, $c_u = \frac{1}{2}(\sigma_1 - \sigma_3) f$ (kPa)	129
	Mode of Failure	Plastic

Deviator stress corrected for area change and membrane effects
