**SLR Land Quality Assessment 2008**

**Waste to Energy Development  
Griffiths Road, Lostock Gralam, Northwich CW9 7TD**

**Phase 2 Land Quality Assessment**

**April 2008  
SLR Ref.: 403.0197.00556**

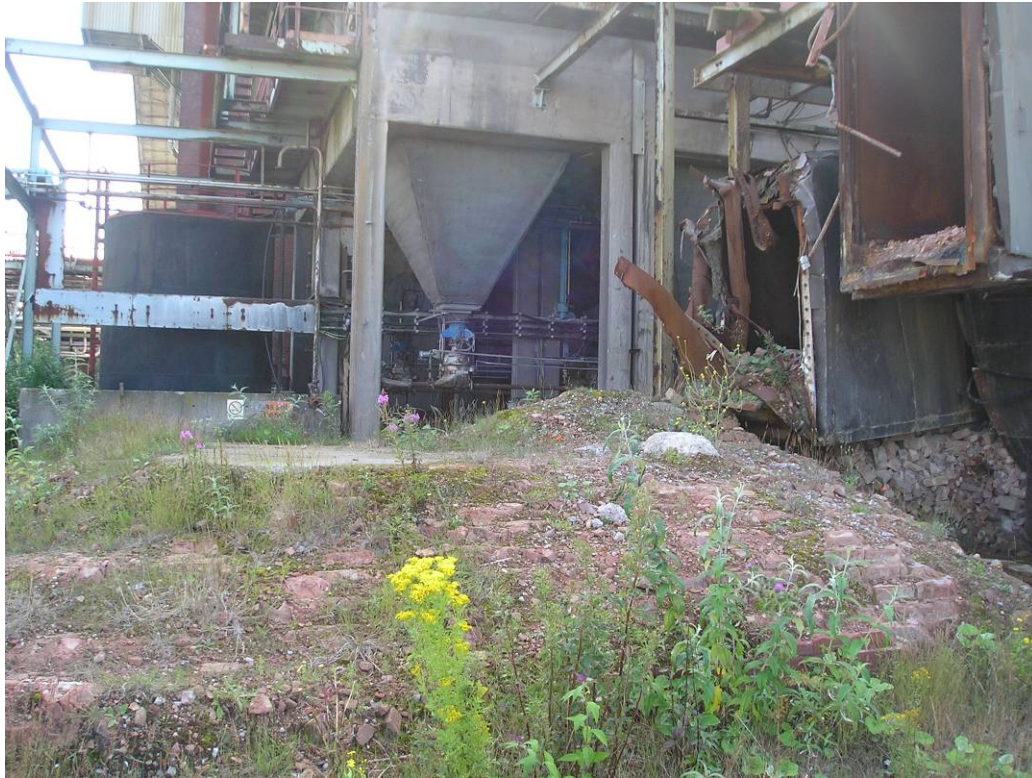
**Plate 3 Hoppers and empty gas oil (diesel) tank**

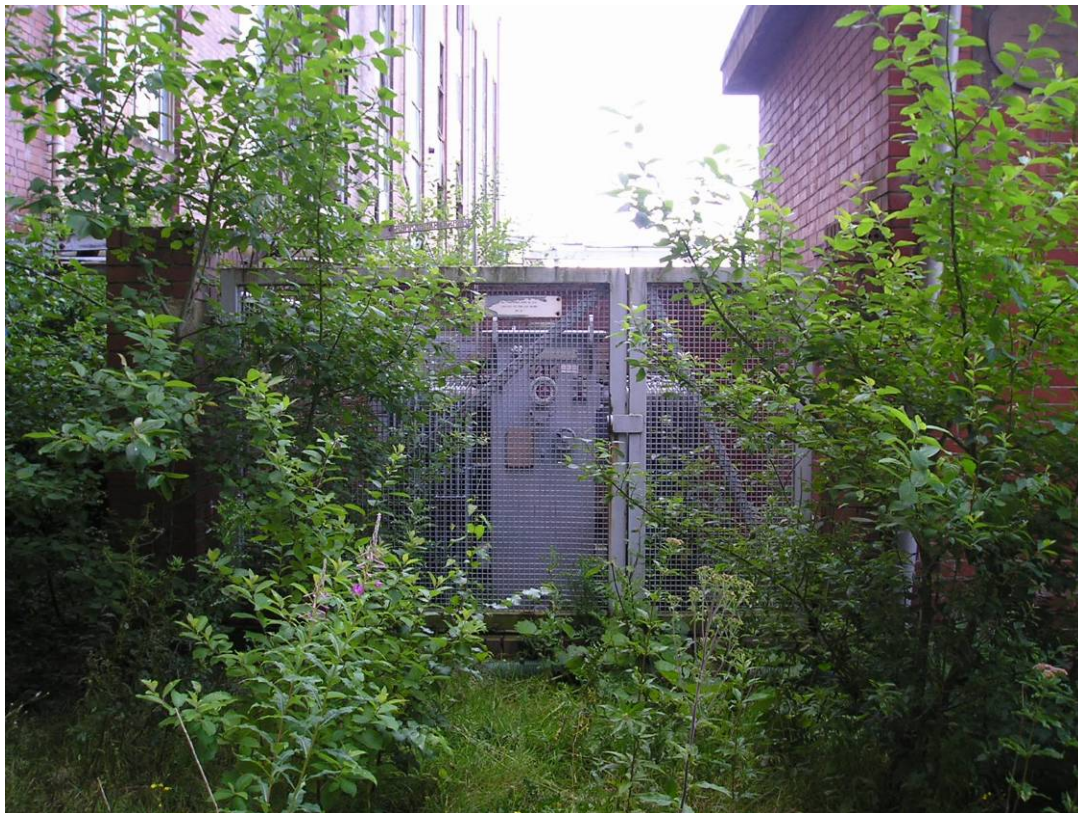
**Plate 4 Transformer adjacent to Boiler House**

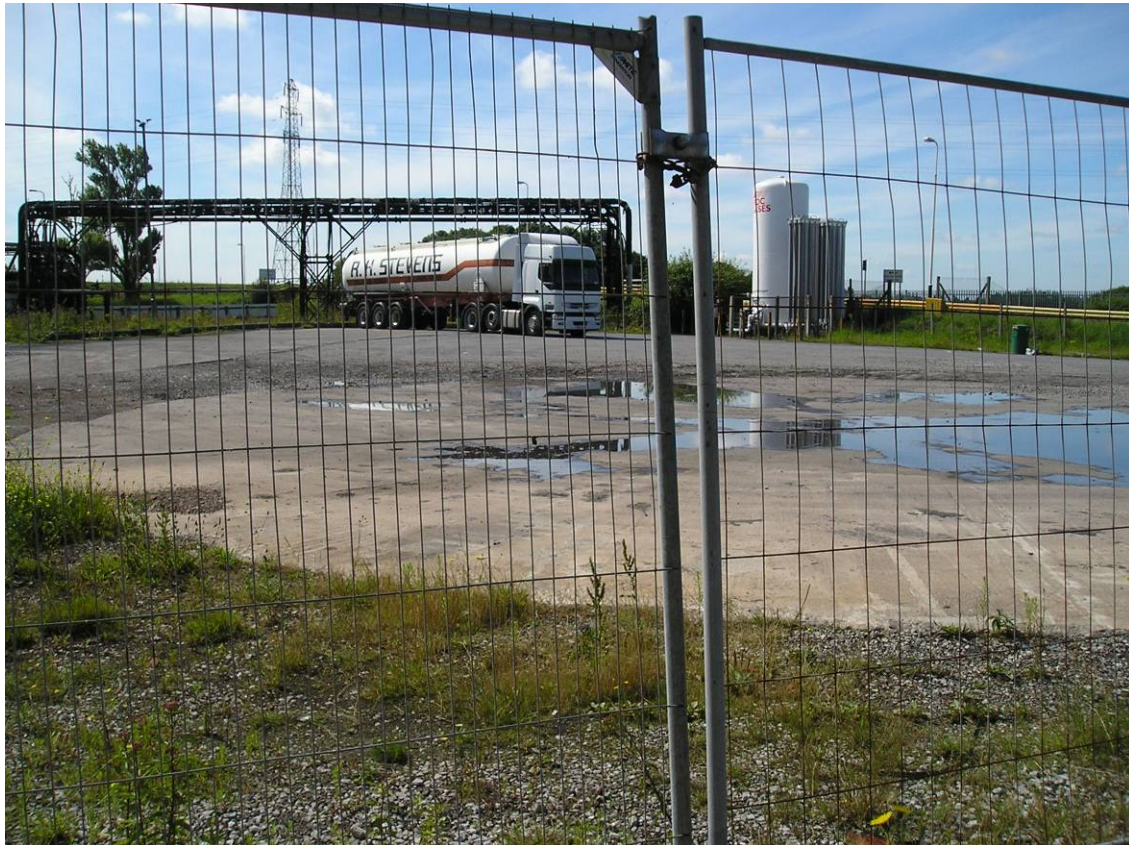
Plate 5 Location of former fuel oil storage tank

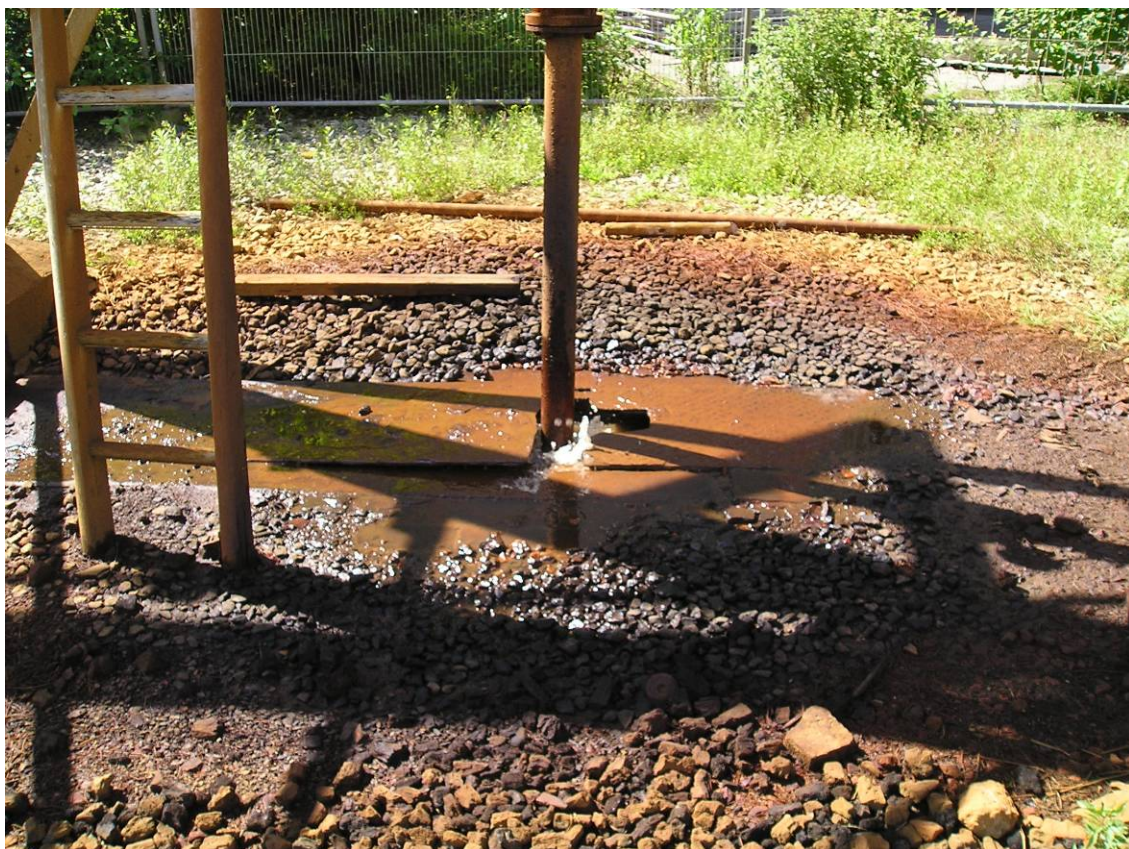
Plate 6 Direct discharge to ground

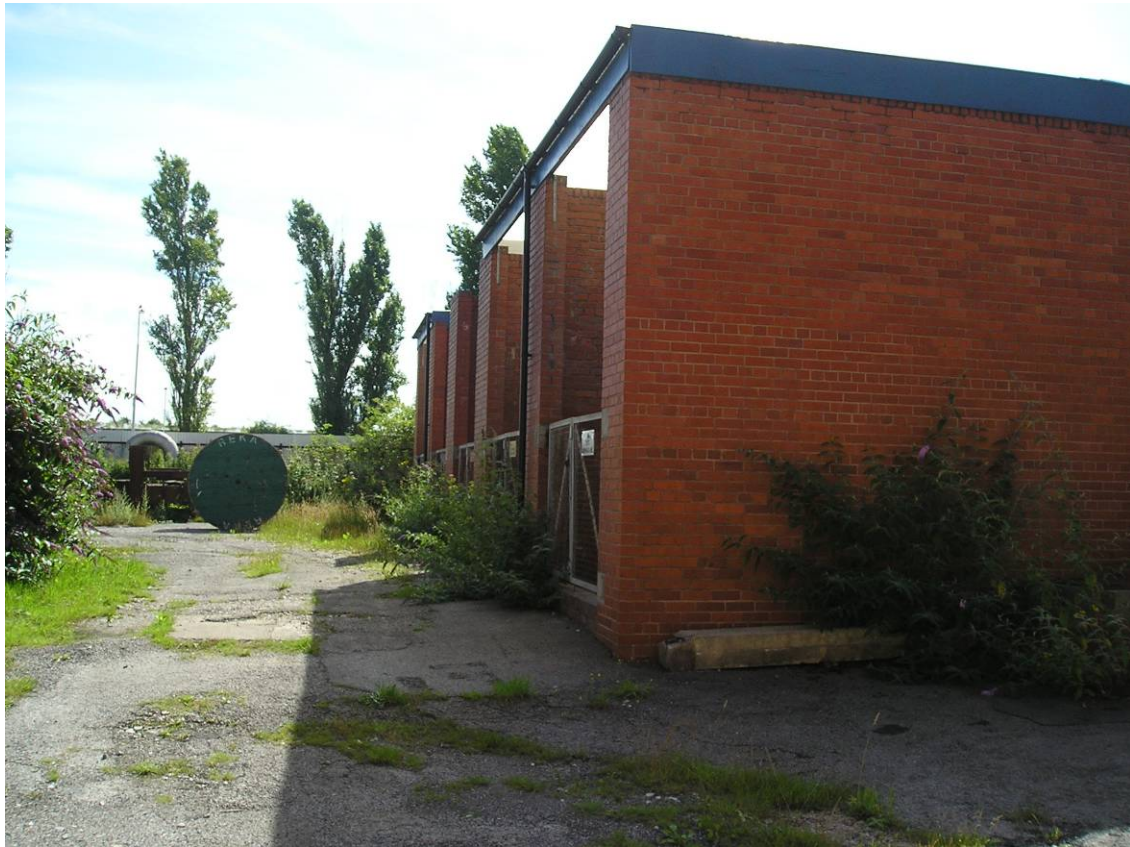
**Plate 7 Transformer compounds**

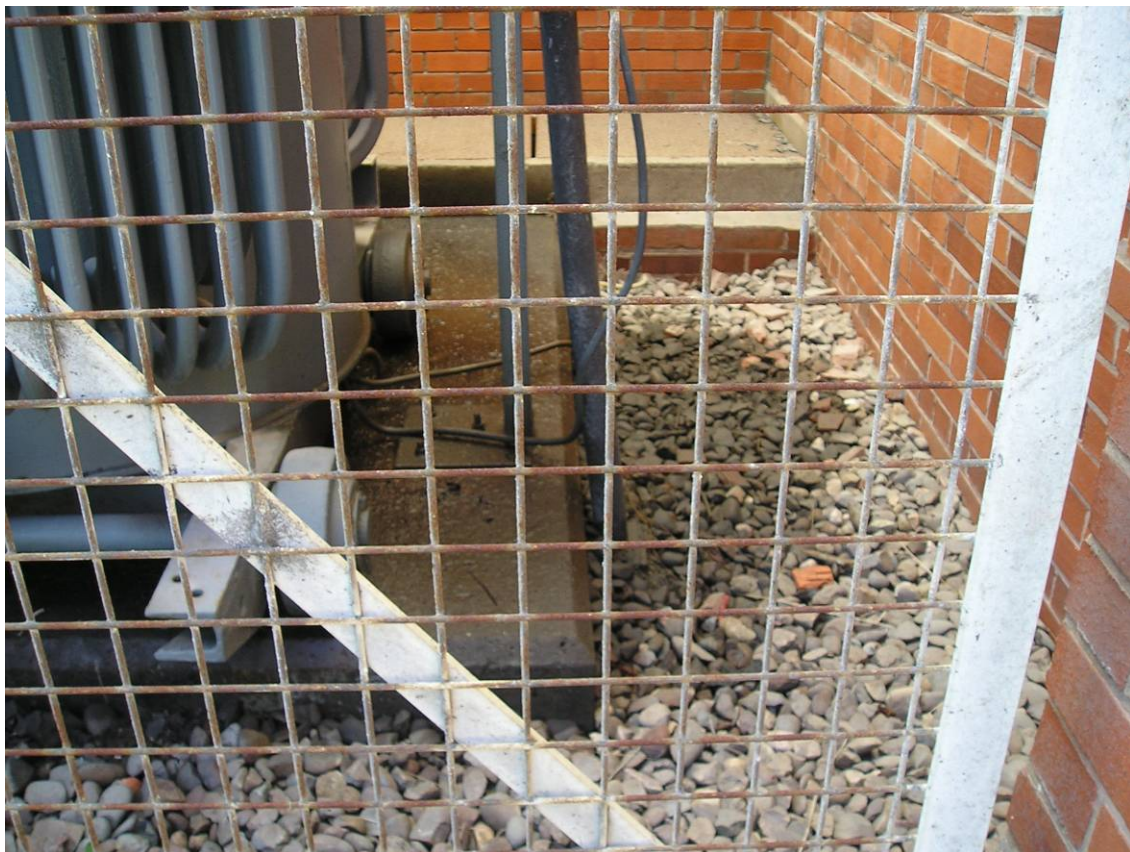
**Plate 8 Transformer oil spillage**

The main potential sources of contamination on site are leaks and spills from historic fuel storage at the site and oils/PCB from the transformer bays. The presence of hydrocarbon contamination in permeable near surface soils could pose risks to construction workers and surface water systems during redevelopment, and site occupants following development; and might require remediation in advance of development. Aggressive and unstable ground conditions and historic foundations are likely to be present which could impact the proposed development. Asbestos and other wastes may be present at the coke storage yard.

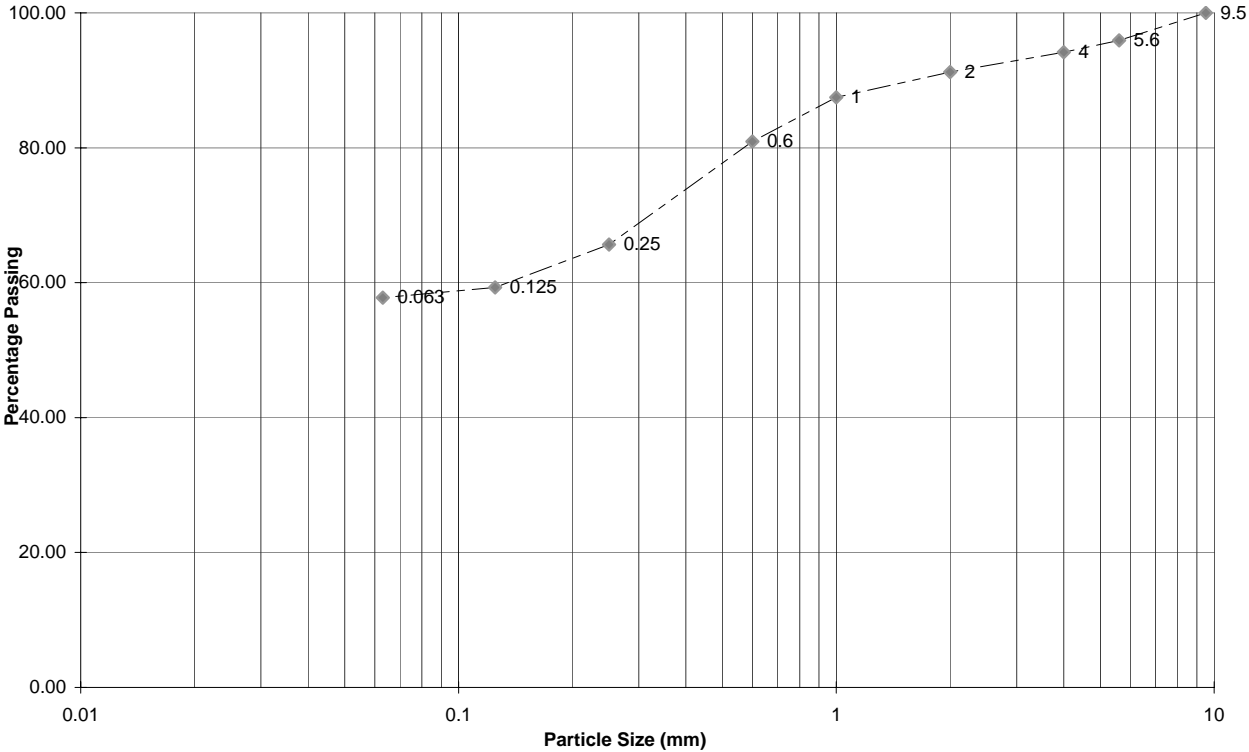
## Particle Size Distribution

Particle Proportions		
>60mm	Cobbles	- %
>2mm	Gravel	8.8 %
>0.063mm	Sand	33.4 %
<0.063mm	Silt & Clay	57.8 %

Description:	slightly gravelly sandy SILT / CLAY
--------------	-------------------------------------

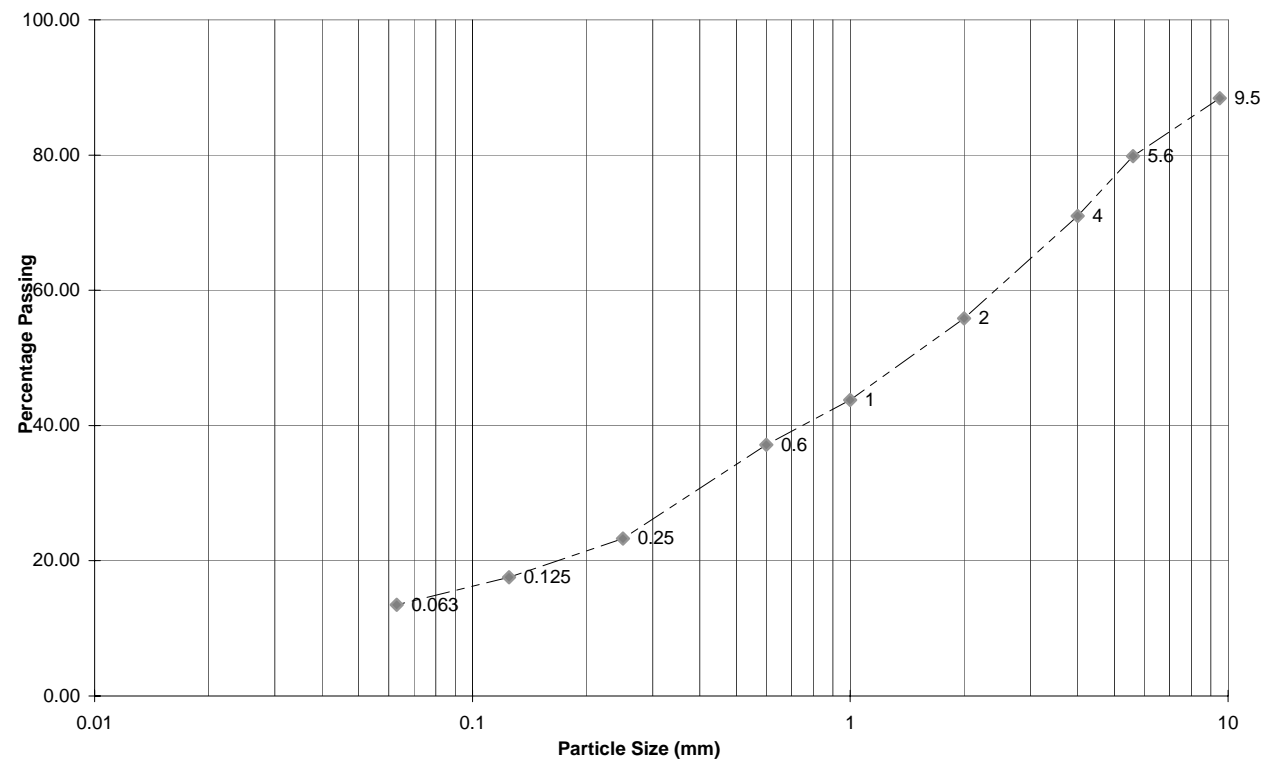
Particle Size Distribution

Particle Proportions		
>60mm	Cobbles	- %
>2mm	Gravel	44.2 %
>0.063mm	Sand	42.3 %
<0.063mm	Silt & Clay	13.5 %

<b>Description:</b>	clayey silty, SAND / GRAVEL
---------------------	-----------------------------

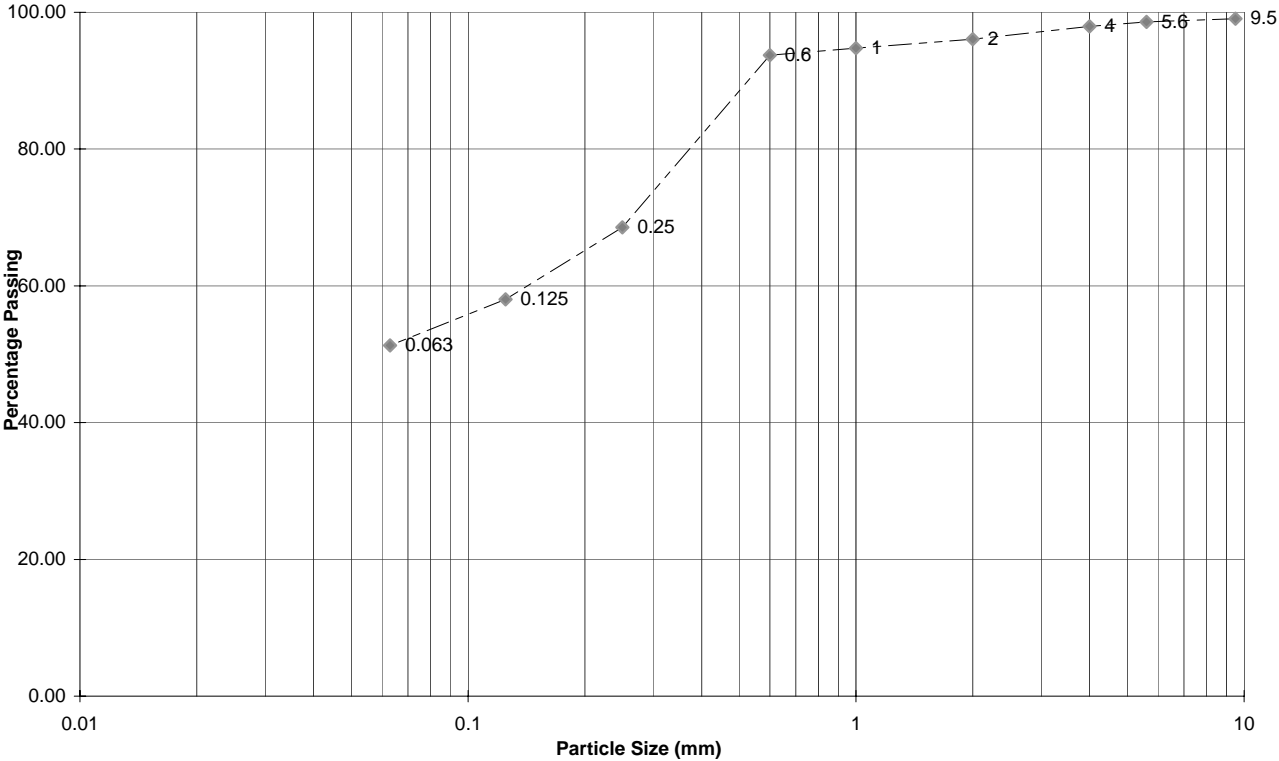
Particle Size Distribution

Particle Proportions			
>60mm	Cobbles	-	%
>2mm	Gravel	3.9	%
>0.063mm	Sand	44.8	%
<0.063mm	Silt & Clay	51.3	%

Description:	slightly gravelly very sandy SILT/CLAY
--------------	--

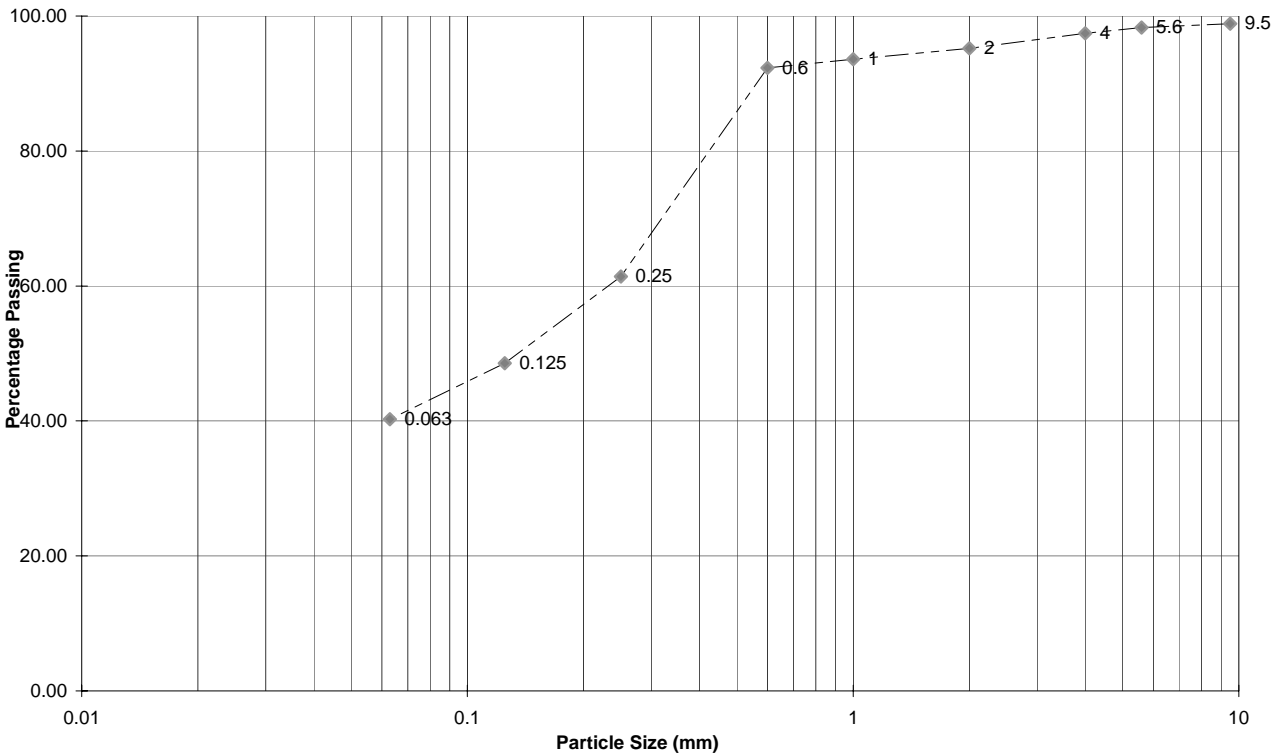
## Particle Size Distribution

Particle Proportions			
>60mm	Cobbles	-	%
>2mm	Gravel	4.8	%
>0.063mm	Sand	55.0	%
<0.063mm	Silt & Clay	40.2	%

Description:	slightly gravelly very clayey silty SAND
--------------	--

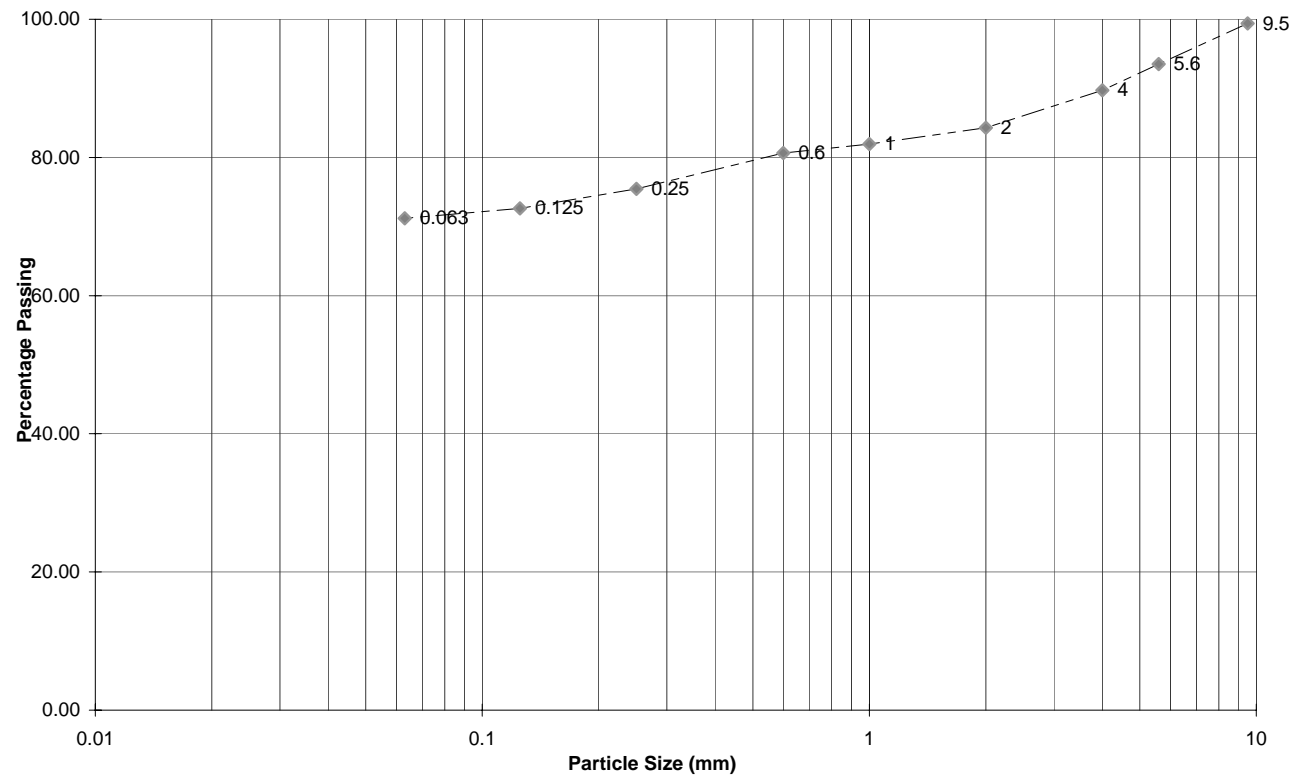
## Particle Size Distribution

Particle Proportions		
>60mm	Cobbles	- %
>2mm	Gravel	15.7 %
>0.063mm	Sand	13.1 %
<0.063mm	Silt & Clay	71.2 %

Description:	sandy gravelly SILT/CLAY
--------------	--------------------------

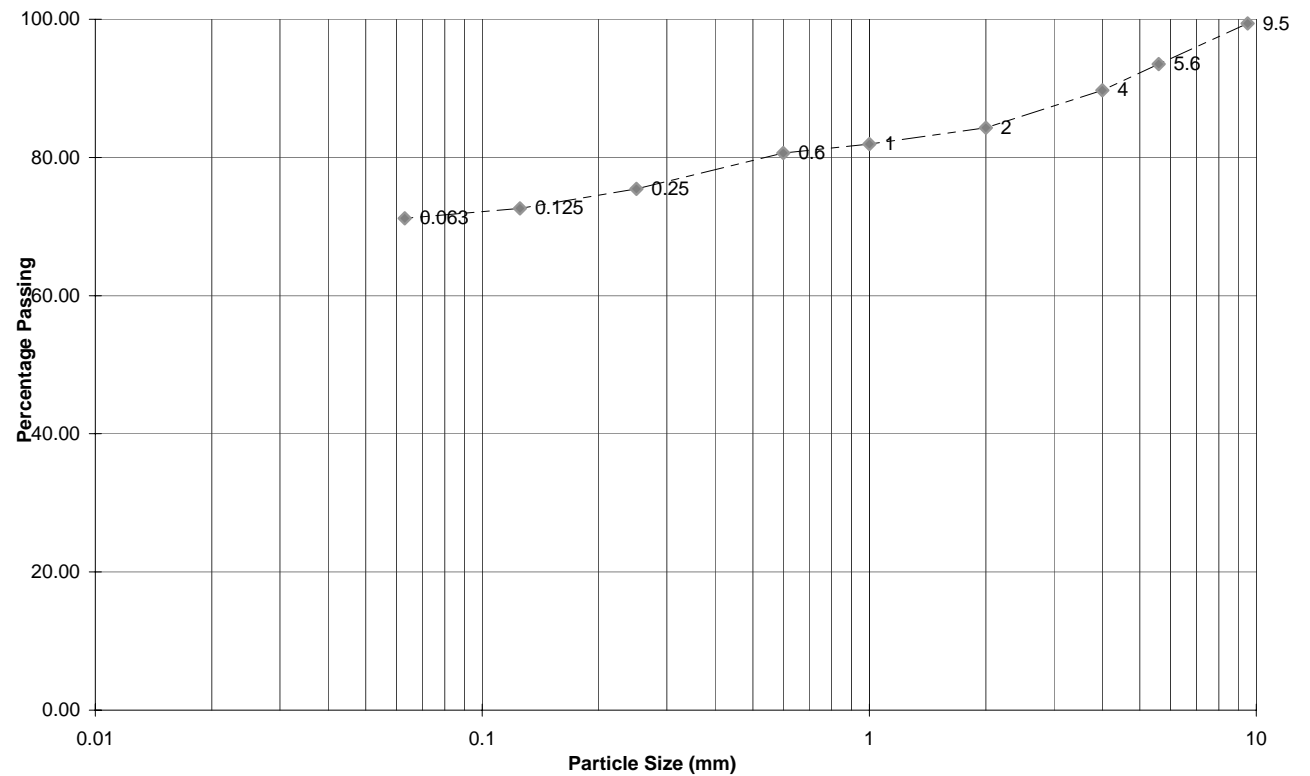
Particle Proportions			
>60mm	Cobbles	-	%
>2mm	Gravel	15.7	%
>0.063mm	Sand	13.1	%
<0.063mm	Silt & Clay	71.2	%

<b>Description:</b>	sandy gravelly SILT/CLAY
---------------------	--------------------------
