Site Condition Report

Crayford Materials Recycling Facility

6th January 2026

Project No.: SOL_25_P143_N+P

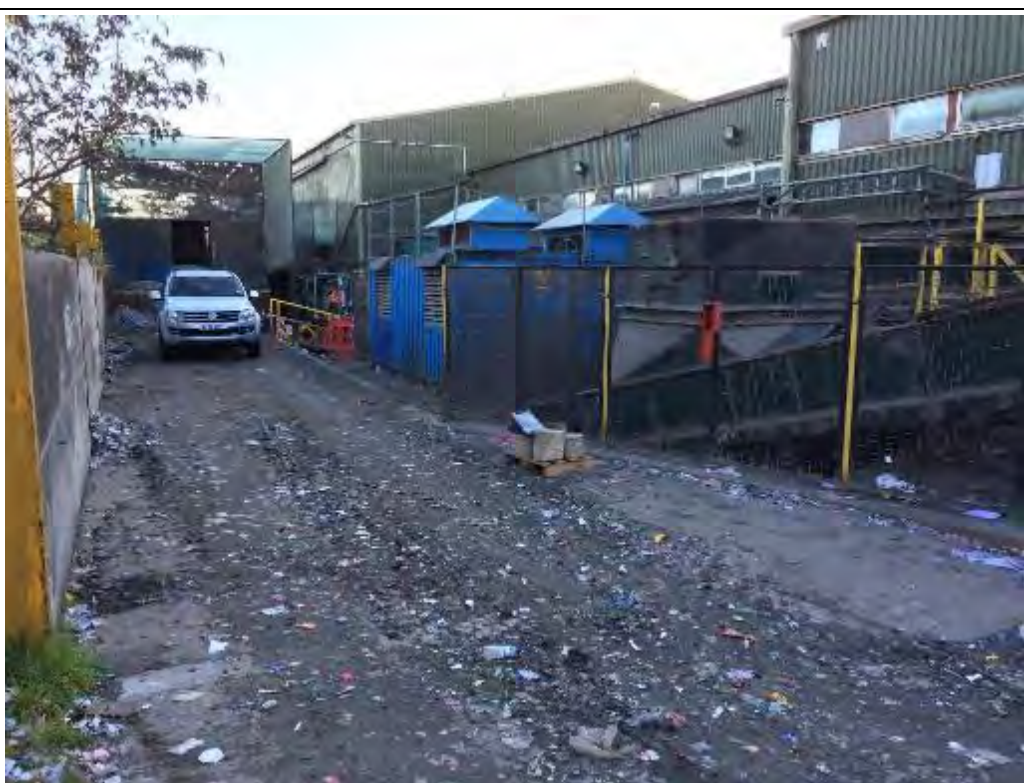
Photo No. 2	Date: Nov 2017
Direction Photo Taken: East

Description:

To the right of the unmade roadway is bordered is the concrete slab on the lower elevation on which the conveyor belt is positioned.

Retaining wall to the left is 2 metres high and constructed of steel beams and concrete panelling. Behind it is the grassed earth bund behind.

formerly covering the Site was apparently removed to create a level surface for development. The base of this earth bund was supported by a retaining wall made of vertical concrete slabs (photos 2, 5 and 10). Between the retaining wall and the Site's installations, was a 5 metre wide concrete hardstanding which served as access to the de-stoner plant (photo 2). The top of the earth bund was maintained as rough grassland (photos 3 and 4).

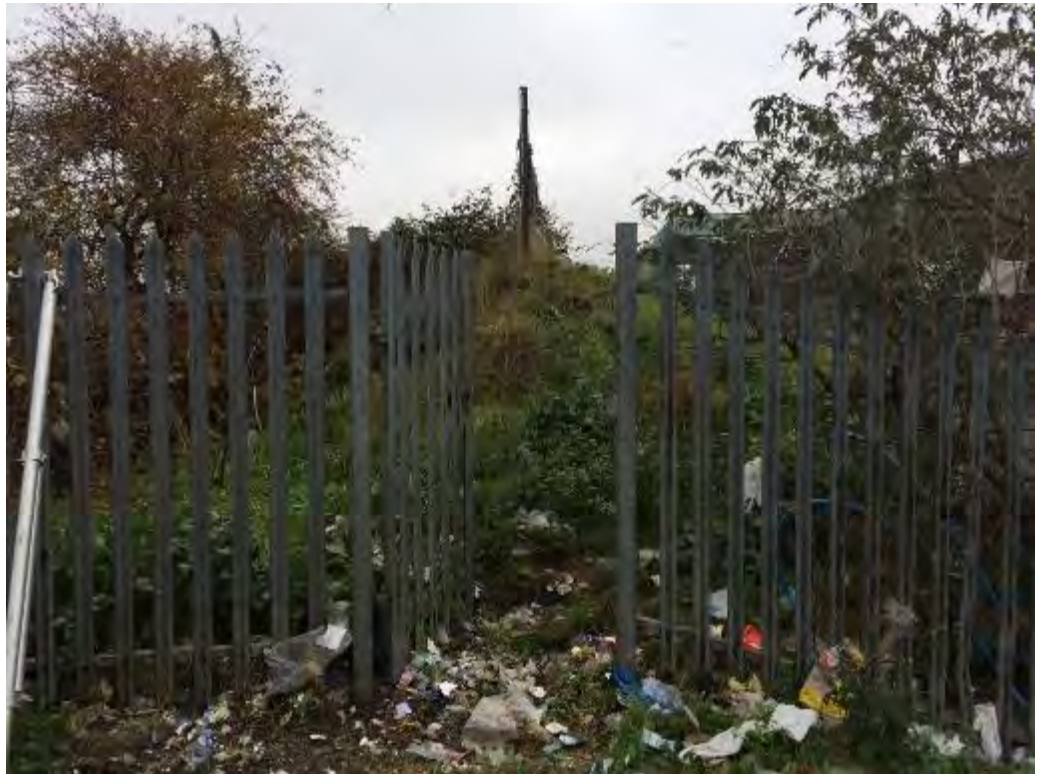
Photo No. 3	Date: Nov 2017
------------------------------	--------------------------

View looking east of the earth bund to the north of the site through a gap in the perimeter fence. There is also a fence line along the top of the earth bund. The retaining wall to the right of the picture is not visible.

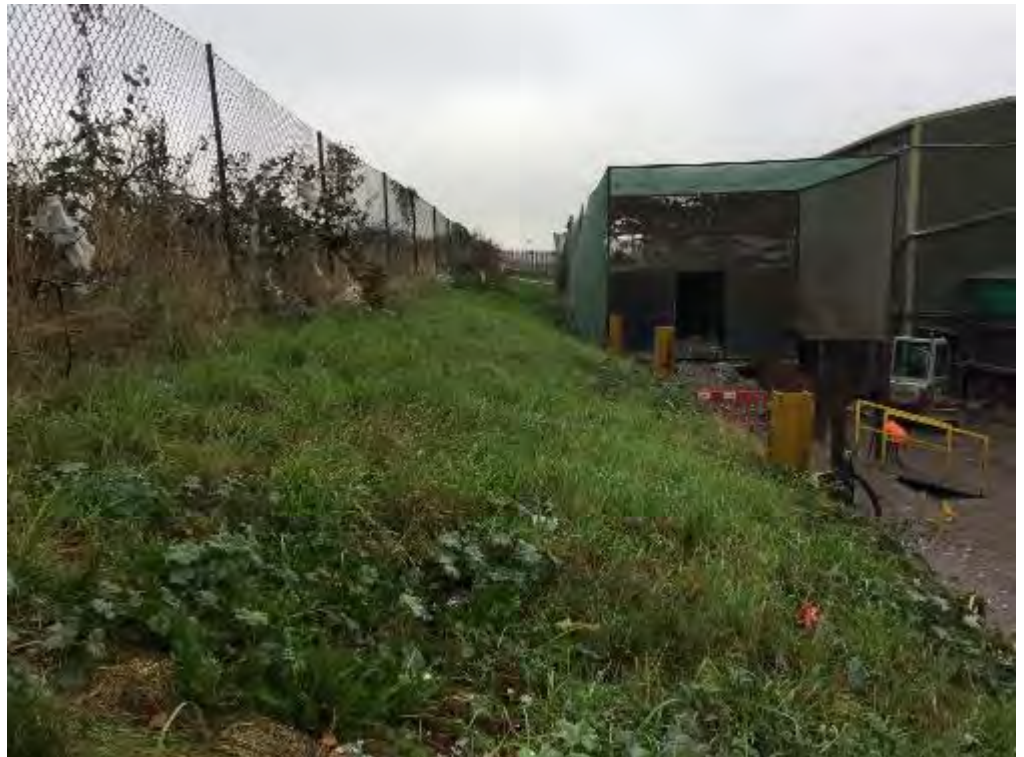
Photo No. 4	Date: Nov 2017
------------------------------	--------------------------

Photo taken from top of earth bund which is grassed and slopes southwards towards the development Site.

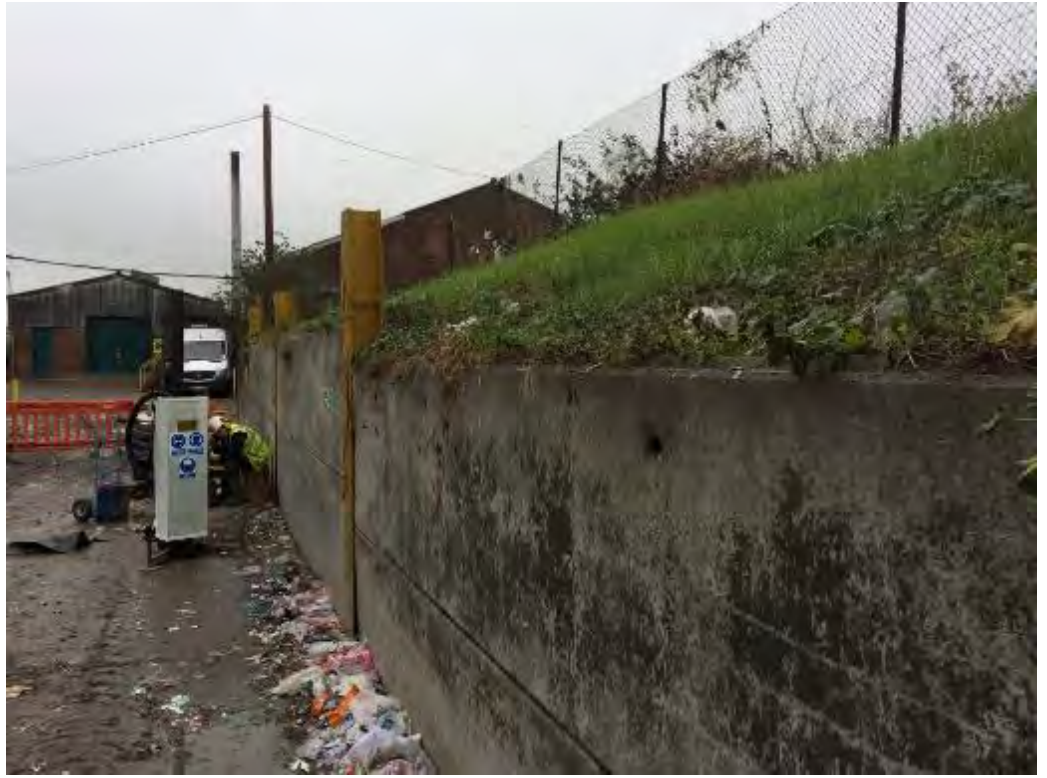
Photo No. 5	Date: Nov 2017
------------------------------	--------------------------

View of the retaining wall and the earth bund along the north of the development Site.

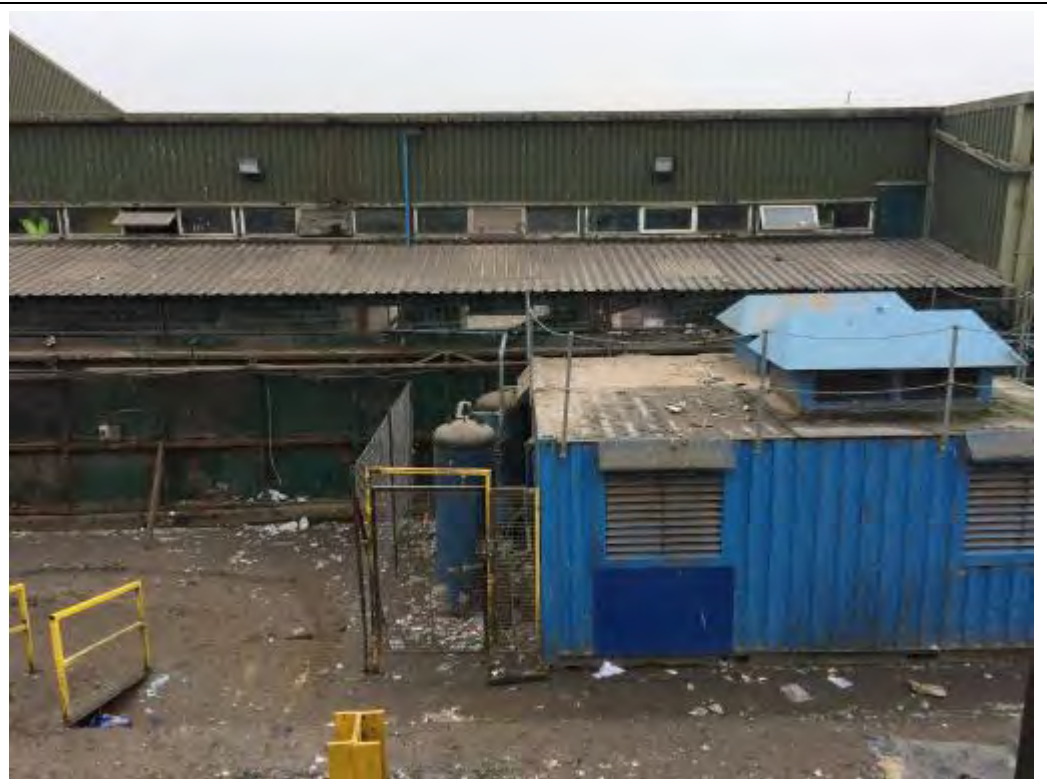
Photo No. 6	Date: Nov 2017
------------------------------	--------------------------

Picking building located to the south of the proposed development Site, to which the new extension will be tied. The compressor is housed within the blue shipping container. The concrete slab is laid at two elevations with approximately 0.50m difference and this step is visible along the front of the view pictured.

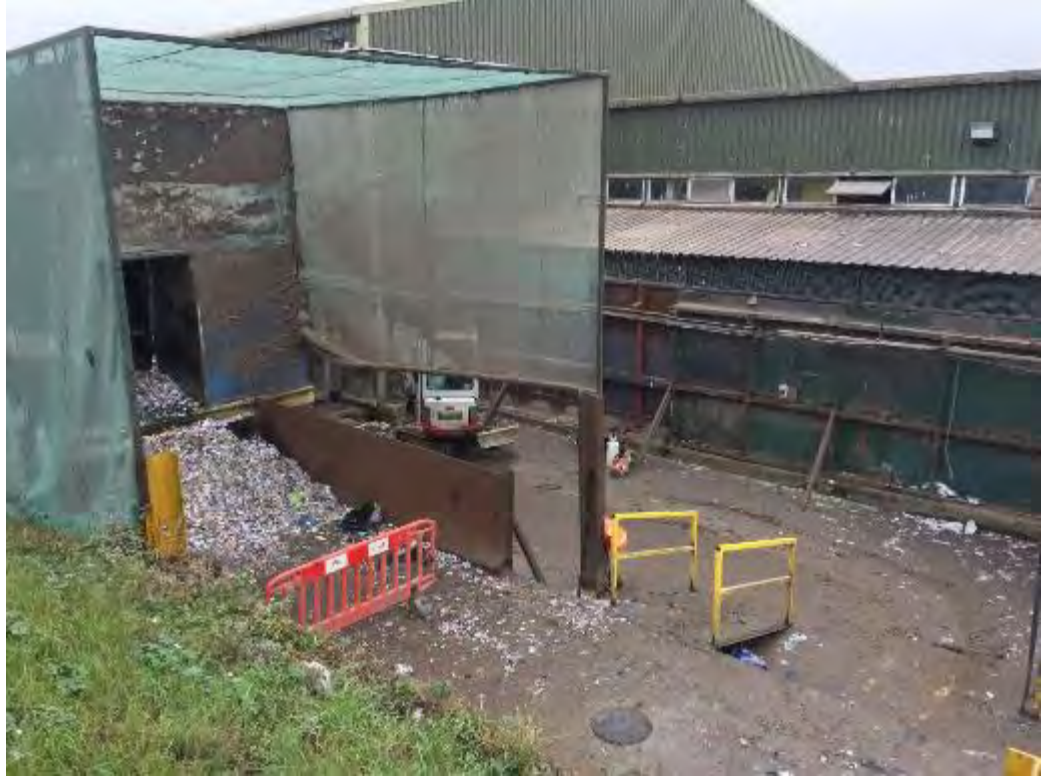
Photo No. 7	Date: Nov 2017
------------------------------	--------------------------

Description:
Concrete slab laid to different elevations with the step down visible between the retaining wall and the picking building. Current picking operations shown in the left of the photo. The main MRF is visible in the distance.

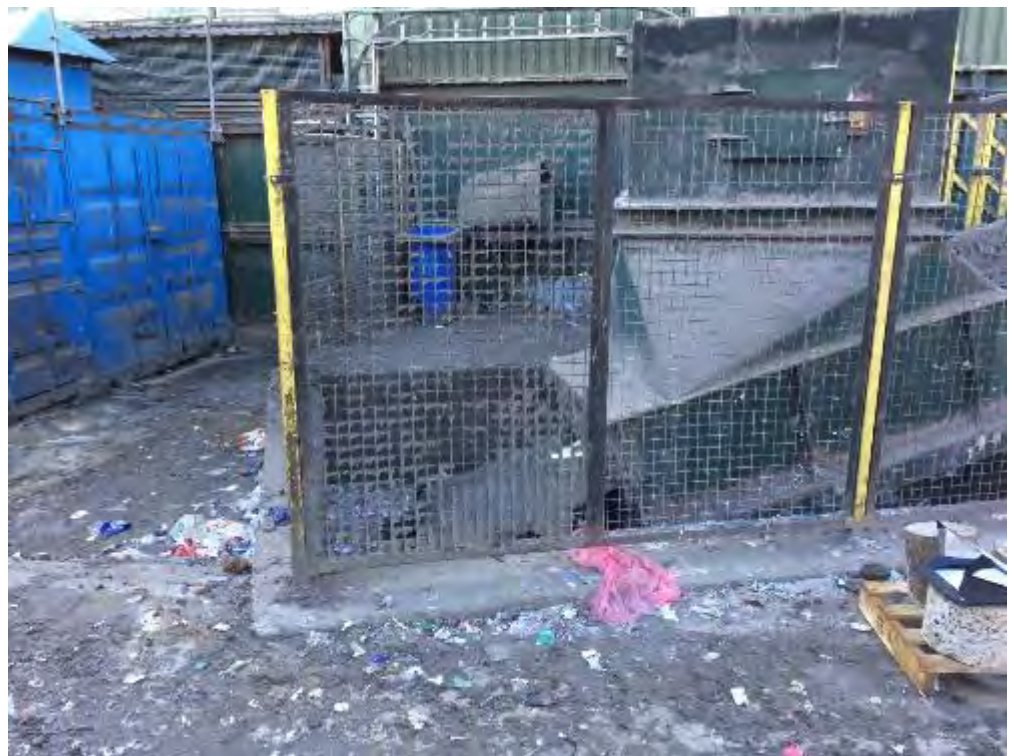
Photo No. 8	Date: Nov 2017
------------------------------	--------------------------

Description:
Closer view of the lower level of concrete hardstanding housing the conveyor. It is 1 metre lower than the surrounding.

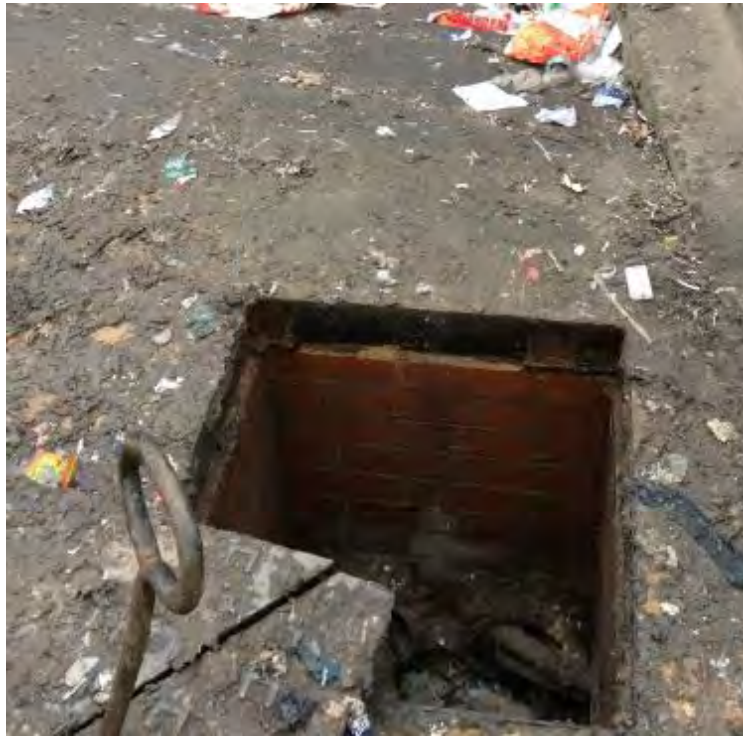
Photo No. 9	Date: Nov 2017
------------------------------	--------------------------

Close up of a manhole chamber containing electrical cables feeding into the MRF building

- 2.3.13 An underground services survey was completed which incorporated the use of CCTV and Ground Penetrating Radar (GPR). This identified the presence of high voltage electrical cables entering the Site from the south-west into a square manhole chamber (photo 9), and then turning 90° towards the main MRF to the south. Surface water drains also enter the Site from west to east and are accessed via a round manhole chamber lid (photos 10 & 11), although these could not be surveyed or inspected due to the presence of blockages.

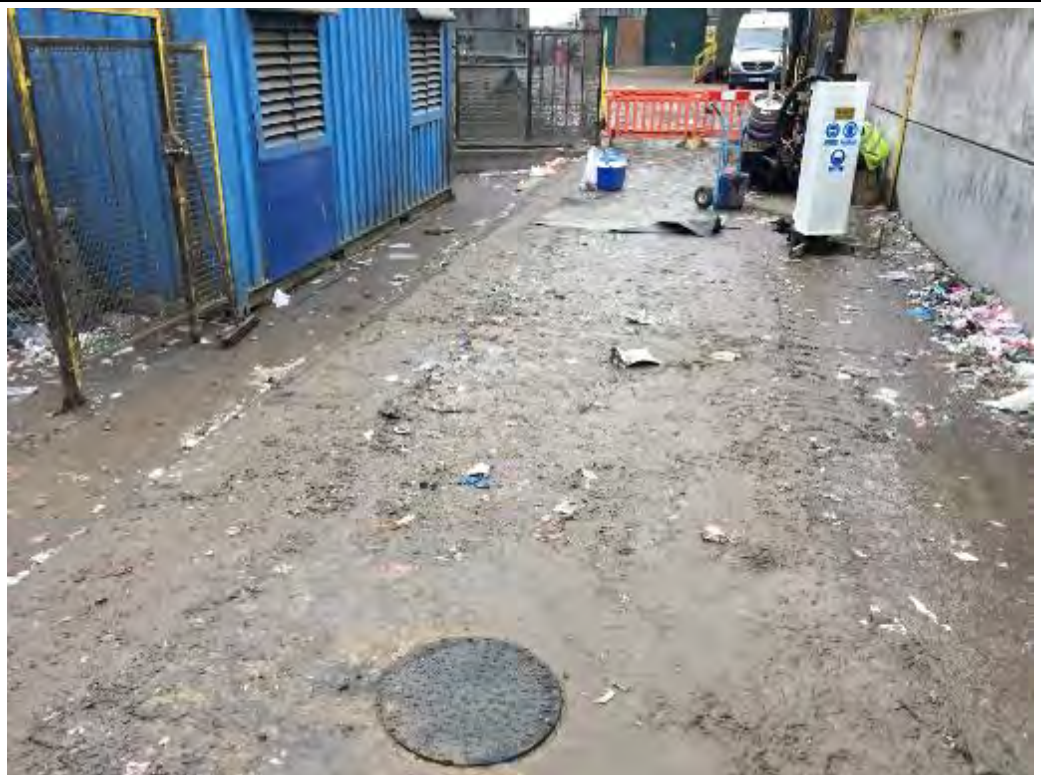
Photo No. 10	Date: Nov 2017
-------------------------------	--------------------------

Concrete access ramp at the base of the retaining wall which is slightly higher than that housing the operations to the left. In the foreground is a drain cover.

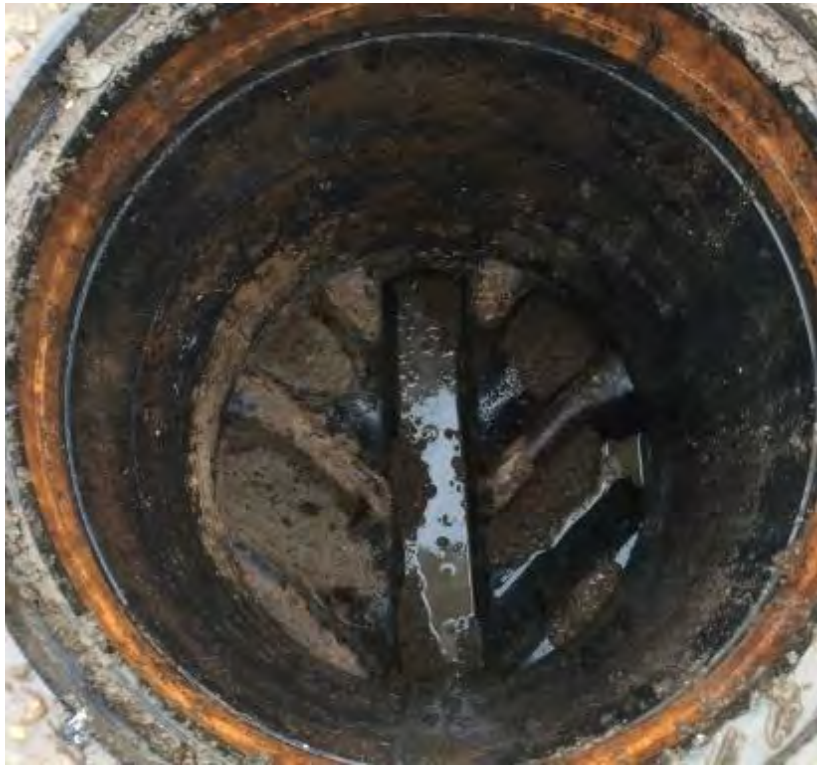
Photo No. 11	Date: Nov 2017
-------------------------------	--------------------------

The inside of the drainage manhole from photo 10, which was blocked

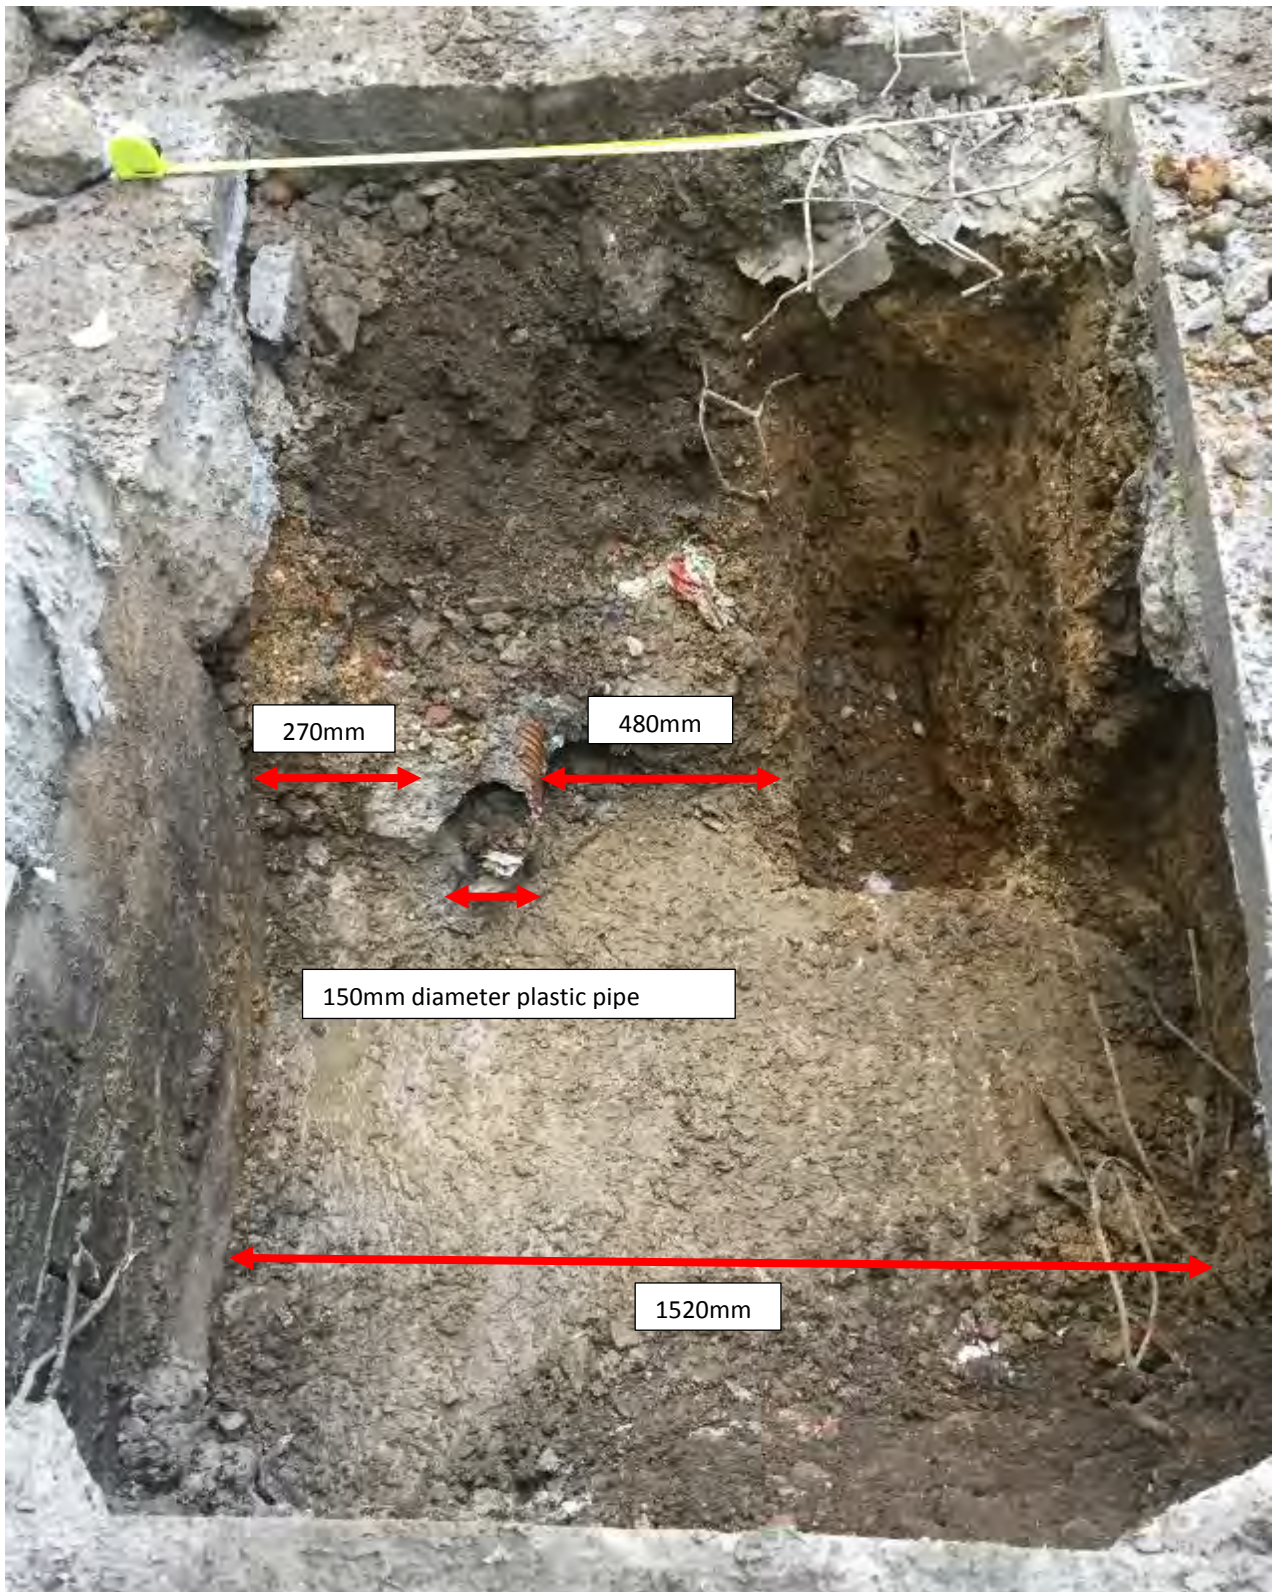
Trial Pit Photographs: Face A

1.29	1.50	Brown medium dense fine to coarse SAND and angular to subangular fine to coarse GRAVEL of chert and flint.			
Trial pit terminated at 1.50m depth.					
Excavated by – 3 tonne mini digger Plan Dimensions of Pit – 1.52m x 1.53m Groundwater – none. Stability – Sides stable Contamination – No visual or olfactory evidence of contamination

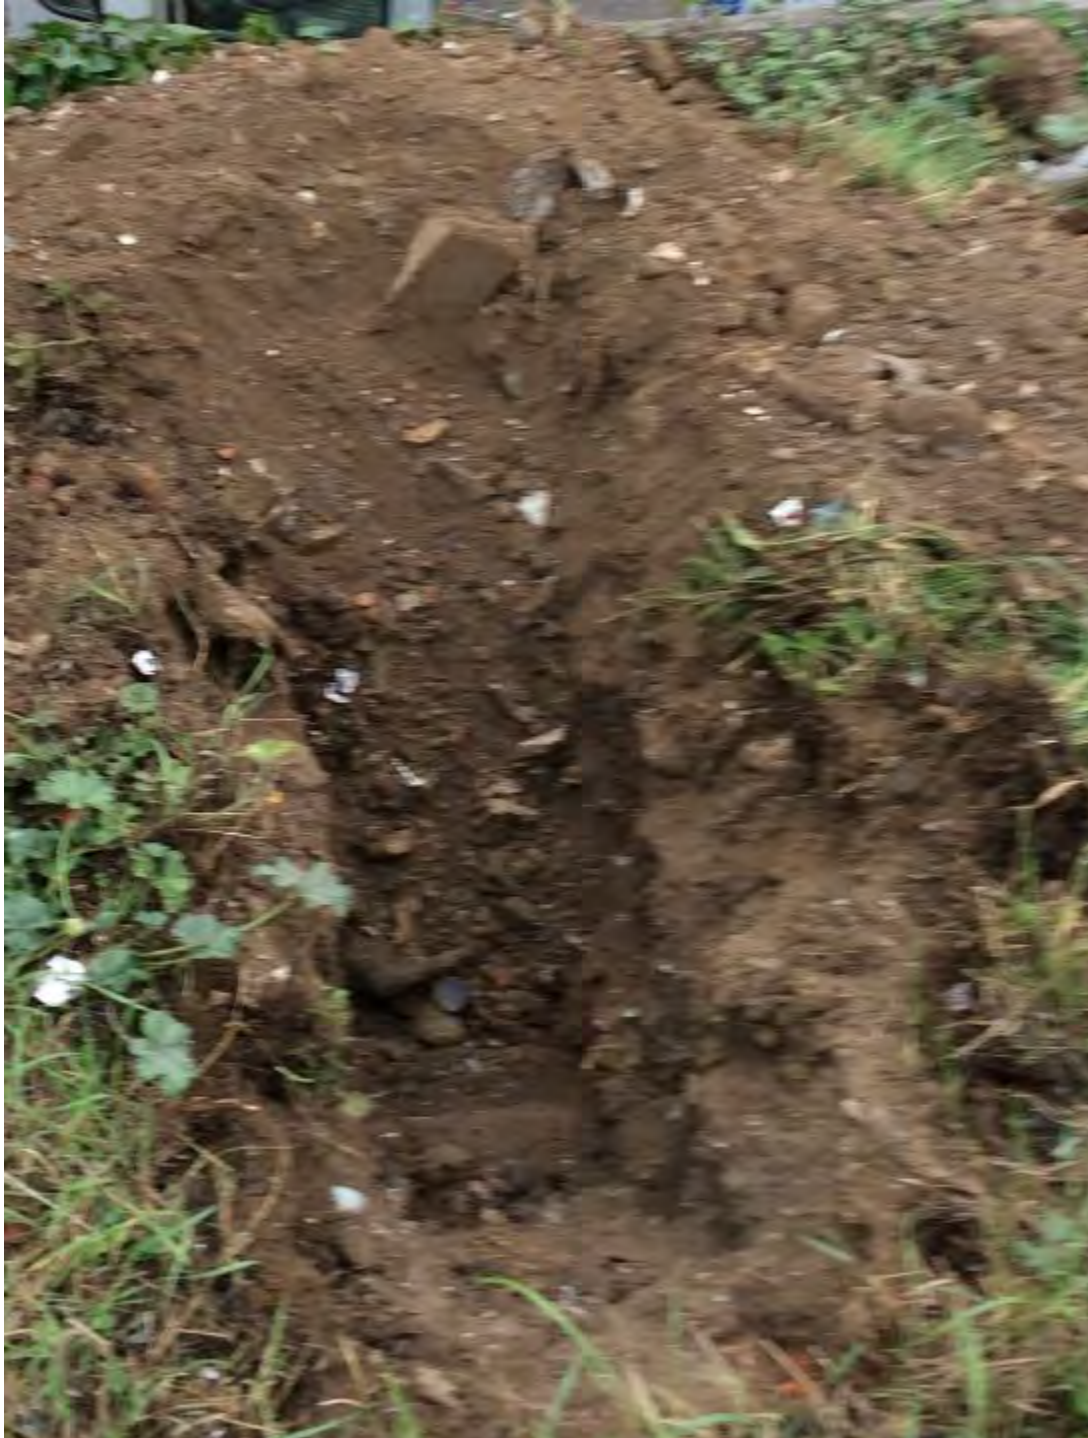
Trial Pit Photographs: Face A

Project: Crayford MRF – Paper lines upgrade		Trial Pit: TP01	
Excavation date: 15 - 17/11/2017		Logged by: DEO	Client: Viridor Waste Management Ltd		Project ID: 3064
Elevation (mAOD)		11.02	Coordinates	E: 552865.297, N: 175789.990	
Depth (m)		Description			Samples
From	To				
0	0.70	MADE GROUND: Grass over loose to medium dense, brown clayey fine to medium SAND and angular to subangular fine to coarse GRAVEL of ash, brick, concrete, masonry stone, with metallic and plastic fragments (Bund)			1ES 0.20 -0.70m
Trial pit terminated at 0.70m depth.					
Excavated by – 3 tonne mini digger Plan Dimensions of Pit – 1.0m x 3.0m Groundwater – none. Stability – Sides stable Contamination – No visual or olfactory evidence of contamination

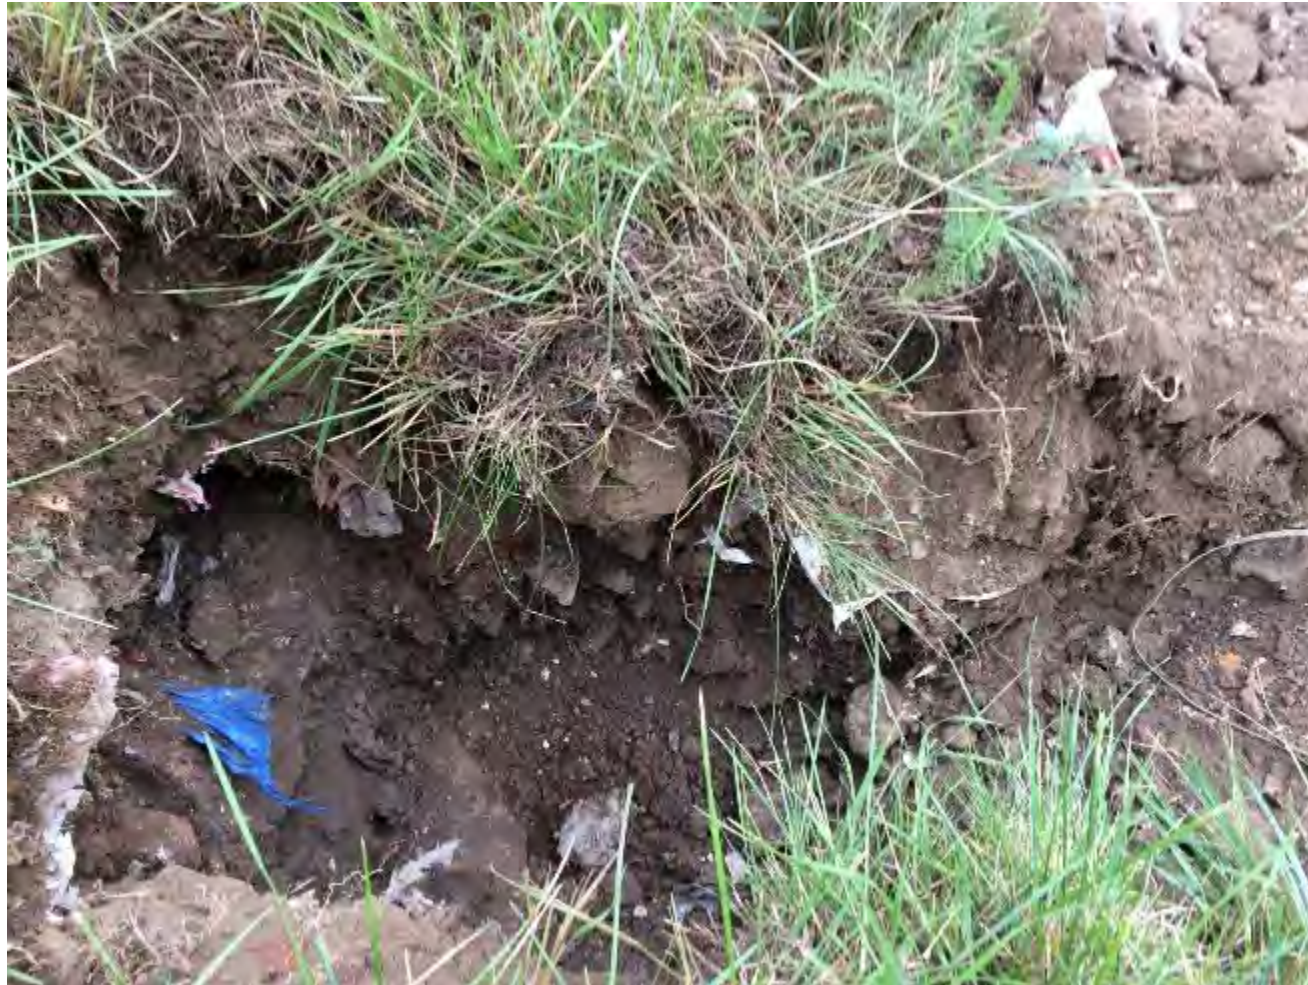
Trial Pit Photographs:

Project: Crayford MRF – Paper lines upgrade		Trial Pit: TP02	
Excavation date: 15 - 17/11/2017		Logged by: DEO	Client: Viridor Waste Management Ltd		Project ID: 3064
Elevation (mAOD)		11.14	Coordinates	E: 552859.802, N: 175788.942	
Depth (m)		Description			Samples
From	To				
0	0.90	MADE GROUND: Grass over loose to medium dense, brown clayey fine to medium SAND and angular to subangular fine to coarse GRAVEL of ash, brick, concrete, masonry stone, with metallic and plastic fragments (Bund)			1ES 0.20 -0.90m
Trial pit terminated at 0.90m depth.					
Excavated by – 3 tonne mini digger Plan Dimensions of Pit – 1.0m x 3.0m Groundwater – none. Stability – Sides stable Contamination – No visual or olfactory evidence of contamination

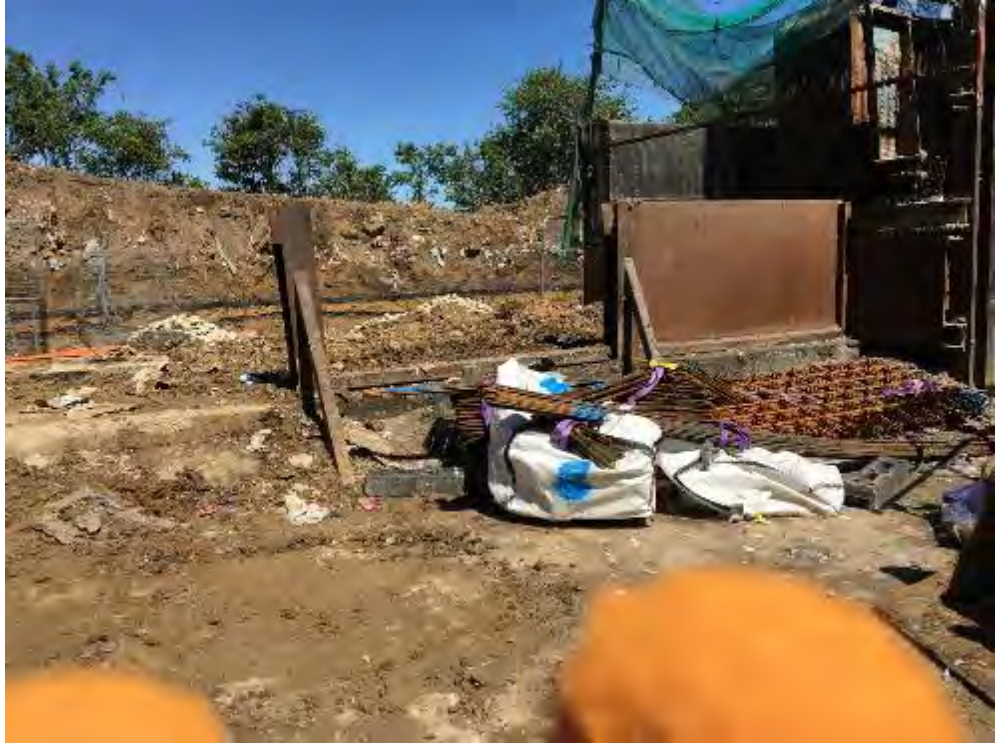
Description: View of earth bund being exposed as part of the enabling works for the paper line upgrade.

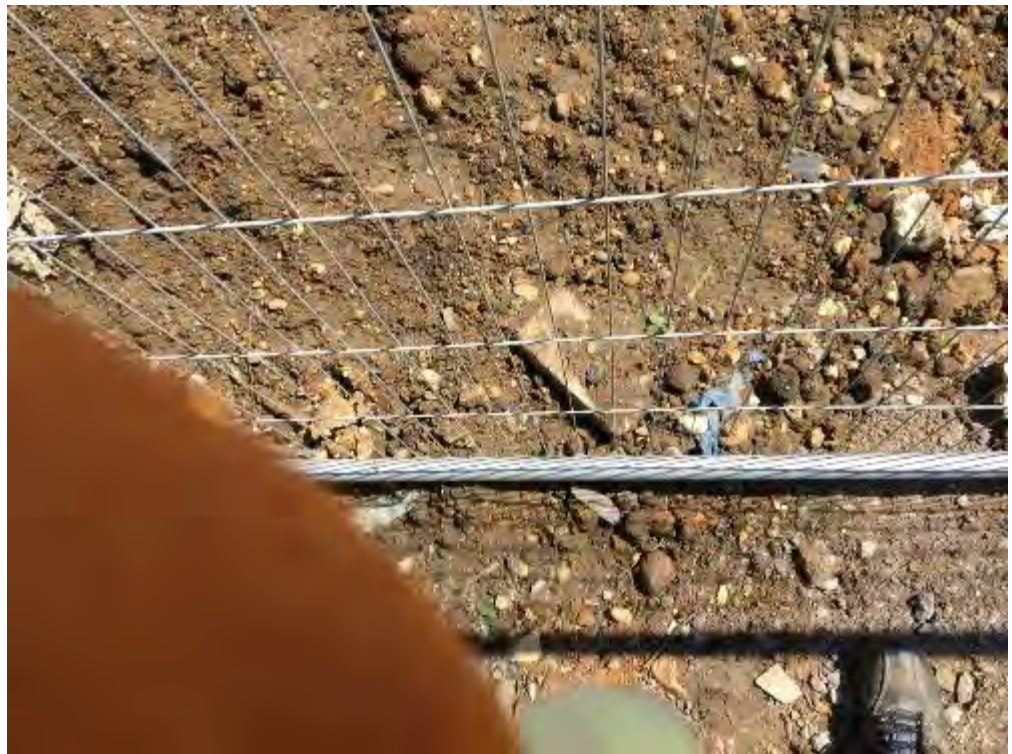
Photo No. 2	Date: 01/05/18
------------------------------	--------------------------

Description: Close-up of material exposed in the earth bund.
--

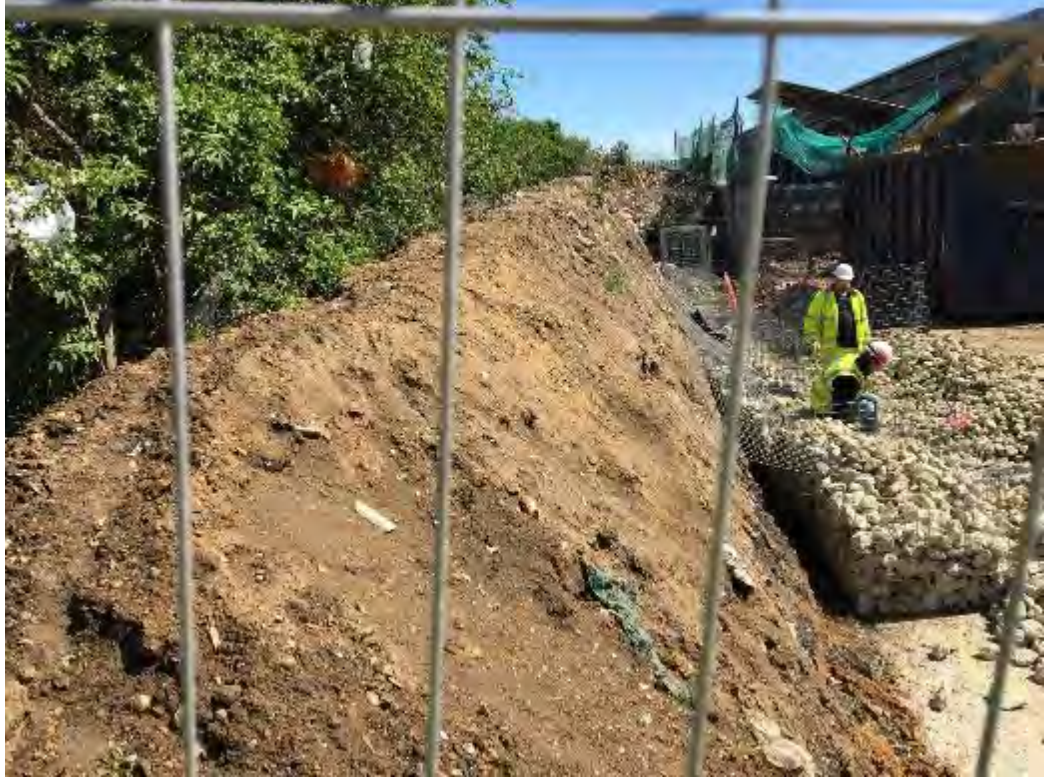
Photo No. 3	Date: 01/05/18
------------------------------	--------------------------

Description:
 Enabling works for the paper line upgrade:
 Installing gabions at the base of the earth bund along the northern side of the Site.

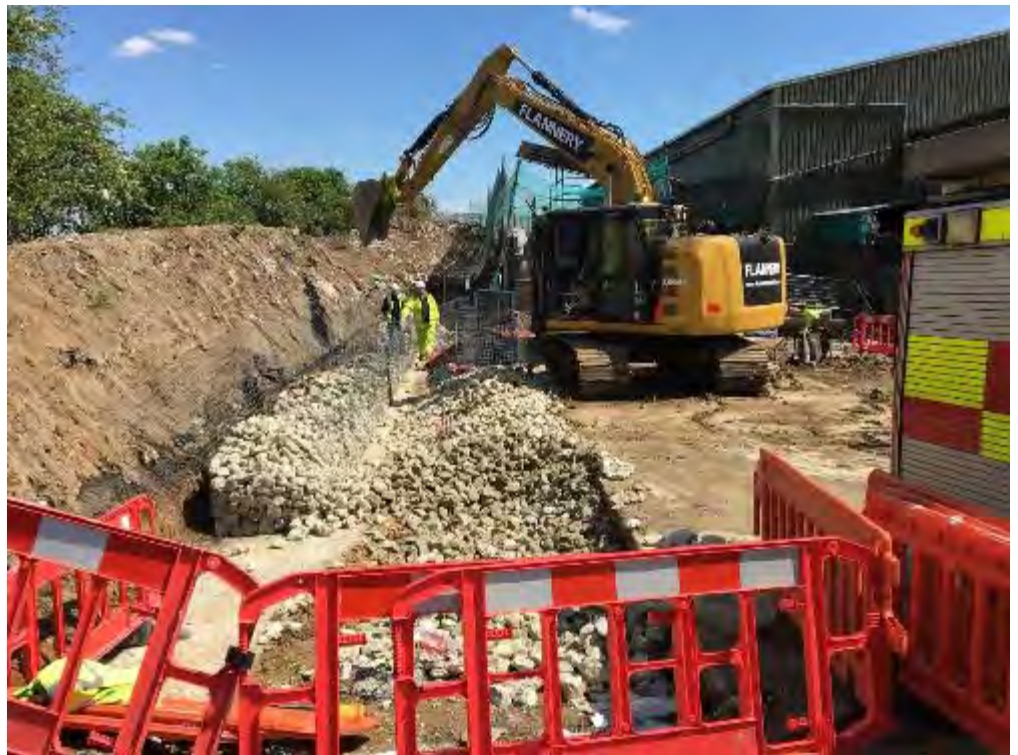
Photo No. 4	Date: 01/05/18
------------------------------	--------------------------

Description:
 Wider view of gabions being installed at the base of the reduced earth bund along the northern side of the Site.

- 3.2.9 The newly exposed face of the earth bund was immediately stabilized by means of gabion walls. At the time of writing it is yet to be covered in topsoil and seeded and this will be done once the construction programme is completed and the area is no longer required for construction traffic. The 1.2m metre gap between the building extension and the new gabion has been finished as a concrete footpath (photos 6, 9, 13) in Appendix 6.

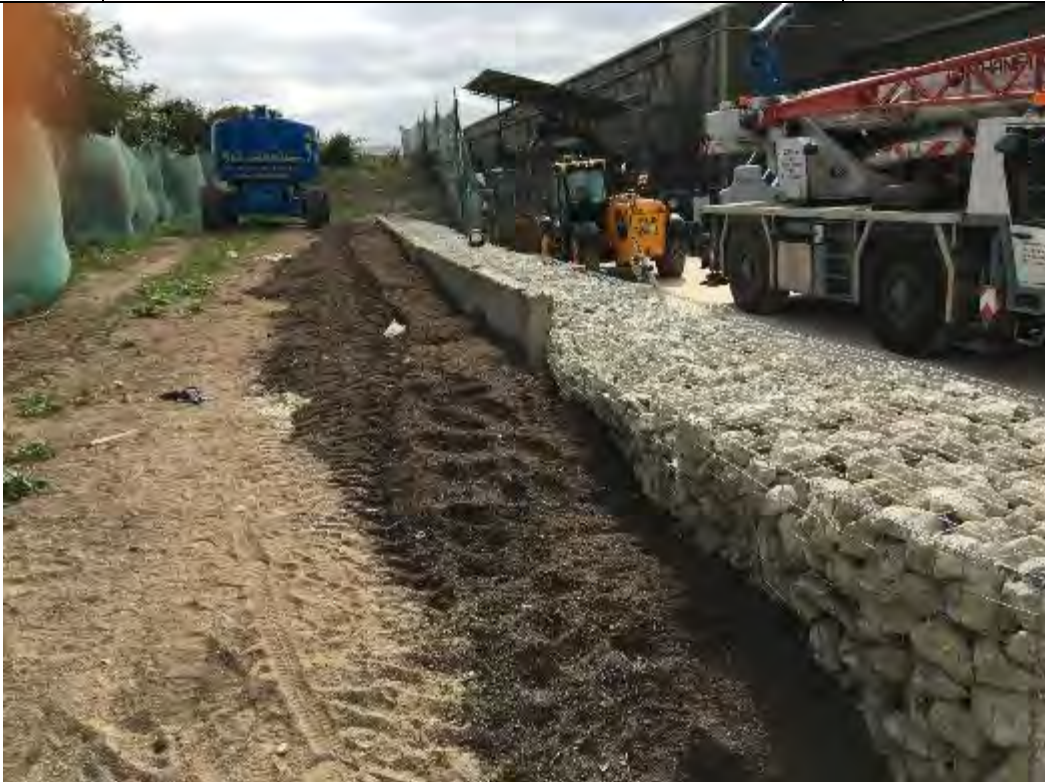
Photo No.
5

Description:
View of reduced bund behind the installed Gabion wall. Top soil being laid to form levels

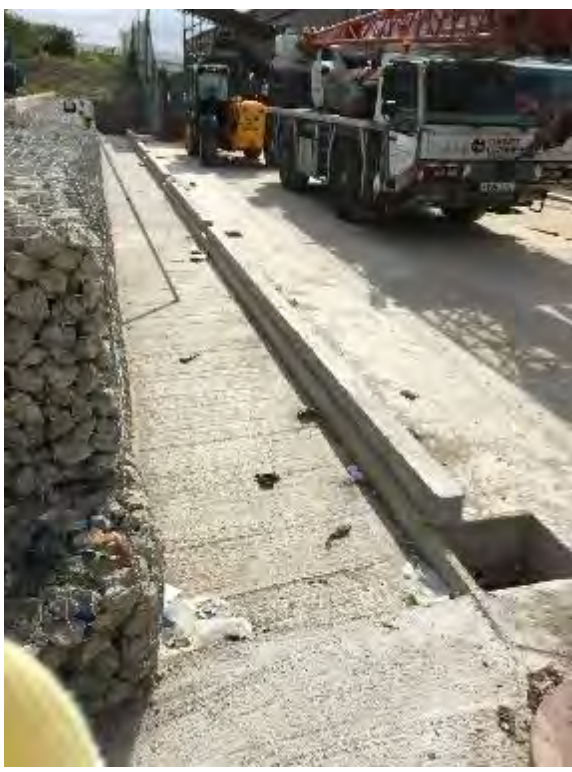
Photo No.
6

Description:
View of new footpath to building side of new Gabion wall. Note concrete upstand reflects the building line

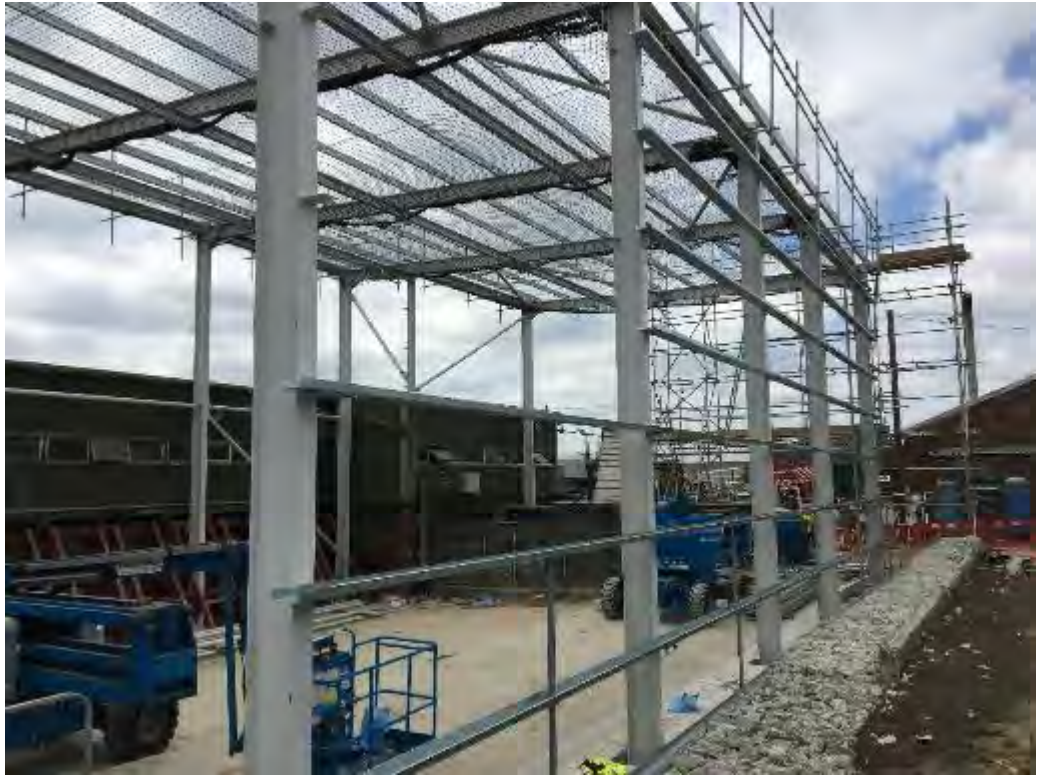
Photo No. 8	Date: 11/07/18
------------------------------	--------------------------

View of the paper line extension under construction, being built over existing concrete floor. North Elevation of structure adjacent to new Gabion wall (external view)

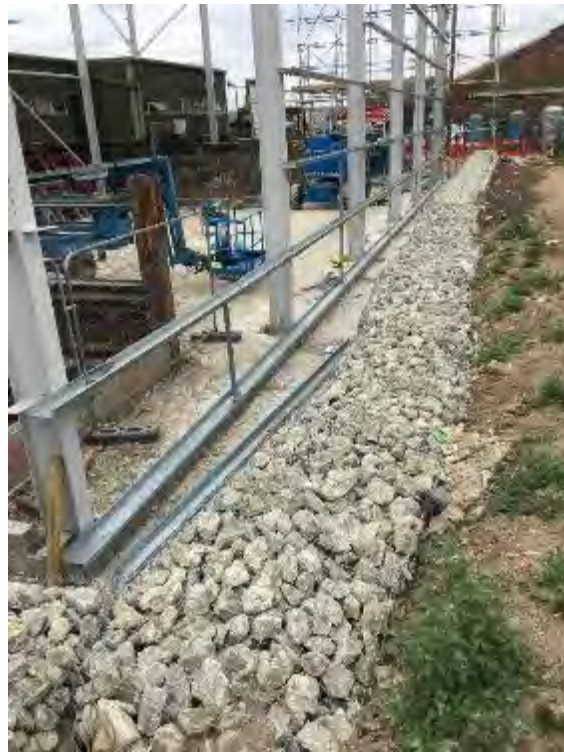
View of the paper line extension under construction on existing concrete floor, top of gabion visible and base of earth bund.

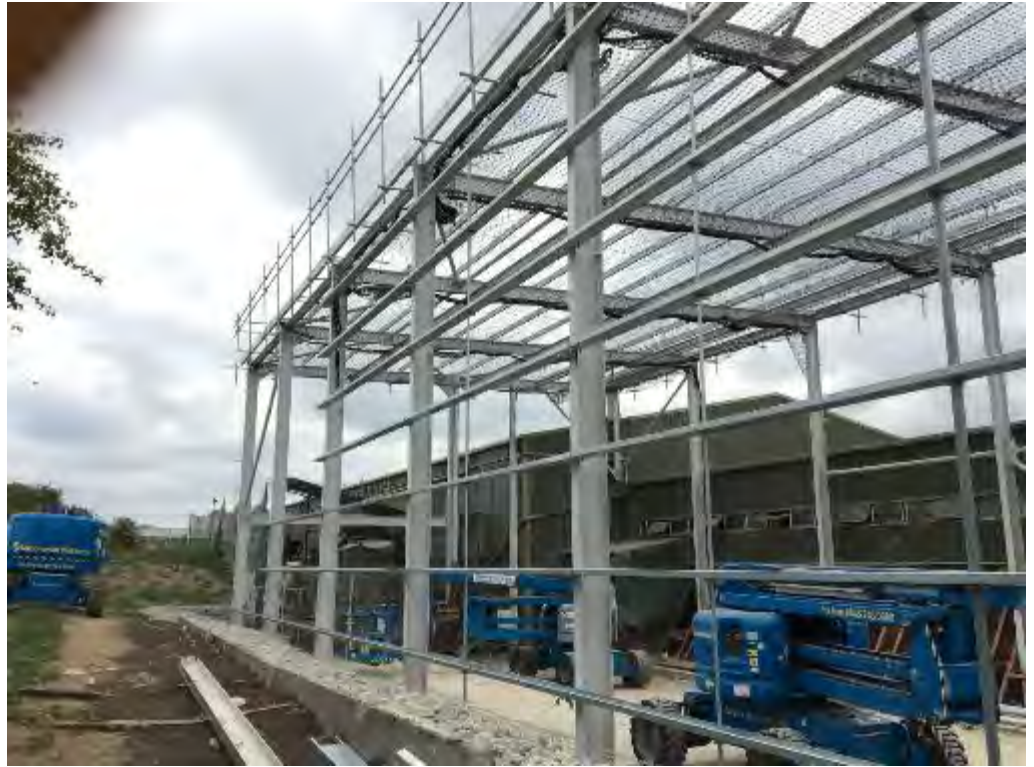
Photo No. 12	Date: 01/08/18
-------------------------------	--------------------------

View of the paper line extension under construction on existing concrete floor. North Elevation of structure adjacent to new Gabion wall (external view)

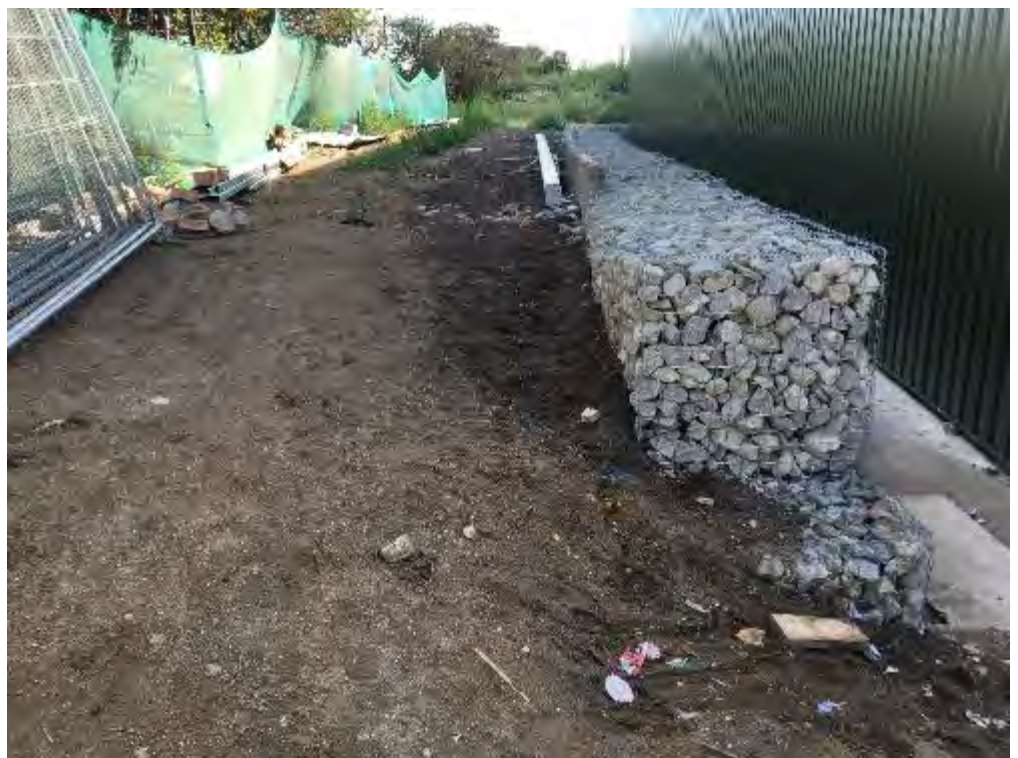
Same view as above, after enclosure of steel skin around structure.

Re-profiled bund behind Gabion wall. Area to be re-graded and seeded to a final finish once site works have been completed

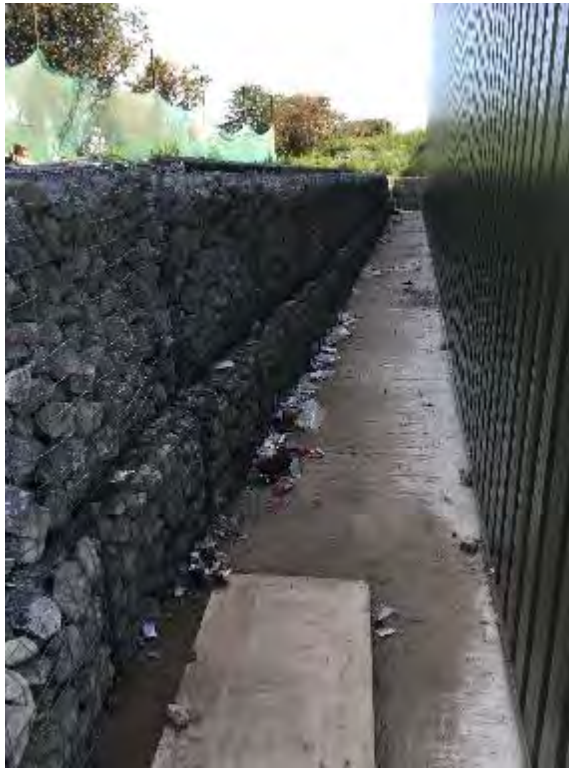
Photo No. 13	Date: 01/08/18
-------------------------------	--------------------------

Description:
 View of the new footpath along the northern wall of the extension. Construction debris will be removed once access for construction is complete.

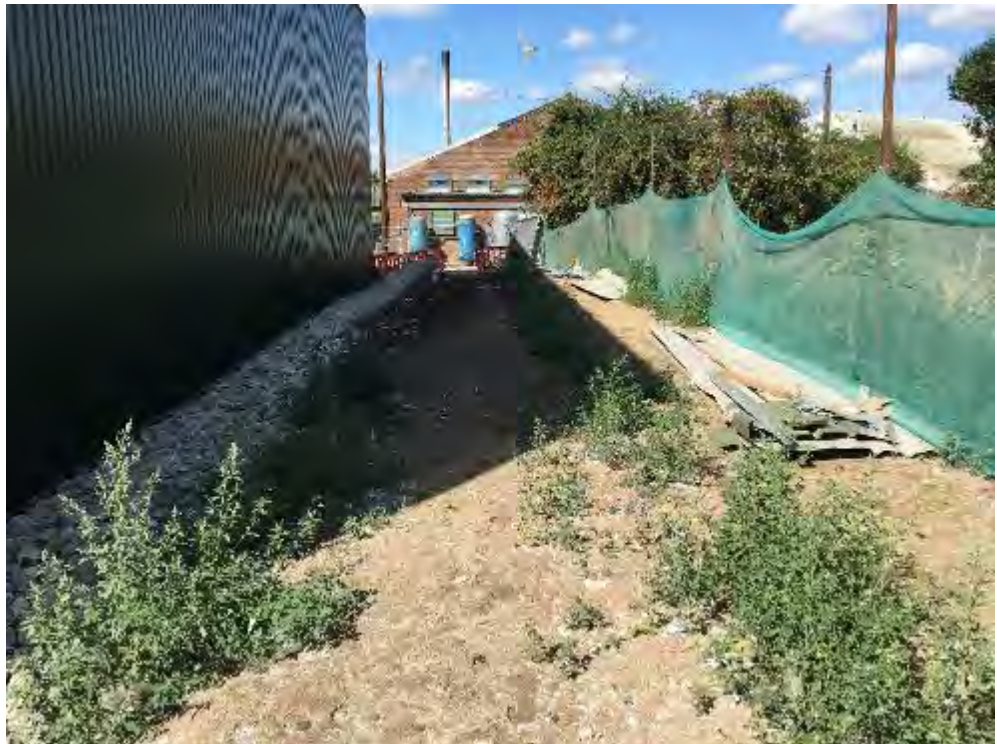
Photo No. 14	Date: 01/08/18
-------------------------------	--------------------------

Description:
 Re-profiled bund behind Gabion wall. Area to be re-graded and seeded to a final finish once site works have been completed. Footpath is hidden between gabion wall and the building face.
