Site Condition Report

Crayford Materials Recycling Facility

6th January 2026

Project No.: SOL_25_P143_N+P

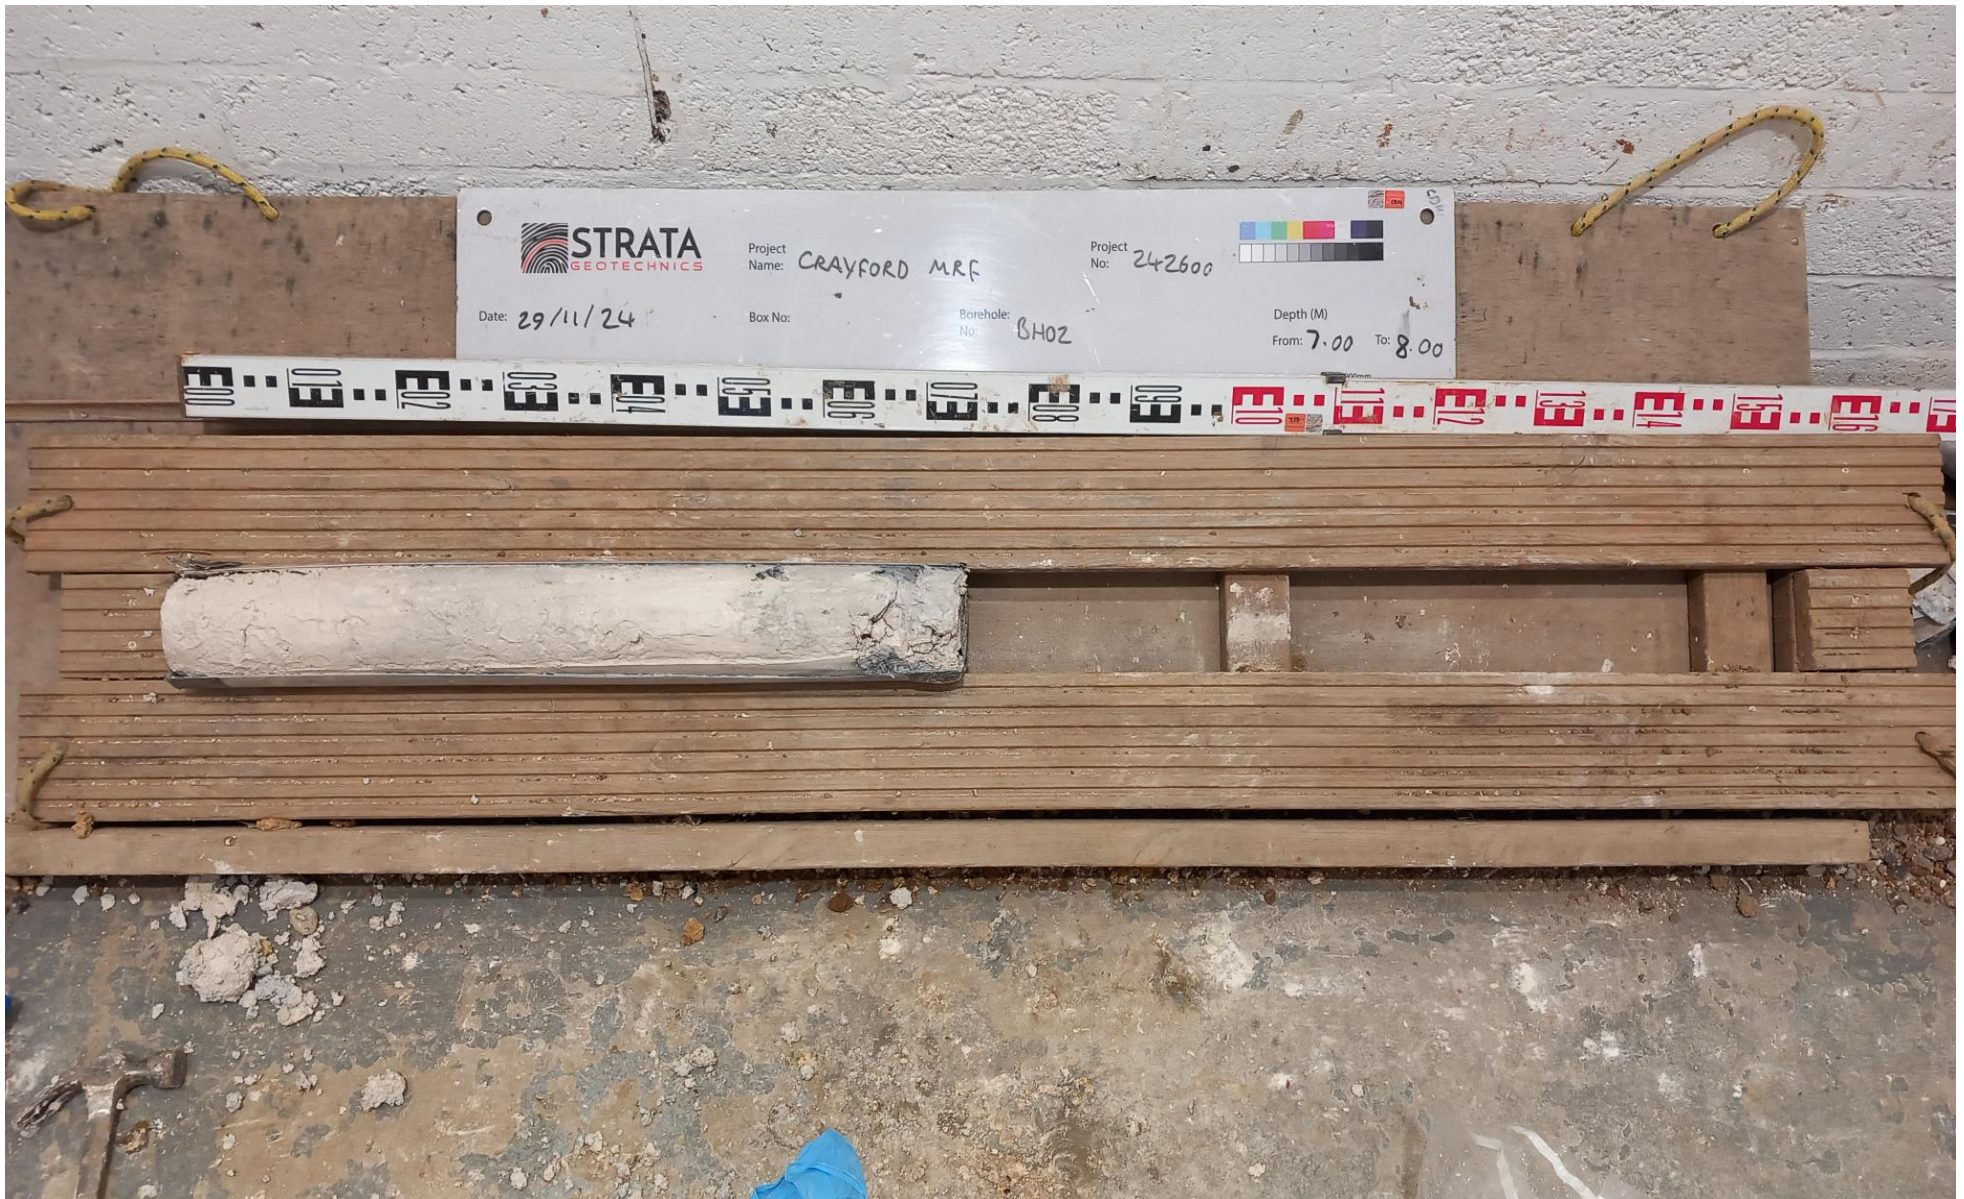
Borehole No: BH02

Depth (M)
From: 6.00 To: 7.00

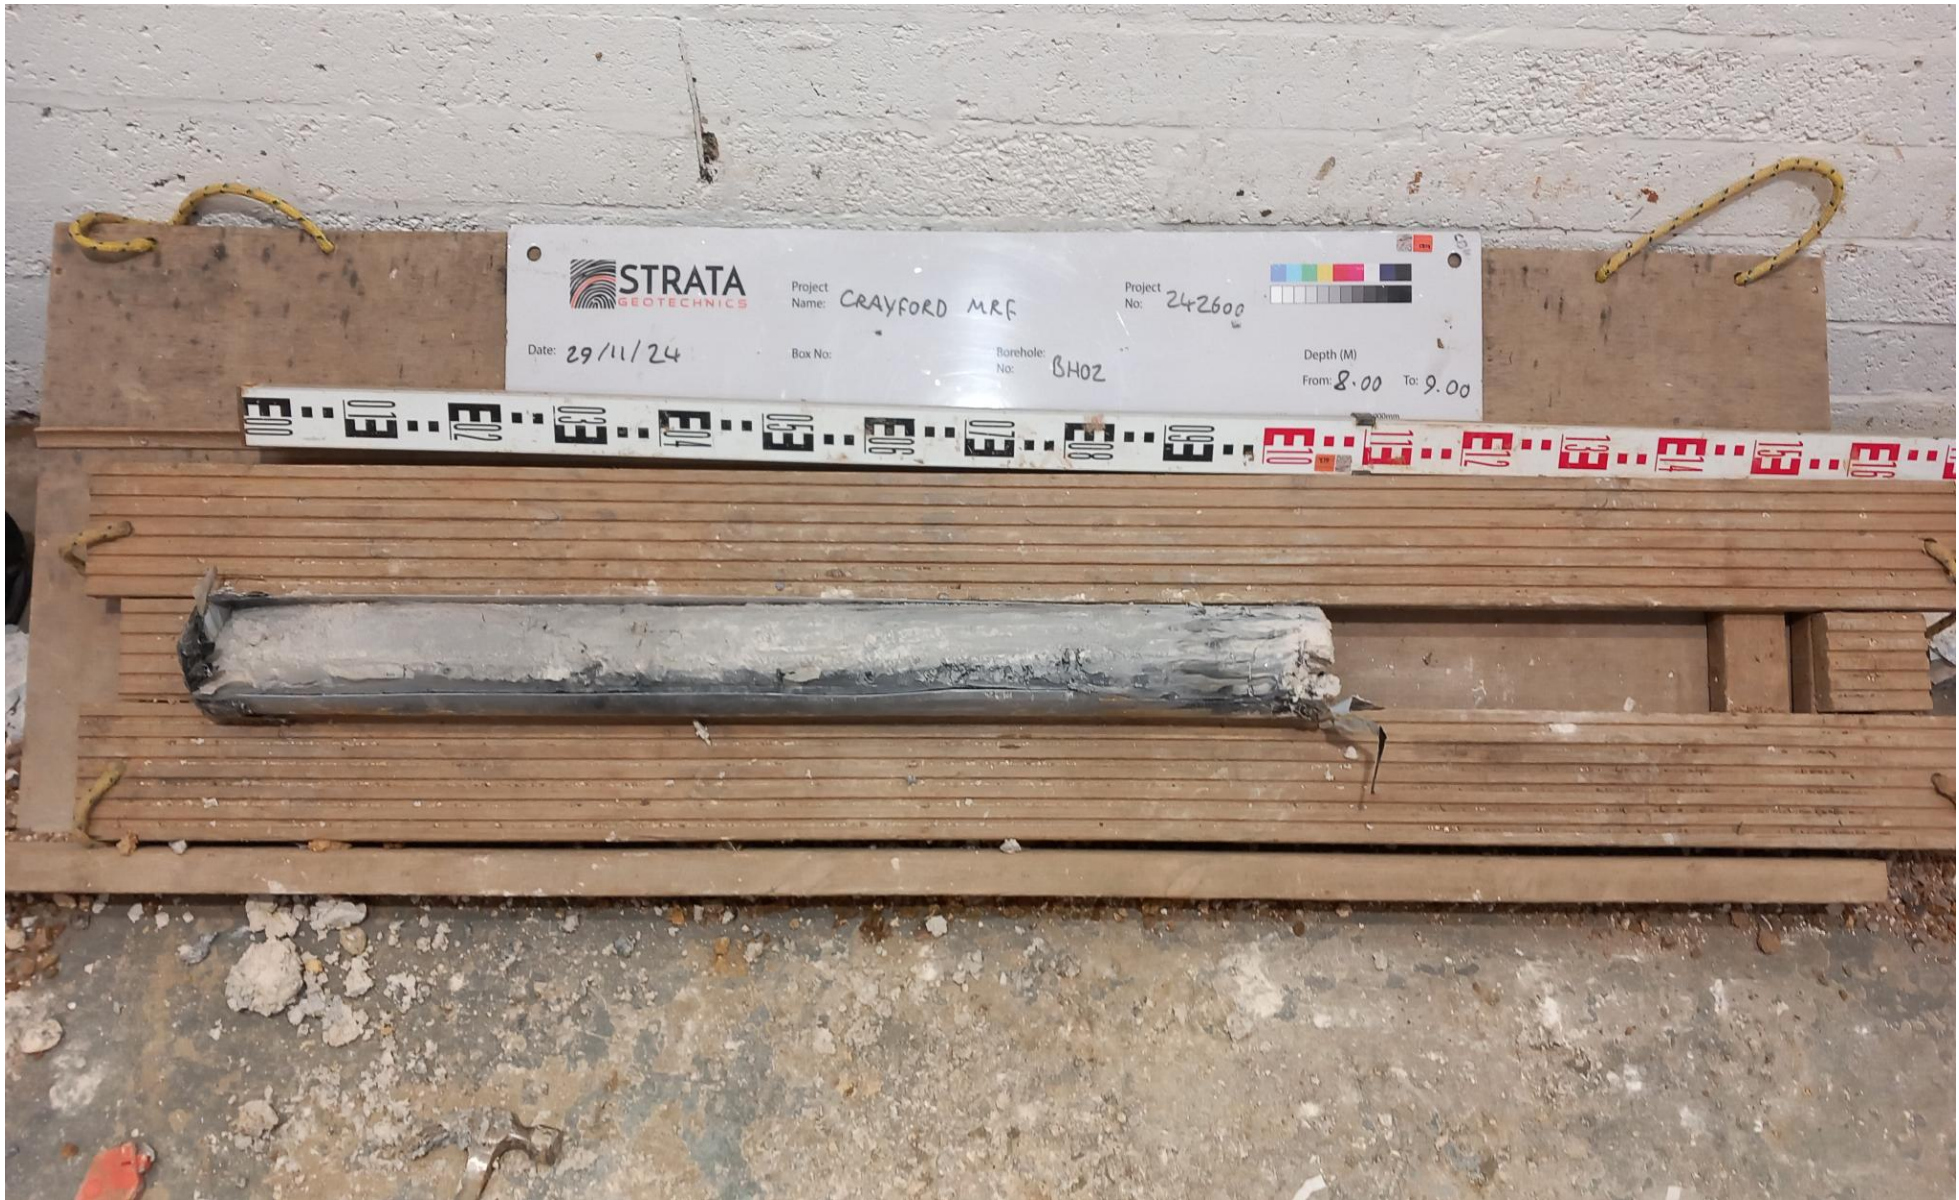
Borehole No: BH02

Depth (M)
From: 7.00 To: 8.00
