Document reference: | 790101_MSD_SCR_GRA December 2024|

A Site Condition Report (SCR) provides information regarding the condition of the land and groundwater at permitted sites at particular points in time throughout its permit history. It is an on-going record of the potential and known contamination risks before a permit is granted, whilst activities are carried out under a permit and at the time of surrounding the permit.

1.0 SITE DETAILS	
Name of the applicant	Southern Water
Activity address	Gravesend Wastewater Treatment Works and Sludge Treatment Centre Dering Way Gravesend Kent DA12 2QF
National grid reference	TQ 66711 73969

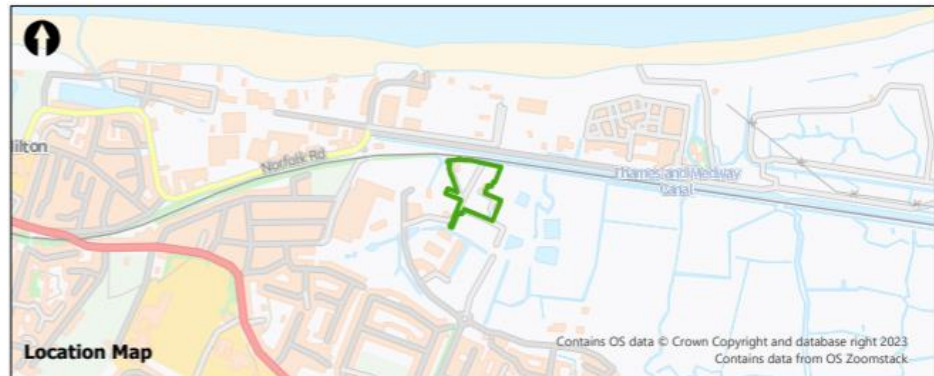
Figure 1.1: Gravesend Sludge Treatment Centre (STC) Site Plan

Source: Extract from 790101_MSD_SiteLayoutPlan_GRA

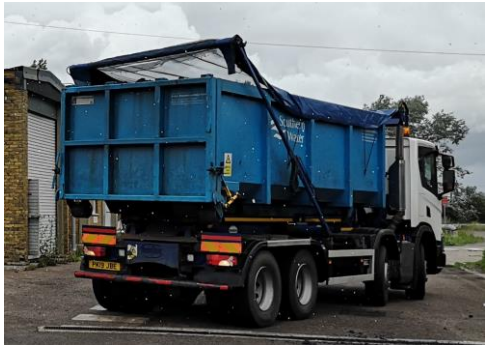
Exemptions	
	What exemptions are used on site? Typically SW have T21, D5 and S1.	
	Cake storage	
SV04	Is any cake imported? If so, how is it unloaded from trucks and where is it unloaded?	<p>Cake from Ham Hill only (storage only as their drying bays are in poor condition)</p> <p>1-2 bins imported daily (covered roro – see below) straight into own cake bay (kept separate from Gravesend cake)</p>

SV05	<p>Where is cake stored?</p> <p>How is cake stored? E.g. Cake bays, silos, directly into skips etc</p>	Cake bays (see plan).
