## SITE INVESTIGATION REPORT - LAND BETWEEN COMMA OIL AND SOUTHERN WATER TREATMENT, DERING WAY, GRAVESEND, DA12 2QH

For Cowland Ltd

Report Number: YE2272, Date: January 2016

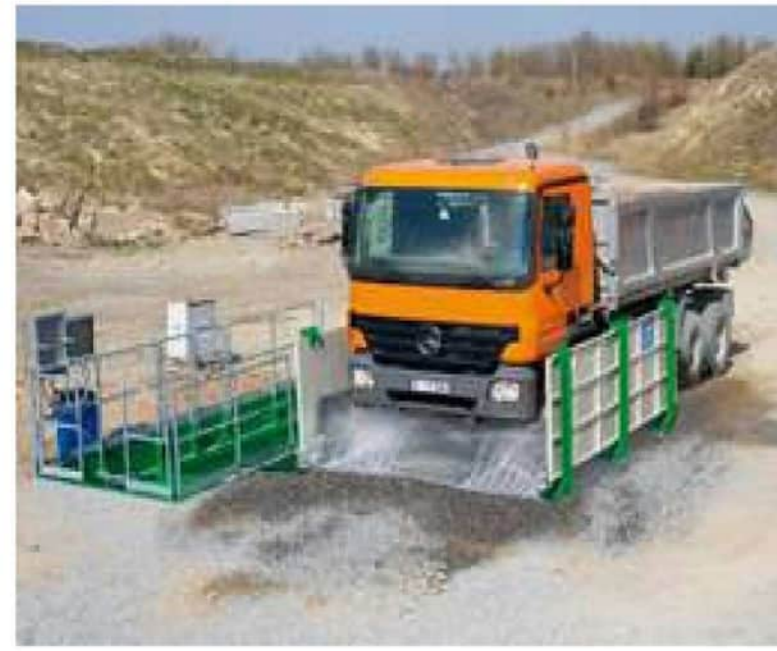
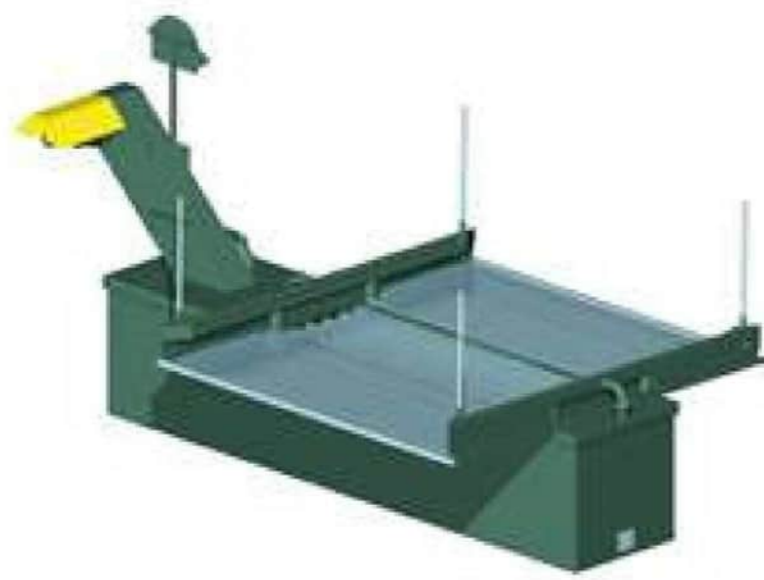
1 x MobyDick Dragon (E) Wheel Washing System On each Plot  
<http://uk.mobydick.com/wheel-washing-systems/?L=9>

PLAN VIEW

SECTION A-A

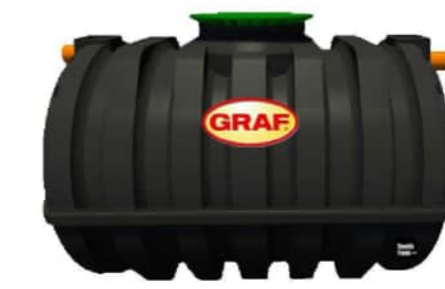
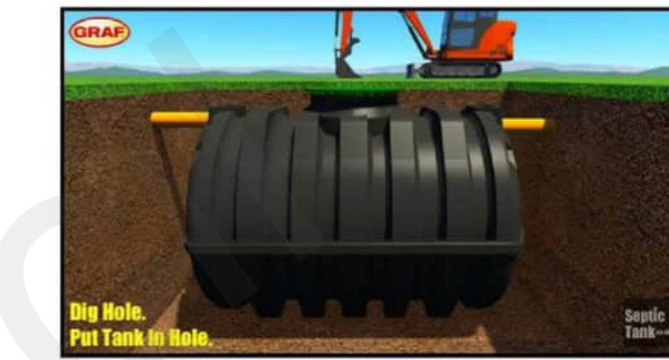
1 x GRAF Carat Septic Tank 6 Person  
 On each Plot  
<http://shop.septic-tank.co.uk/septic-tanks/graf-carat-septic-tank-6-person>

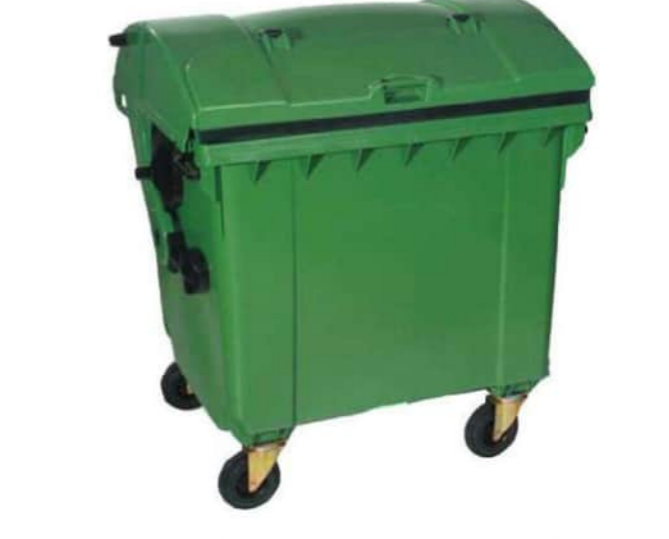
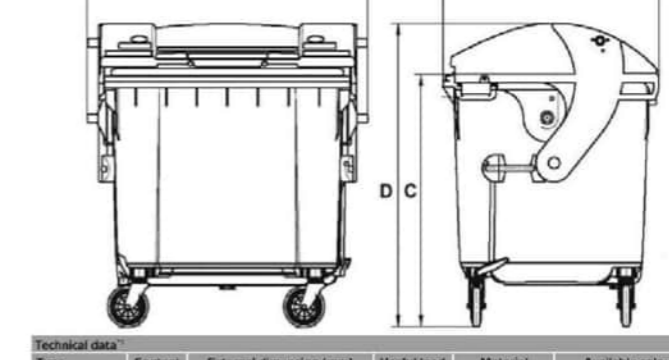
1 X EXTRA LARGE WHEELED BIN (1100 LITRE) WITH 4 WHEELS AND ROLL TOP LID ON EACH PLOT  
<http://www.plastor.co.uk/content/extra-large-wheeled-bin-1100-litre-4-wheels-and-roll-top-lid>

| Technical data | Content | External dimensions (mm) | Internal dimensions (mm) | Weight (kg) | Material | Associated colors | | |
| Model 1100 | 1100 | 1285 | 1135 | 862 | 1670 | 440 | HDPE / HDPE / UV resistant / cadmium-free | Grey / (RAL) green / (RAL) yellow (RAL 1023) |

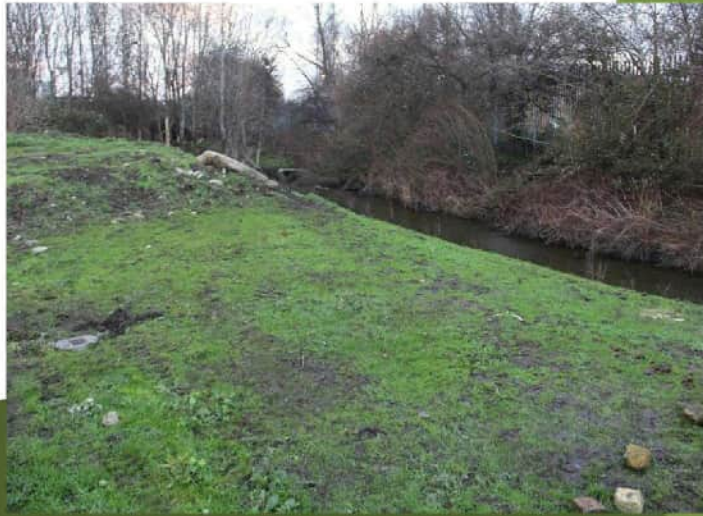
- A. WS6 location looking north.
- B. WS5 location looking west.
- C. WS4 location looking northwest.
- D. WS3 location looking west.

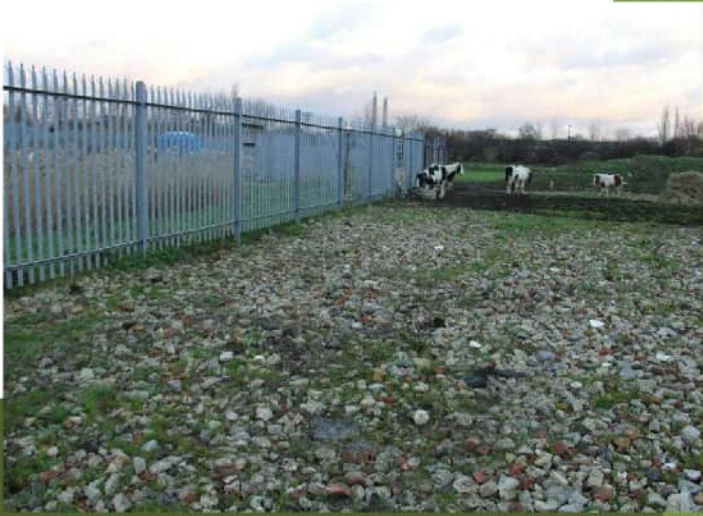
- E. WS1 location looking northwest.
- F. Access issues close to WS6, drill rig kept slipping on clayey surface.
- G. Looking west along the small slope where the rig had access issues.
- H. Raised bund topography.

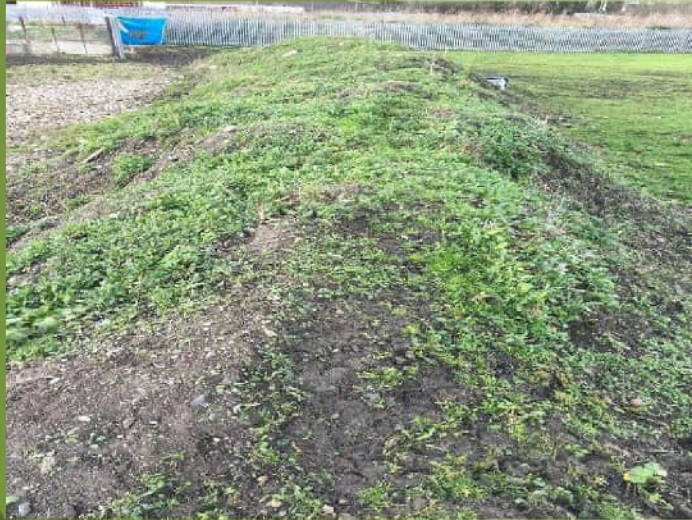
H.

Whilst the site is generally flat, there are two distinct areas that have been artificially raised. The northern 1/5<sup>th</sup> of the site has been raised by approximately 1m. There is a bund running east - west in the middle of the site that is approximately 1.5m high and runs about 20m in length and is 2m wide.

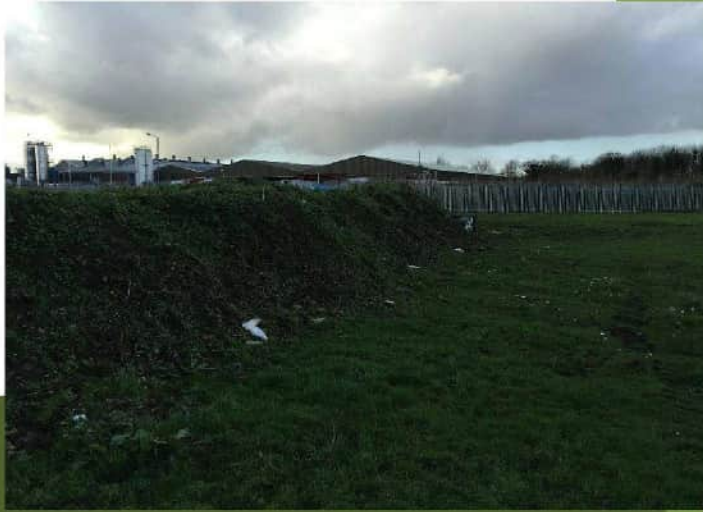
I. Raised bund level.
