Issue and Revision Record

Document reference: | 790101_MSD_SCR_GRA February 2024|

1.0 SITE DETAILS	
Name of the applicant	Southern Water
Activity address	Gravesend Wastewater Treatment Works and Sludge Treatment Centre Dering Way Gravesend Kent DA12 2QF
National grid reference	TQ 66711 73969

A. Site Walkover Record

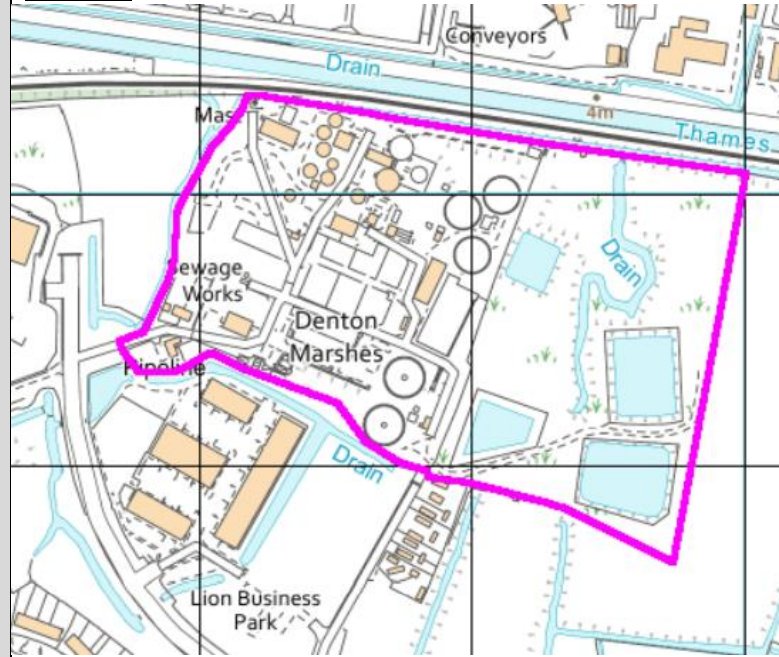
Figure 1.1: Gravesand WTW and the Sludge Treatment Centre (STC) Site Plan

2.0 Condition of the land at permit issue	
Environmental setting including: <ul style="list-style-type: none"> geology hydrogeology surface waters 	<p>Land use</p> <p>The site (Figure 1.1 taken from the Landmark Envirocheck Report) is located to the east of the town of Gravesend. The site currently hosts the Gravesend Wastewater Treatment Works (WTW), within which the Gravesend Sludge Treatment Centre (STC), hereby referred to as ‘the Site’ is located. The sewage treatment works was constructed approximately in the mid-1920s and reconfigured in 1982 in a new configuration. The majority of the process areas of the treatment works are in the northern half of the site area, and there are areas of worked ground on the Site which extend further to the east (as determined by satellite imagery, herein called the ‘eastern marshes’).</p> <p>Two residential properties exist at the site entrance in the south-west of the site. To the north, the Thames and Medway canal bounds the site, with a freight yard and sand and gravel distributors beyond. To the east of the site, agricultural fields are identified. To the south and the west of the site, industrial land uses are present, including a mechanical service (50m southwest of the site), garage (20m south) and a car dealer (110m south). A lubricant manufacturer is noted 80m southwest of the site area.</p>
