# Swadlincote Resource & Recovery Park (SRRP)

## Desk Study

Doc ref: 15659-HYD-XX-ZZ-RP-DS-0001

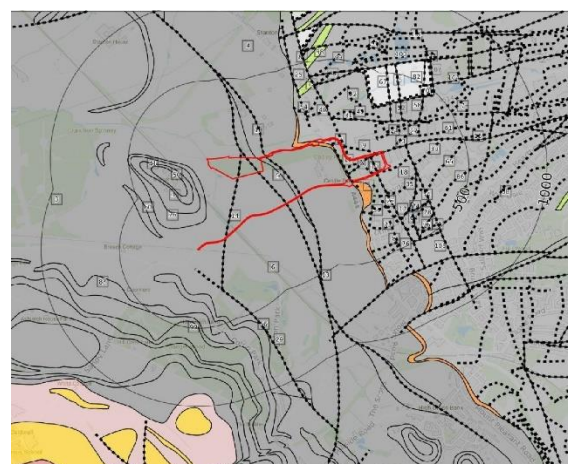
Figure 2.11: Solid geology.  
(Reproduced with permission from Groundsure)

The Groundsure report indicates that 2 normal faults are located onsite.

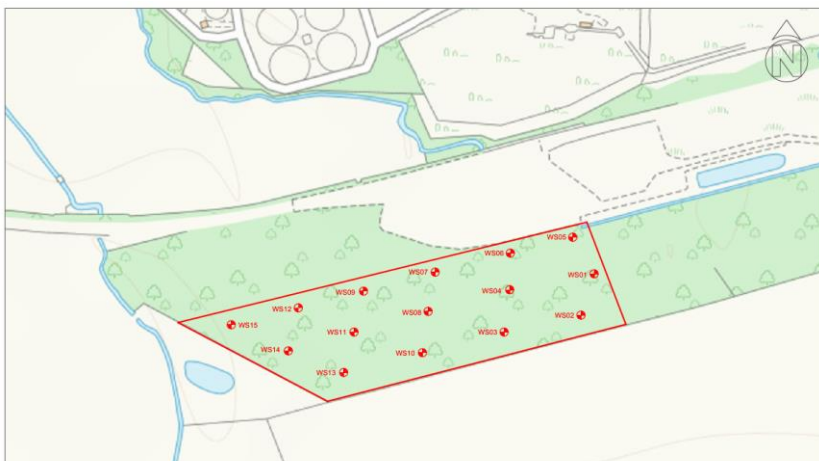
Figure 2.12: Borehole location plan for previous ground investigation  
(Reproduced from Groundtech Consulting report GRO-20195-1699)

- Made Ground to between 0.55m and 2.6m bgl, comprising:
  - Gravelly sand of mixed lithology including brick
  - Black sandy gravelly clay of mixed lithology including brick.
- Light brown, brown and red brown clayey gravelly sand to between 0.70m bgl and 3.00m bgl (no stratum identified, probable weathered Helsby Sandstone Formation);
- Grey mottled orange variably gravelly sandy clay to between 0.90m bgl and 3.00m bgl (not identified, probable Alluvium)
- Extremely weak to weak blue grey to red brown mudstone to between 0.95m bgl and 2.6m bgl (not identified, probable Chester Formation)
- Weathered grey brown to grey sandstone to between 2.00m bgl and 2.70m bgl (not identified, probable Helsby Sandstone Formation).

The ground investigations also notes visible rootlets present to 2.00m bgl. The previous ground investigation location plan and red line plan is presented in Figure 2.12 below.

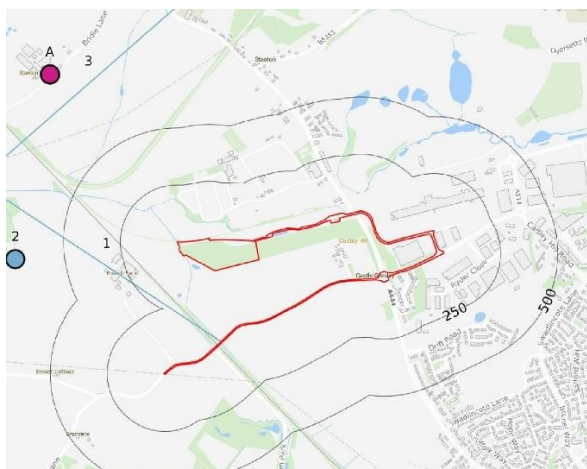
Figure 2.13: Groundwater abstraction zones  
(Reproduced with permission from Groundsure)

The site is not within a groundwater Source Protection Zone (SPZ), see Figure 2.13. The Groundsure report indicates that the groundwater vulnerability of the site as High, see Figure 2.14.

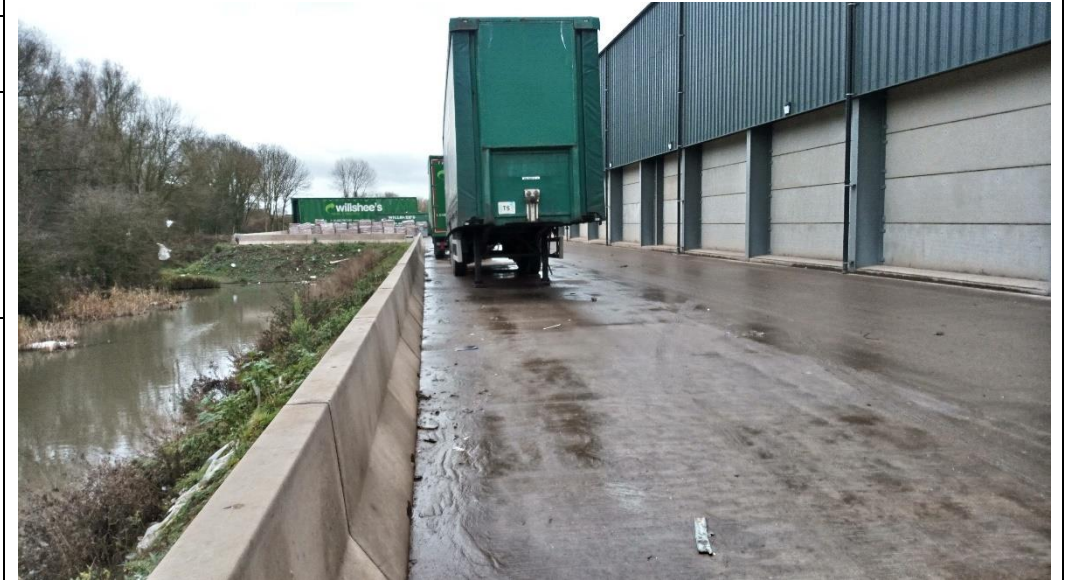
<p><b>Desk Study Photograph 2</b></p>

<p><b>Date:</b> 04/12/20</p>	
<p><b>Direction Photograph Taken:</b> Looking west from adjacent warehouse</p>	
<p><b>Description:</b> Recycling facility at boundary and ponded area</p>
