Dove Valley Park

Project Name Dove Valley Park

Location Foston, Derbyshire

Title Ground Conditions Assessment Report

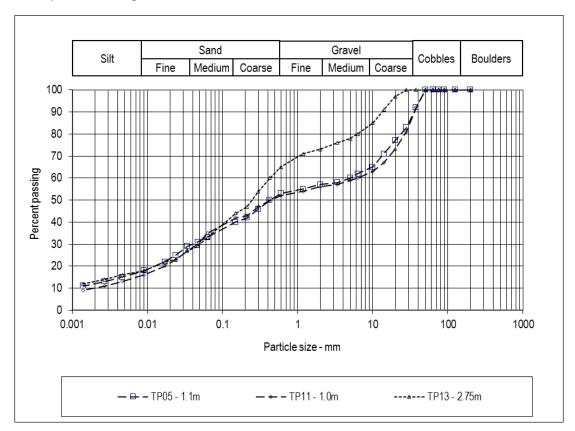
Figure 2: Made ground PSD results

Three particle size distribution tests were carried out on the made ground, both from the topsoil and the earth bunds. The results are presented in Figure 2 overleaf.

The results indicate the reworked natural soils to comprise a slightly silty/clayey sandy GRAVEL/gravelly SAND.

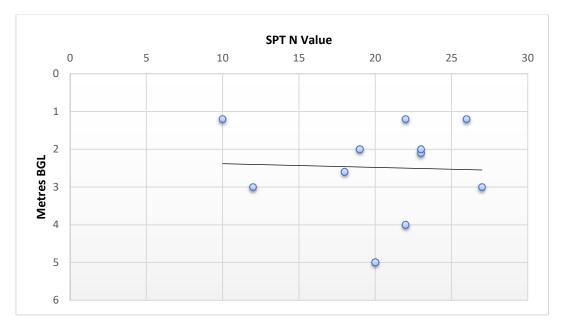
Figure 3: Glaciofluvial deposits SPT vs Depth plot

SPT N values in the residual clay ranged from 10 to 27, with an average value of 20 indicating a stiff clay or medium dense sand/gravel. The glaciofluvial deposits do not show a trend of increasing density with depth across the site as shown in Figure 7 below:

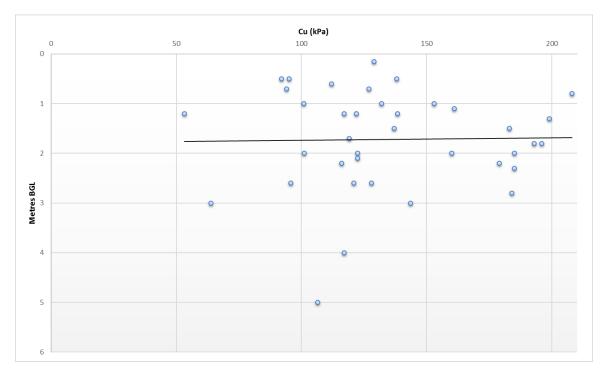
Figure 4: Glaciofluvial deposits Cu vs Depth plot

27 sets of hand shear vane readings were taken in the cohesive glaciofluvial deposits, with the undrained shear strength (Cu) results ranging from 92kPa to 208kpa. Figure 4 below shows a plot of measured Cu values, along with Cu values correlated from SPT N values, showing a range of values from 64kPa to 144kPa. The average Cu value across both data sets is 135kPa. The data does not indicate a trend of increasing strength with depth and highlights the differing strength in soils that may bew encountered laterally.

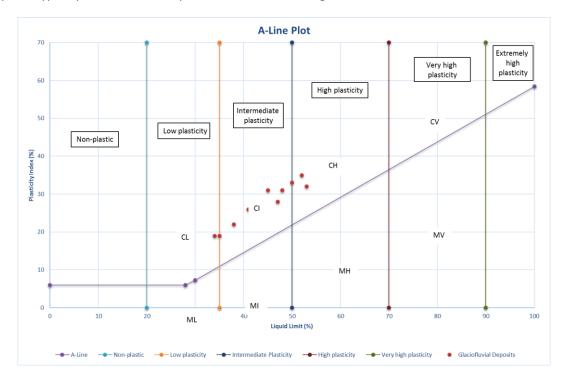
Figure 5: A-Line plot glaciofluvial deposits

Ten plasticity index tests were scheduled on the clays from the glaciofluvial deposits, with the result shown in Figure 5 below. The samples are typically shown to be of intermediate plasticity, with three samples indicating high plasticity. The clays will typically have a moderate potential for volume change with variations in moisture content.

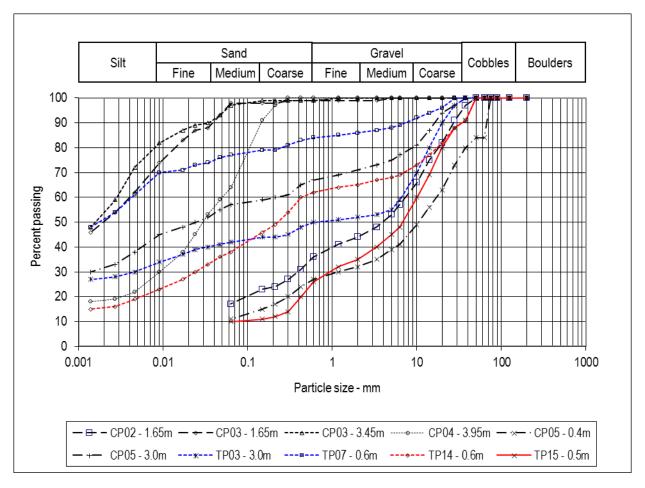
Figure 6: Residual soils PSD results

Ten particle size distribution tests were scheduled on samples from the glaciofluvial deposits, wit the results summarised in Figure 6 below.

The results show the high degree of variability across the glaciofluvial deposits, with the soils broadly divided into a sandy GRAVEL or sandy gravelly CLAY.

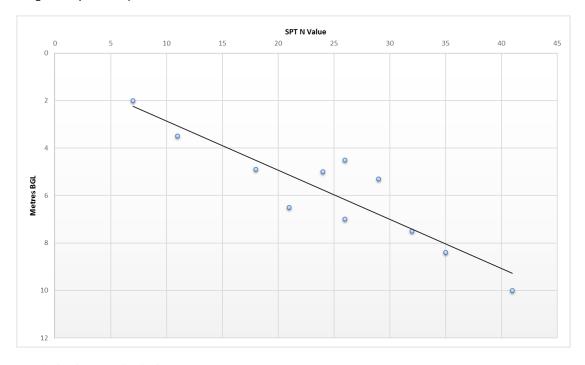
Figure 7: Residual soils SPT vs depth plot

Nine SPT tests were carried out within the residual soils of the Mercia Mudstone Group, which returned values of between 7 and 41, with an average N value of 24. The results are plotted in Figure 7 below and indicate a strong trend of increasing density with depth.

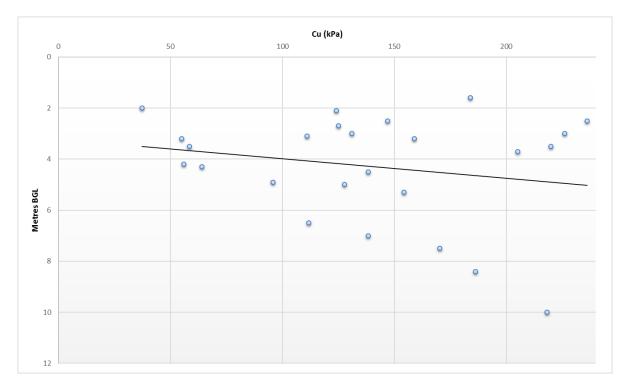
Figure 8: Residual soils Cu vs depth plot

18 sets of hand shear vane readings were taken within the residual clay, with the undrained shear strength (Cu) results ranging from 37kPa to 218kpa. Figure 8 below shows a plot of measured Cu values, along with Cu values correlated from SPT N values, showing a range of values from 47kPa to 236kPa. The average Cu value across both data sets is 130kPa, indicating a primarily stiff clay. The Cu results have been plotted in figure 8 below, and do not show a strong trend of increasing strength with depth.

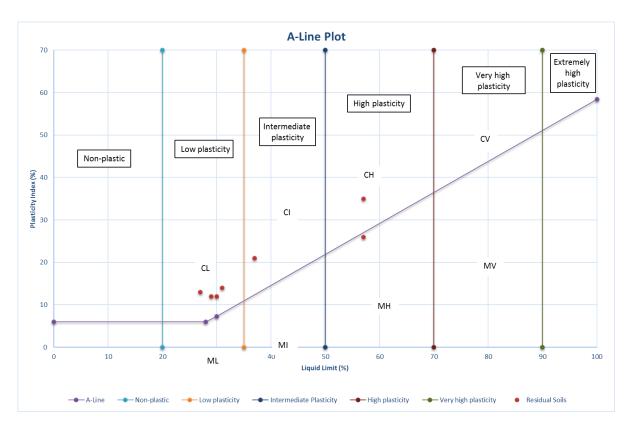
Figure 9: A-Line plot residual soils

Seven plasticity index tests were scheduled on the residual clays of the Mercia Mudstone Group, with the result shown in Figure 9 overleaf. The residual clay is typically shown to be of low plasticity, with one and two samples indicating intermediate and high plasticity respectively. Whilst the residual soils can generally be expected to show low volume change potential, encountering zones of high plasticity clay should be considered during detailed design.

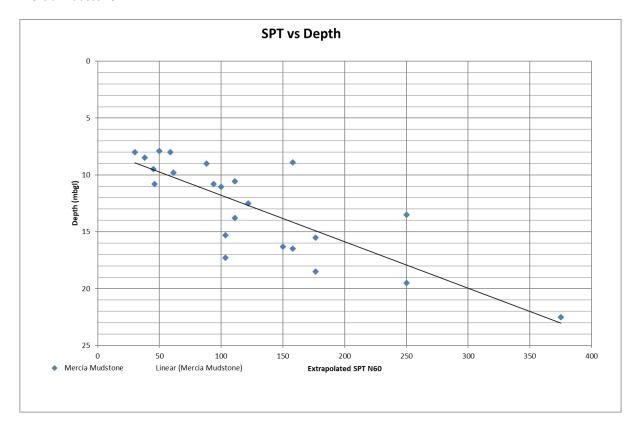
Figure 10: Mercia Mudstone SPT vs Depth

SPT testing was only undertaken within the Mercia Mudstone Group where poor core recovery was encountered, and in all instances the SPT tests refused. The SPT N values are plotted below, and show results ranging from 38 to an extrapolated N_{60} value of 375. The results indicate a strong profile of increasing strength with depth for the competent Mercia Mudstone.

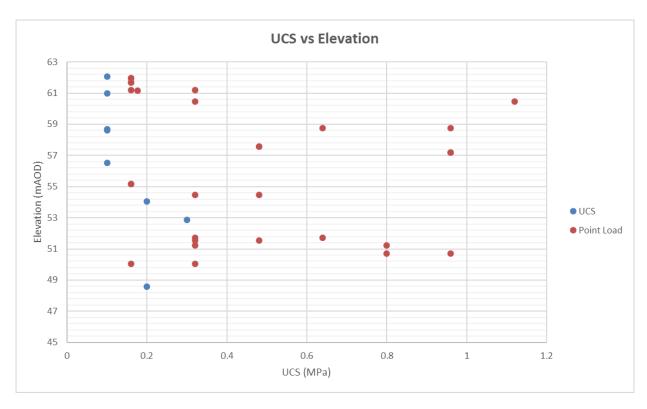
Figure 11: UCS vs Elevation Plot

The results indicate the rock is very weak and does not show a strong trend of increasing strength with depth, or with changes in elevation.

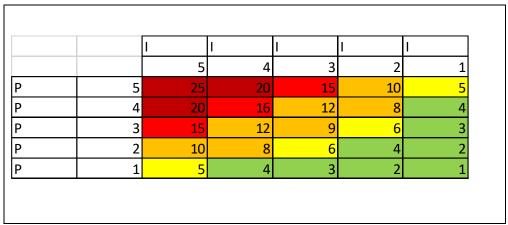
Figure 13: Risk matrix

The register is based on a matrix similar to the conceptual site model (CSM) for contamination in the sections above. The main constituents of the register are the Identified Hazard, Preconditioning and Consequence. They will govern the likelihood of the event occurring and impact resulting for event occurrence which are rated 1-5 with 1 being Very low and 5 being Very High. These will be multiplied together in order to inform a risk rating for each of the identified hazards.

Risk Rating (R) = Probability (P) x Impact (I)

Table 22: Risk Rating						
Risk Rating	PxI					
Severe	20-25					
High	15-16					
Moderate	9-12					
Low	6-9					
Negligible	1-4
