Newbottle Street, Houghton-le-Spring

Ground Investigation Interpretive Report and  
Groundwater Risk Assessment

Hellens Land

September 2022

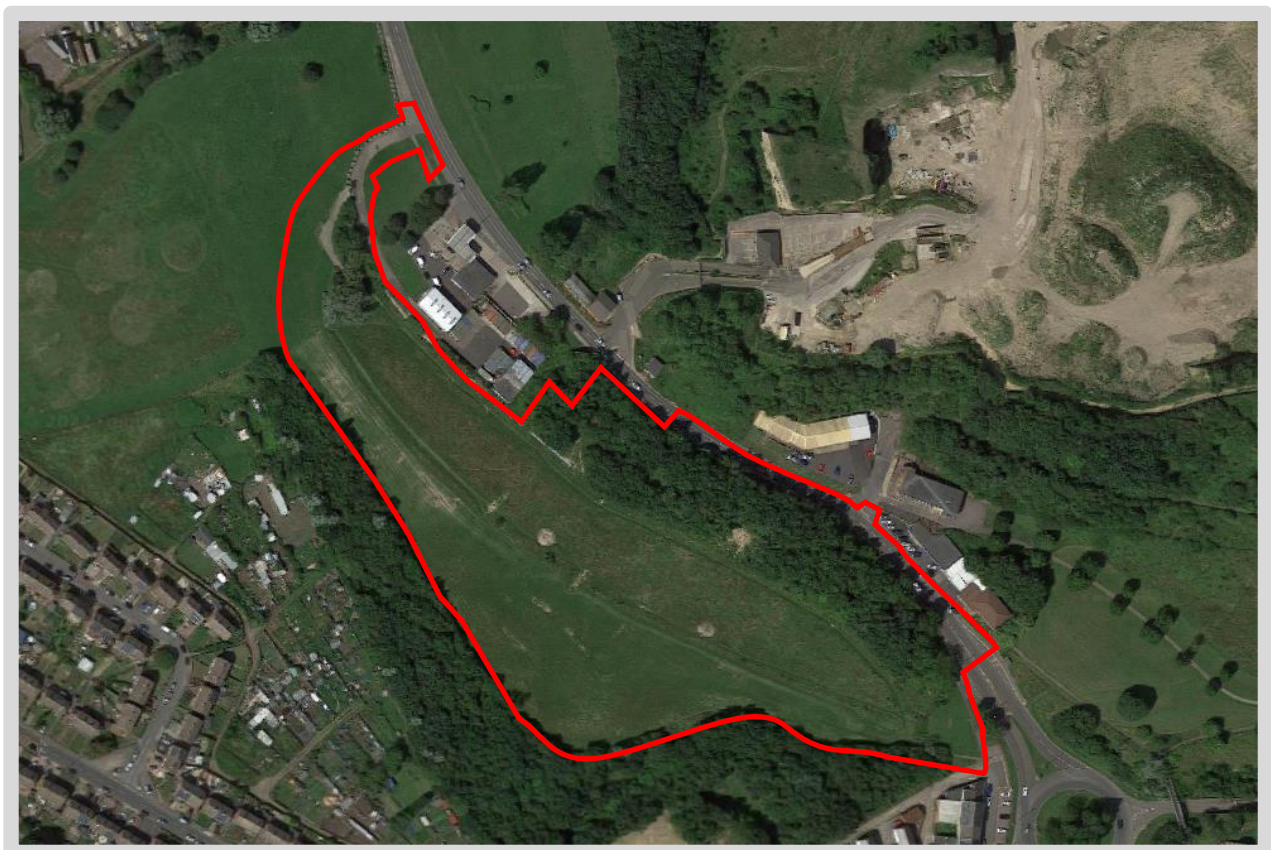
Fig.2 – Aerial Photograph Showing Development Area

A general site location plan of the site is presented as Figure 1 and an aerial photograph as Figure 2.

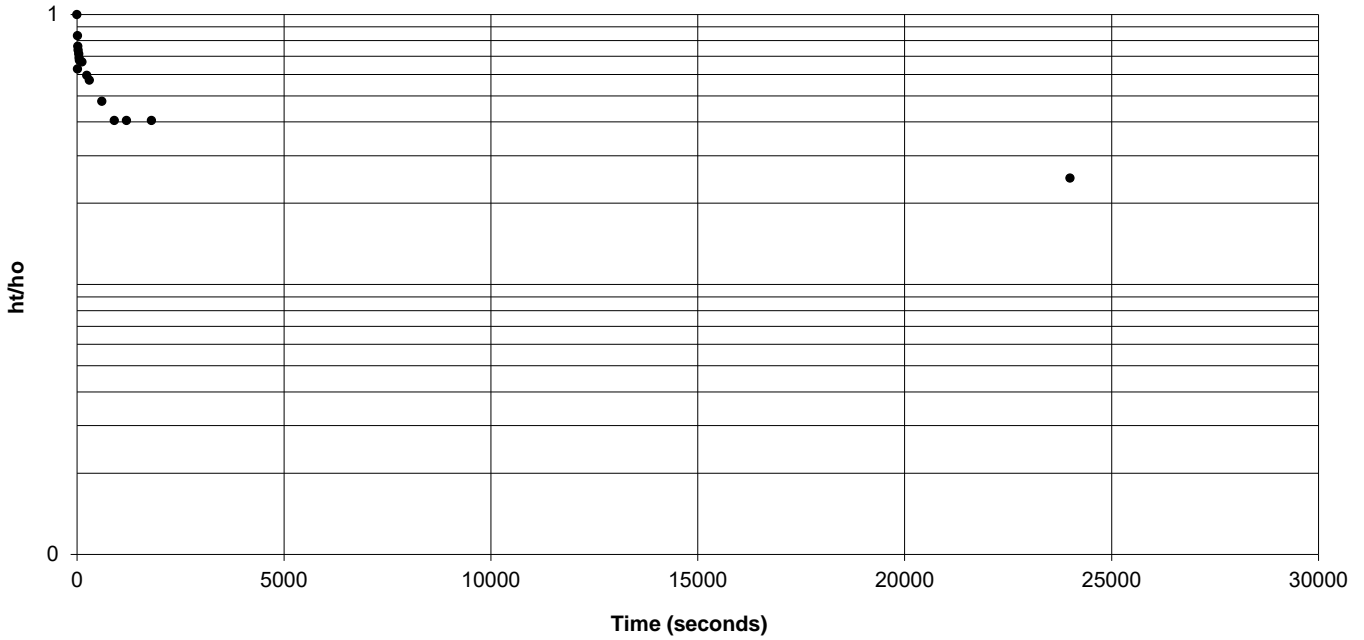
BOREHOLE No.: CP-01	TEST No.: 1
FALLING HEAD TEST IN BOREHOLE	DEPTH (m) 8.00 DATE 07/08/2019 SHEET 1

Time Elapsed (secs)	Depth of water below Top of Casing d <sub>t</sub> (m)	h (m) (d <sub>i</sub> -d <sub>t</sub> )	h <sub>t</sub> /h <sub>0</sub>	
0	2.500	2.1	1.00	Depth of Test Section 2.50m to 8.00m
10	2.850	1.750	0.83	Borehole Depth 8.00m Borehole Diameter 86mm
20	3.000	1.600	0.76	Casing Depth .00m
30	3.050	1.550	0.74	Depth to Standing Water Level bgl (d <sub>1</sub> ) 4.60m
40	3.100	1.500	0.71	Height of casing agl (h <sub>c</sub> ) .00m
50	3.150	1.450	0.69	Height of top of casing above water table 4.60m
60	3.180	1.420	0.68	Depth to Water at Start of Test below casing level (d <sub>0</sub> ) 2.50m
120	3.200	1.400	0.67	Depth to Water at End of Test below casing level 3.750
10	3.280	1.320	0.63	Depth to Filter at Start of Test
240	3.350	1.250	0.60	Depth to Filter at End of Test
300	3.400	1.200	0.57	Response Zone (L) = 5.50m
600	3.600	1.000	0.48	Borehole Diameter in Test Section (D) = 0.09m
900	3.750	0.850	0.40	Cross-sectional Area of Borehole (A) = 0.0058m <sup>2</sup>

3 No falling head tests were undertaken within CP01 (8.0m bgl) , CP04 (9m bgl) and CP16B (6.0m bgl) within the Made Ground. The ground conditions within the boreholes generally comprised Made Ground of dark grey, gravelly sandy Clay where the gravel includes fine to medium, angular coal, brick, sandstone, brick ash and slag (potentially colliery spoil). It is considered hat the ground conditions encountered within CP01, CP04 and CP16B are representative of the site Made Ground material (please see exploratory hole logs in **Appendix B** for confirmation).

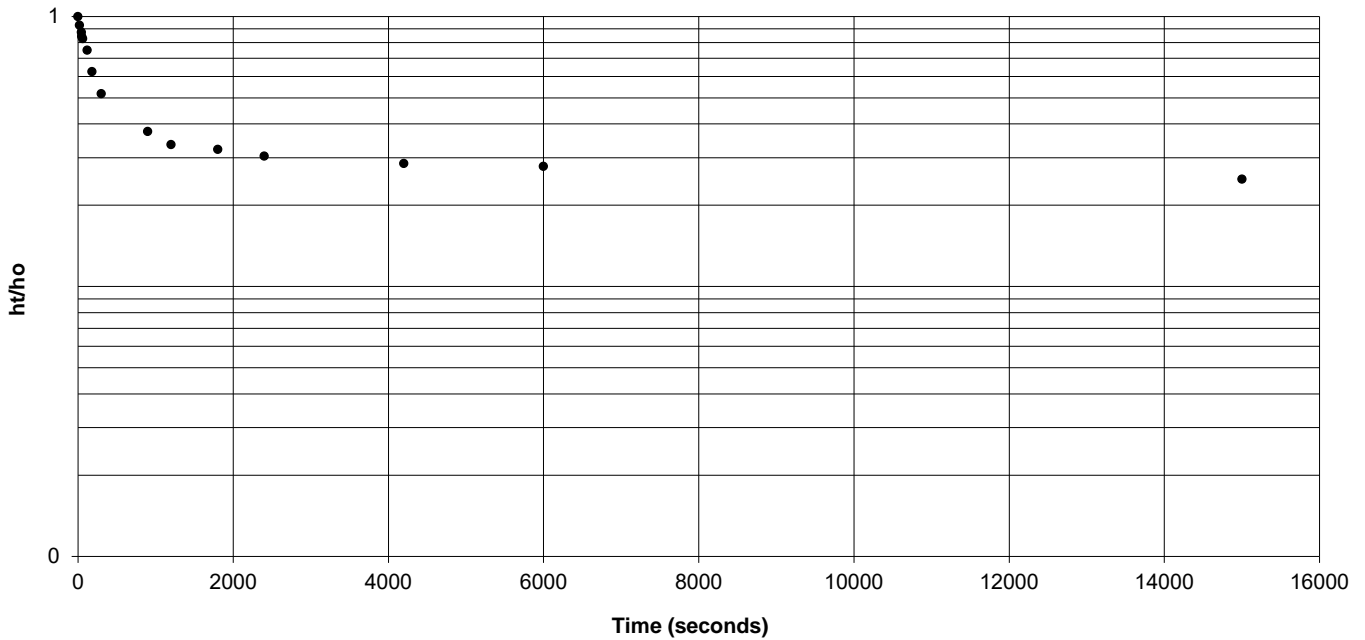
BOREHOLE No.: CP-04	TEST No.: 1
FALLING HEAD TEST IN BOREHOLE	DEPTH (m) 9.00 DATE 07/08/2019 SHEET 1

Time Elapsed (secs)	Depth of water below Top of Casing $d_t$ (m)	$h$ (m) ( $d_1 - d_t$ )	$h_t/h_0$	
0	5.900	2.800	1.00	Depth of Test Section 5.90m to 8.70m
10	6.000	2.700		Borehole Depth 8.70m Borehole Diameter 86mm
20	6.100	2.600	0.93	Casing Depth .00m
30	6.200	2.500		Depth to Standing Water Level bgl ( $d_1$ ) (Assumed) 8.70m
45	6.250	2.450	0.88	Height of casing agl ( $h_c$ ) .00m
50	6.340	2.360	0.84	Height of top of casing above water table 8.70m
60	6.380	2.320	0.83	Depth to Water at Start of Test below casing level ( $d_0$ ) 5.90m
120	6.600	2.100	0.75	Depth to Water at End of Test below casing level 7.920
180	6.950	1.750	0.63	Depth to Filter at Start of Test
240	7.150	1.550		Depth to Filter at End of Test
300	7.250	1.450	0.52	Response Zone (L) = 2.80m
600	7.500	1.200		Borehole Diameter in Test Section (D) = 0.09m
900	7.650	1.050	0.38	Cross-sectional Area of Borehole (A) = 0.0058m <sup>2</sup>
1200	7.760	0.940	0.34	Intake factor (BS5930 p50): Figure D (F) = 4.212449791

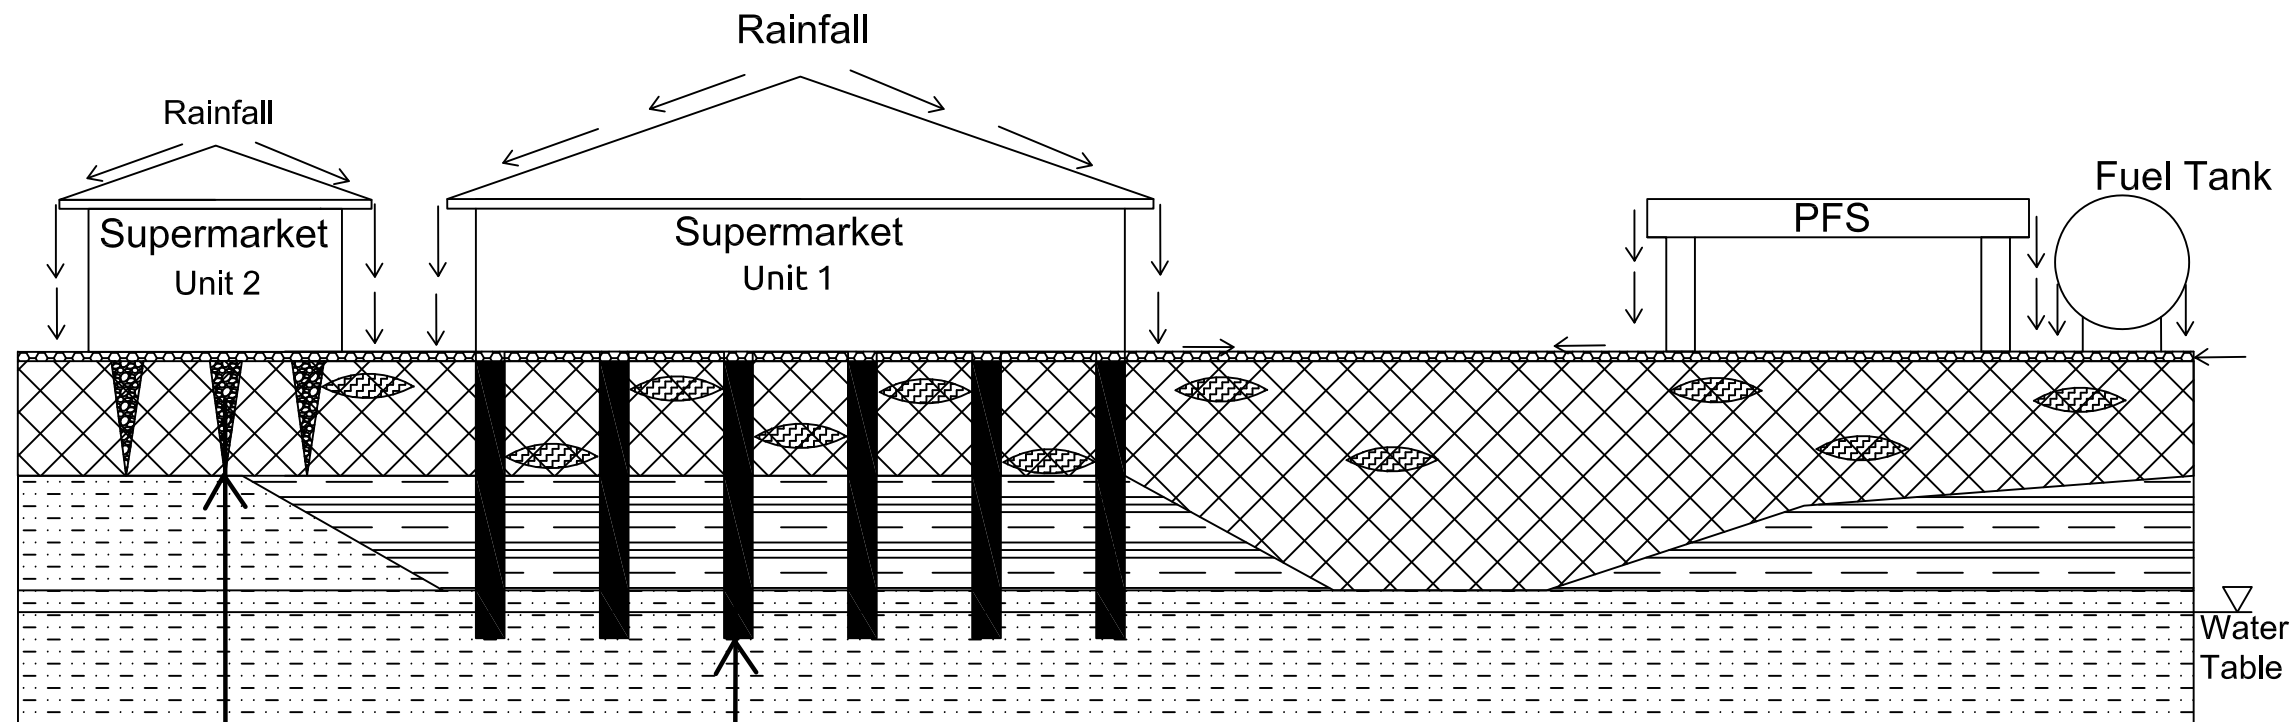
Stone Column Foundations into Underlying Clay/Rock

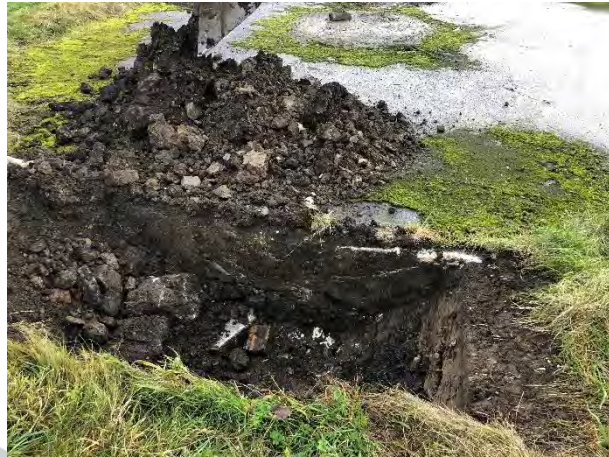
**Photo No.1 - 433550-001**

The concrete was observed to be good condition with no obvious signs of deterioration. As can be seen in the photographs below;

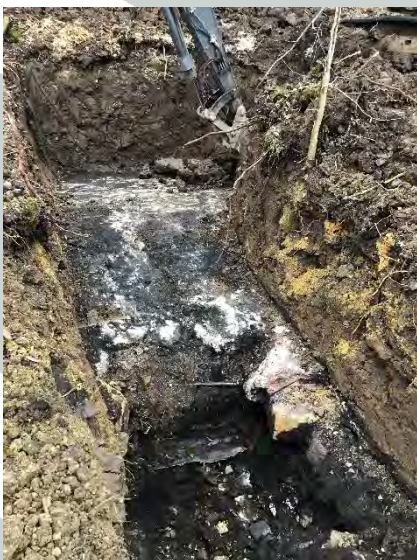
On completion of the tree clearance works trial trenching was undertaken to locate the potential mineshaft. Photographs of the trenching are shown below for reference;

**Photo No. 3 - 433550-003**  
Southern Edge of Concrete

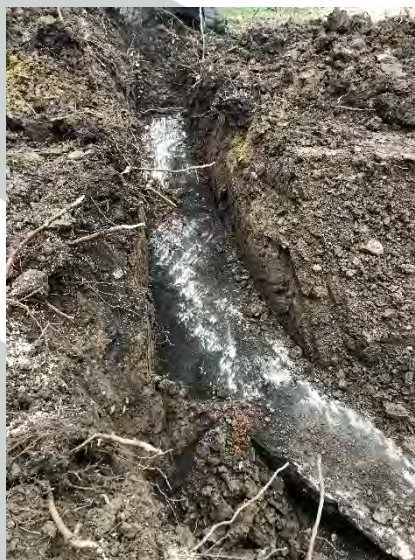
**Photo No. 4 - 433550-003**  
Eastern Edge of Concrete

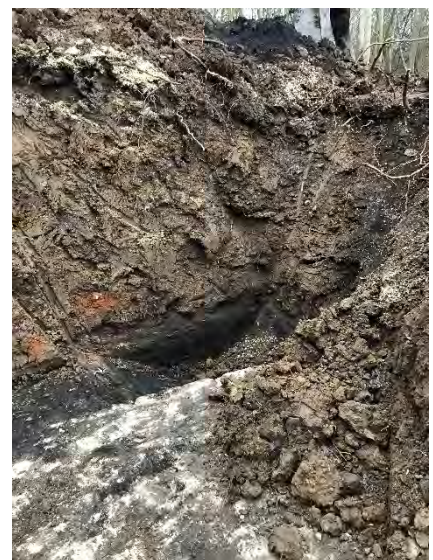
**Photo No. 5 - 433550-003**  
North Eastern Edge of Concrete
