HELLENS LAND LIMITED

NEWBOTTLE STREET, HOUGHTON-LE-SPRING

ENVIRONMENTAL SETTING AND SITE DESIGN (ESSD)

DATE ISSUED: MAY 2023
JOB NUMBER: NT16098
REPORT NUMBER: 0007
VERSION: V1.0
STATUS: FINAL

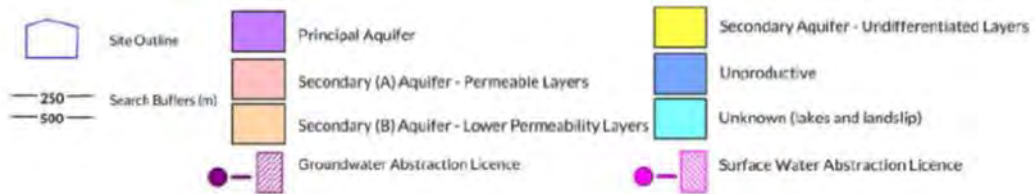
Fig.3 -Bedrock Aquifer Classification

The solid geology located beneath the site is designated as **Principal and Secondary (A) Aquifers**; Principal Aquifers comprise of high intergranular and fracture permeability, usually providing a high level of water storage and may support water supply to rivers on a strategic scale. This includes the Yellow Sand Formation which is designated as a Principal Aquifer by the Environment Agency. The site is situated at the geological base of the limestone classified as a Principal Aquifer and is considered the most sensitive receptor rather than the underlying Middle Coal Measures strata which is a secondary (A) aquifer.

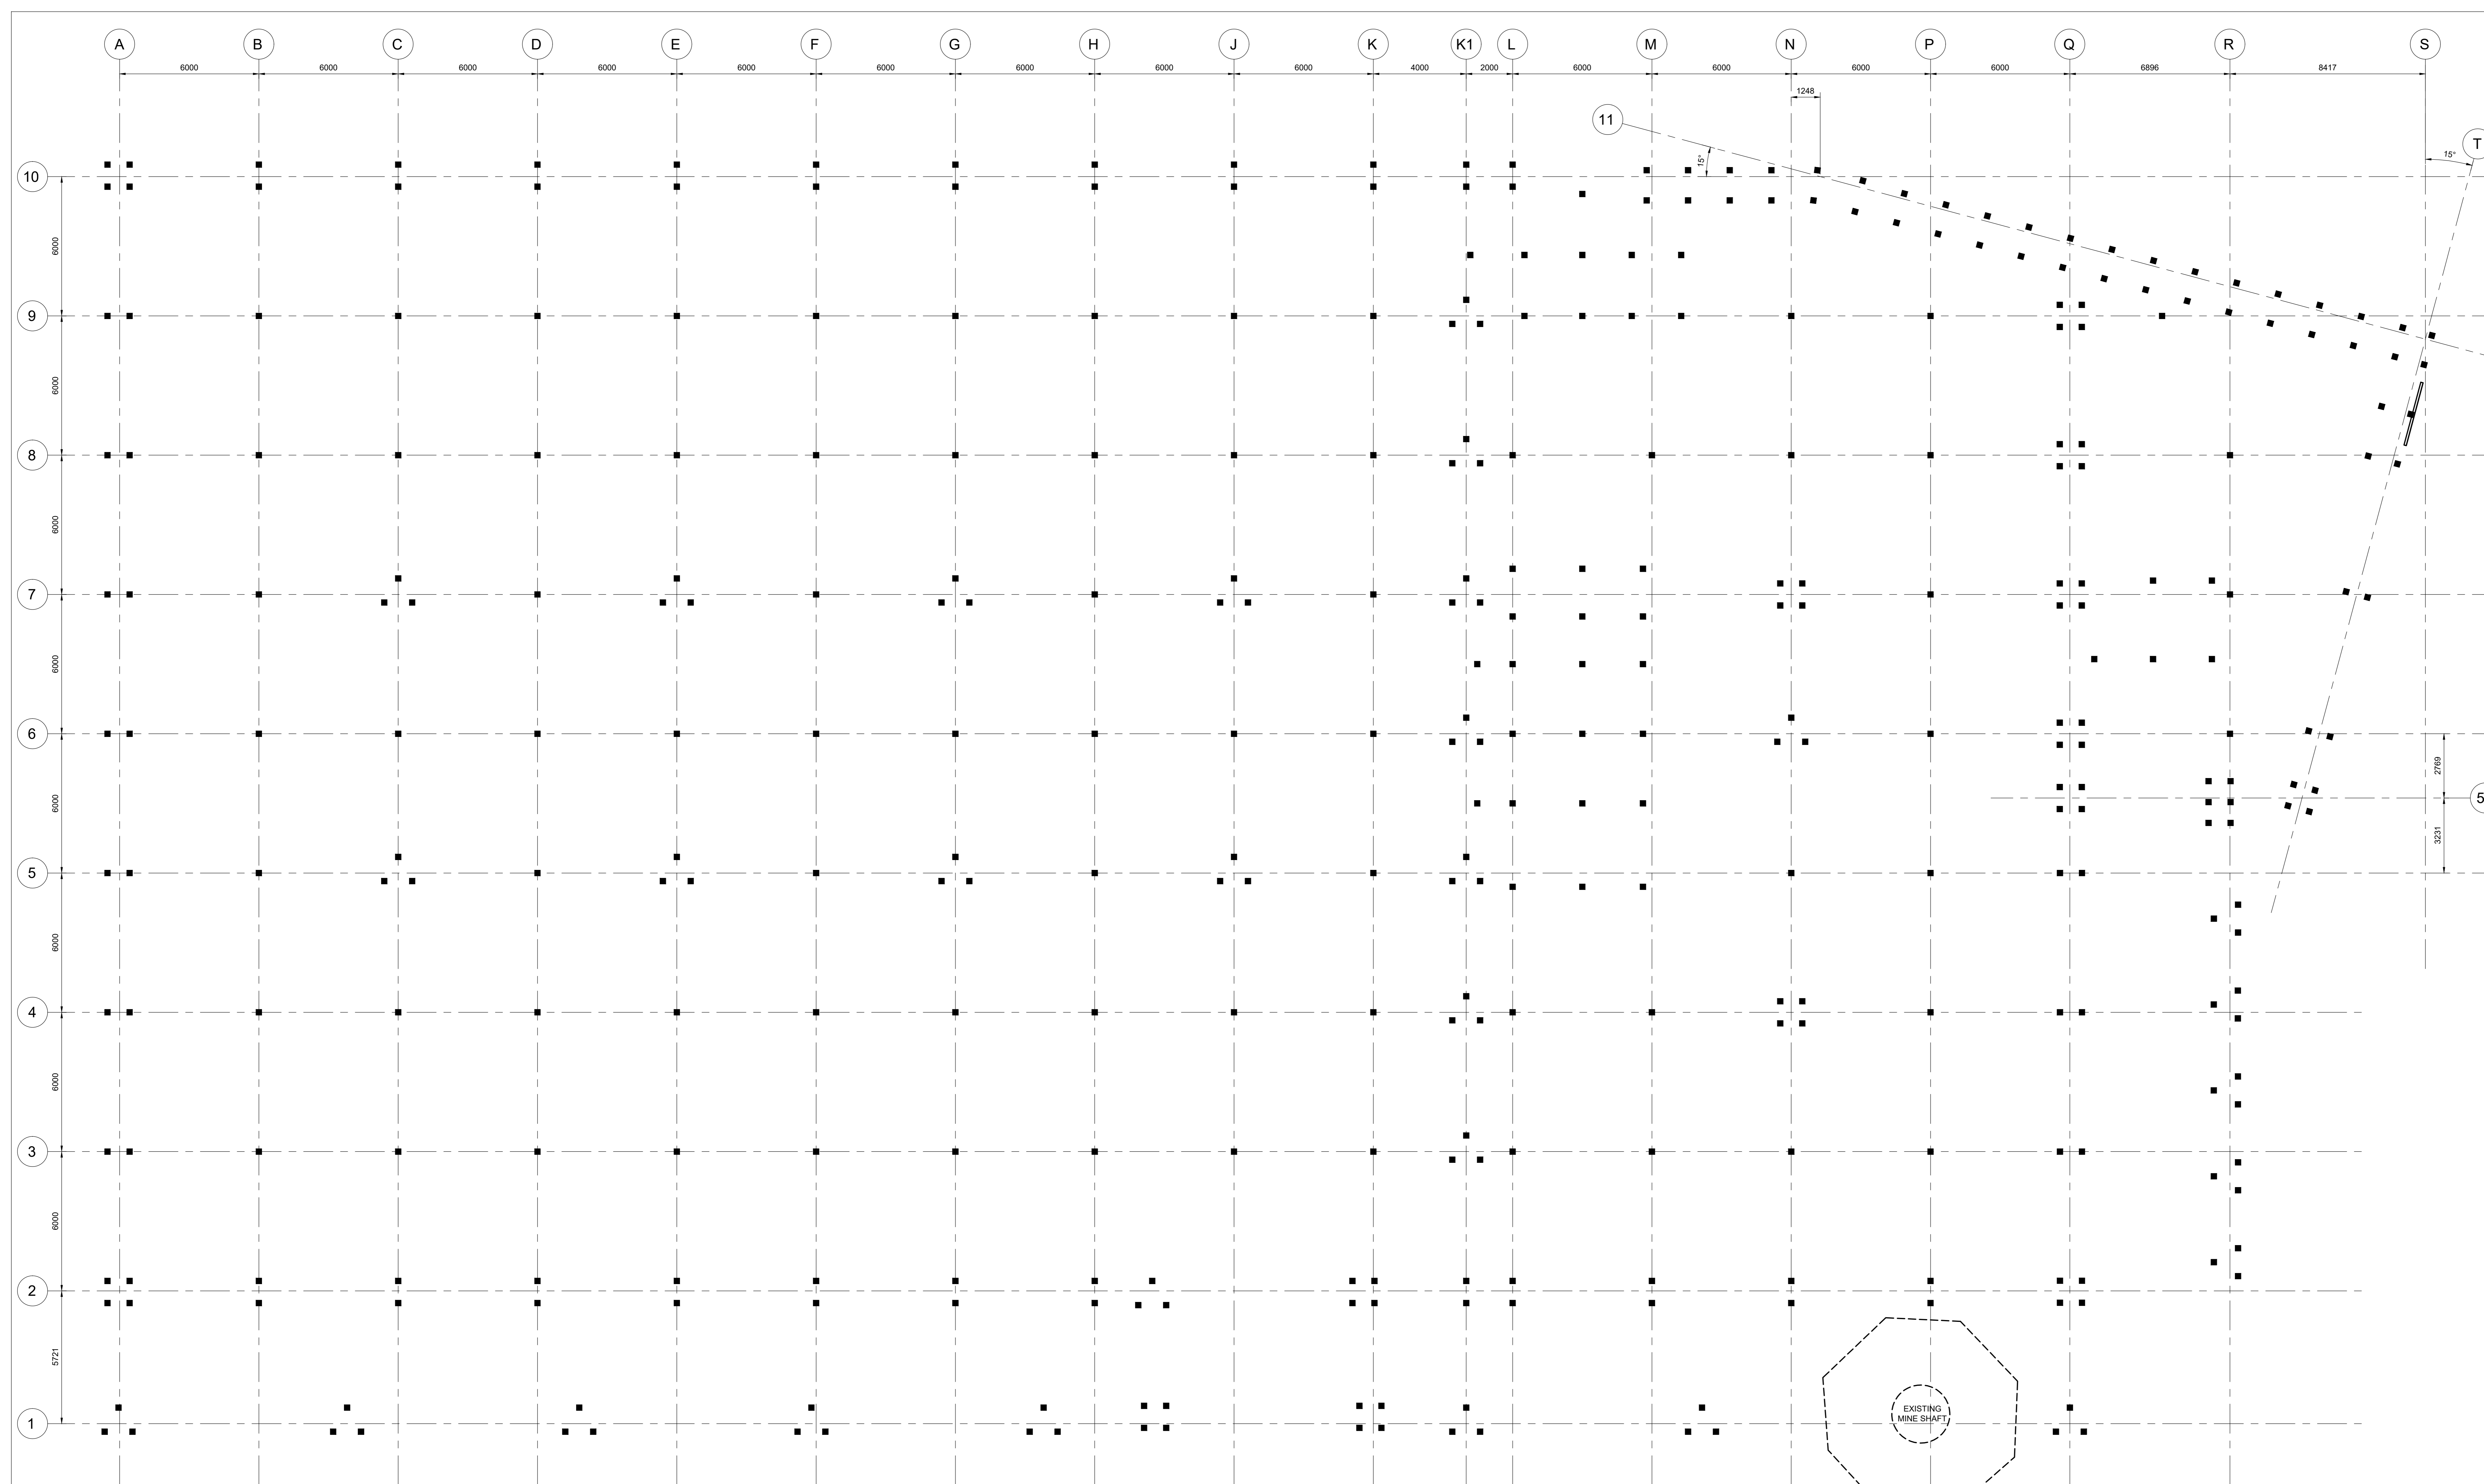
PLAN
1:100

Health and Safety Notes:
 The following key residual health and safety risks have not been eliminated by design and are identified below:
 - Refer Design Risk Assessments Ref: 2020011-DRA
 Safe methods and systems of work remain the responsibility of the contractor.
 This drawing shall be read in conjunction with specification ref: 2020011-SP-007 Piling
