Asphalt Recycling Facility - Coxhoe Quarry

Bespoke Environmental Permit Application

Appendix 11 – Habitat Risk Assessment

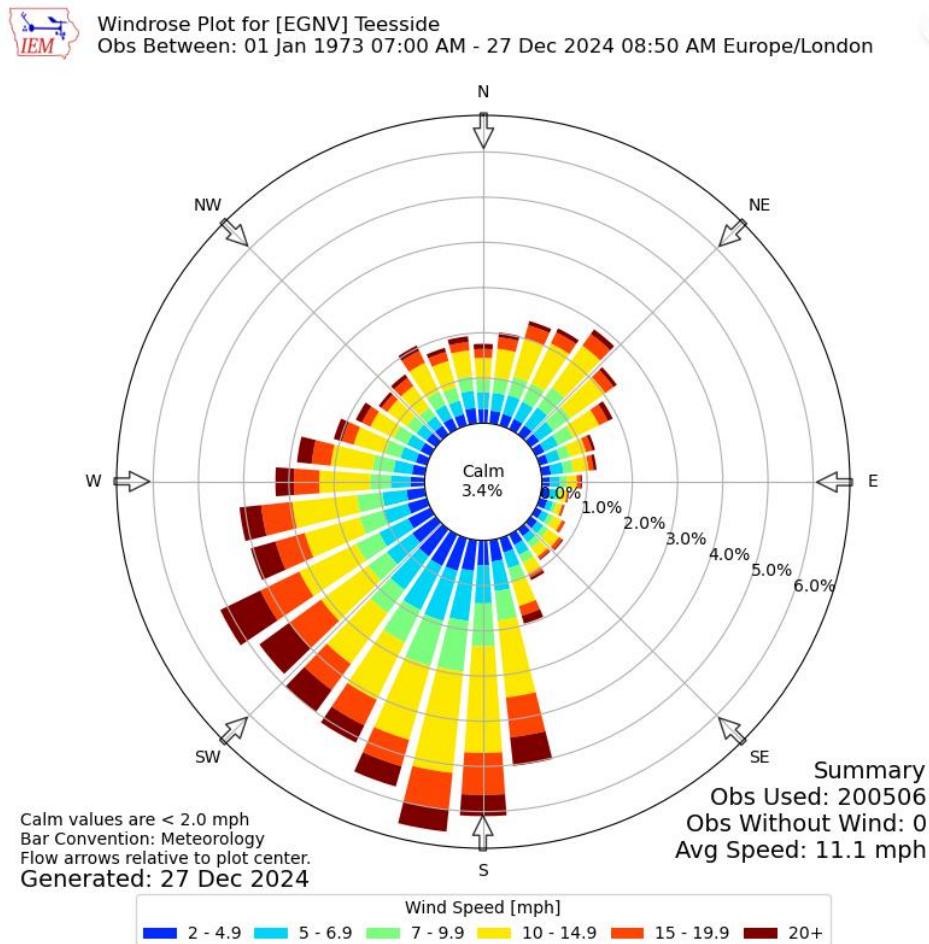
Diagram 1 Teesside Windrose, Observations between July 1973 - December 2024²

2.5.1 A Windrose dated December 2024 from the Site's nearest meteorological station at Teesside Airport is presented at Diagram 1.

2.5.2 The Windrose indicates that the predominant wind direction in the vicinity of the Site is towards the north and north-east.

2.5.3 Neither the Raisby Hill Grassland SSSI or presence of GCNs ponds are in the predominant downwind direction of the Asphalt Recycling Facility.

2.5.4 Raisby Hill Quarry SSSI is located within the predominant downwind direction of the Site, the exposed quarry faces are designated due to their geological significance.
