Site Condition Report

Endolys Plastics to Oil Facility

Project No.: SOL_25_P050_PYR

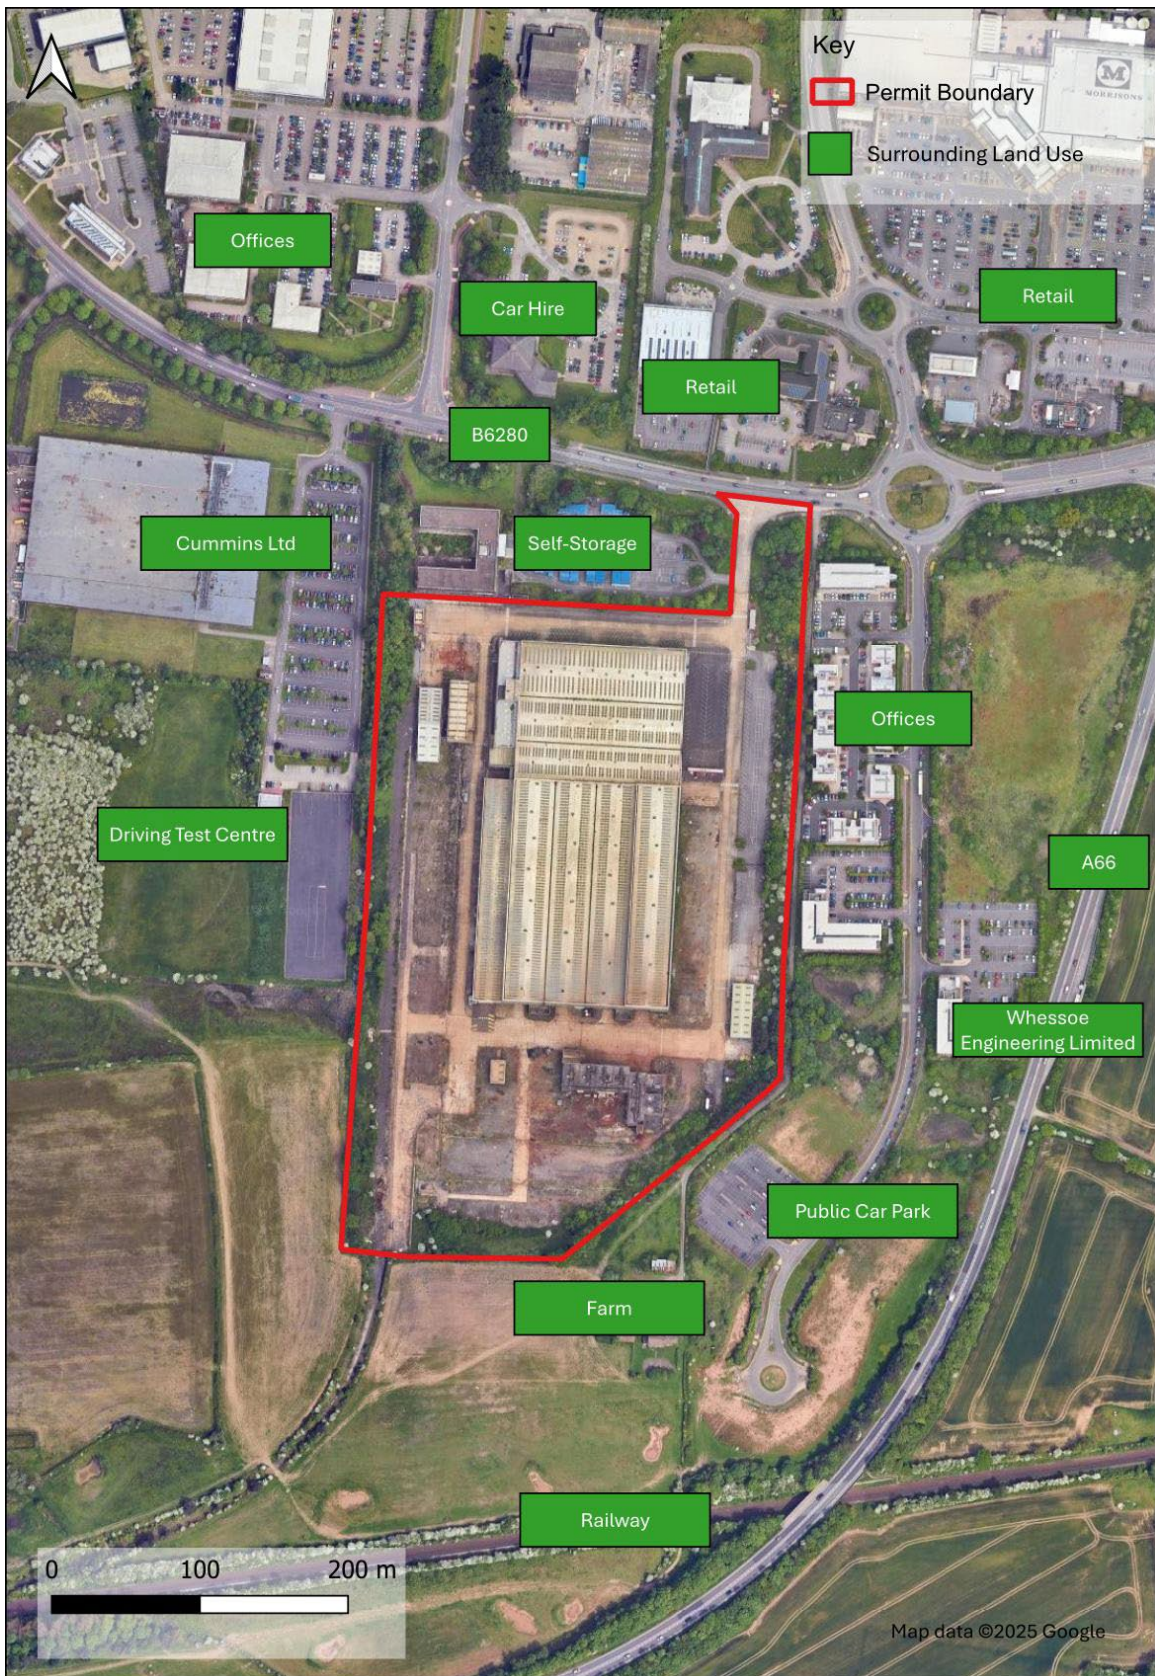
Figure 1-1 – Proposed permit boundary and surrounding (off-site) activities

The application permitted installation boundary is outlined in **Figure 1-1**.

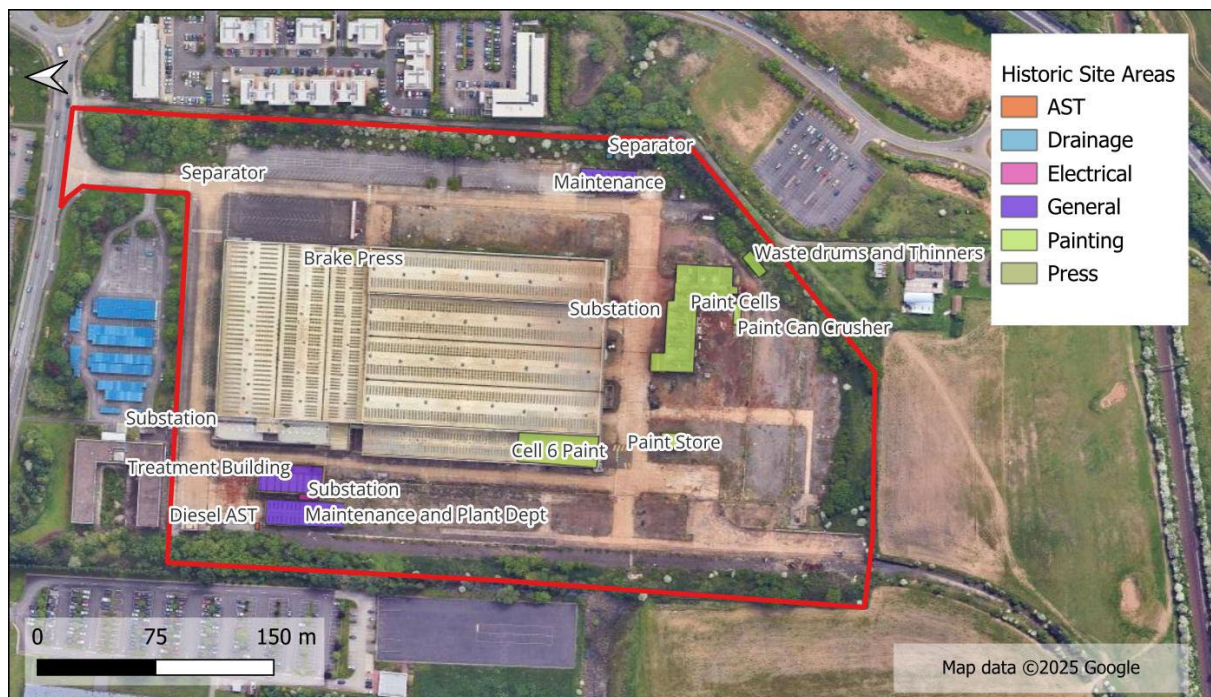
Figure 3-8 – Historic targets based on 2011 site layout

Given the nature of the previous activities (heavy engineering), the following potential contaminants of concern (CoC) have been considered:

- Asbestos
- Metals and their compounds (various types and sources)
- Inorganic chemicals (ammonium chloride (welding areas), boron (corrosion inhibitors. etc.)

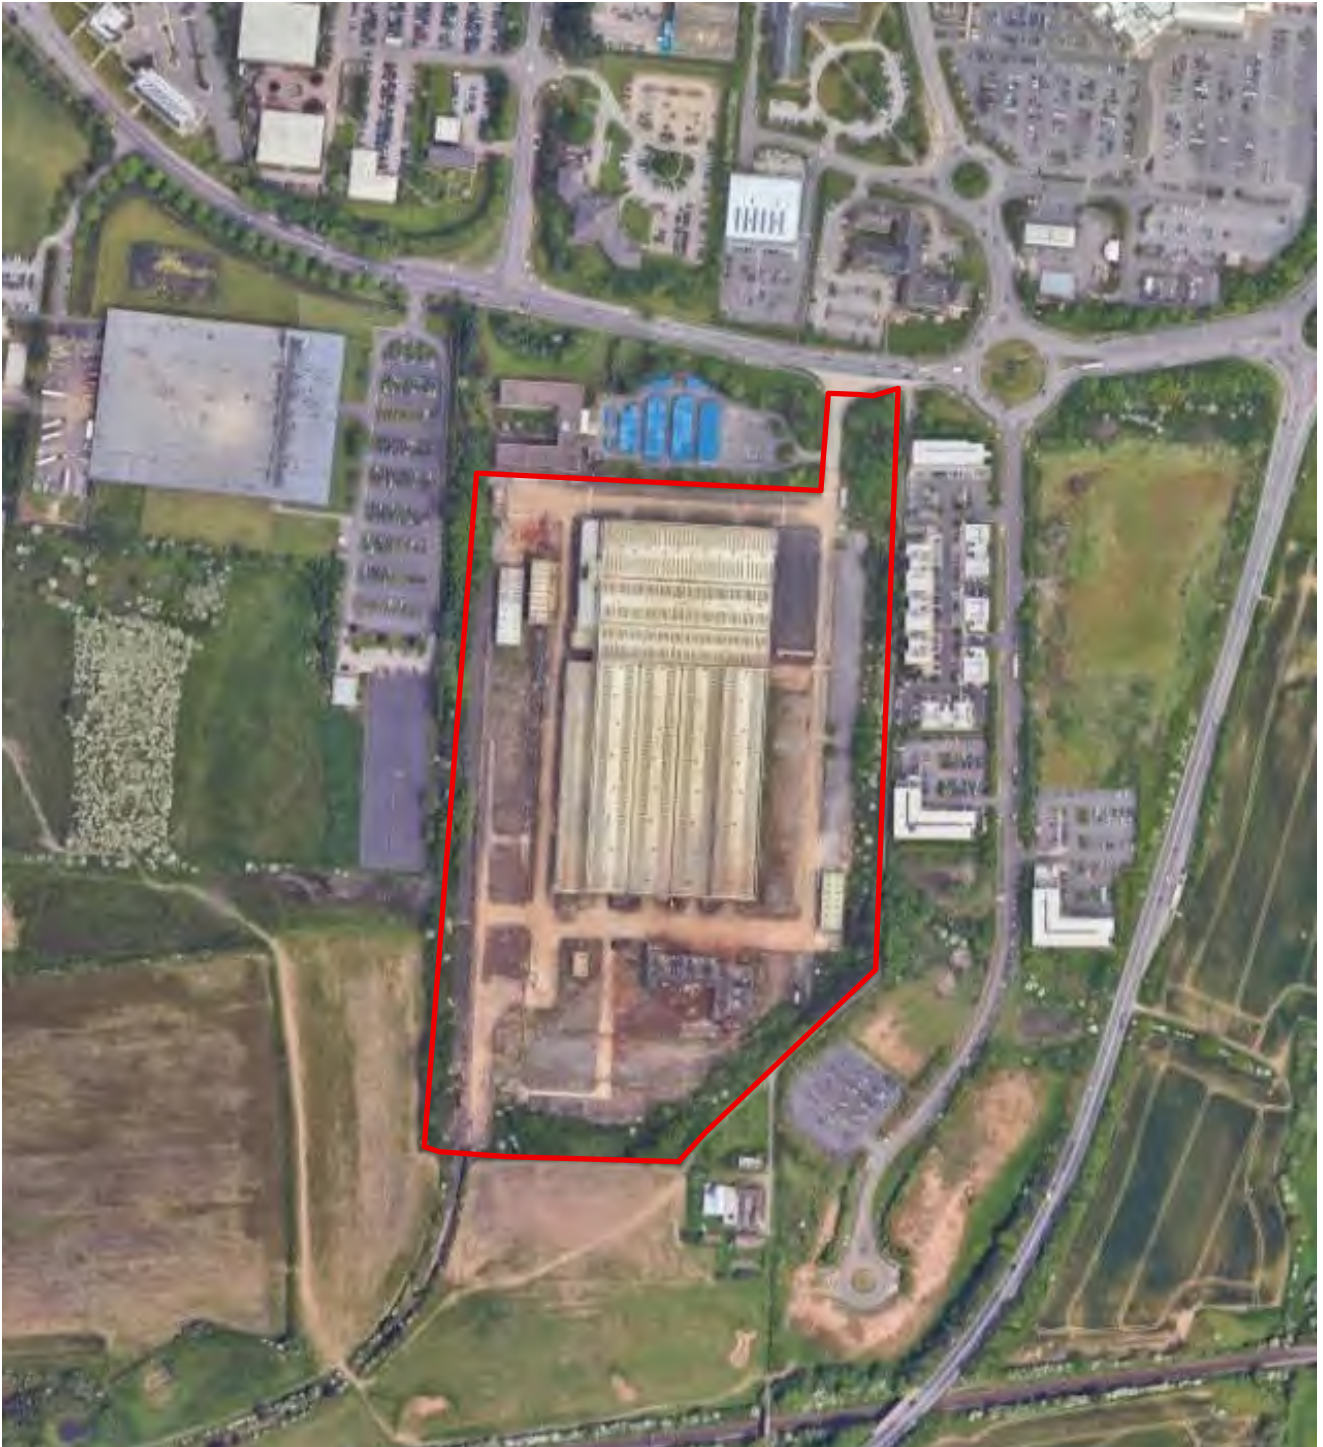
PROJECT NAME	Cleveland House, Yarm Road, Darlington	CLIENT	Earth & Marine Environmental Consultants Ltd
TITLE	Site Constraints Plan	PROJECT NO.	P6534J3273
DATE	October 2025	FIGURE NO.	2

2.1.4 The locations of the above features are indicated on the site constraints plan in Figure 2, Appendix 1.

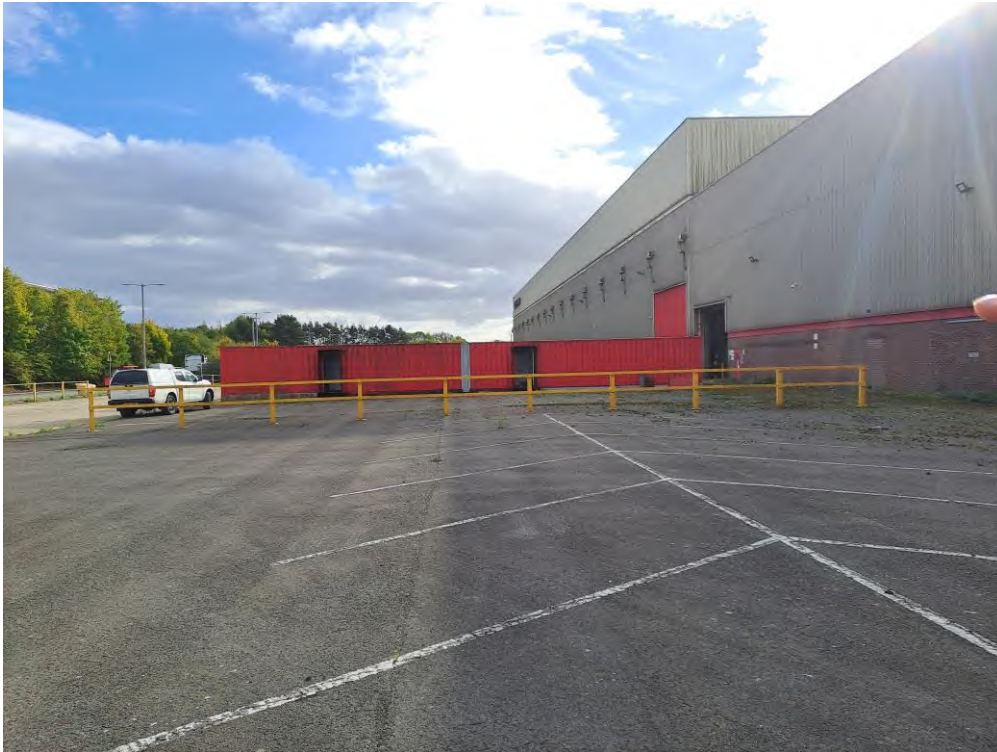
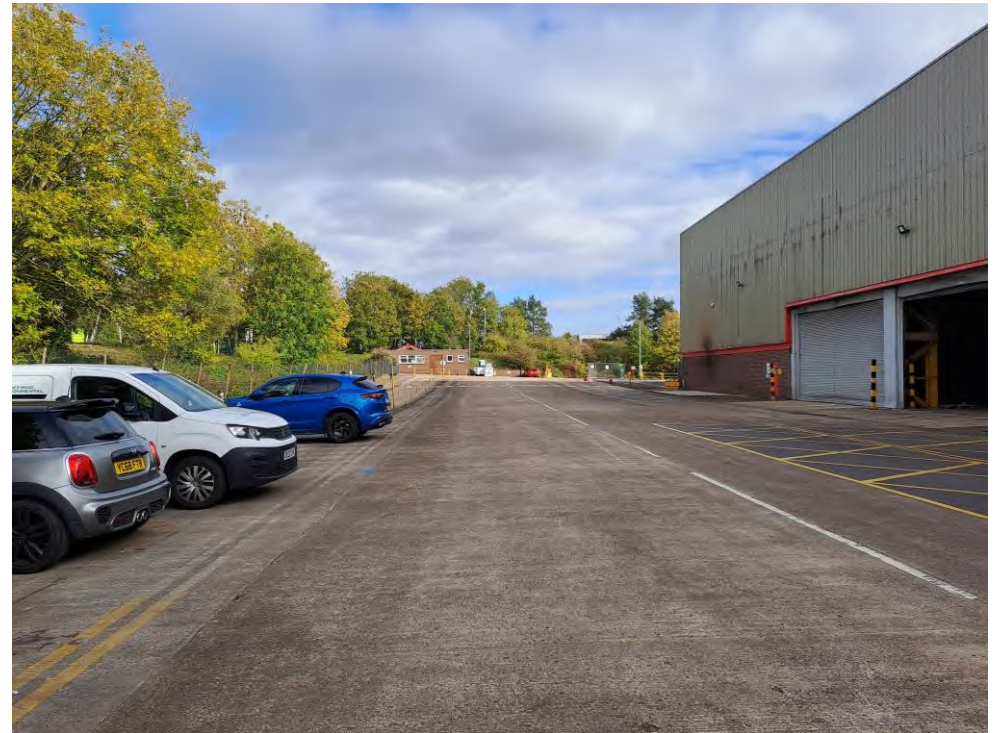
PROJECT NAME	Cleveland House, Yarm Road, Darlington	CLIENT	Earth & Marine Environmental Consultants Ltd
TITLE	Walkover Photo Plan	FIGURE	3
Photo 1: Overview of site from the main access point looking south.		Photo 2: Roadway to the north of the main building looking east.

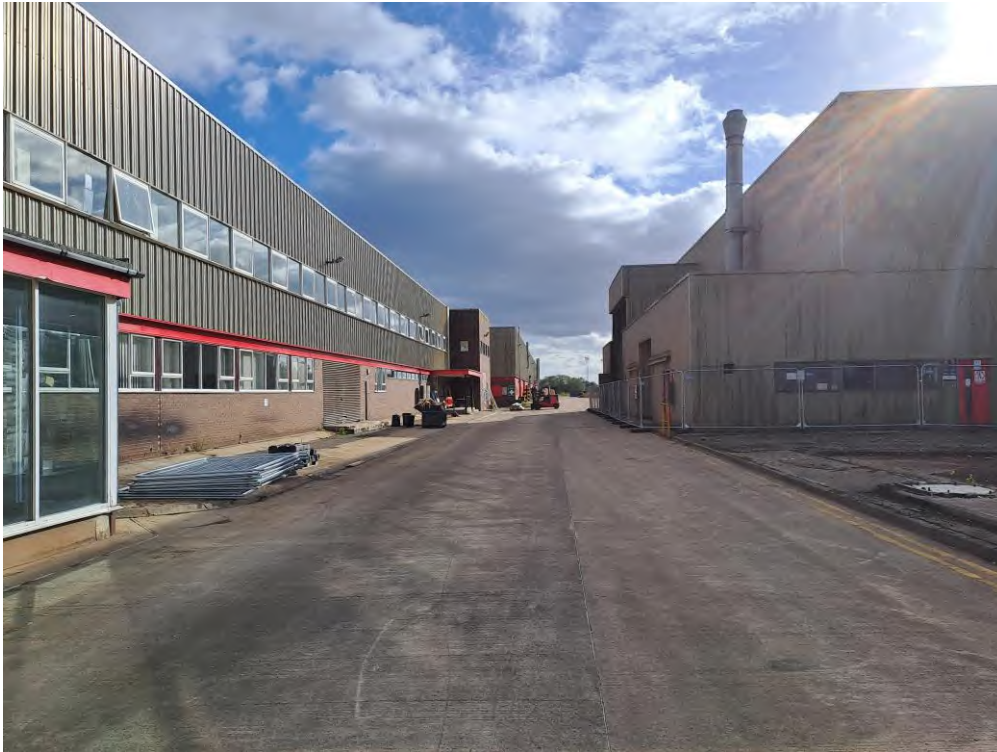
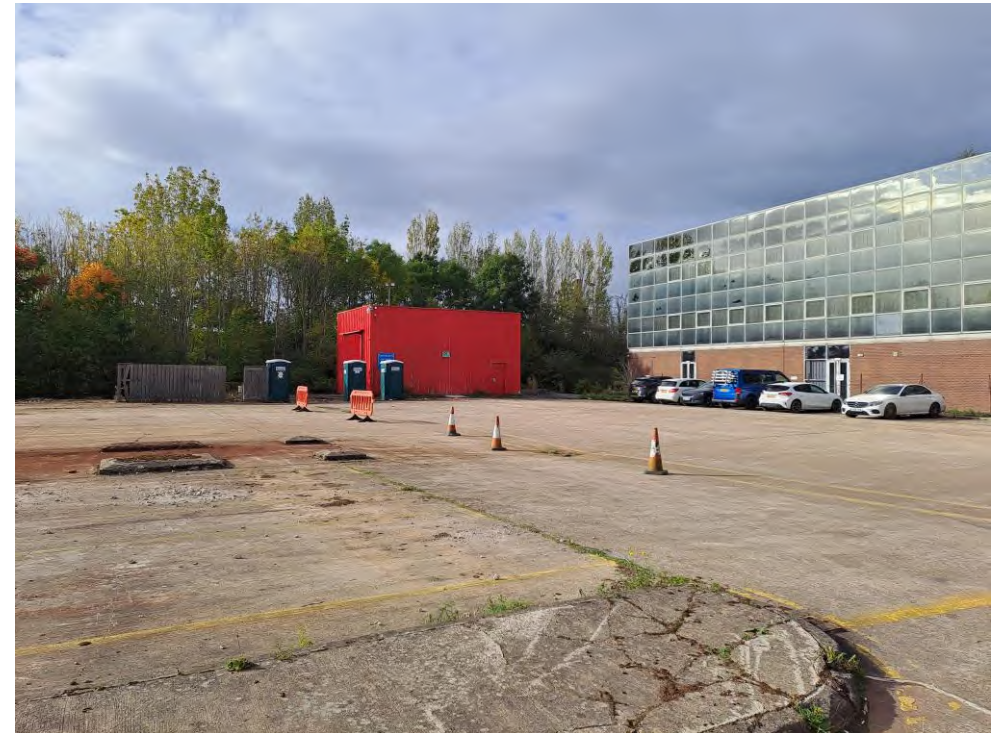
PROJECT NAME	Cleveland House, Yarm Road, Darlington	CLIENT	Earth & Marine Environmental Consultants Ltd
TITLE	Walkover Photo Plan	FIGURE	3
Photo 3: West of main building looking south.		Photo 4: West of main building looking northwest.

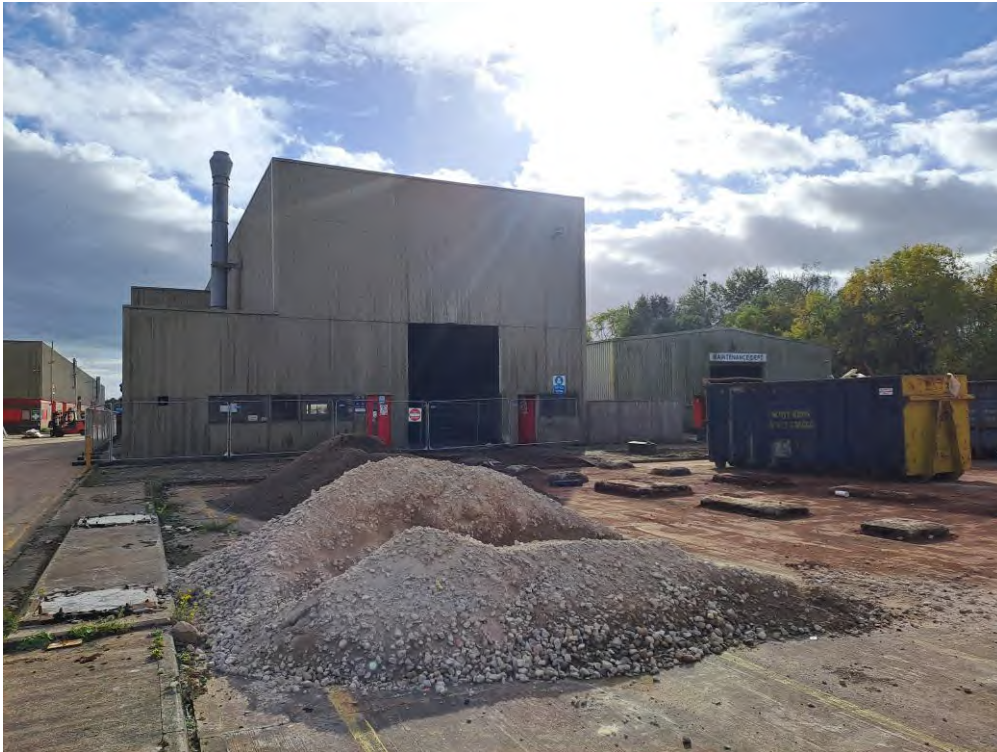
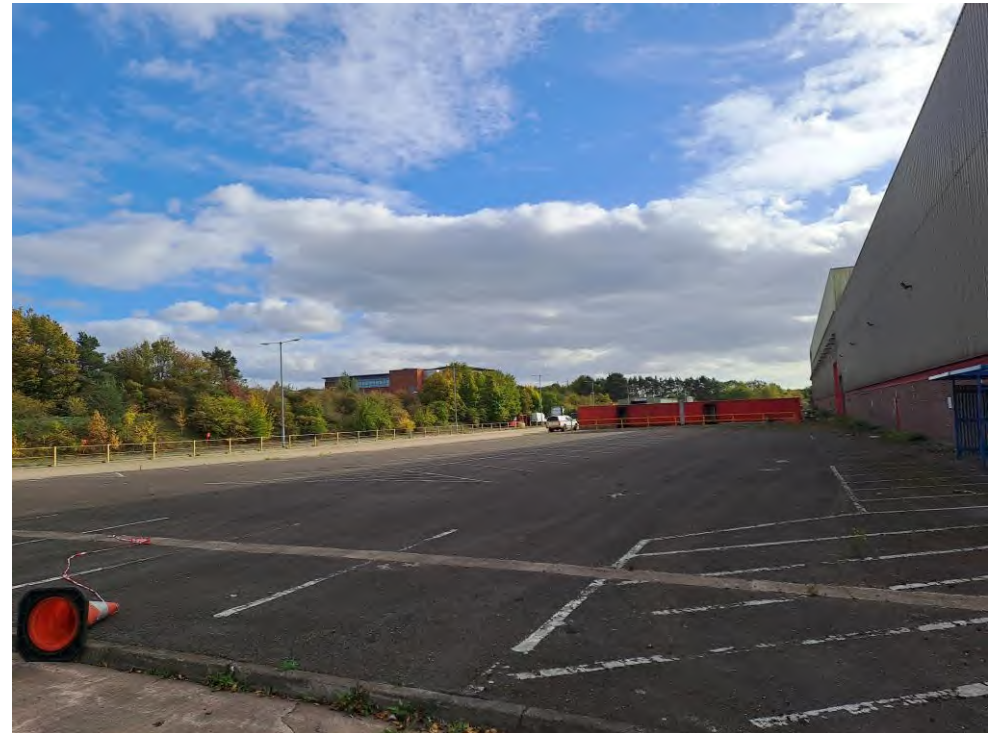
PROJECT NAME	Cleveland House, Yarm Road, Darlington	CLIENT	Earth & Marine Environmental Consultants Ltd
TITLE	Walkover Photo Plan	FIGURE	3
Photo 5: Buildings in the northwest of site, understood to be a former treatment building, and maintenance and plant depot.		Photo 6: Parking area/yard to the east of the main building looking south.

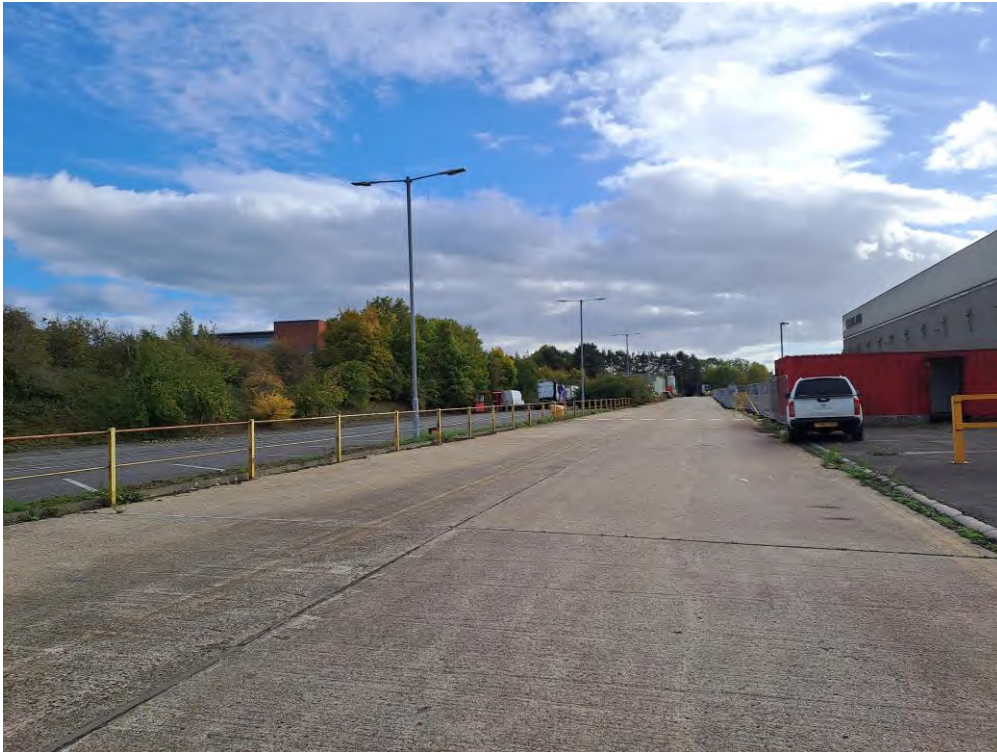
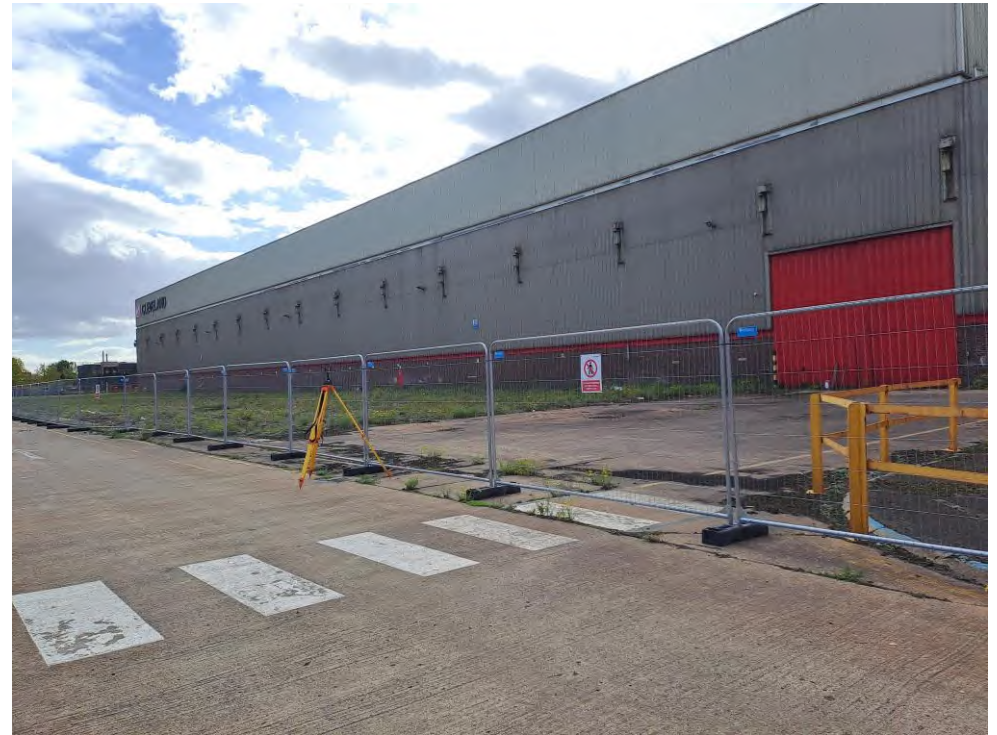
PROJECT NAME	Cleveland House, Yarm Road, Darlington	CLIENT	Earth & Marine Environmental Consultants Ltd
TITLE	Walkover Photo Plan	FIGURE	3
Photo 7: Roadway to the east of the main building looking south.		Photo 8: Fenced area directly adjacent to the east of the main building.

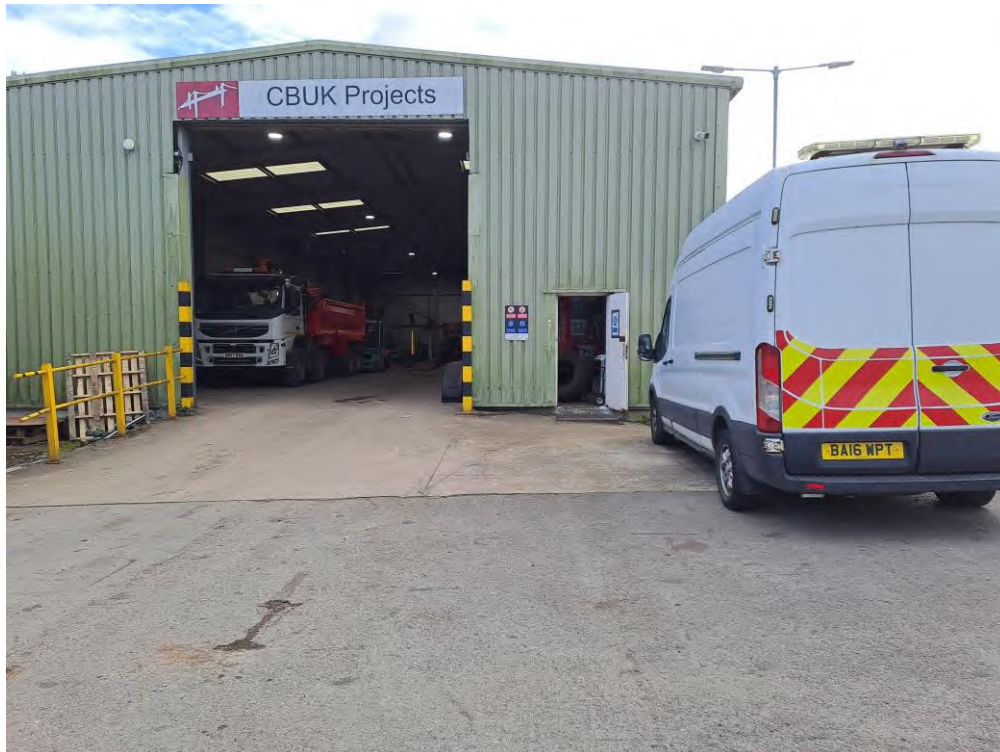
Photo 9: Temporary vehicle maintenance building in the southeast of site.

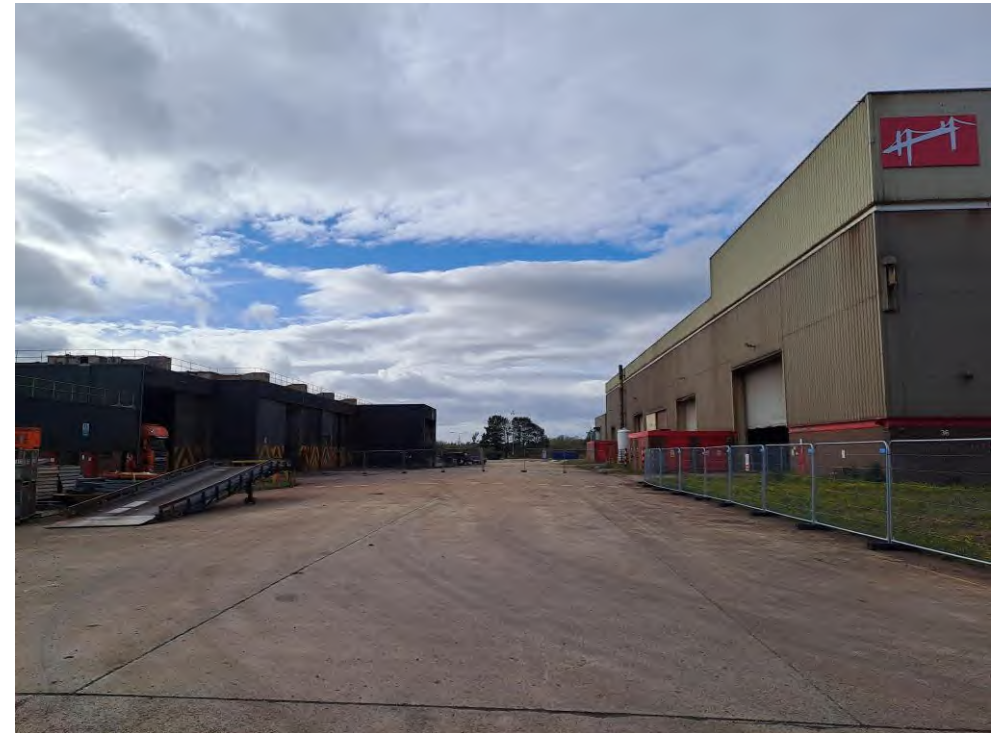
Photo 10: Southeast of main building looking west

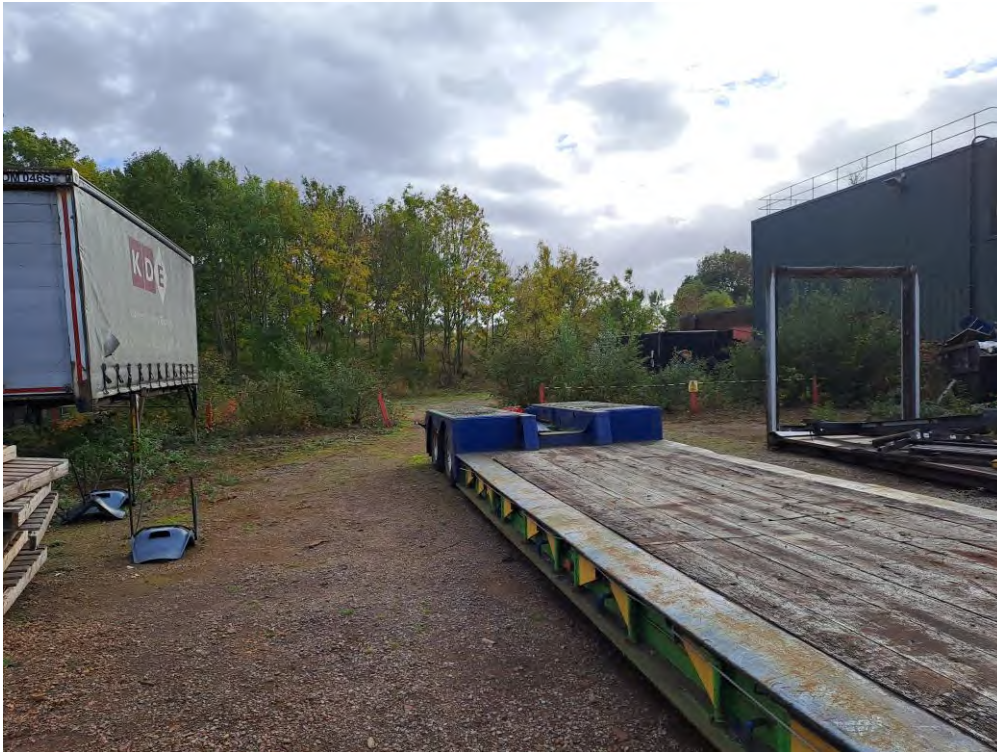
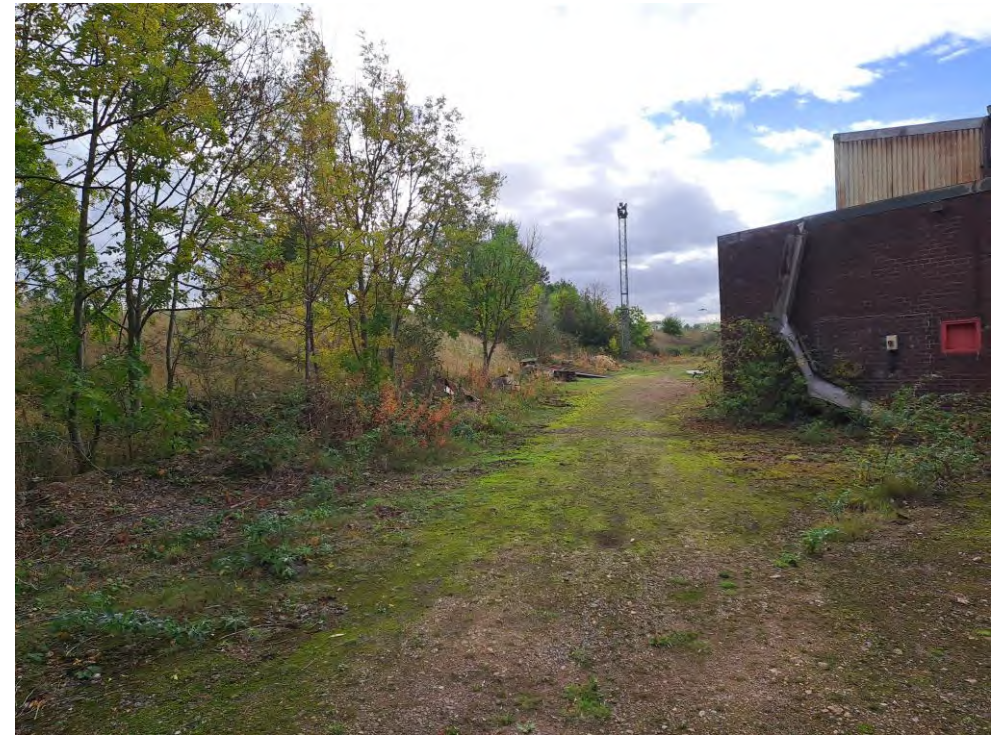
PROJECT NAME	Cleveland House, Yarm Road, Darlington	CLIENT	Earth & Marine Environmental Consultants Ltd
TITLE	Walkover Photo Plan	FIGURE	3
Photo 11: Southeast of the main building looking south.		Photo 12: Roadway/path in the southeast of site.

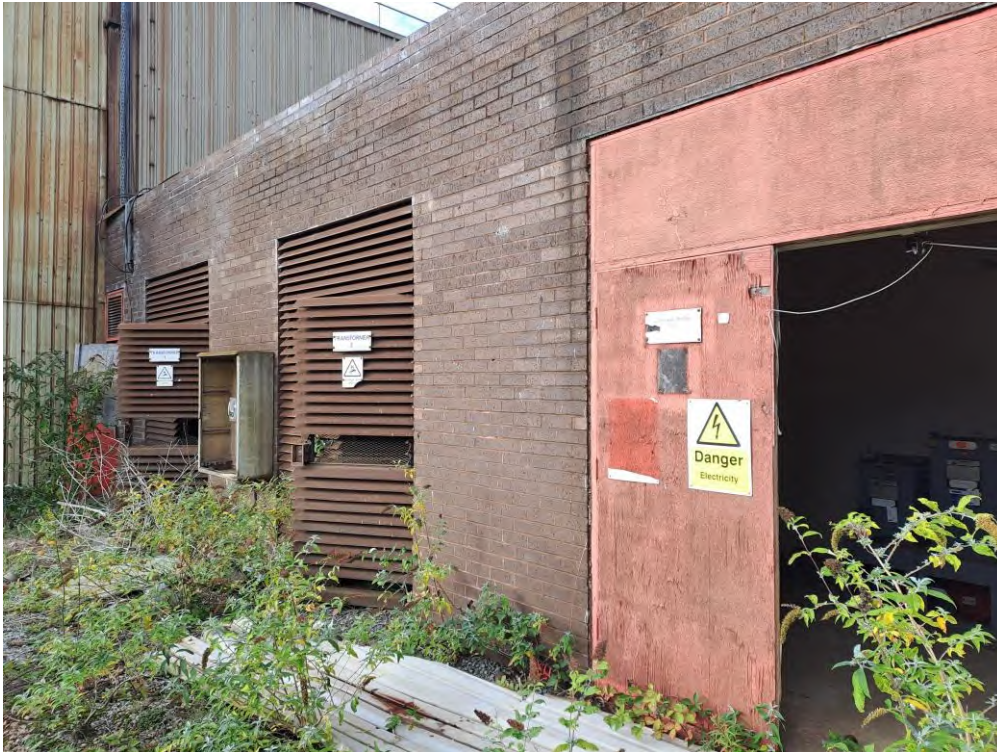
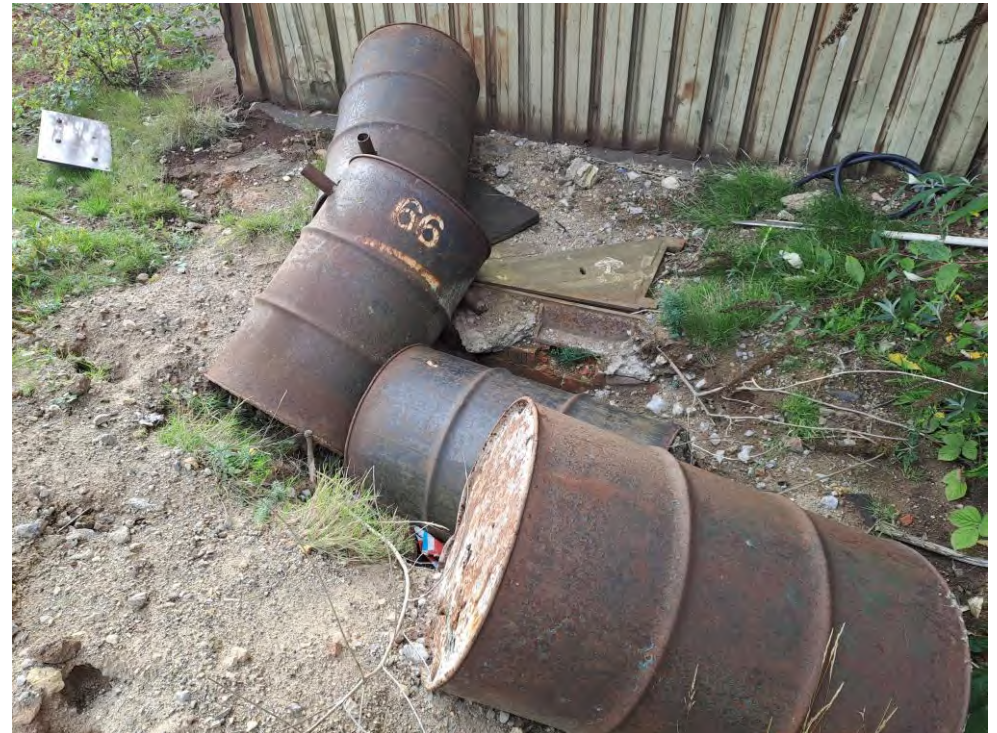
Photo 13: Former plant room adjacent to the south of the former painting buildings in the southeast of site.	Photo 14: Barrels to the south of the painting buildings.
---	--

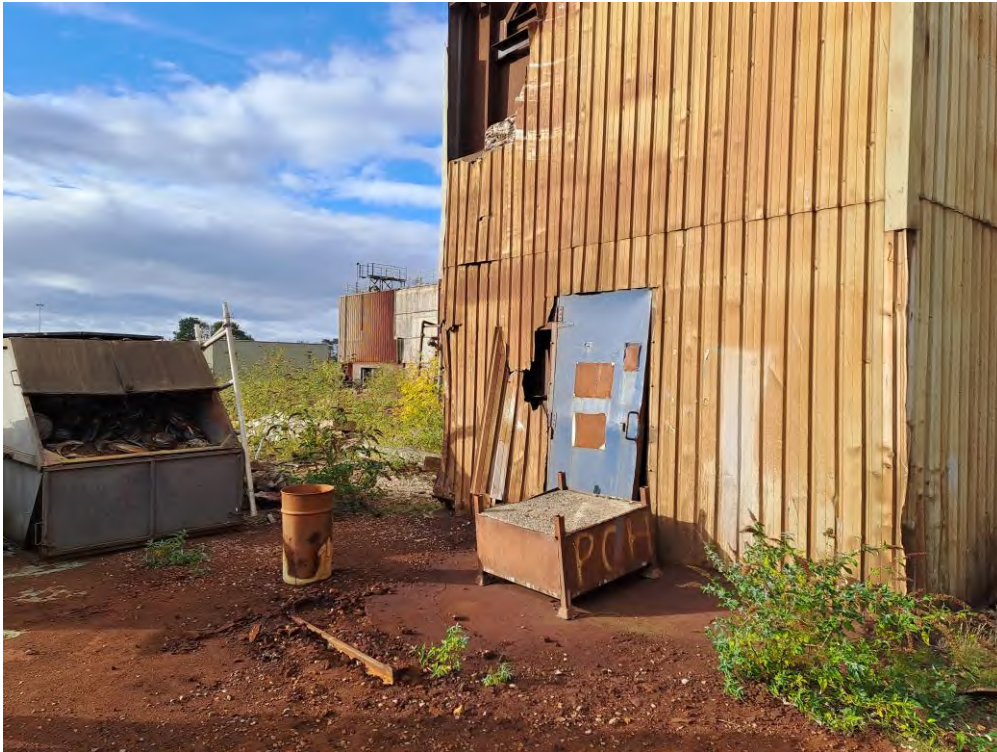
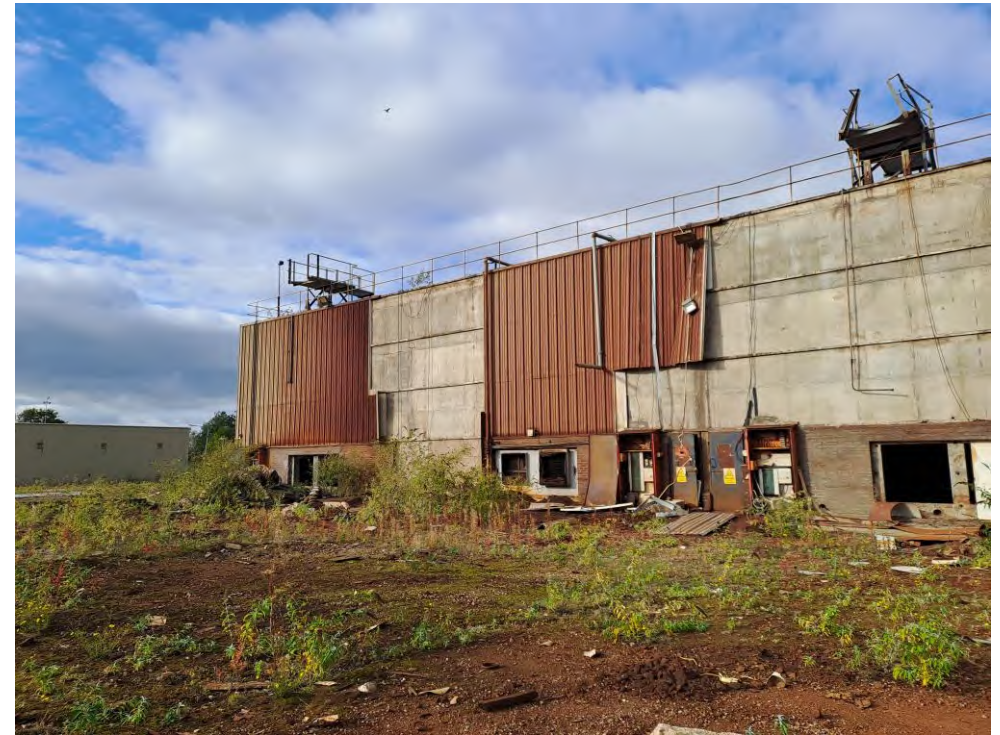
PROJECT NAME	Cleveland House, Yarm Road, Darlington	CLIENT	Earth & Marine Environmental Consultants Ltd
TITLE	Walkover Photo Plan	FIGURE	3
Photo 15: Brown staining and metal debris on ground surface to the south of paint workshop.		Photo 16: Another image of brown staining and metal debris on ground surface to the south of paint workshop.

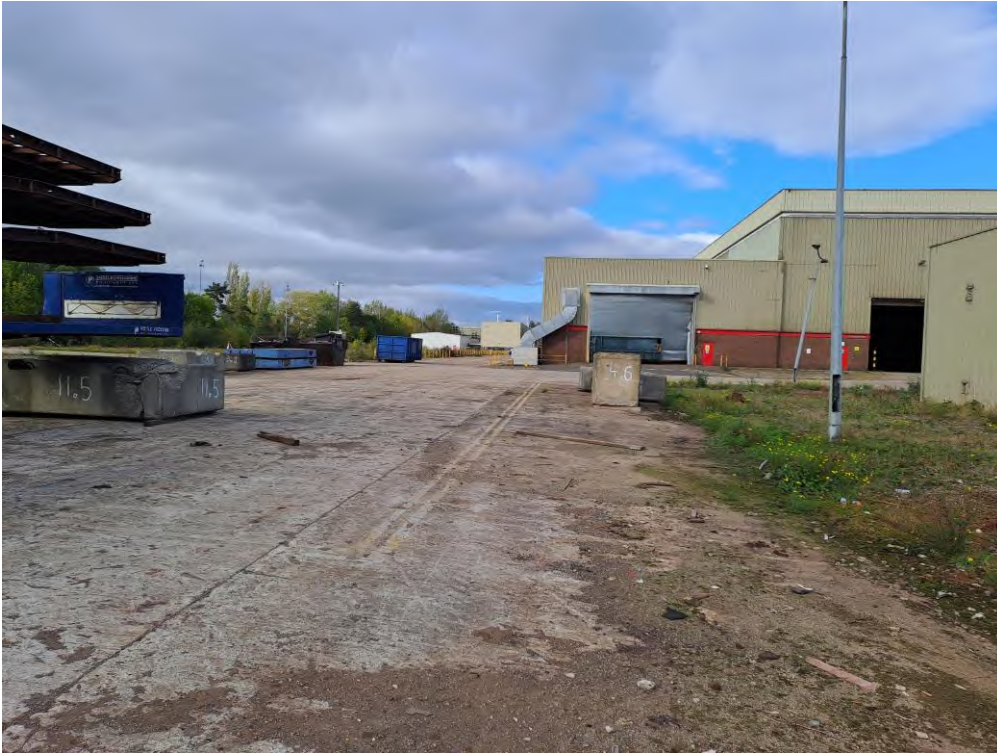
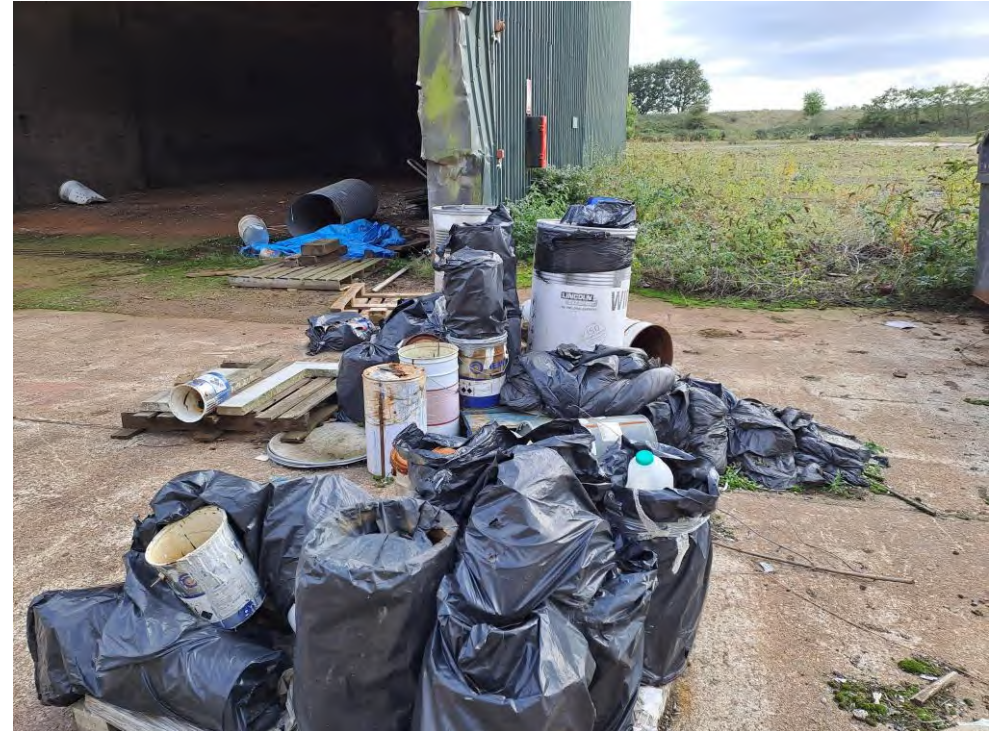
PROJECT NAME	Cleveland House, Yarm Road, Darlington	CLIENT	Earth & Marine Environmental Consultants Ltd
TITLE	Walkover Photo Plan	FIGURE	3
Photo 19: Roadway to the southwest of the main building.		Photo 20: General waste stored by former painting area.

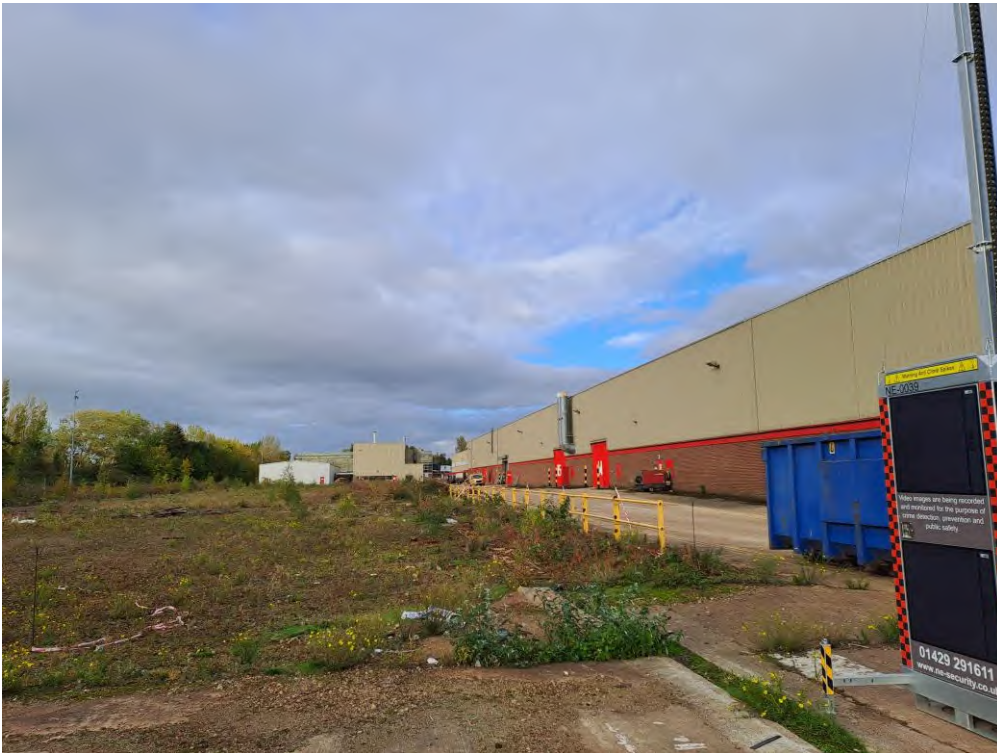
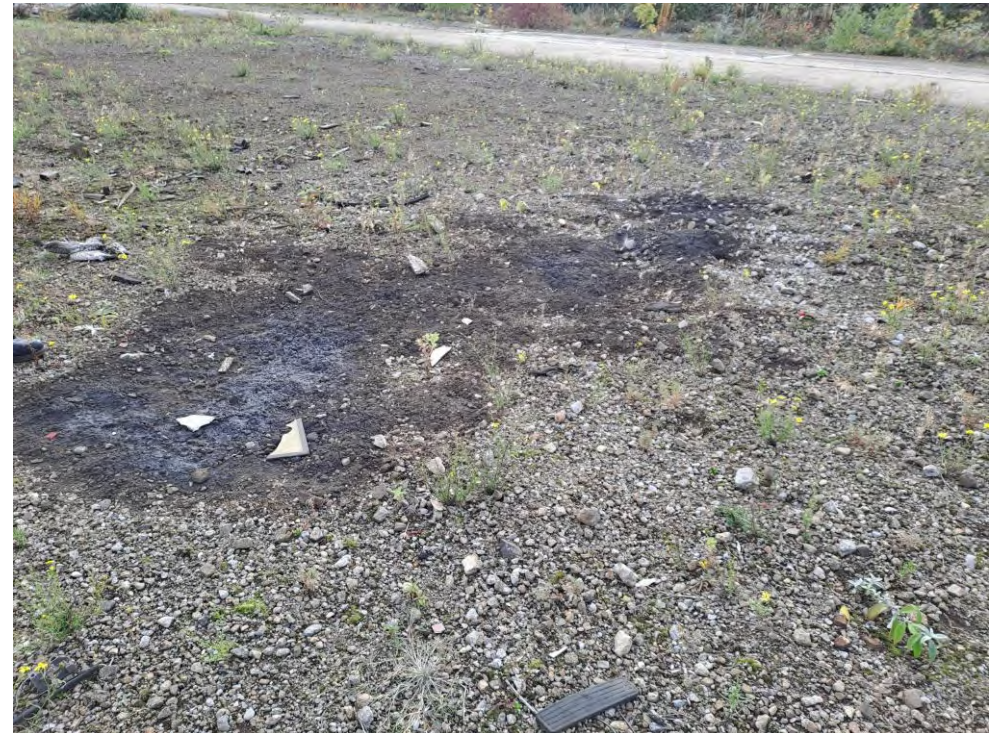
PROJECT NAME	Cleveland House, Yarm Road, Darlington	CLIENT	Earth & Marine Environmental Consultants Ltd
TITLE	Walkover Photo Plan	FIGURE	3
Photo 23: Open area to the west of the main building looking north.		Photo 24: Black staining observed in the open area to the west of the main building.

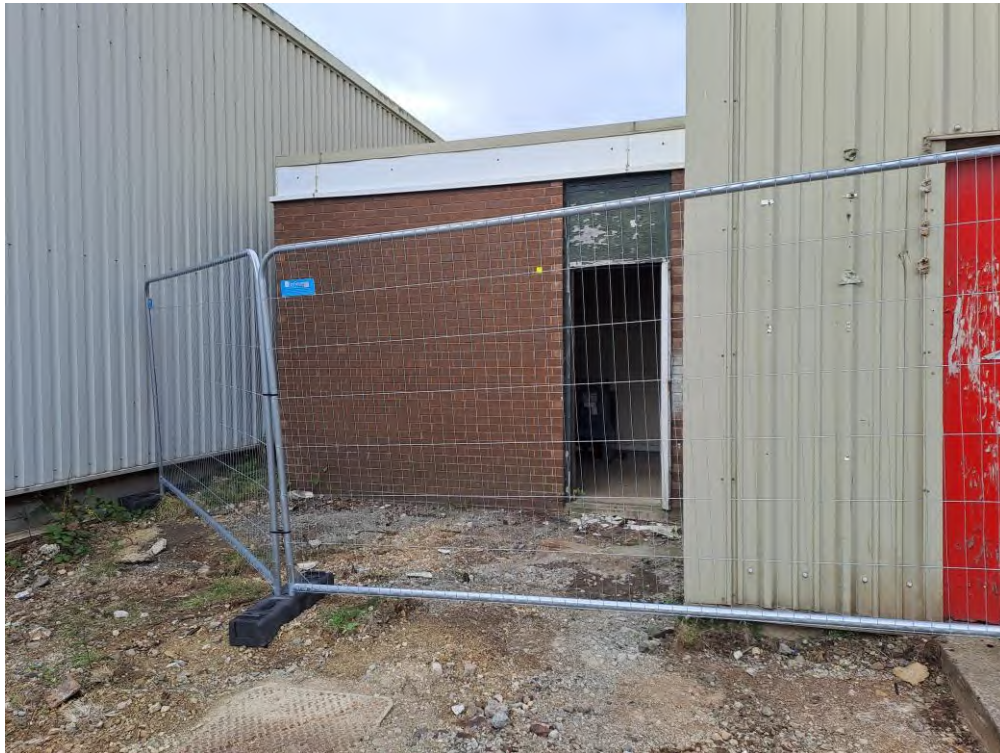
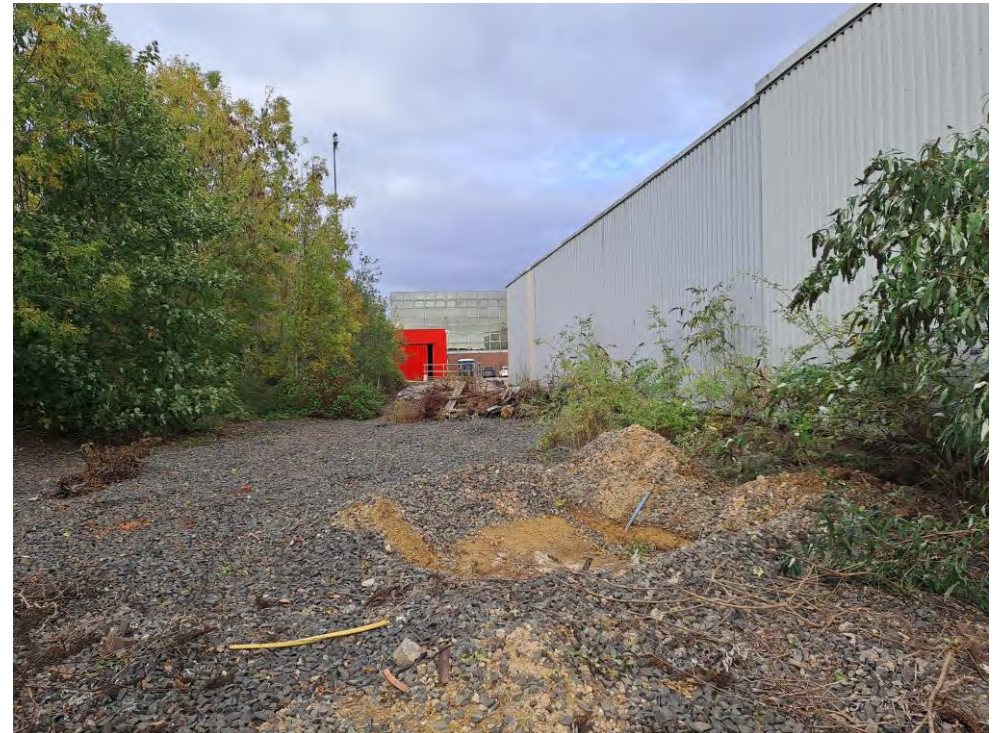
PROJECT NAME	Cleveland House, Yarm Road, Darlington	CLIENT	Earth & Marine Environmental Consultants Ltd
TITLE	Walkover Photo Plan	FIGURE	3
Photo 25: Substation in between the former treatment building and plant and maintenance depot in the northwest of the site.		Photo 26: Area to the west of the plant and maintenance depot, where an above ground fuel tank is understood to have been formerly present.
