Site Condition Report

Endolys Plastics to Oil Facility

Project No.: SOL_25_P050_PYR

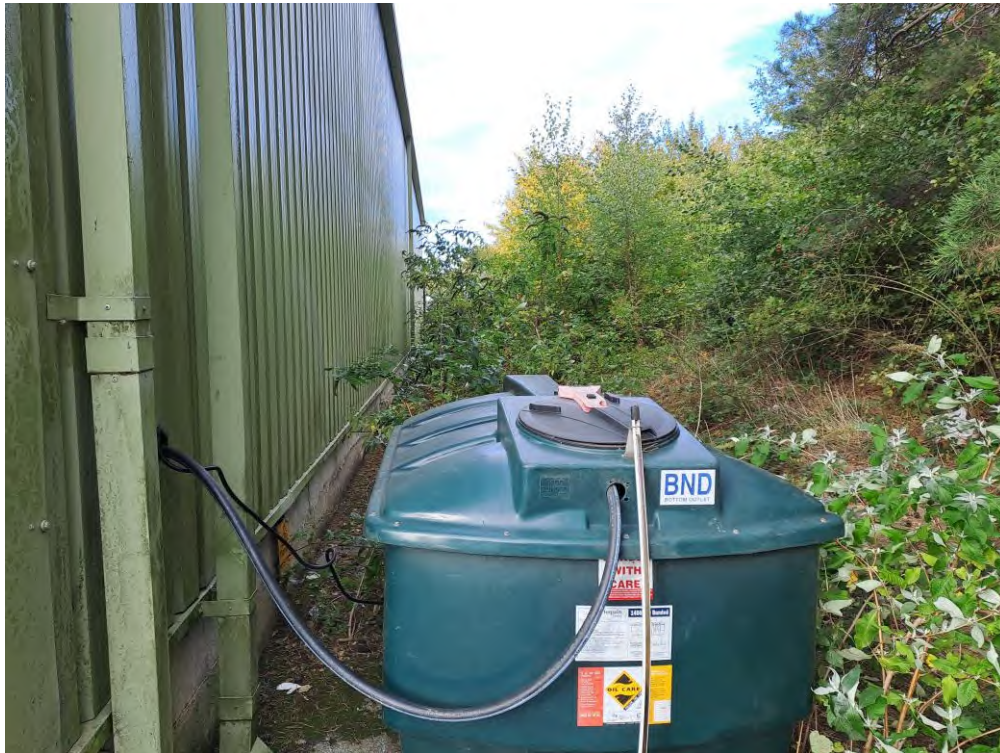
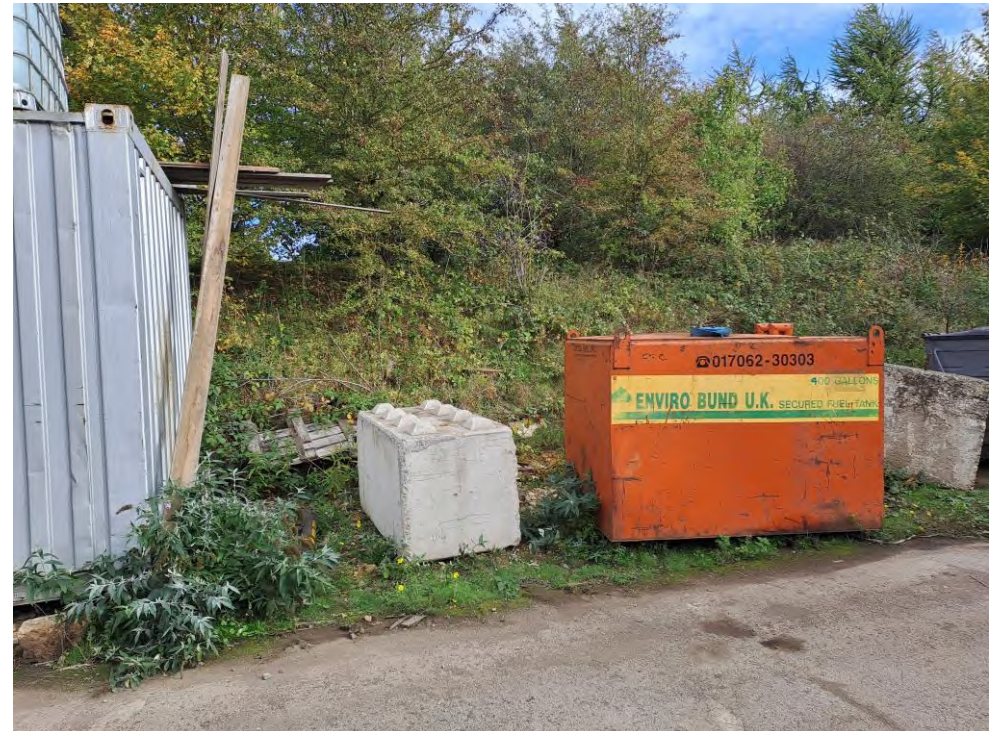
PROJECT NAME	Cleveland House, Yarm Road, Darlington	CLIENT	Earth & Marine Environmental Consultants Ltd
TITLE	Walkover Photo Plan	FIGURE	3
Photo 27: An above ground tank, which appears to be used for storing fuel oil, adjacent to the east of the vehicle maintenance unit in the southeast of site.		Photo 28: An above ground tank, which appears to be used for storing diesel, to the north of the vehicle maintenance unit in the southeast of site.

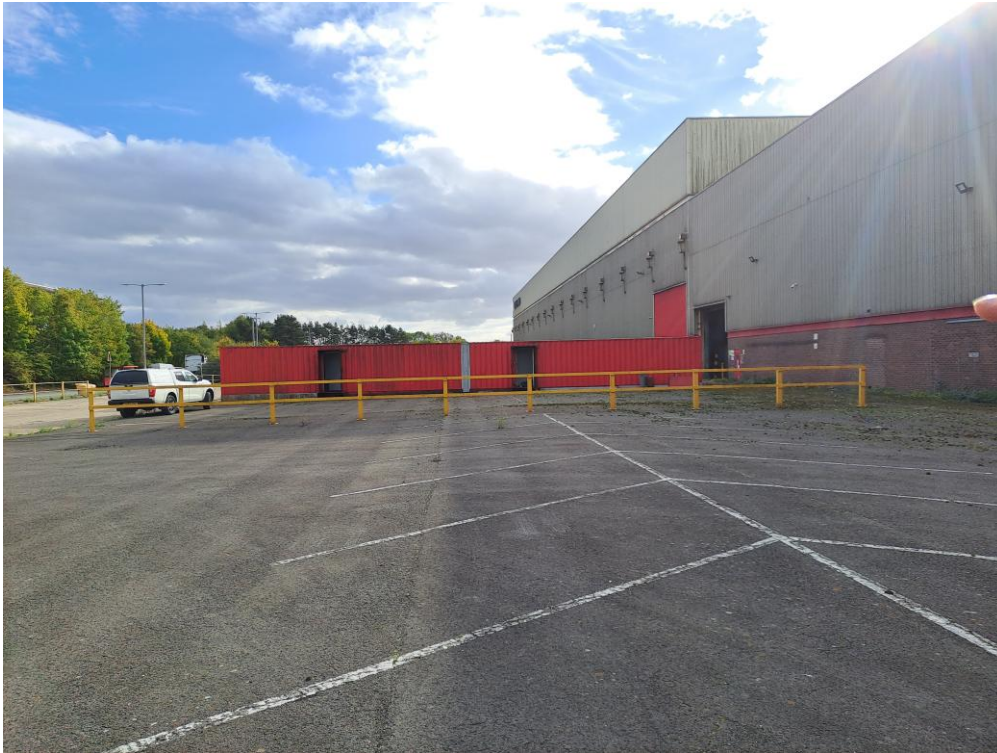
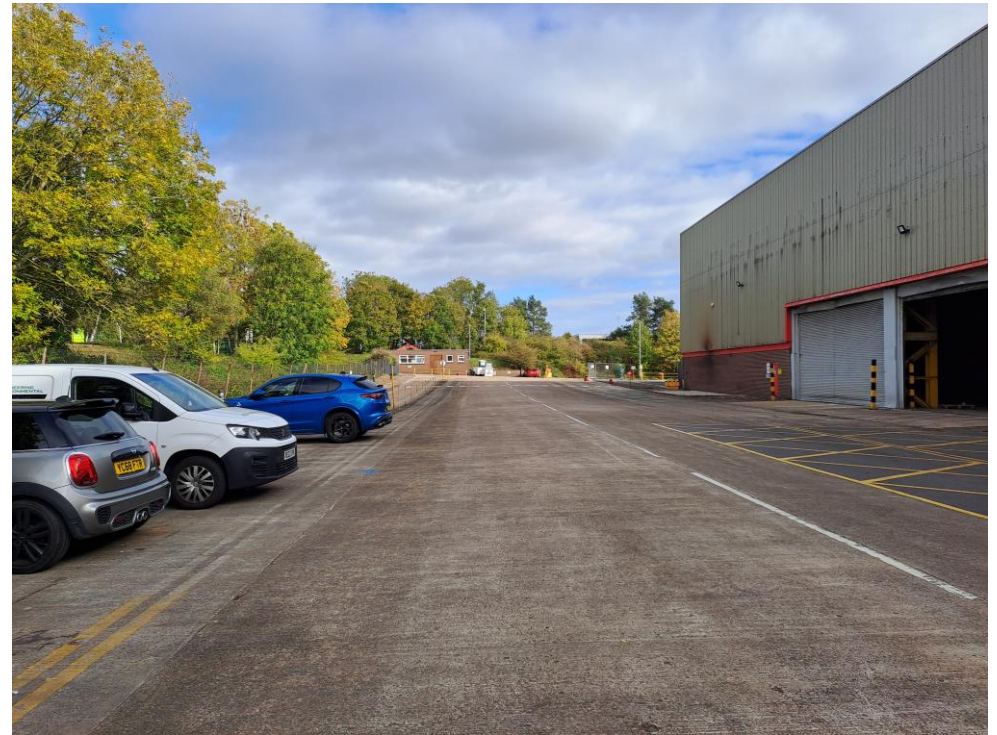
PROJECT NAME	Cleveland House, Yarm Road, Darlington	CLIENT	Earth & Marine Environmental Consultants Ltd
TITLE	Walkover Photo Plan	FIGURE	3
Photo 1: Overview of site from the main access point looking south.		Photo 2: Roadway to the north of the main building looking east.

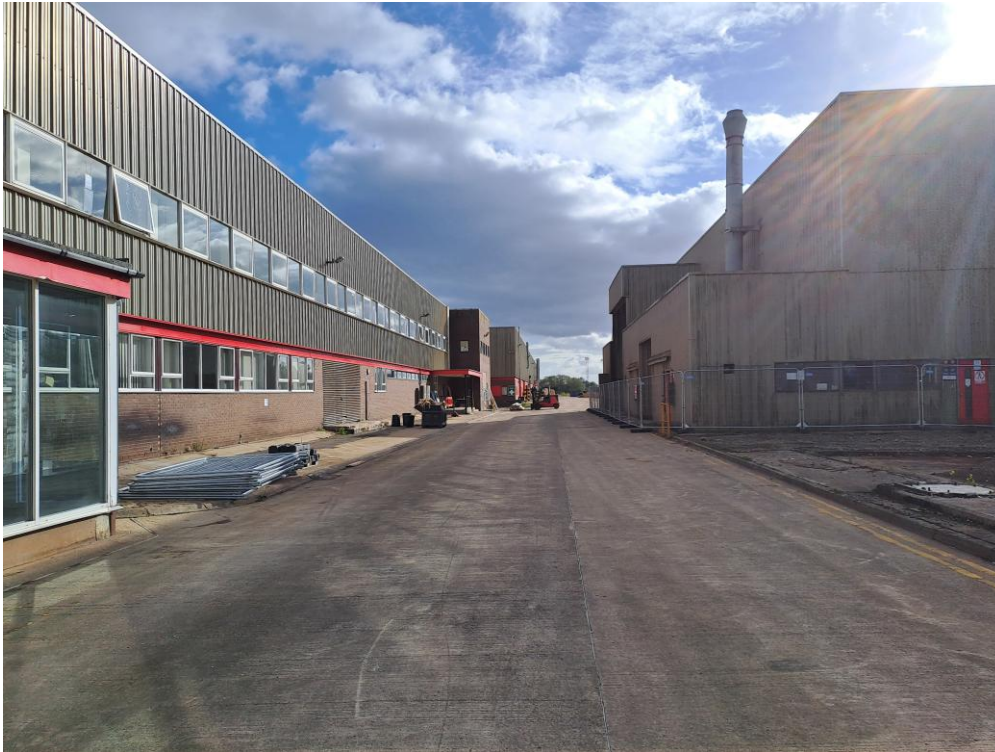
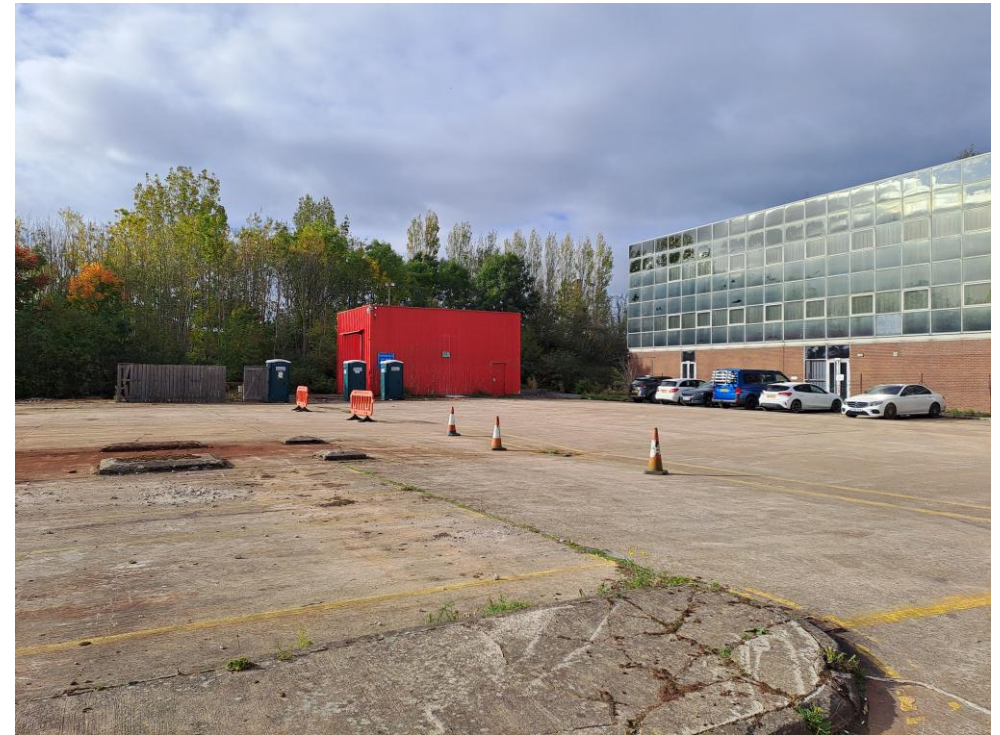
PROJECT NAME	Cleveland House, Yarm Road, Darlington	CLIENT	Earth & Marine Environmental Consultants Ltd
TITLE	Walkover Photo Plan	FIGURE	3
Photo 3: West of main building looking south.		Photo 4: West of main building looking northwest.

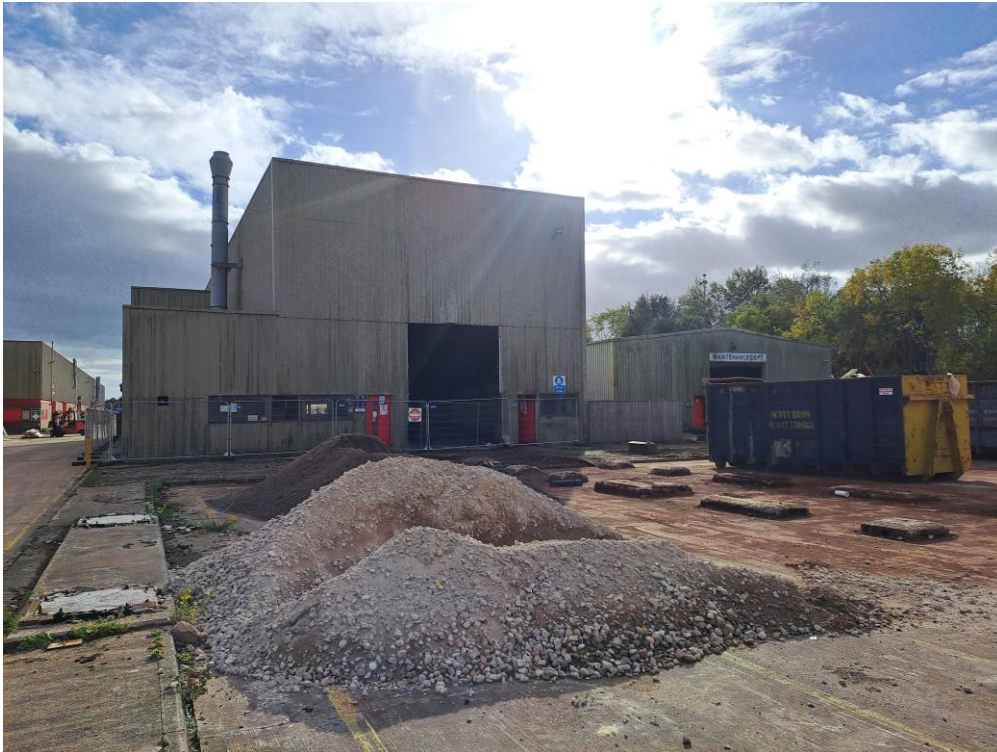
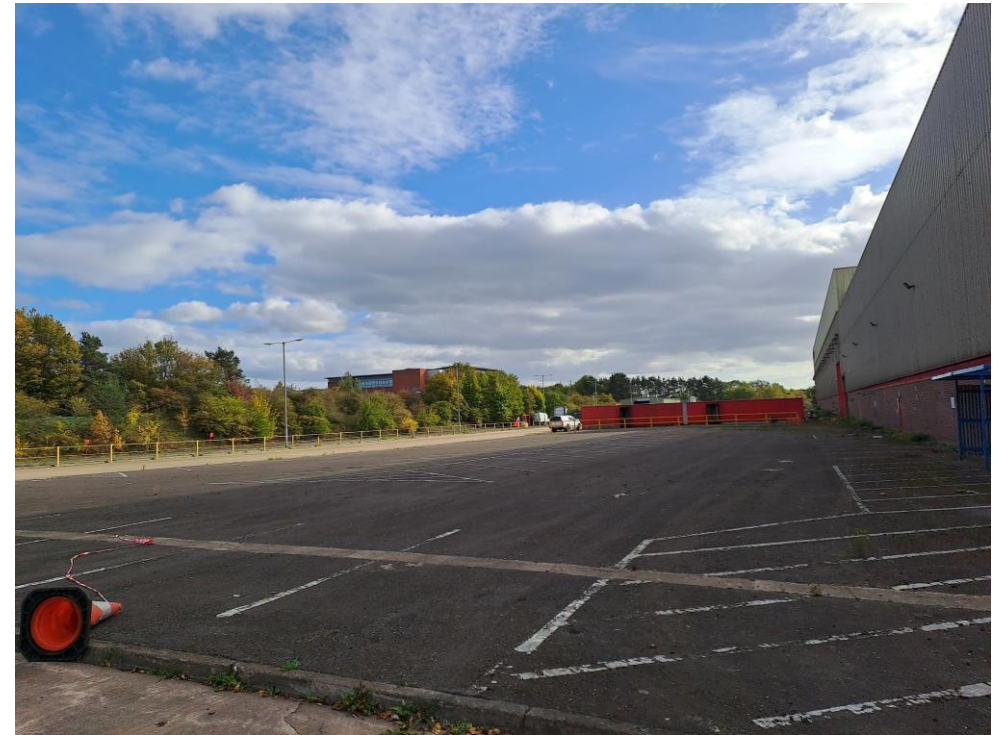
PROJECT NAME	Cleveland House, Yarm Road, Darlington	CLIENT	Earth & Marine Environmental Consultants Ltd
TITLE	Walkover Photo Plan	FIGURE	3
Photo 5: Buildings in the northwest of site, understood to be a former treatment building, and maintenance and plant depot.		Photo 6: Parking area/yard to the east of the main building looking south.

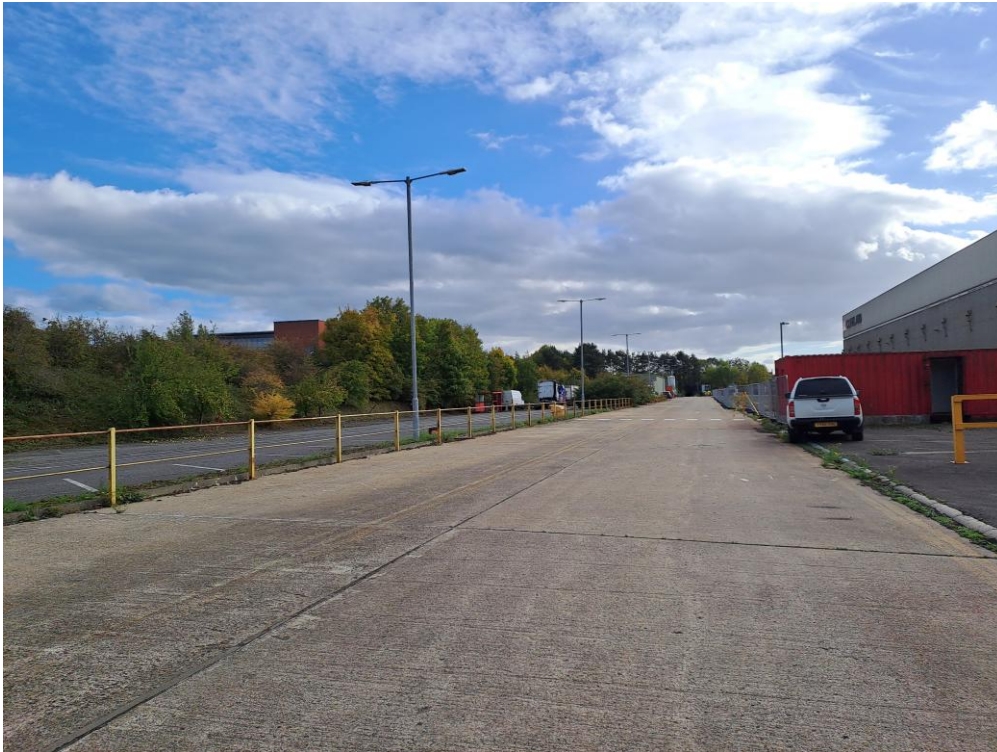
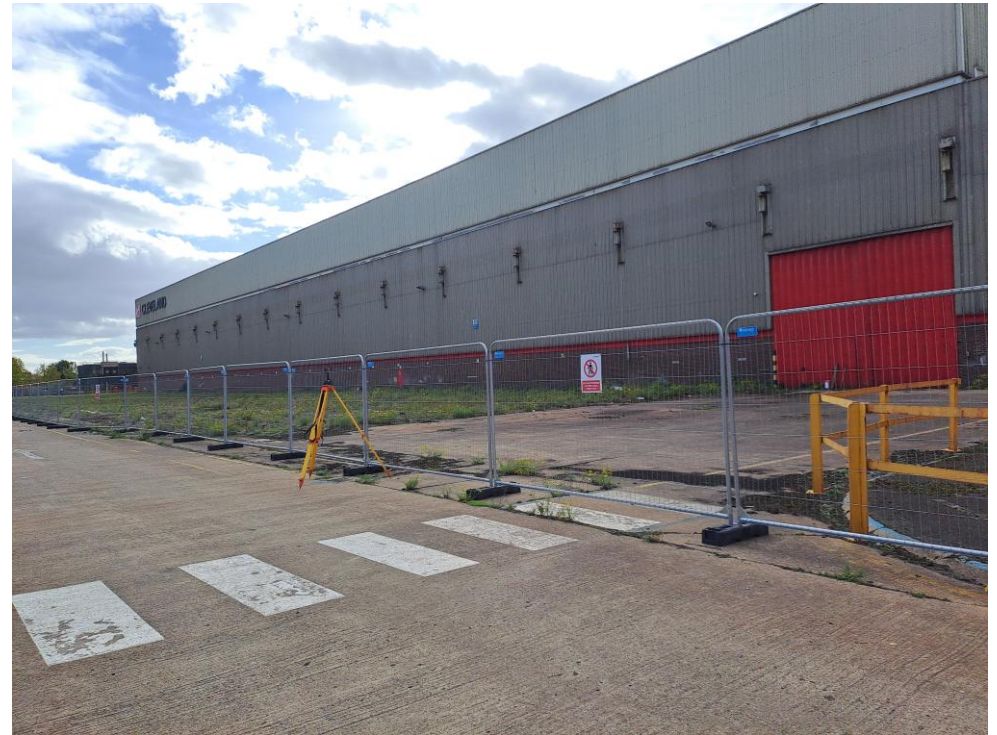
PROJECT NAME	Cleveland House, Yarm Road, Darlington	CLIENT	Earth & Marine Environmental Consultants Ltd
TITLE	Walkover Photo Plan	FIGURE	3
Photo 7: Roadway to the east of the main building looking south.		Photo 8: Fenced area directly adjacent to the east of the main building.

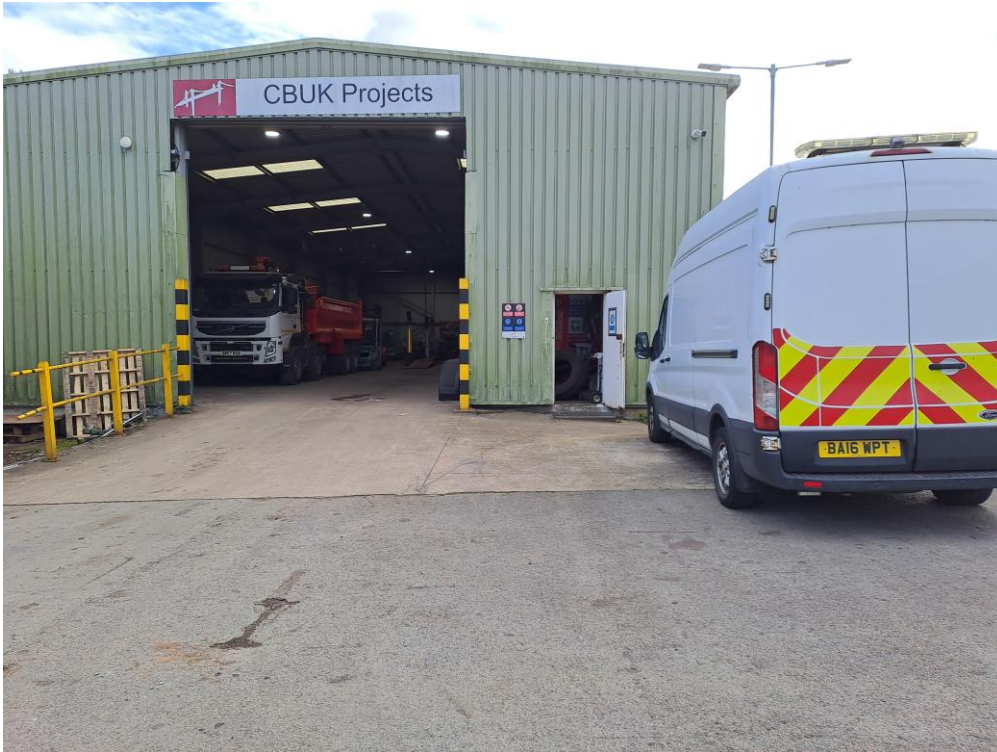
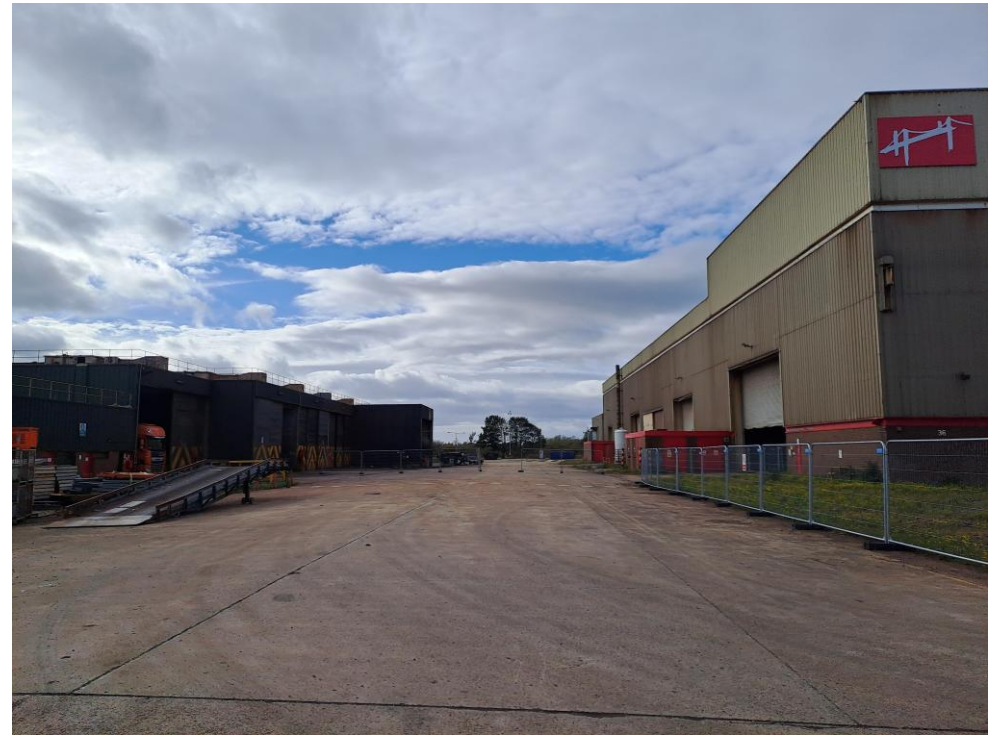
PROJECT NAME	Cleveland House, Yarm Road, Darlington	CLIENT	Earth & Marine Environmental Consultants Ltd
TITLE	Walkover Photo Plan	FIGURE	3
Photo 9: Temporary vehicle maintenance building in the southeast of site.		Photo 10: Southeast of main building looking west

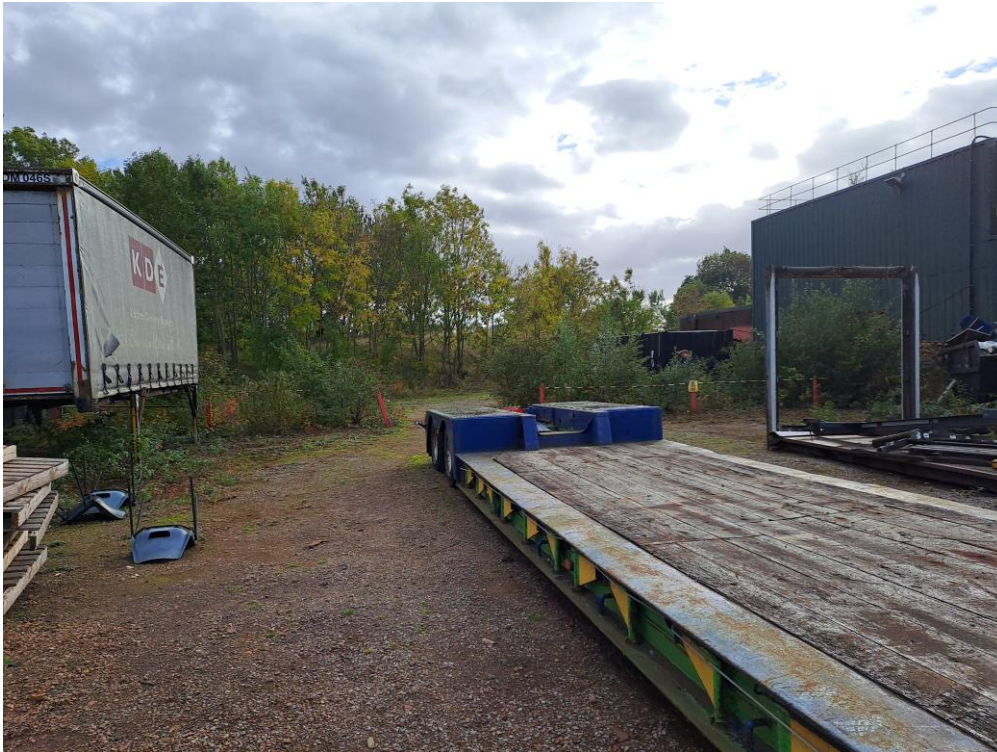
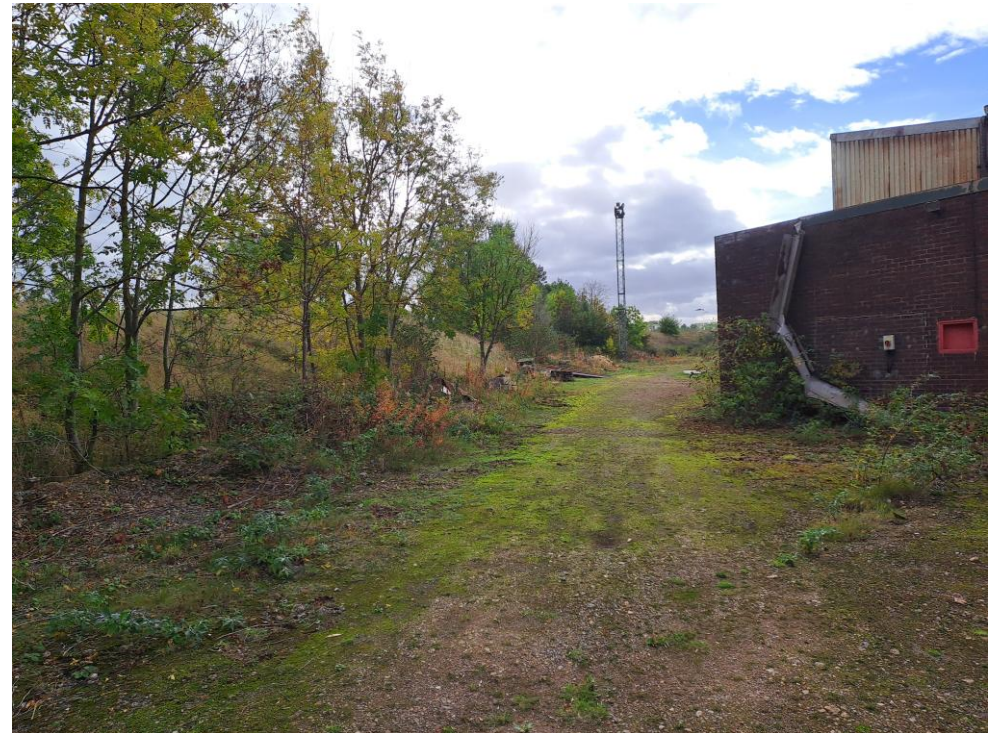
PROJECT NAME	Cleveland House, Yarm Road, Darlington	CLIENT	Earth & Marine Environmental Consultants Ltd
TITLE	Walkover Photo Plan	FIGURE	3
Photo 11: Southeast of the main building looking south.		Photo 12: Roadway/path in the southeast of site.

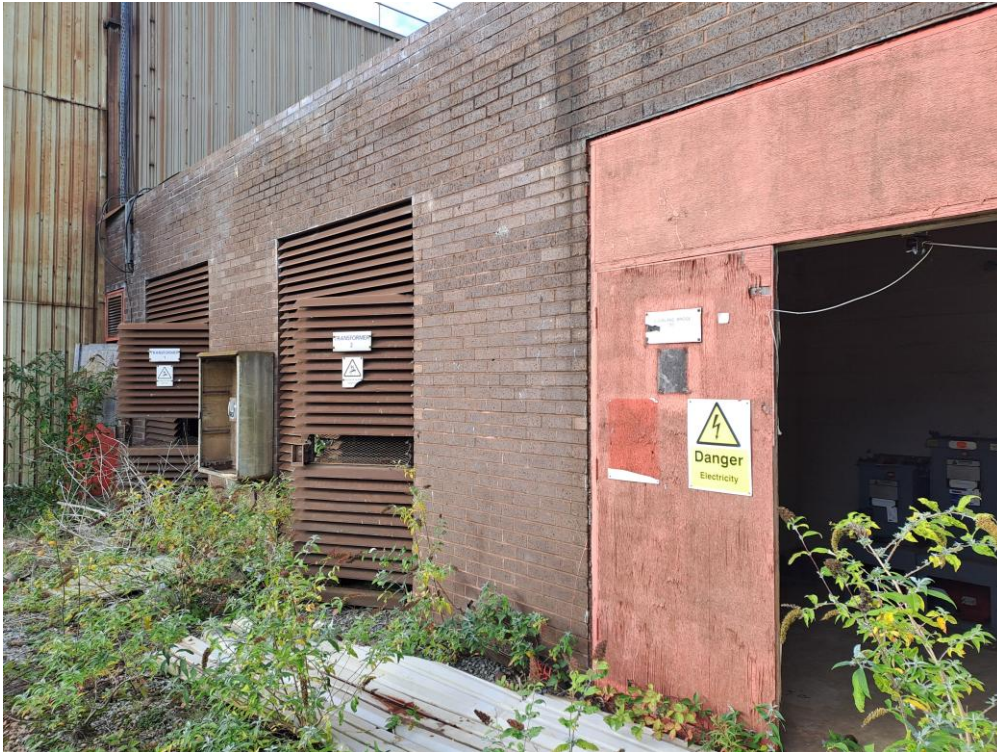
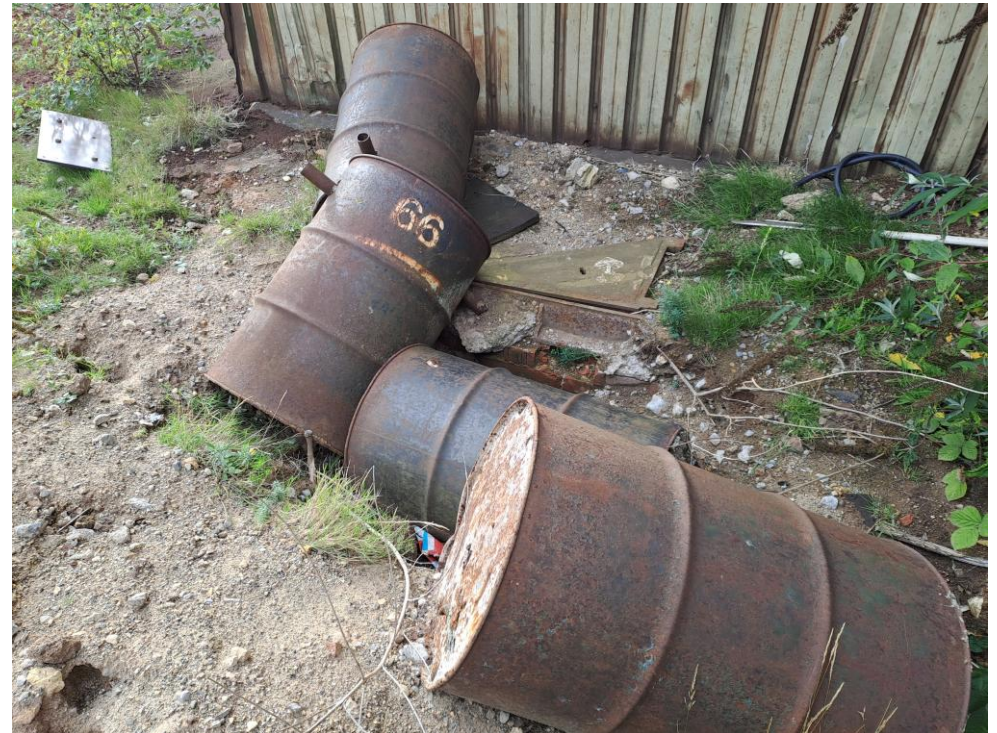
PROJECT NAME	Cleveland House, Yarm Road, Darlington	CLIENT	Earth & Marine Environmental Consultants Ltd
TITLE	Walkover Photo Plan	FIGURE	3
Photo 13: Former plant room adjacent to the south of the former painting buildings in the southeast of site.		Photo 14: Barrels to the south of the painting buildings.

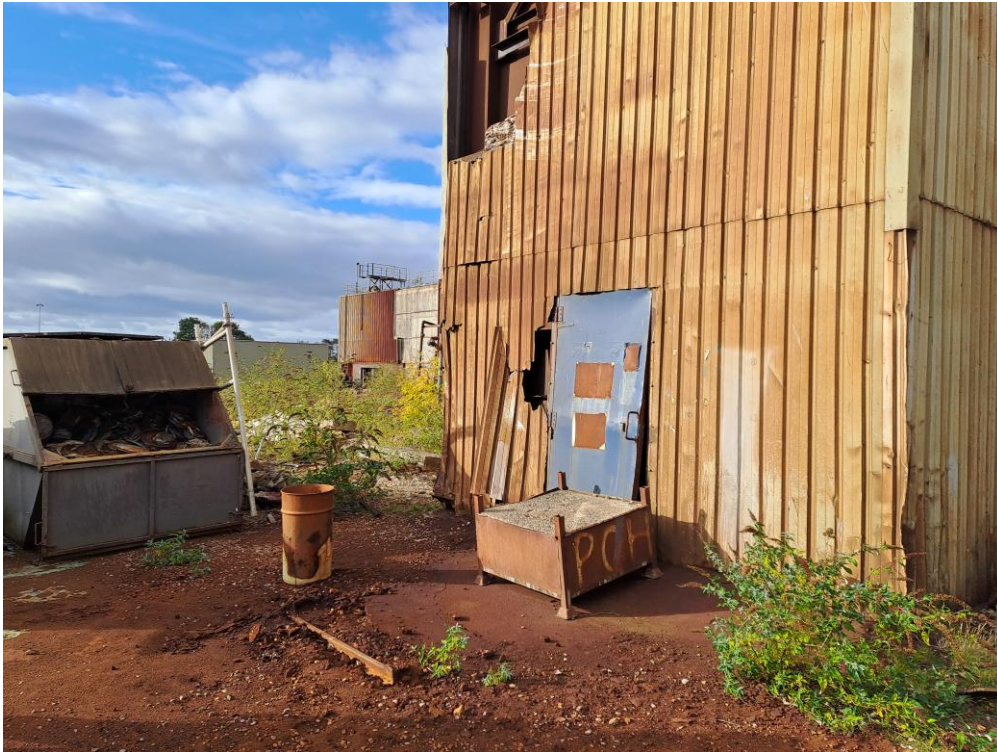
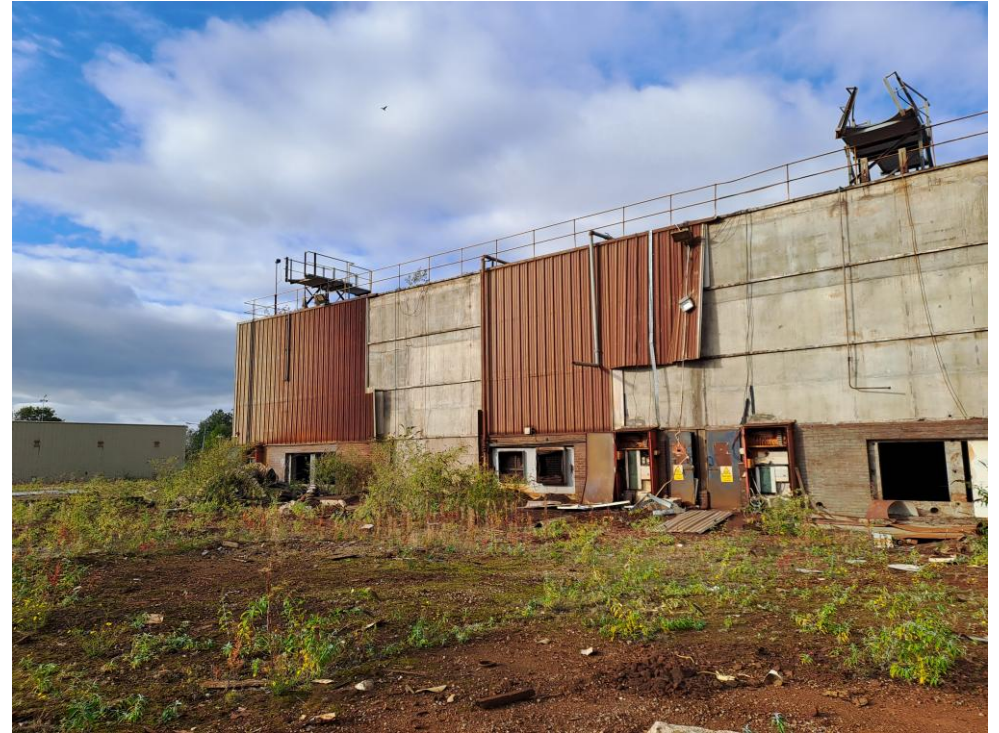
PROJECT NAME	Cleveland House, Yarm Road, Darlington	CLIENT	Earth & Marine Environmental Consultants Ltd
TITLE	Walkover Photo Plan	FIGURE	3
Photo 15: Brown staining and metal debris on ground surface to the south of paint workshop.		Photo 16: Another image of brown staining and metal debris on ground surface to the south of paint workshop.

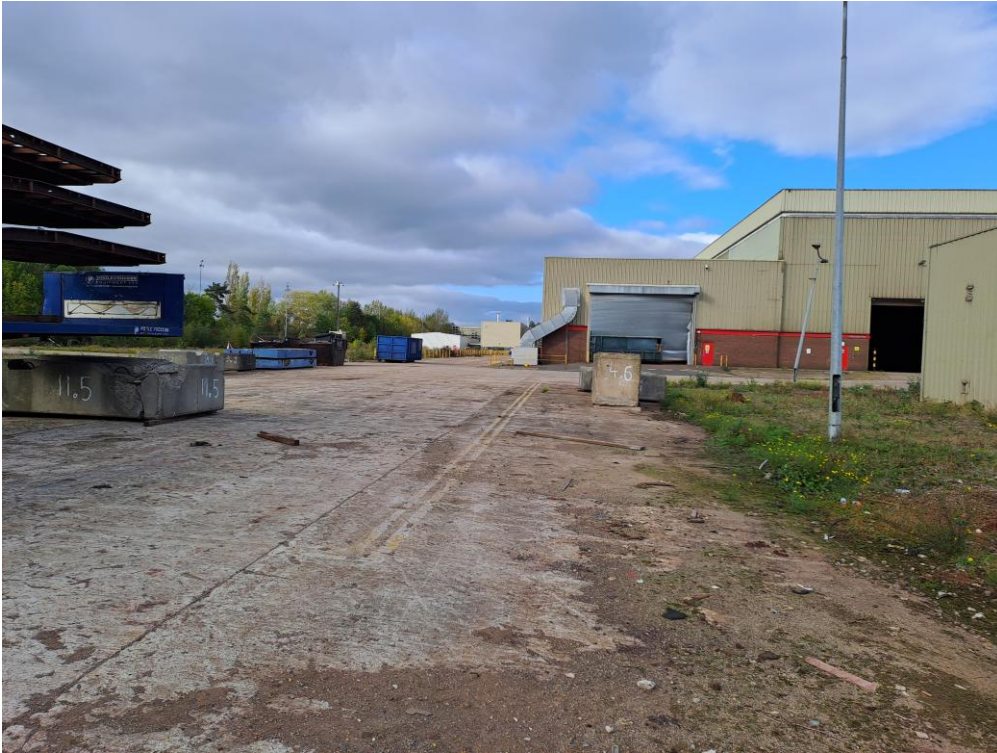
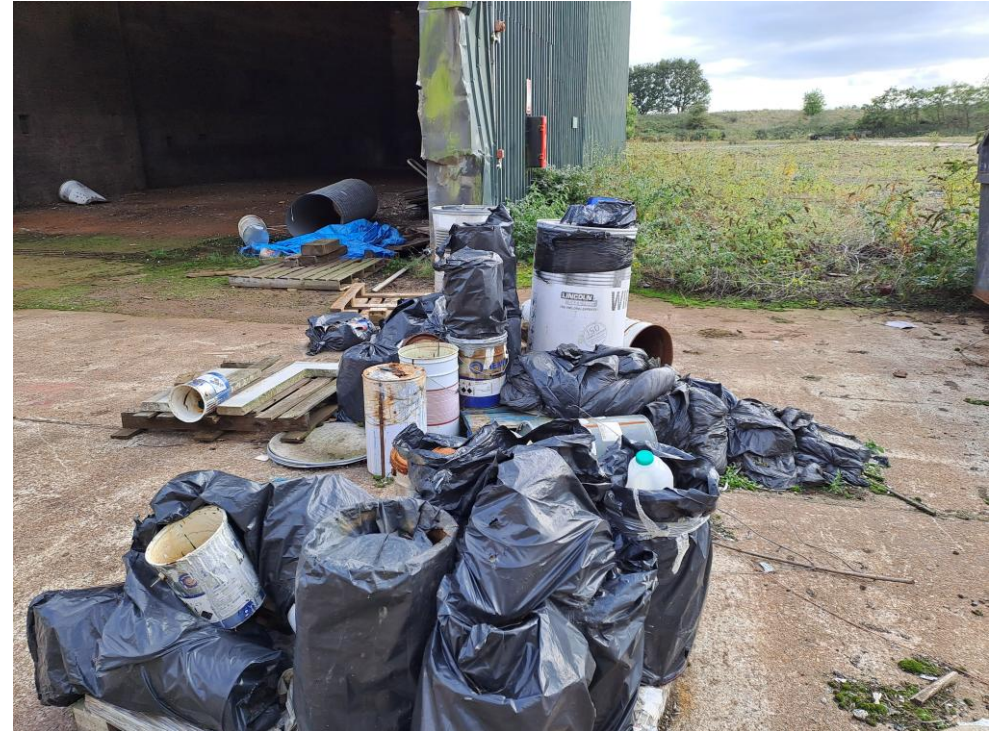
PROJECT NAME	Cleveland House, Yarm Road, Darlington	CLIENT	Earth & Marine Environmental Consultants Ltd
TITLE	Walkover Photo Plan	FIGURE	3
Photo 19: Roadway to the southwest of the main building.		Photo 20: General waste stored by former painting area.

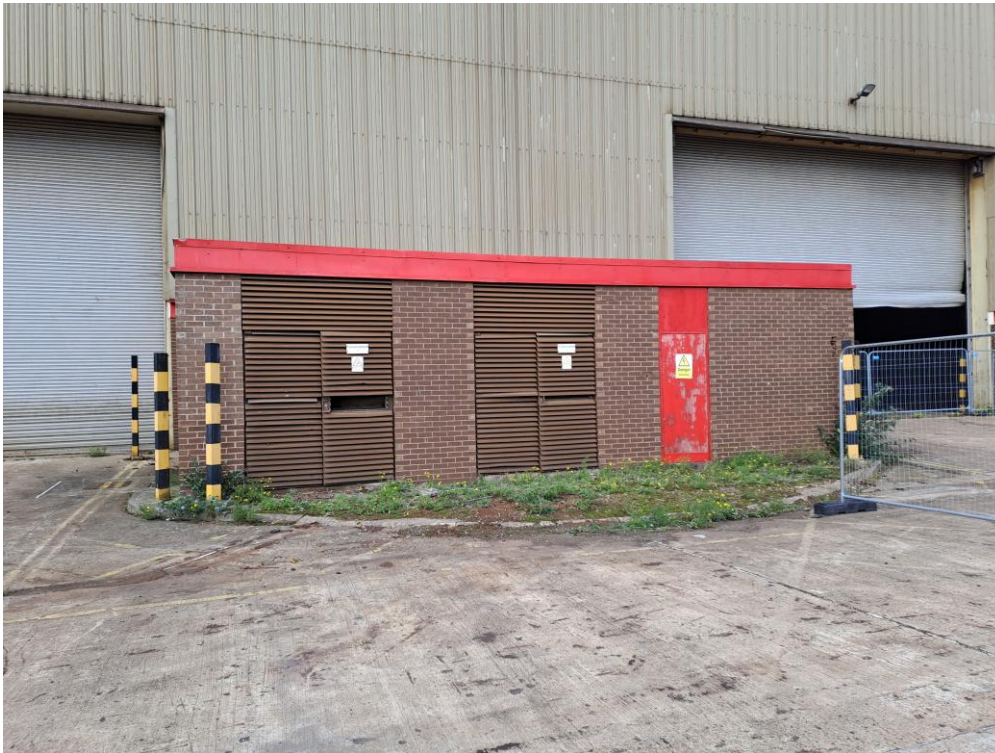
Photo 21: Electrical substation in the centre of site, adjacent to the south of the main building.

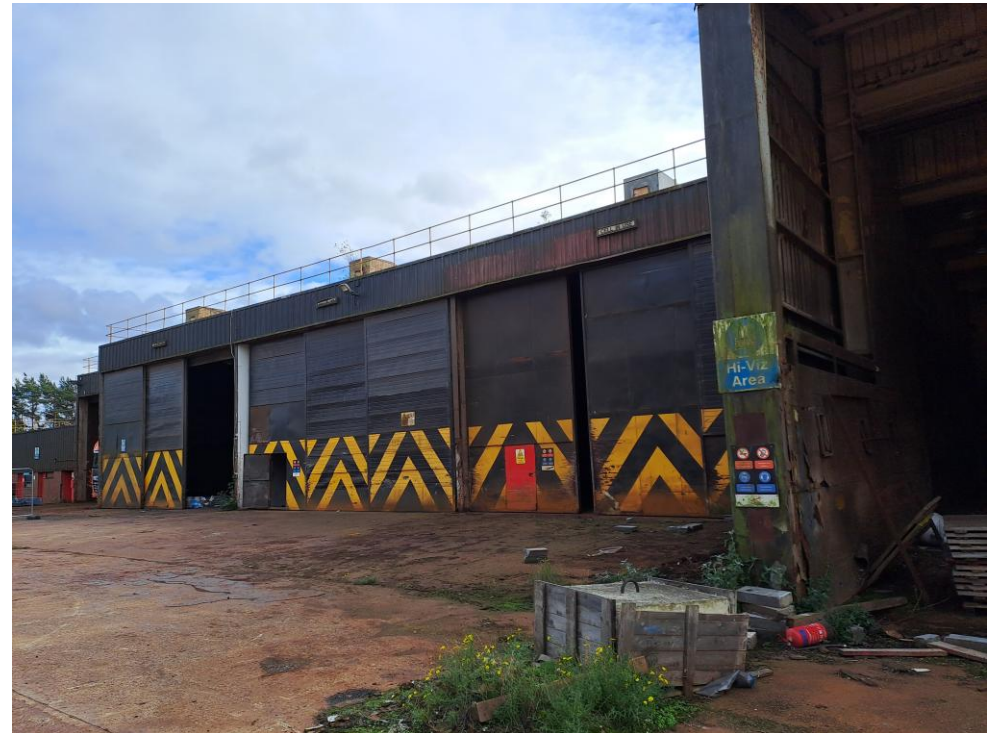
Photo 22: Former paint workshops in the south of the site.

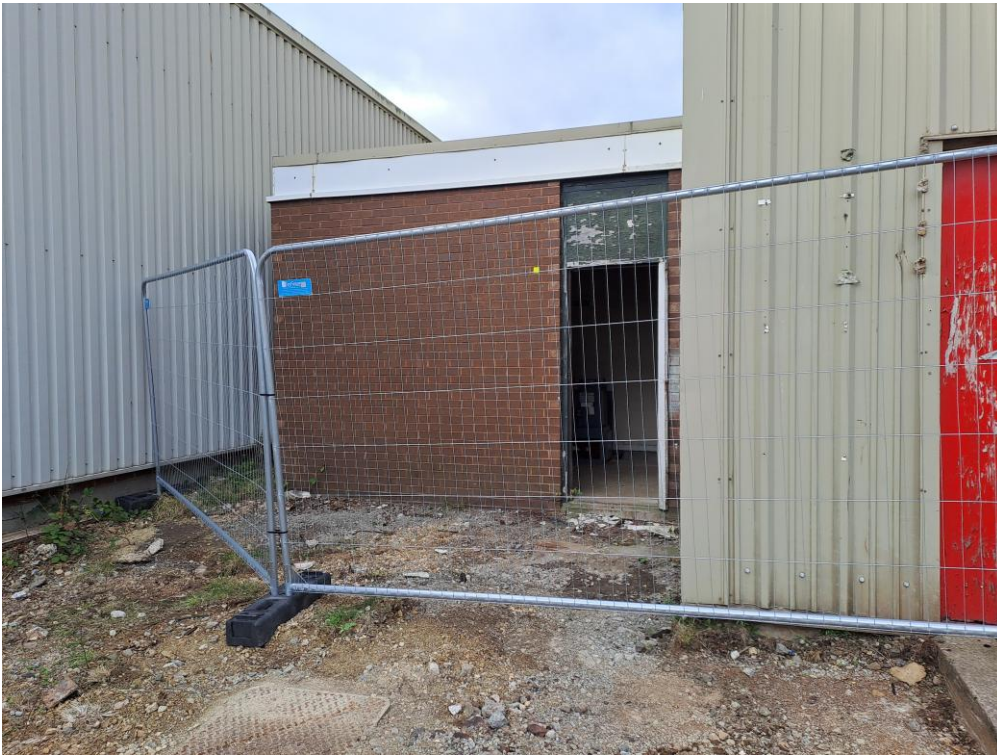
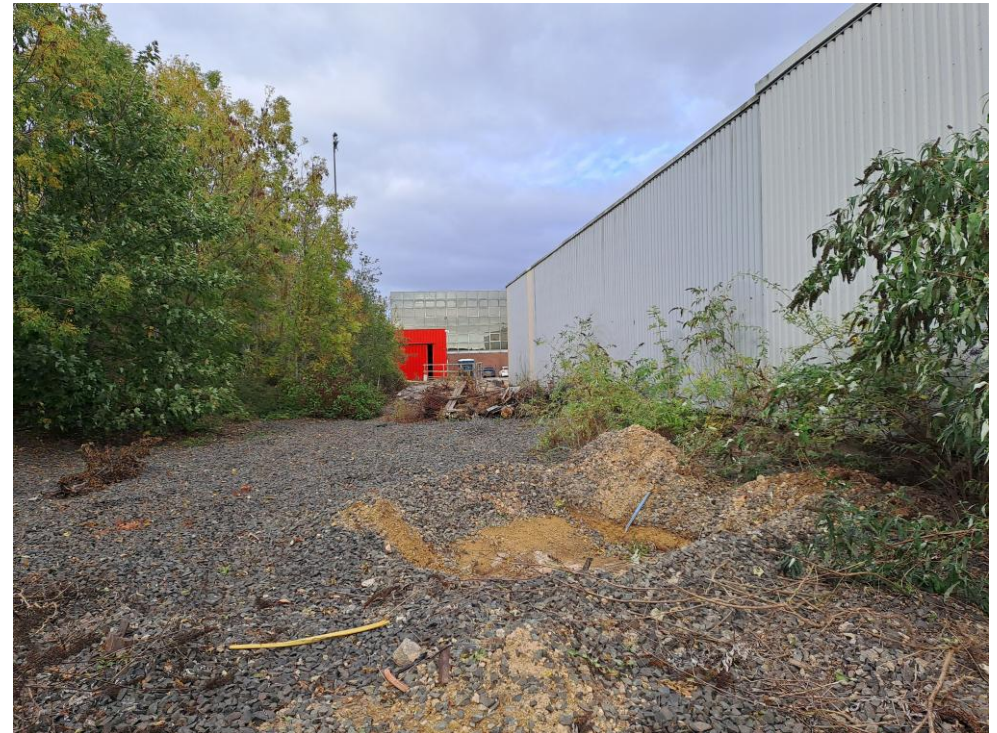
PROJECT NAME	Cleveland House, Yarm Road, Darlington	CLIENT	Earth & Marine Environmental Consultants Ltd
TITLE	Walkover Photo Plan	FIGURE	3
Photo 25: Substation in between the former treatment building and plant and maintenance depot in the northwest of the site.		Photo 26: Area to the west of the plant and maintenance depot, where an above ground fuel tank is understood to have been formerly present.

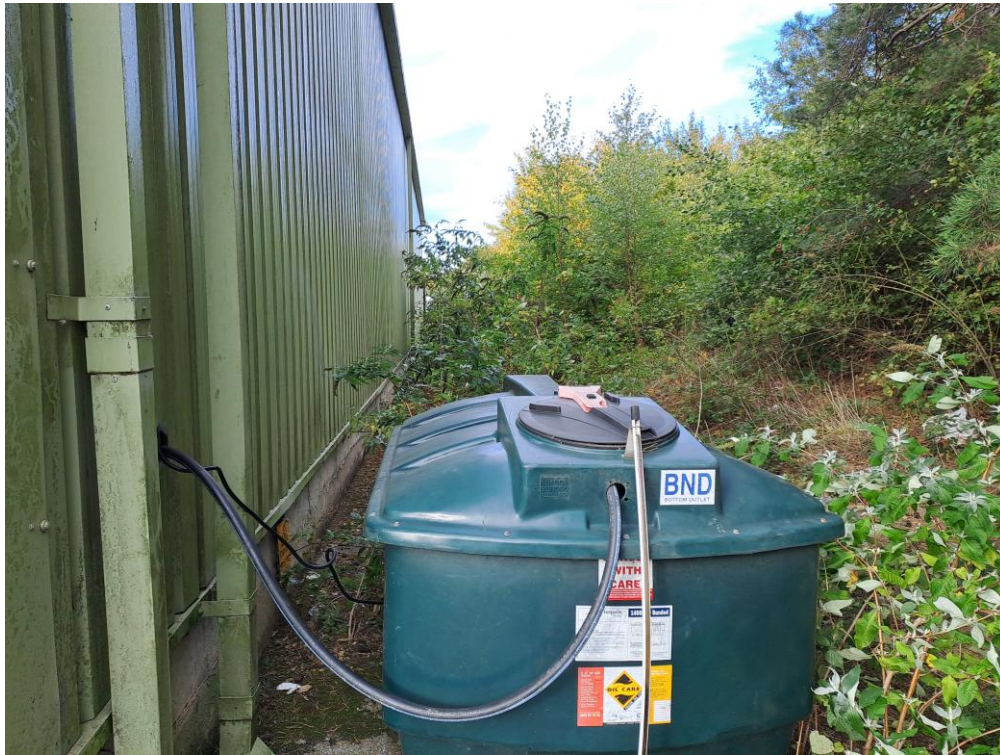
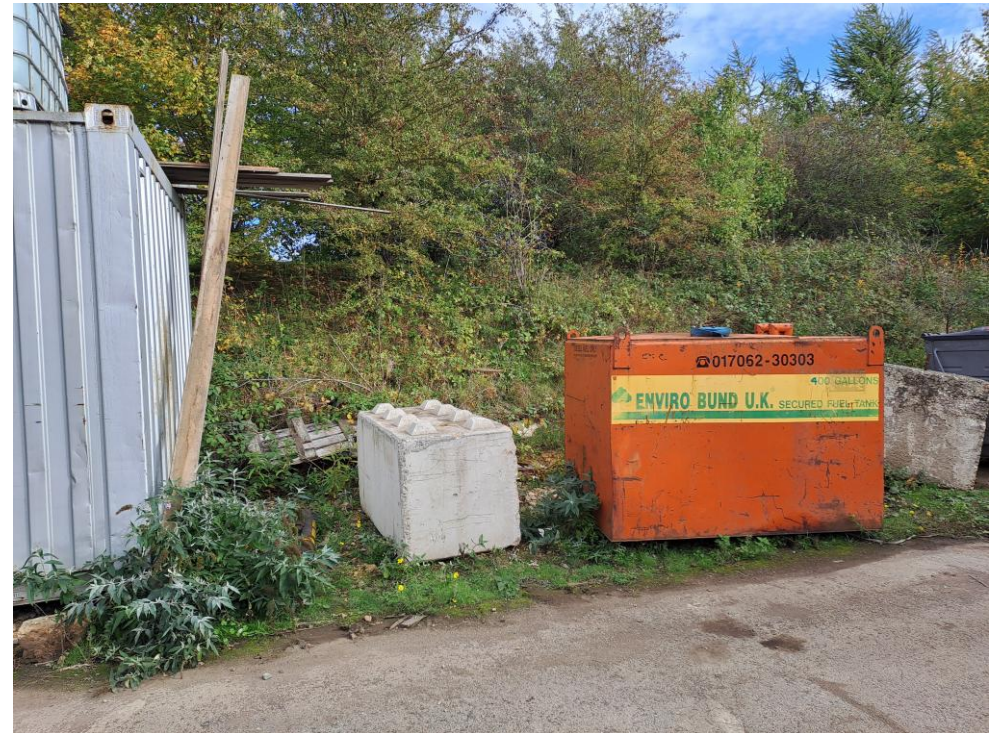
PROJECT NAME	Cleveland House, Yarm Road, Darlington	CLIENT	Earth & Marine Environmental Consultants Ltd
TITLE	Walkover Photo Plan	FIGURE	3
Photo 27: An above ground tank, which appears to be used for storing fuel oil, adjacent to the east of the vehicle maintenance unit in the southeast of site.		Photo 28: An above ground tank, which appears to be used for storing diesel, to the north of the vehicle maintenance unit in the southeast of site.
