Tetron Contracts Ltd
Middleton Quarry, Pollington

**Conceptual Model, Environmental Setting
and Site Design Report**

Job No 163407/ESSD

October 2022

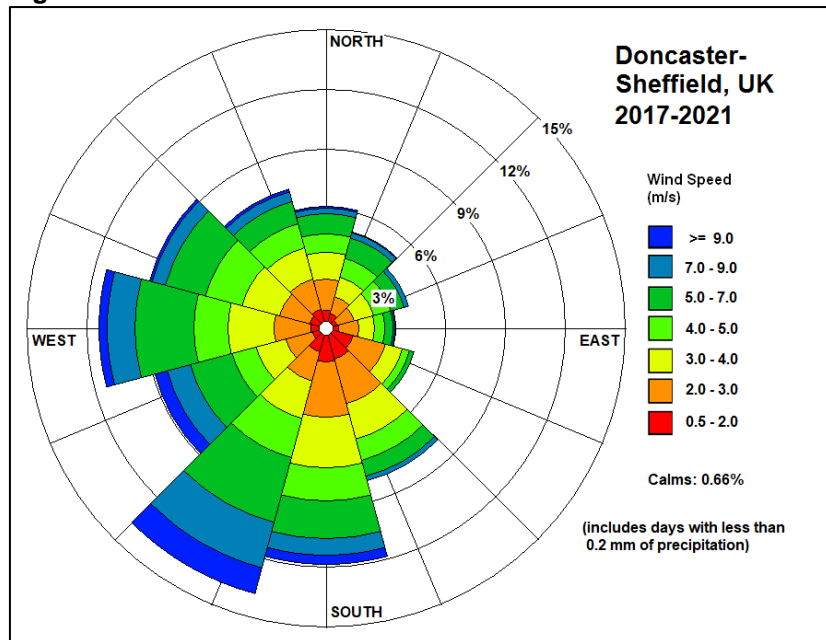
Figure 1. Doncaster - Sheffield Windrose

- 3.1 The operating controls during the restoration are set out in the Dust Emissions Management Plan (163407/DEMP).
- 3.2 Neither the site nor the surrounding land is an Air Quality Management Area (AQMA).
- 3.3 The frequency of exposure and likelihood of any fugitive emissions on sensitive land uses is determined by the magnitude of release, proximity of receptors and prevailing meteorological conditions.
- 3.4 Meteorological wind data for five years, has been acquired from ADM Limited. The wind data has been taken from the Met Office Station in Doncaster-Sheffield, which is approximately 23 km south of the site. The prevailing wind direction is from the west south west. This is considered representative of the conditions at the site.

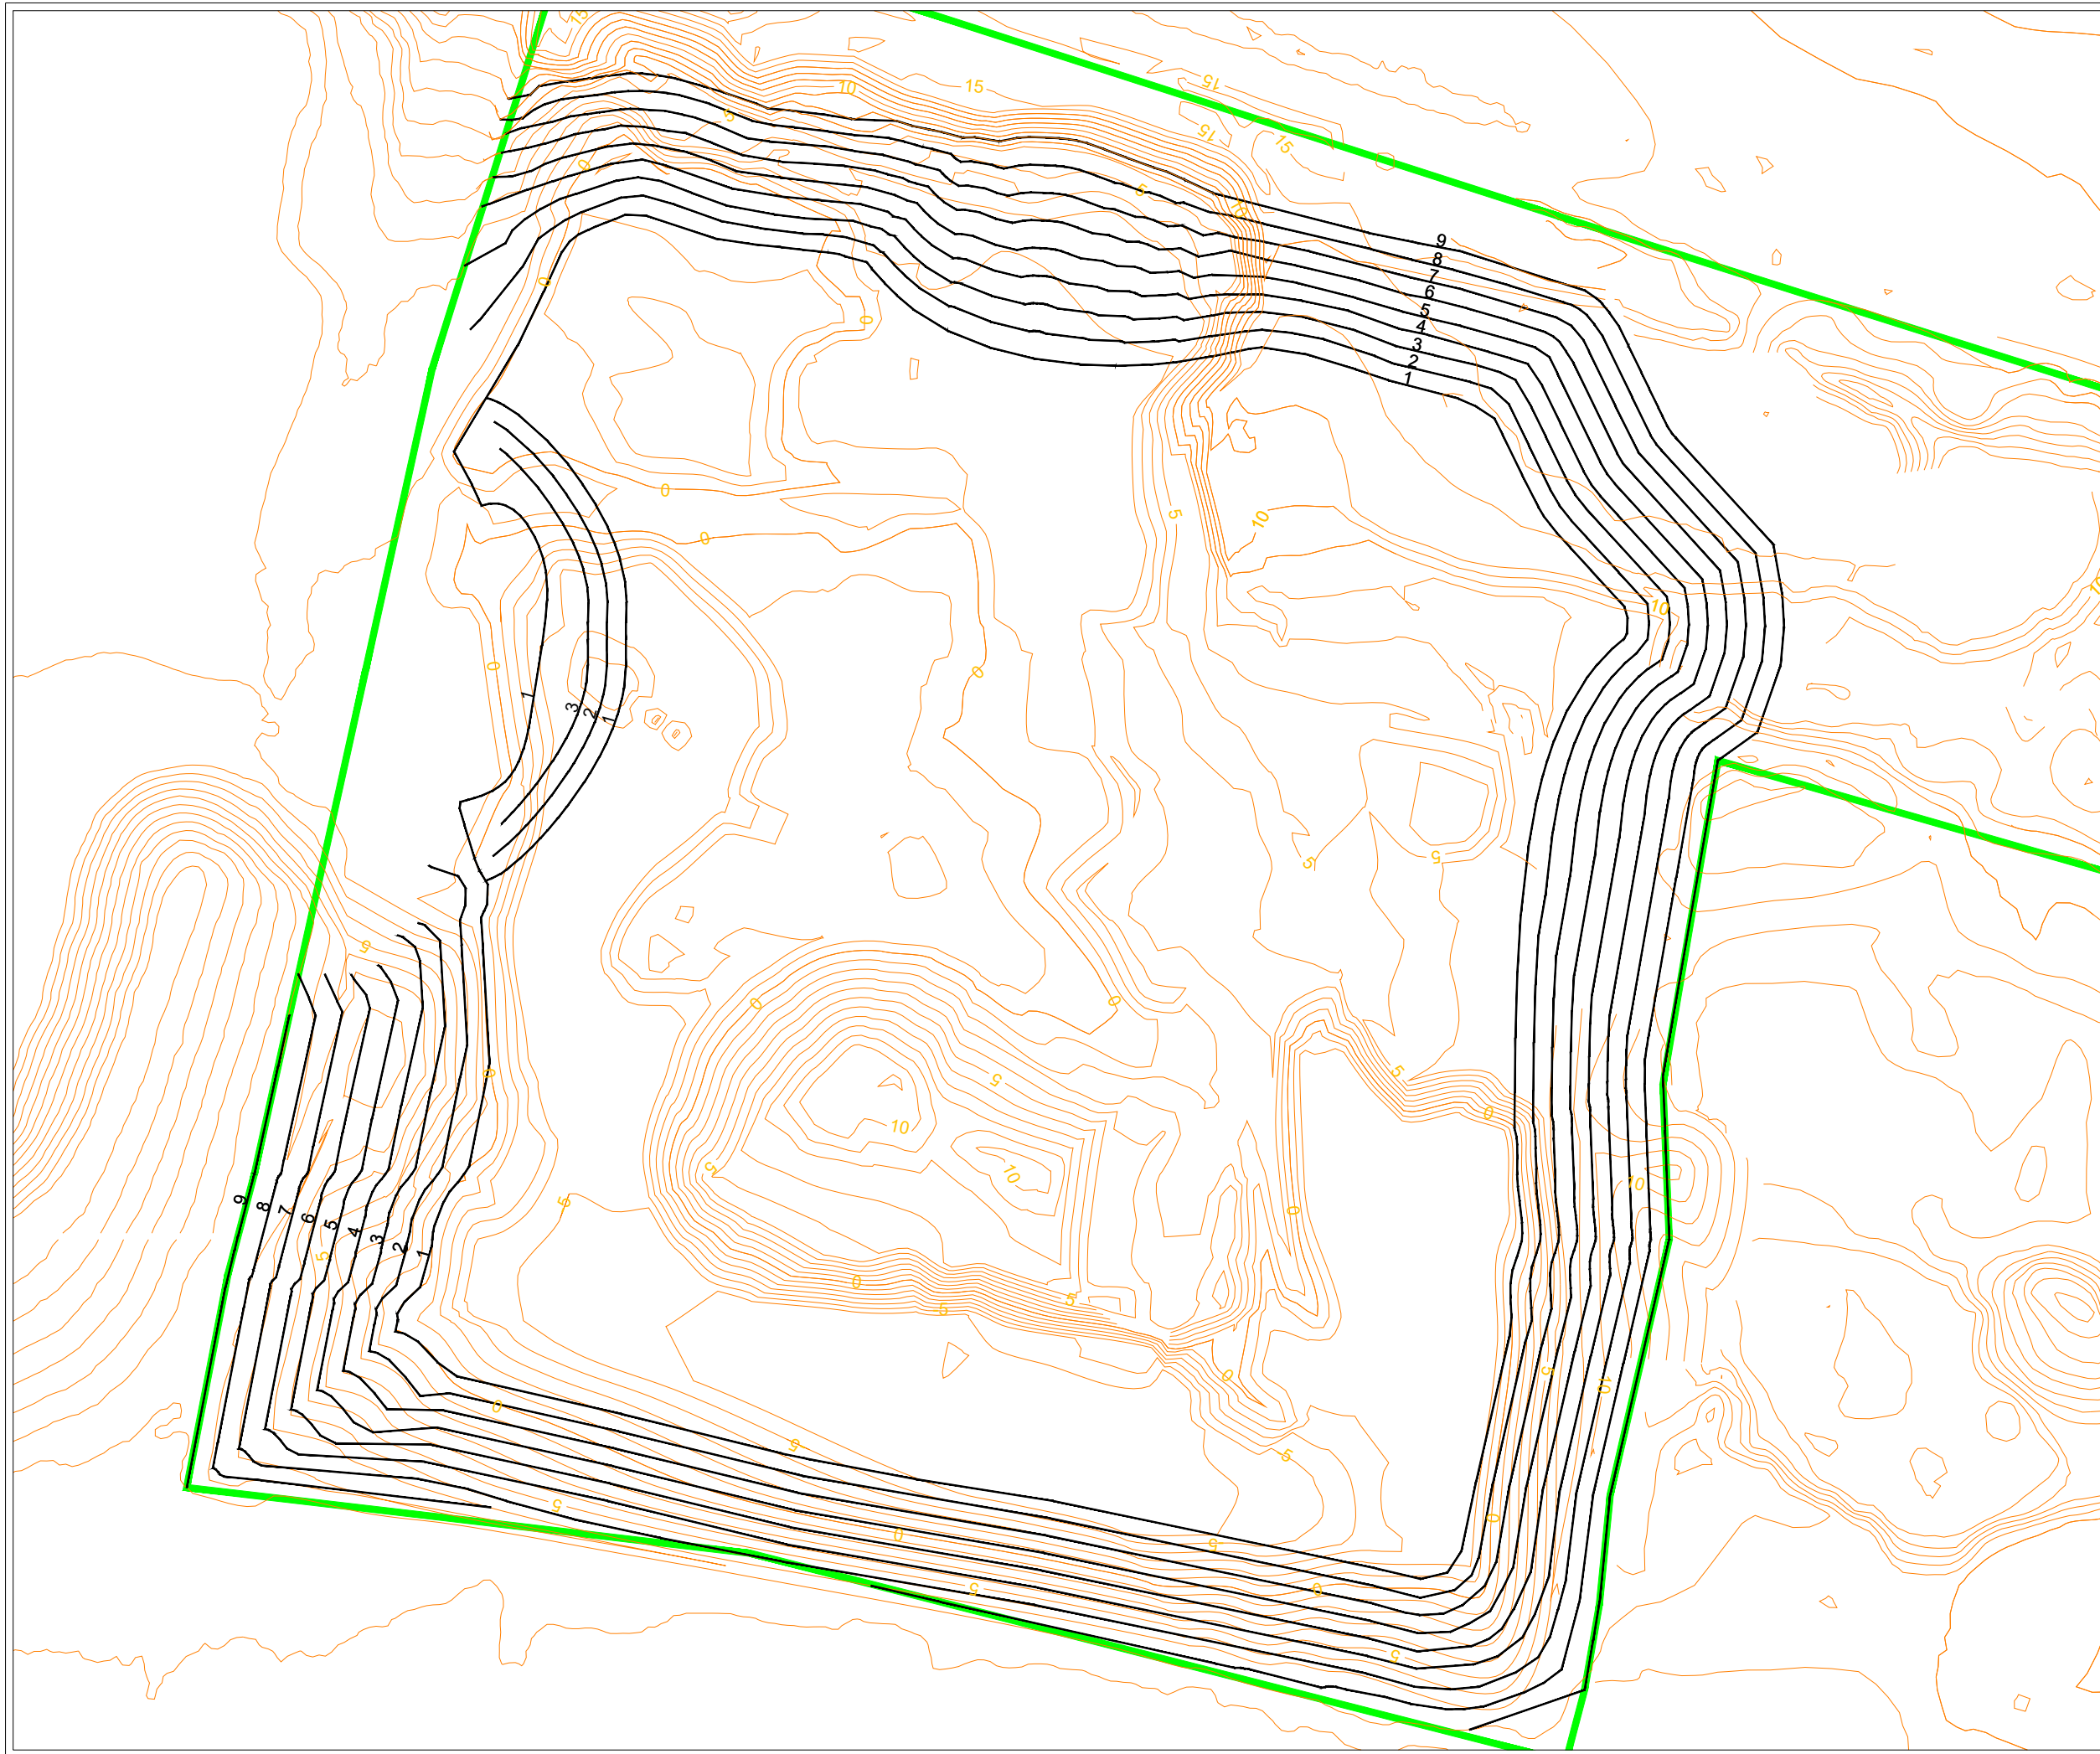
Scale	Date	Dec'22	Drg. No.	Rev.
1:1,000@A3	Drawn	Chkd.	163407/D/004	
	KW	EB

Key:
— Permit Boundary
— Existing Contours (m AOD)
— Geological Separation Layer Contours (m AOD)

- 1.2 The site location plan is shown on drawing 163407/D/001. Plans showing the site in relation to surrounding land uses, cultural and natural heritage, and sensitive receptors are shown on 163407/D/002, 163407/ESSD/D/001 and 002. The topography of the existing quarry void is shown on 163407/D/004.

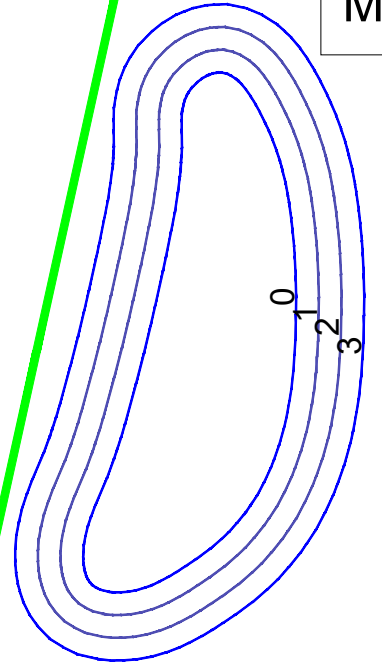
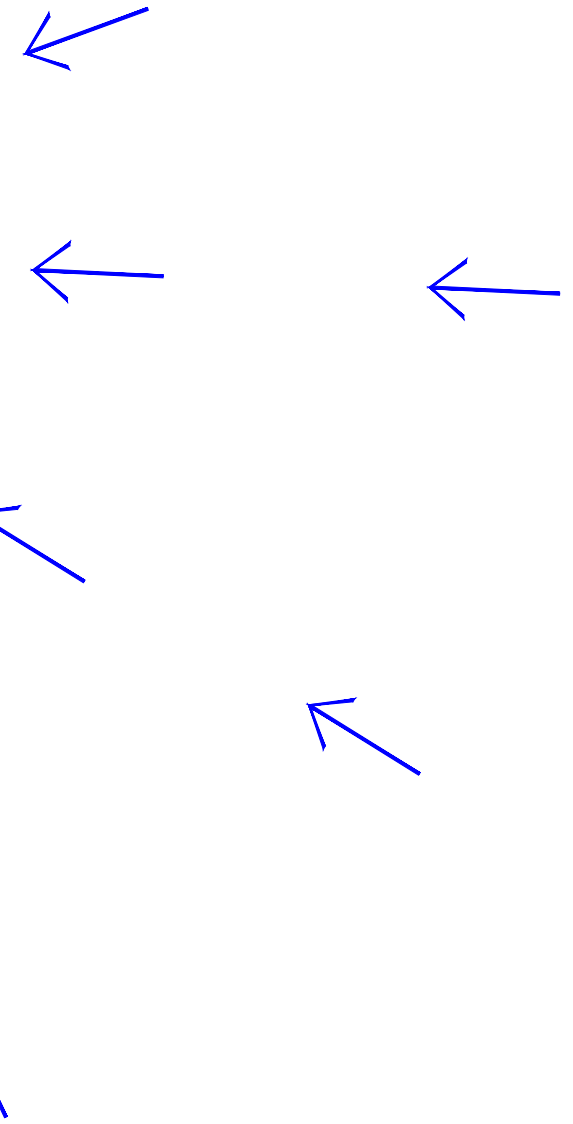
Scale	Date	Jan'22	Drg. No.	Rev.
1:1,000@A3	Drawn	KW	Chkd. EB	163407/D/008

Overland Flow

Impermeable Area: 6.4 ha (64,000 m²)
 Infiltration Rate: 1.09x 10⁻⁵ m/s
 1:100 year + 40% cc Rainfall Event
 Top of Bank: 3.0 m AOD
 Bottom of Bank - 0.0 m AOD
 TWL: 2.70 m AOD (100 y+cc)
 Max Volume: 5100 m³

- 2.6 A plan and cross-sectional diagrams of the existing topography on site are shown on 163407/D/005 and 163407/CS/D/001 and 003.
- 2.7 The proposed revised restoration levels has consequences on the approved drainage design therefore this has been updated and is presented in drawing 163407/D/008.

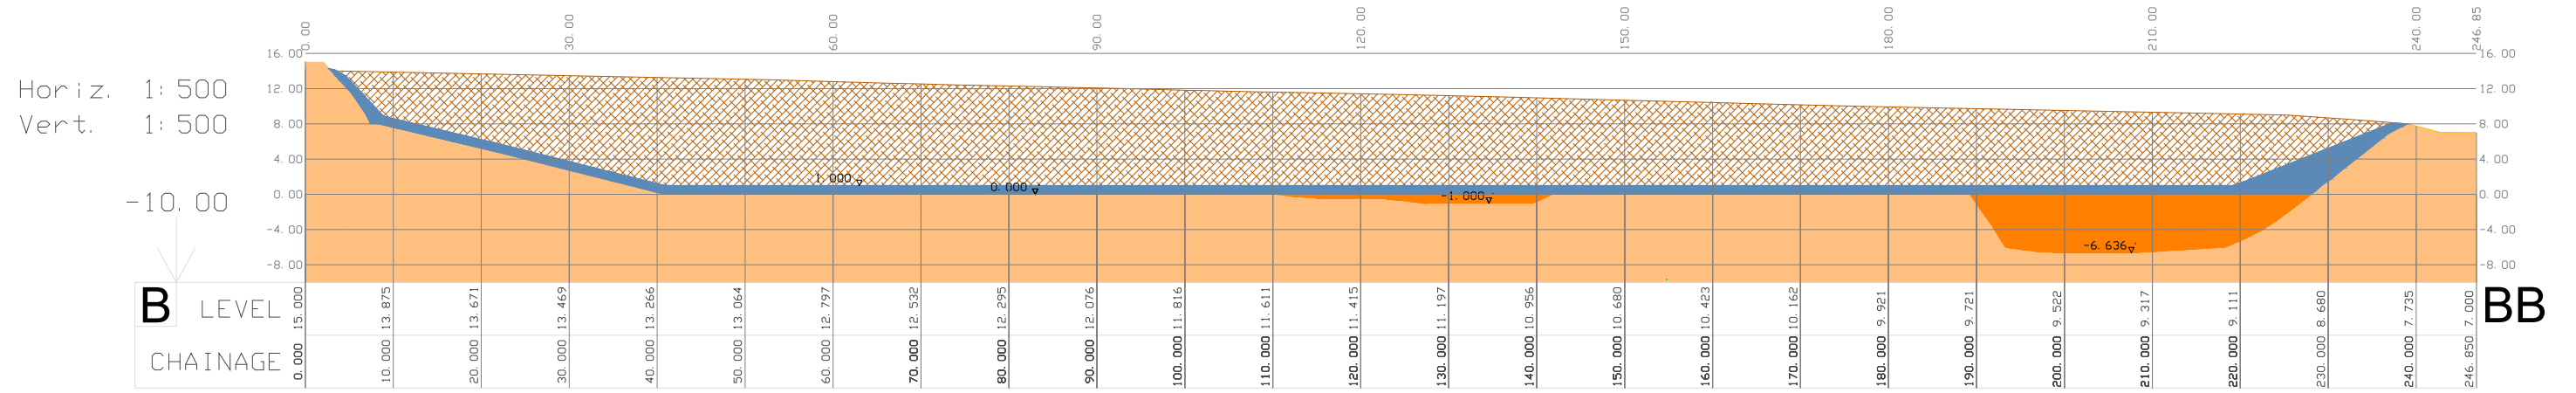
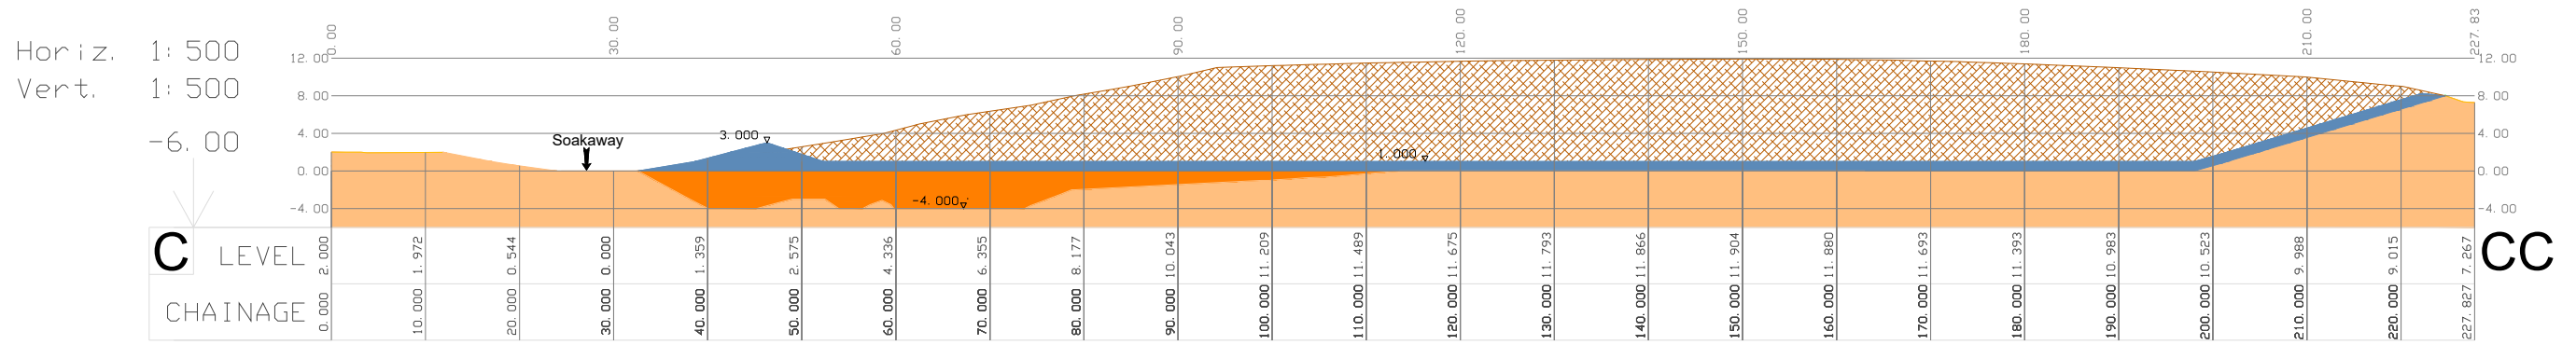
- Key:**
- Sandstone
 - Clean Fill Material
 - Geological Separation Layer
 - Inert Waste

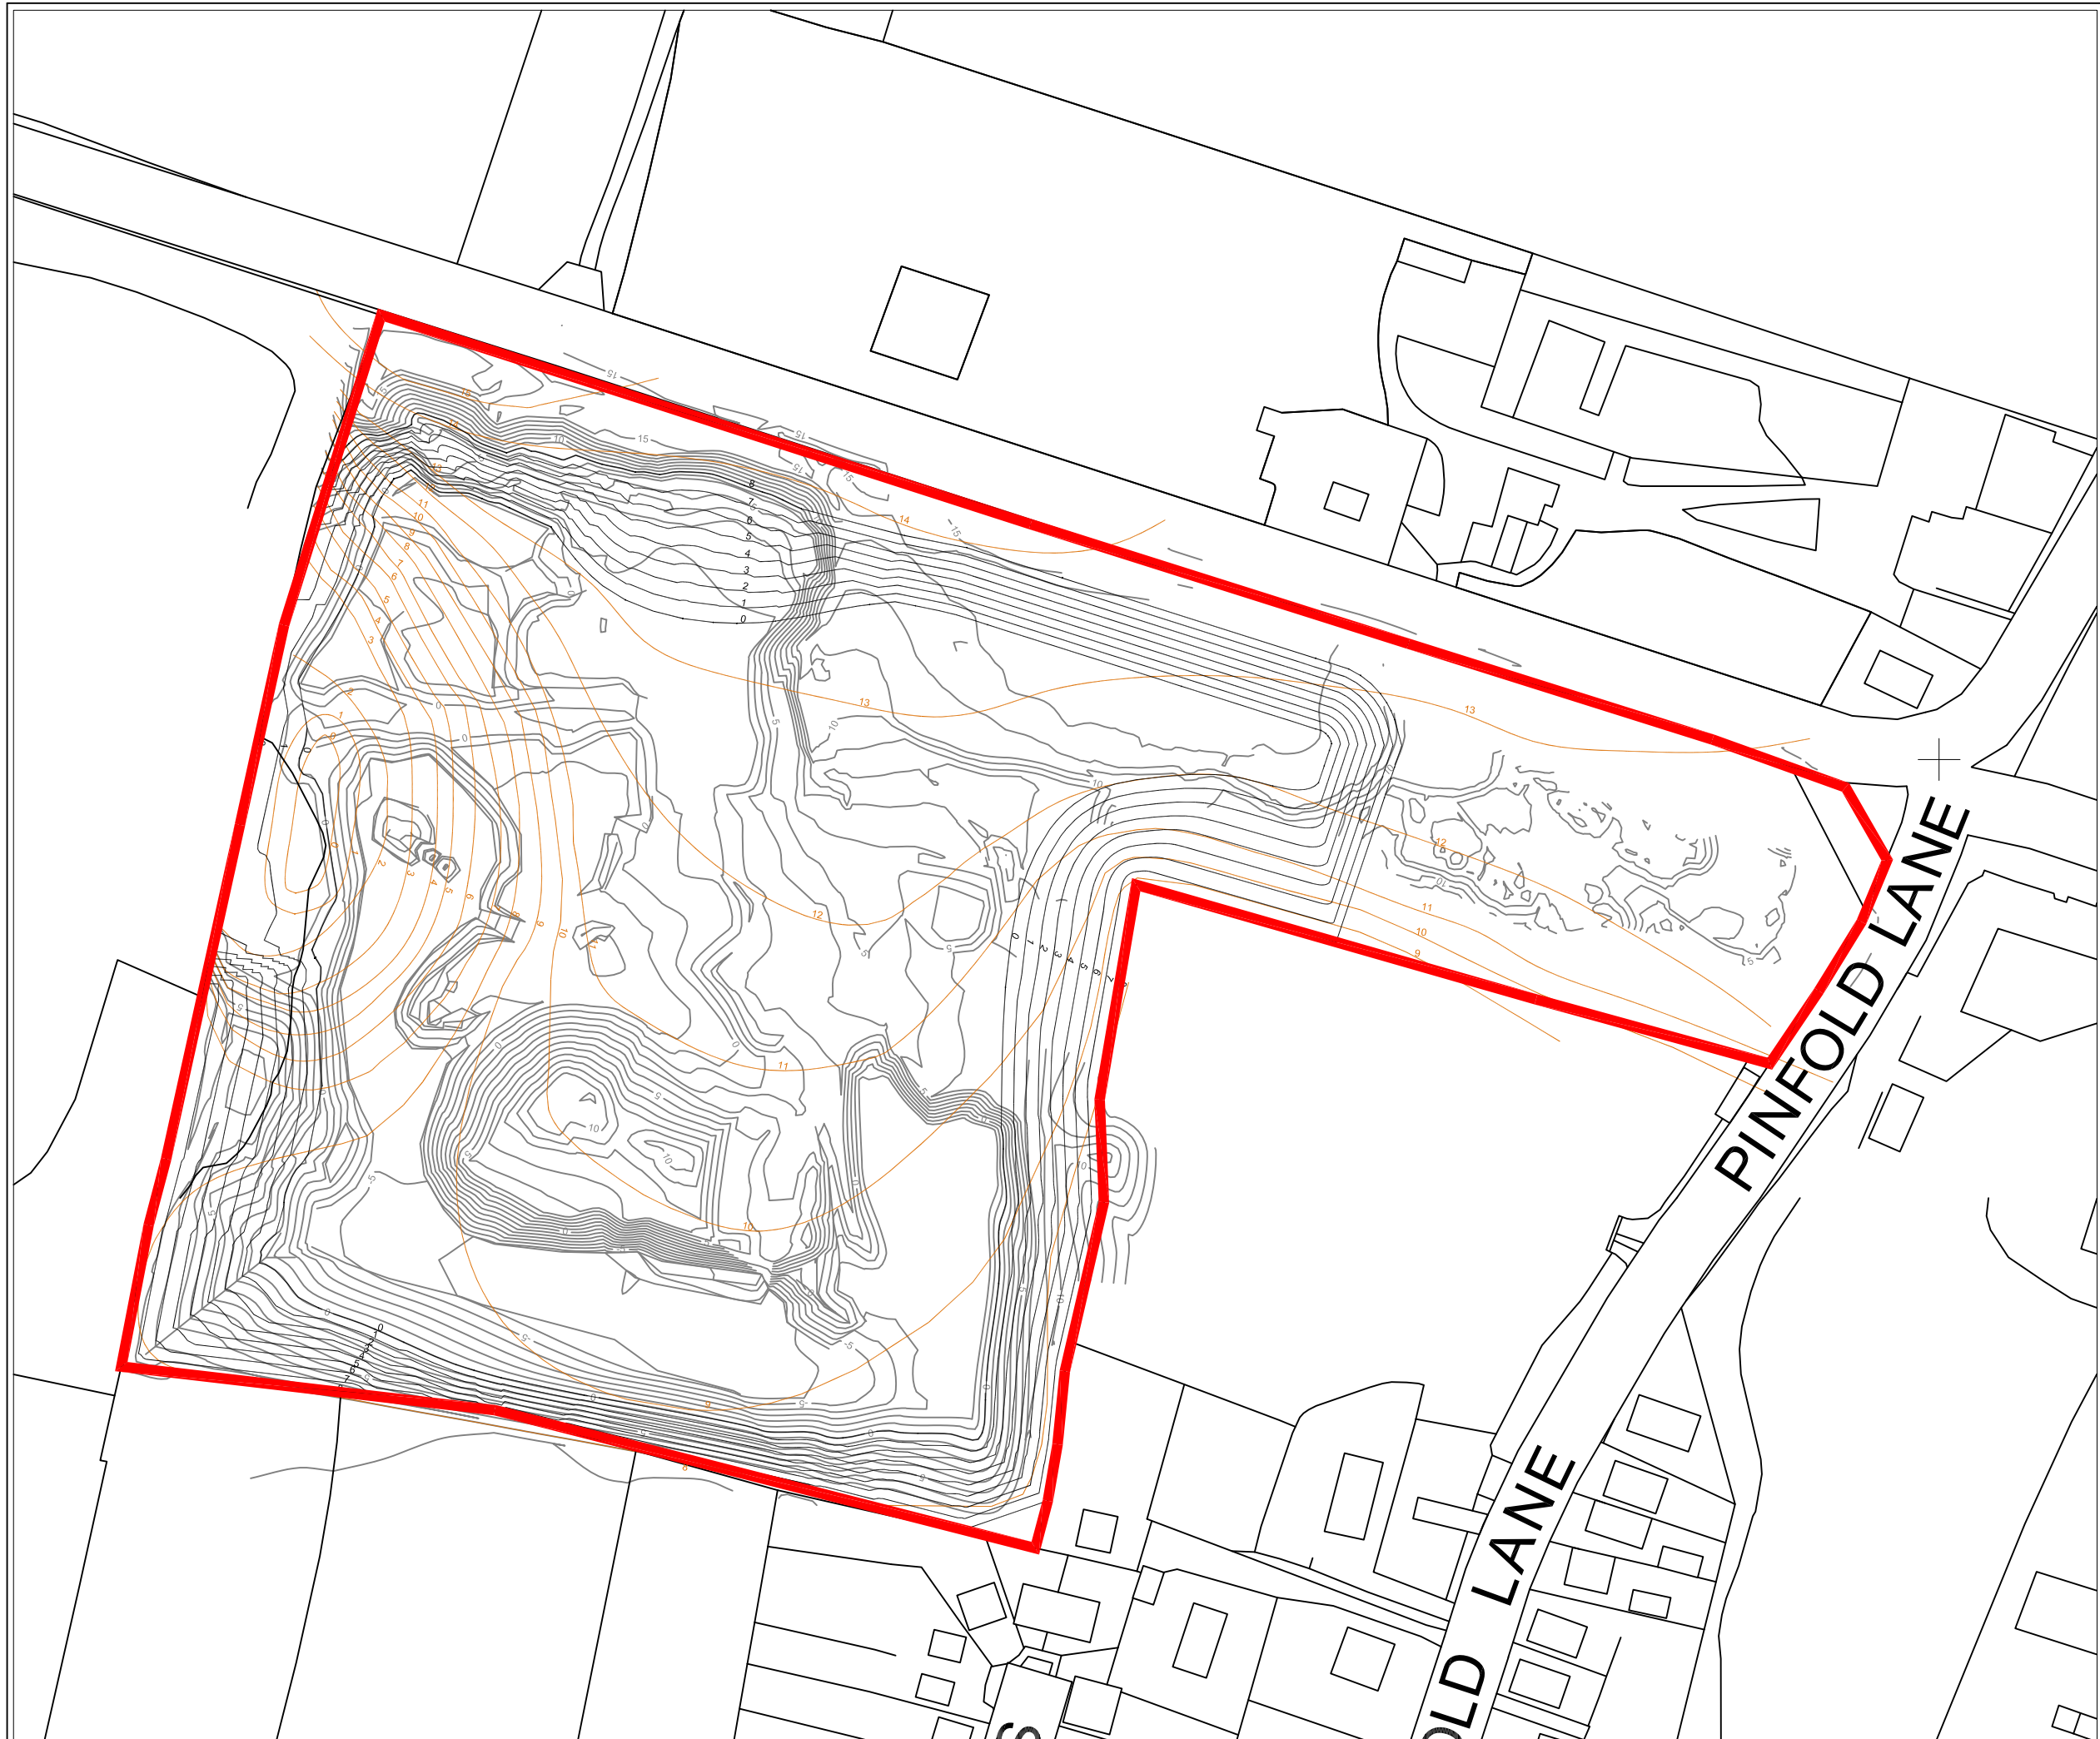
- Key:**
- Site Boundary
 - Existing contours (m AOD)
 - Proposed excavation contours (m AOD)
 - Proposed restoration contours (m AOD)

- Notes:**
1. The area within the site boundary is circa 6.4 ha.
 2. The proposed excavation volume between 0 to 8 m AOD is circa 148,530 m³.

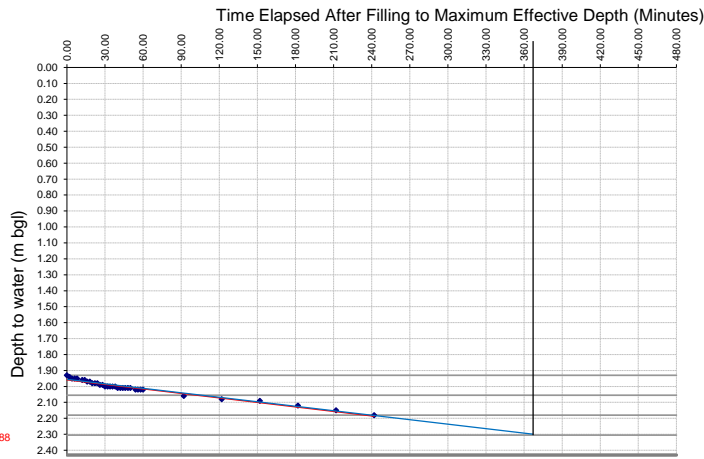
Soakaway SA01 (Test 1)

Trial Pit Dimensions (m)

100% Full (Maximum Effective Depth)
 75% Full
 50% Half-Full
 25% Full (Refill Level)
 0% Full (Base of Pit - Empty)

Parameter	Formula	Result	Unit
Volume outflowing between 75% and 25% effective depth	Vp75-25	1.85	m³
The mean surface area through which outflow occurs, taken to be the trial pit sides to 50% effective depth and including the base of the trial pit	ap50	10.25	m²
The recorded time for the outflow between 75% and 25% effective depth	tp75-25	276.00	minutes
Soil Infiltration Rate	$(Vp75-25 \div (ap50 \times (tp75-25 \times 60)))$	0.000109	metres/second

In order to obtain an estimated infiltration rate for the first soakaway test, the data has been extrapolated from 242 minutes to 368 minutes (recorded in blue) where it is anticipated that the 25% refill level would be achieved. The extrapolation results recorded a soil infiltration rate of 1.09×10^{-5} metres/second.

- 2.7 The underlying bedrock geology was identified during site investigation and soakage tests undertaken. The infiltration rate was measured between 1.09×10^{-5} and 2.13×10^{-5} m/s. The tests are shown in Appendix C.

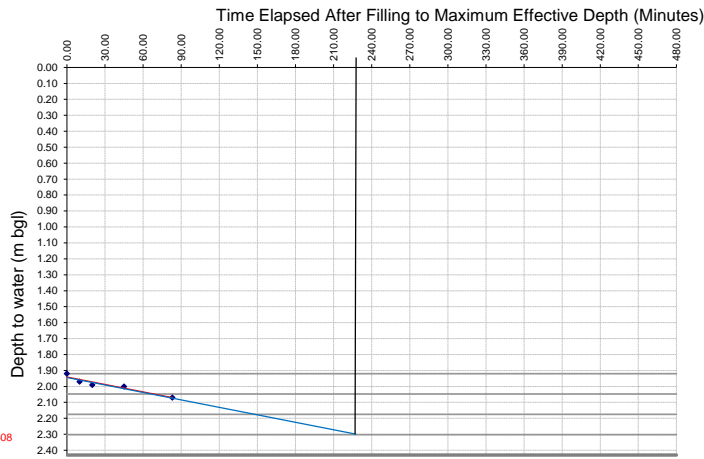
Soakaway SA01 (Test 2)

Trial Pit Dimensions (m)

Parameter	Formula	Result	Unit
Volume outflowing between 75% and 25% effective depth	Vp75-25	1.887	m ³
The mean surface area through which outflow occurs, taken to be the trial pit sides to 50% effective depth and including the base of the trial pit	ap50	10.307	m ²
The recorded time for the outflow between 75% and 25% effective depth	tp75-25	143.00	minutes
Soil Infiltration Rate	$(Vp75-25 \div (ap50 \times (tp75-25 \times 60)))$	0.0000213	metres/second

In order to obtain an estimated infiltration rate for the second soakaway test, the data has been extrapolated from 83 minutes to 226 minutes (recorded in blue) where it is anticipated that the 25% refill level would be achieved. The extrapolation results recorded a soil infiltration rate of 2.13×10^{-5} metres/second.

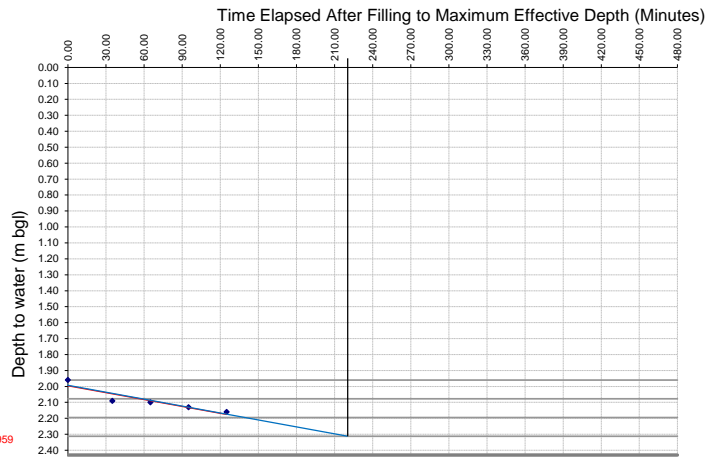
Soakaway SA01 (Test 3)

Trial Pit Dimensions (m)

100% Full (Maximum Effective Depth)
 75% Full
 50% Half-Full
 25% Full (Refill Level)
 0% Full (Base of Pit - Empty)

Parameter	Formula	Result	Unit
Volume outflowing between 75% and 25% effective depth	Vp75-25	1.739	m ³
The mean surface area through which outflow occurs, taken to be the trial pit sides to 50% effective depth and including the base of the trial pit	ap50	10.079	m ²
The recorded time for the outflow between 75% and 25% effective depth	tp75-25	183.00	minutes
Soil Infiltration Rate	$(Vp75-25 \div (ap50 \times (tp75-25 \times 60)))$	0.0000157	metres/second

In order to obtain an estimated infiltration rate for the third soakaway test, the data has been extrapolated from 125 minutes to 218 minutes (recorded in blue) where it is anticipated that the 25% refill level would be achieved. The extrapolation results recorded a soil infiltration rate of 1.57×10^{-5} metres/second.
