SITE CONDITION REPORT

1.0 SITE DETAILS	
Name of the applicant	4Recycling Ltd
Activity address	The Old Peat Works Reading Gate Swinefleet Goole East Riding of Yorkshire DN17 4BL
National grid reference	SE 76875 16851
Document reference and dates for Site Condition Report at permit application and surrender	Part B2_5b Site Condition Report 12 th October 2018 – Permit Application
Document references for site plans (including location and boundaries)	2.4 Existing Site Plan (as part of Part B2_5b Site Condition Report)

Section 2 Condition of the land at permit submission¹

Photographic Record October 2018

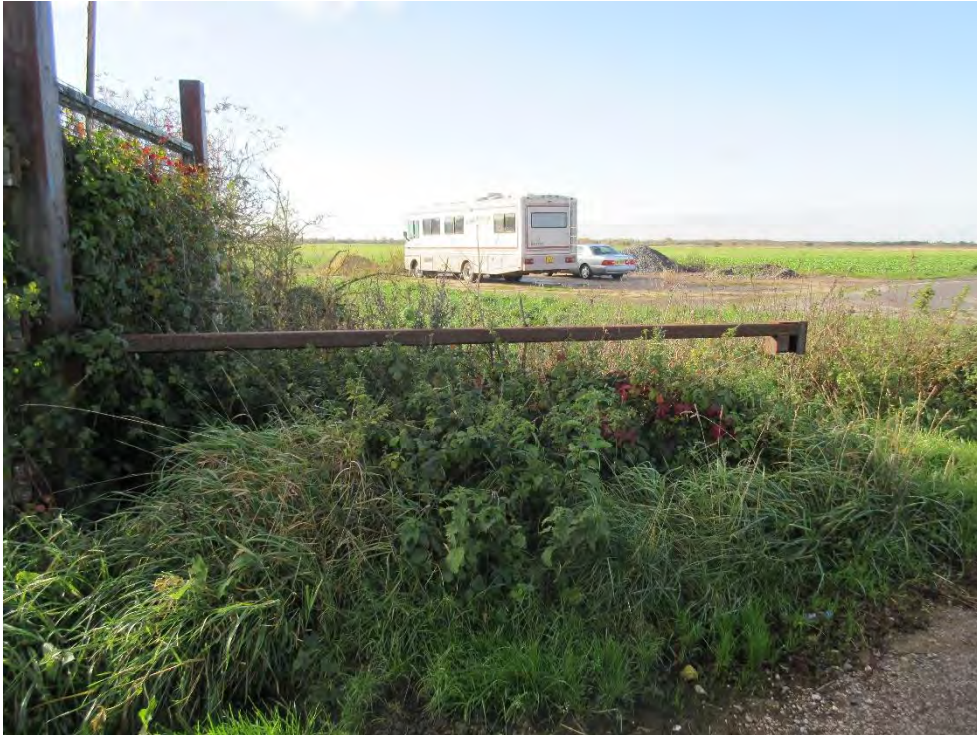
Site access is gained from the north of the site at the western end on a metalled road through the site gate currently consisting of a single metal pole (figure 1).

Figure 1 View to SW from site entrance showing metal pole (gate) and remains of a more robust gate (left).

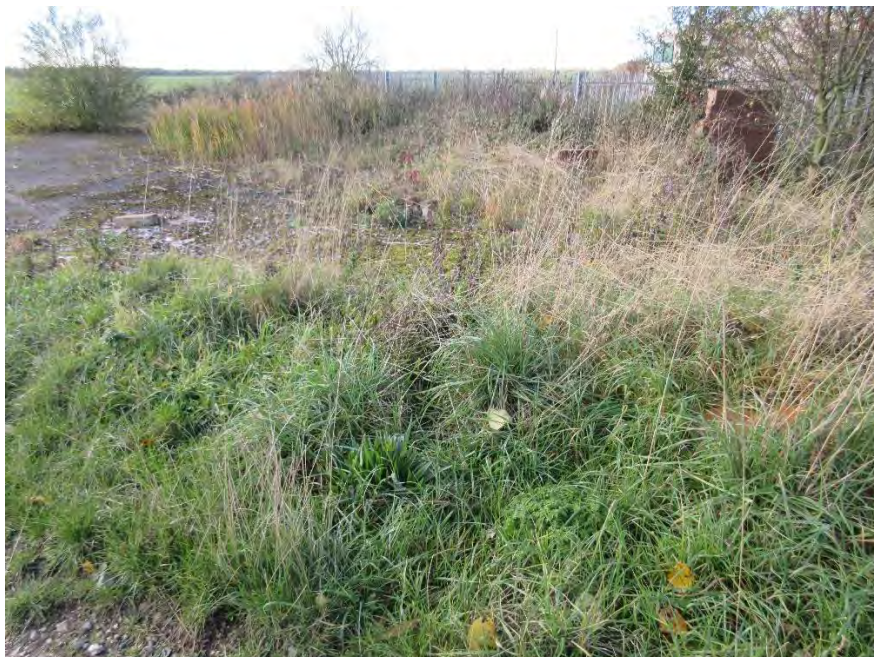
Rudimentary brickwork and hardstanding remains of what possibly was a site office at the entrance (figure 2).

Figure 2 View to south west showing remaining brickwork of possible site office, fencing and hardstanding.

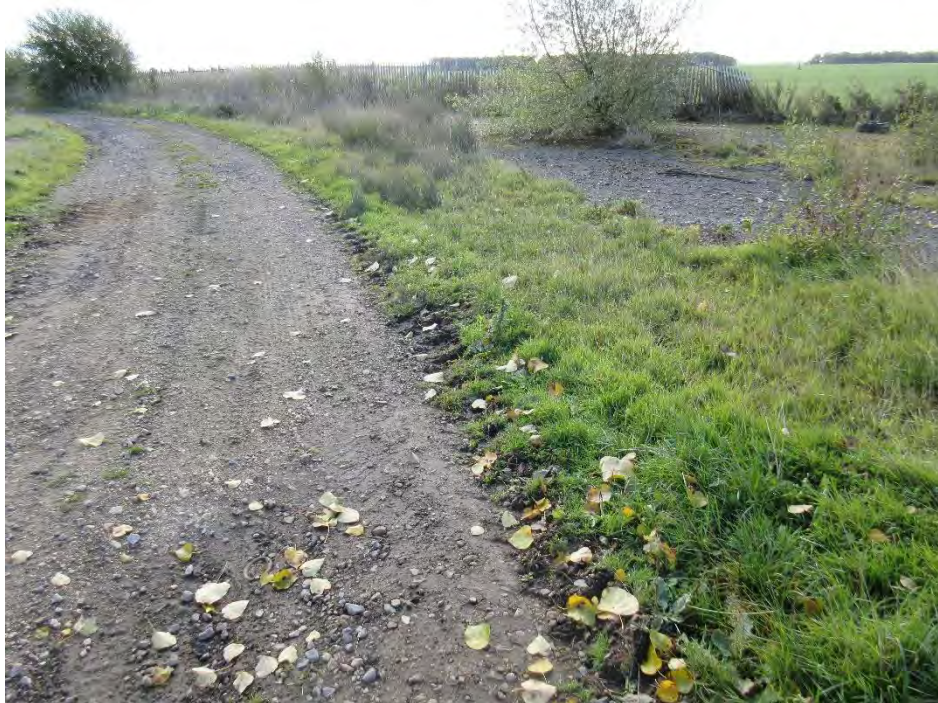
At the entrance, the metalled road turns 90 degrees east and runs along the north of the site but a non-metalled stone track branches to the south. A small area of hardstanding lies to the west of the track.

Figure 3 View to south showing hardstanding to west of track.

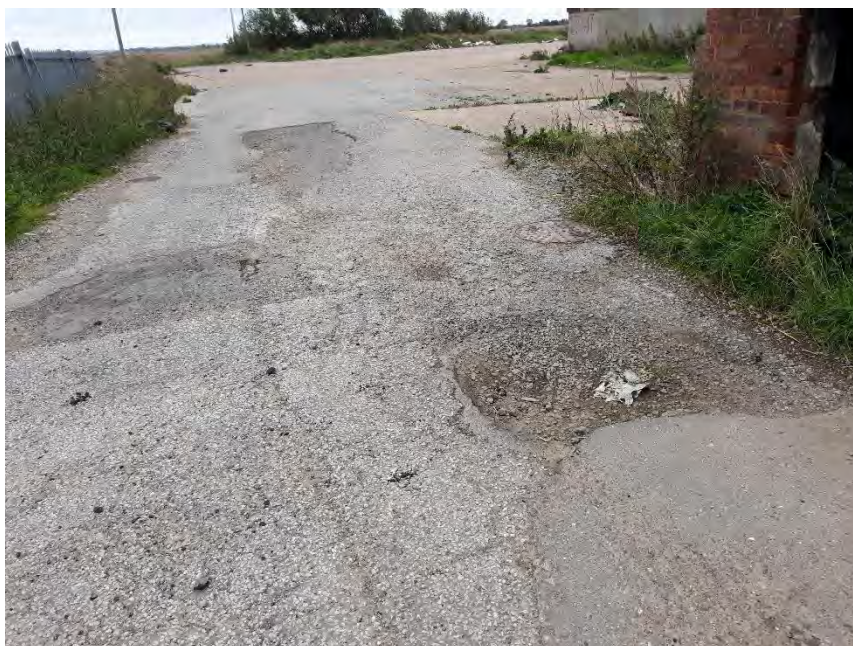
The track circumvents the pond to the north reaching the large concreted area to the west of the buildings. Both the metalled road and the stone track are in a reasonable to good condition although some pot holing, break-up and patching of the road has occurred near the brick building approximately 190m east of the entrance (figure 4).

Figure 4 Poor condition of roadway alongside northern boundary

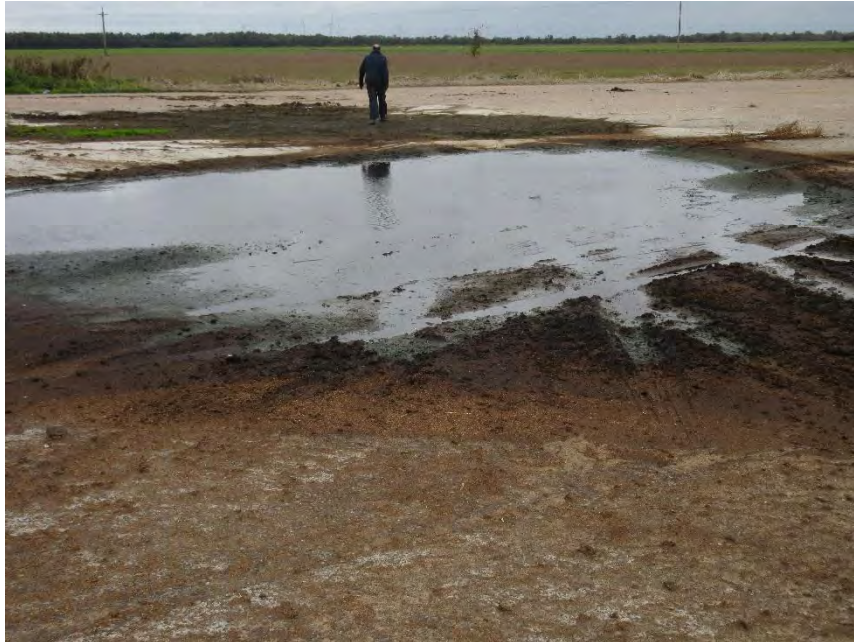
Although secure with metal security fencing in the past, it is now completely absent on both the southern (figure 5) and eastern sides.

Figure 5 Overview to the south where fence is absent

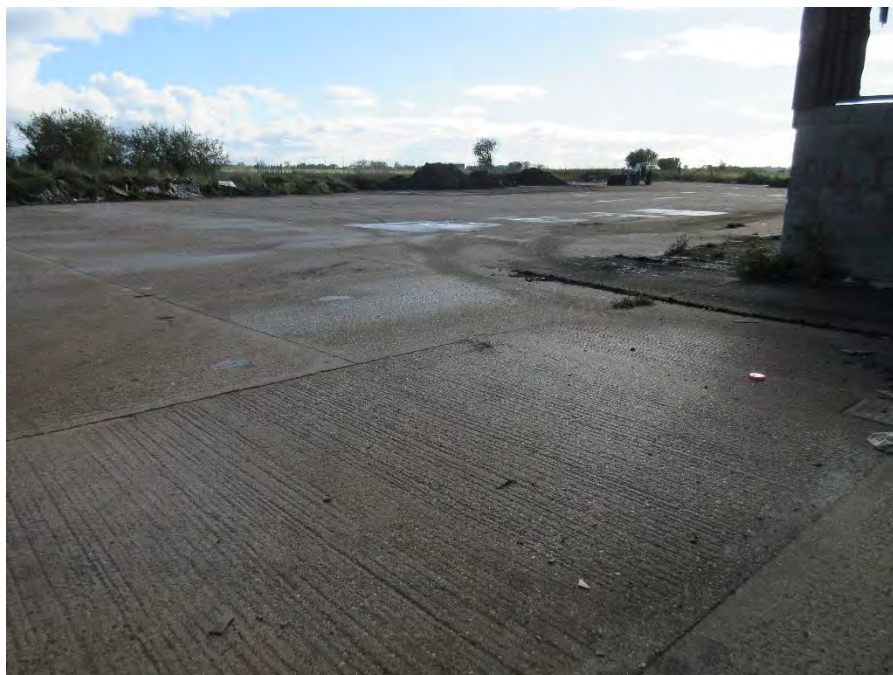
Figure 6 Overview to the east where fence is absent

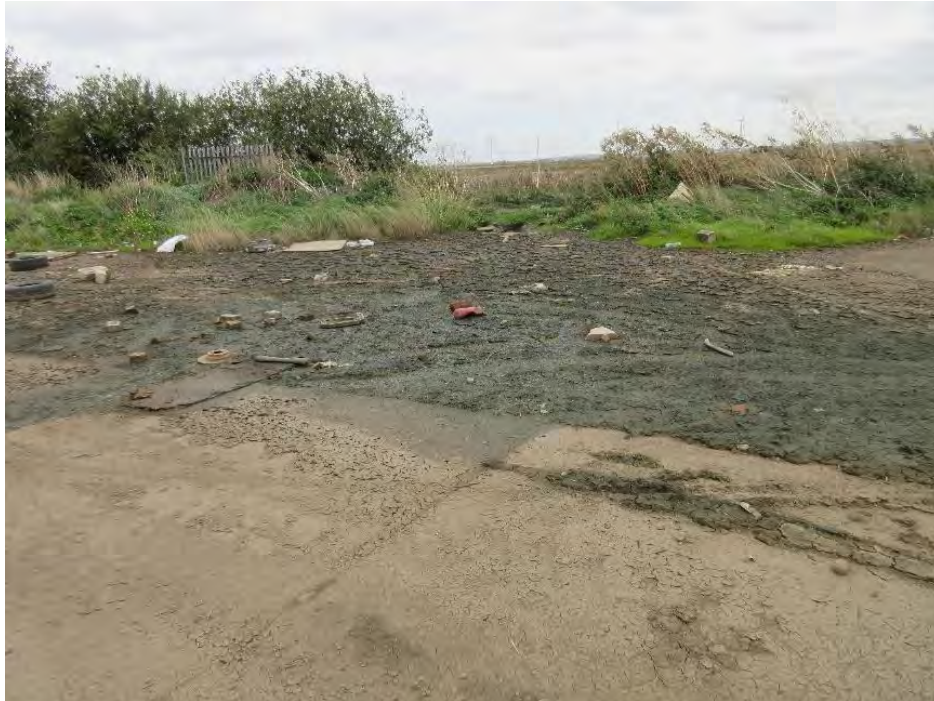
It is present along the majority of the northern side but incomplete (figure 7)

Figure 7 View towards the north showing incomplete fence

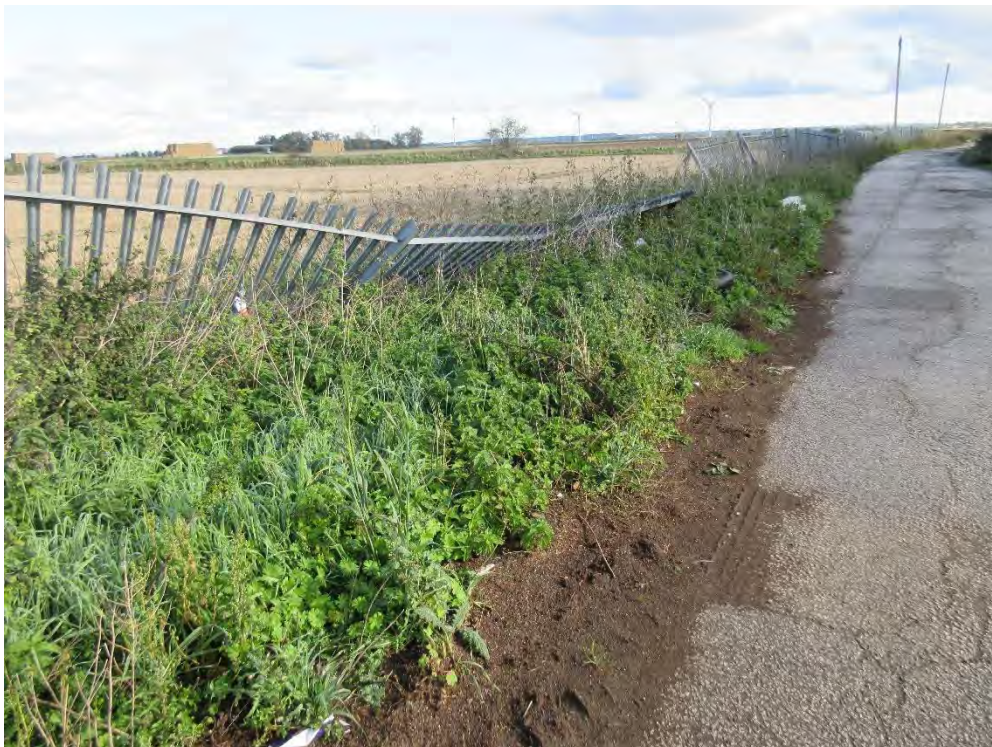
and where present, generally in a poor state of repair along the northern boundary (figure 8).

Figure 8 Fence along the northern boundary in a poor state of repair.

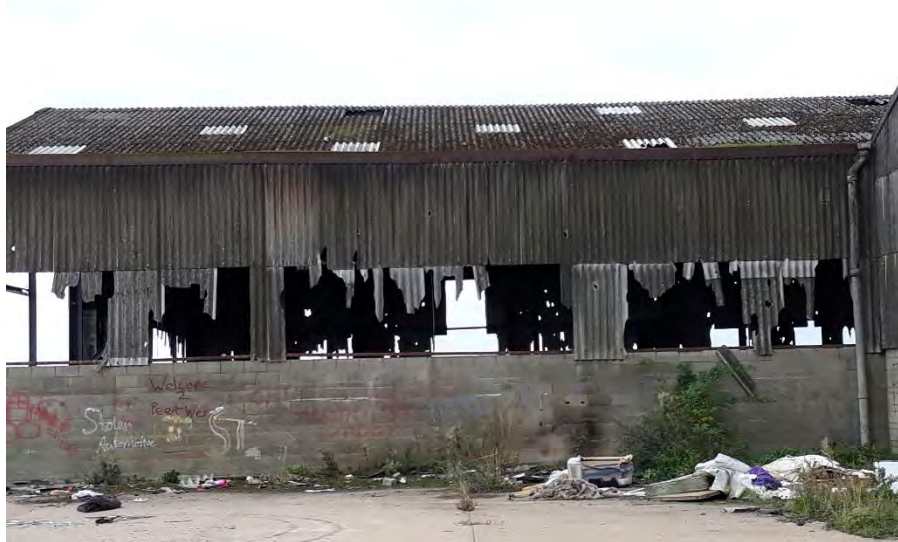
The buildings are open to the elements and generally in a damaged and poor state. Although largely complete and repairable, some sheeting, particularly sky lighting in the roof and significant areas of the asbestos wall cladding, require replacement (figure 9).

Figure 9 Side View North– missing skylight, damaged asbestos cladding, flytipped debris

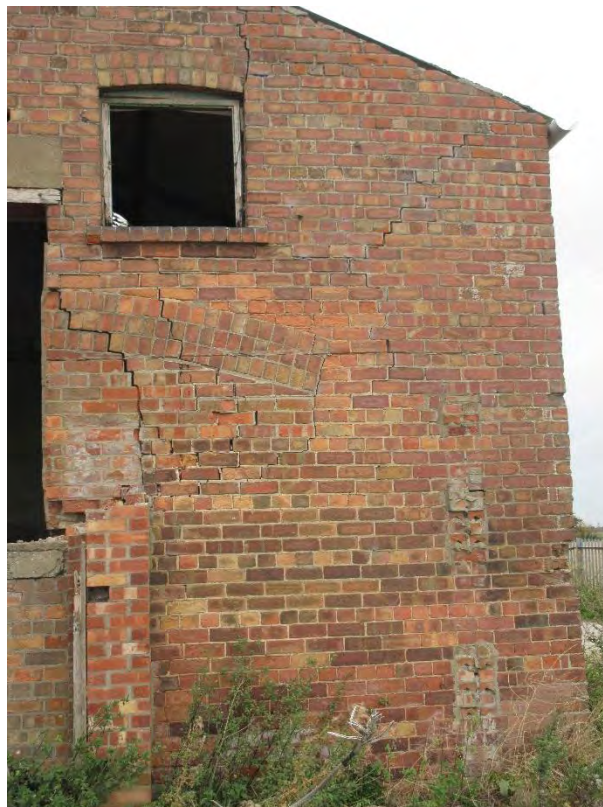
Although appearing to be structurally sound, there are areas of damaged fractured brickwork requiring repair (figure 10).

Figure 10 Brick building – End View East– missing window and door, fractured brickwork

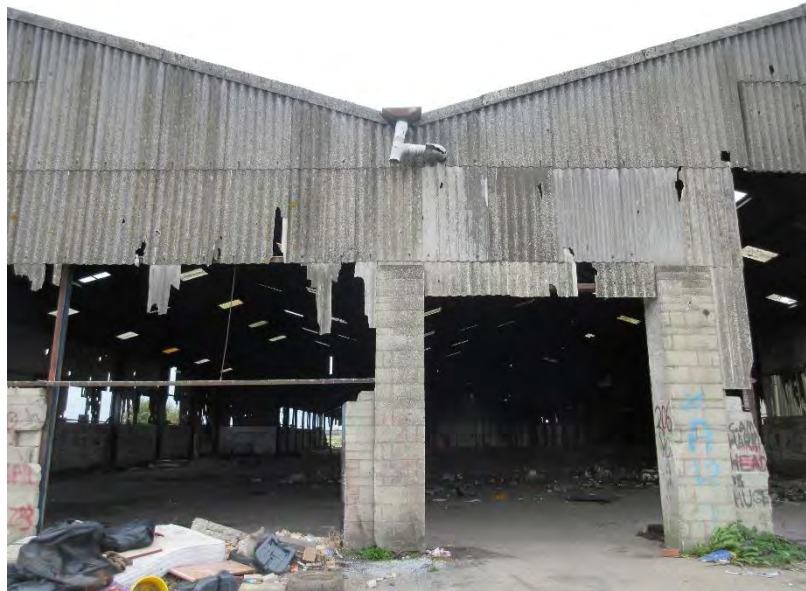
There are no remaining glass windows, some of the walling and doors are missing and most of the guttering and downpipes are absent (figure 11). There is no functioning guttering.

Figure 11 End View East – damaged asbestos cladding, missing wall and doors

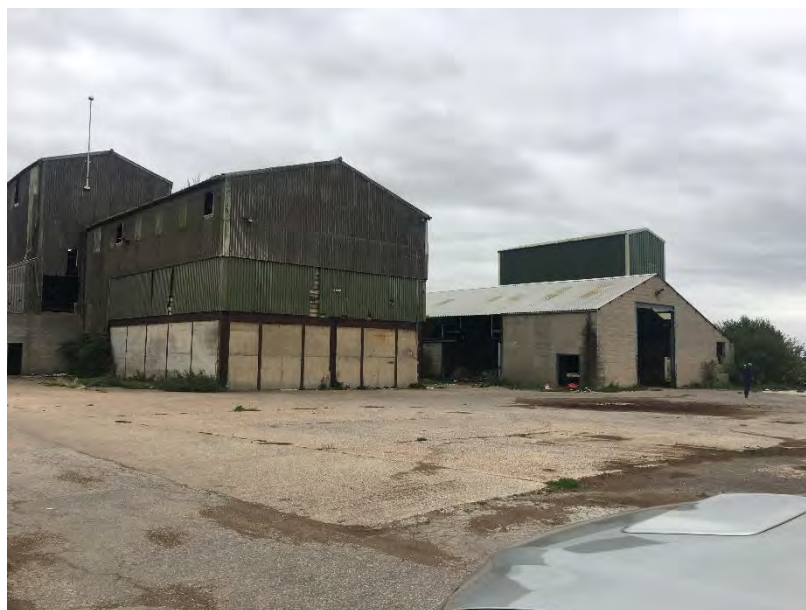
There are large areas of concrete that do not require attention (figure 12).

Figure 12 Concrete apron in a good condition in the north west

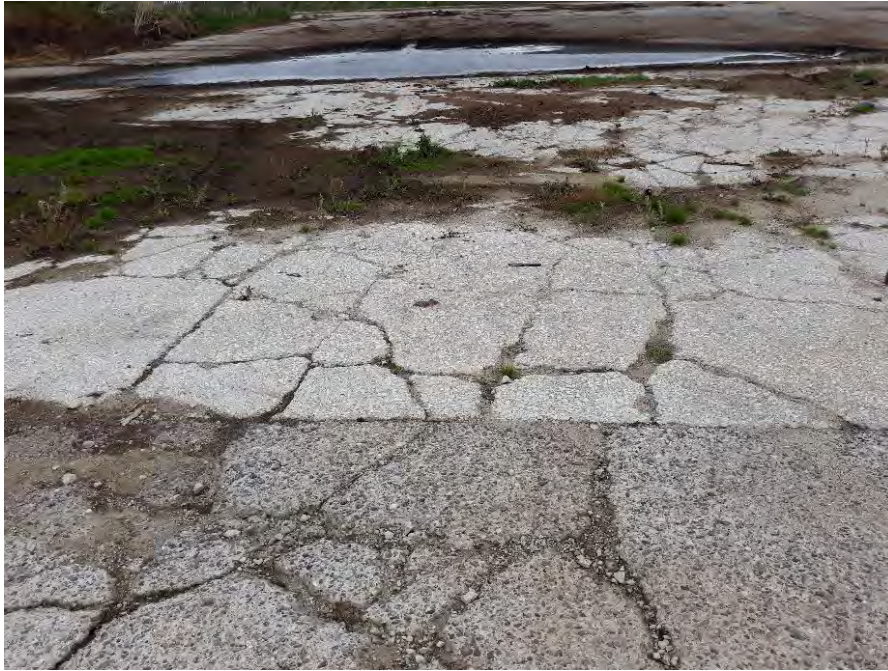
However, some of the concreted areas have significant fracturing (figure 13) and have subsided in varying directions which has led to pooling of rainwater.

Figure 13 Part of damaged concrete apron in the south west

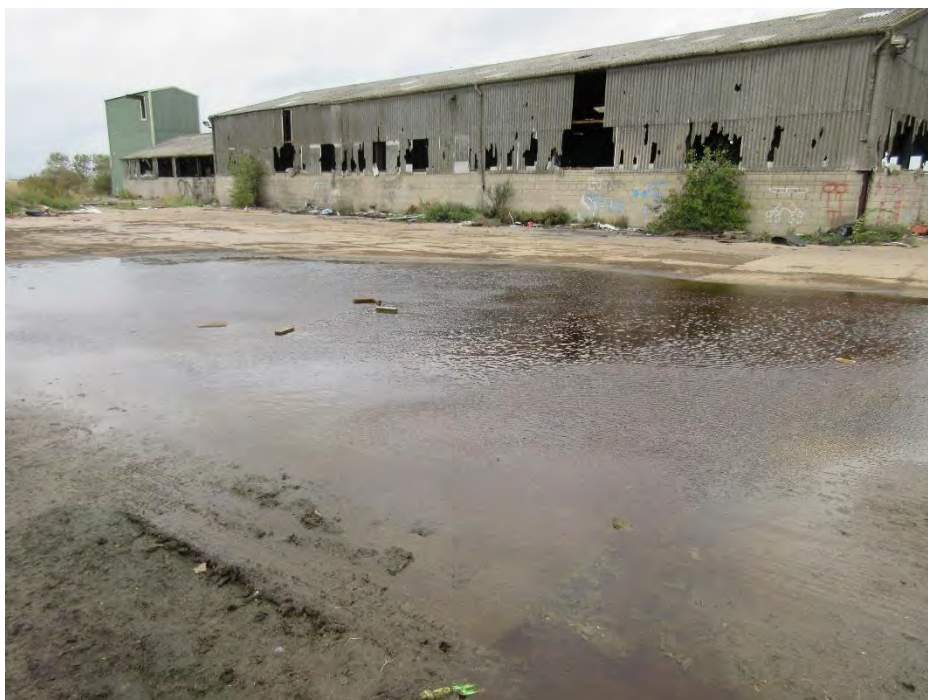
Figure 14 Concrete Apron to south east - pooling of water

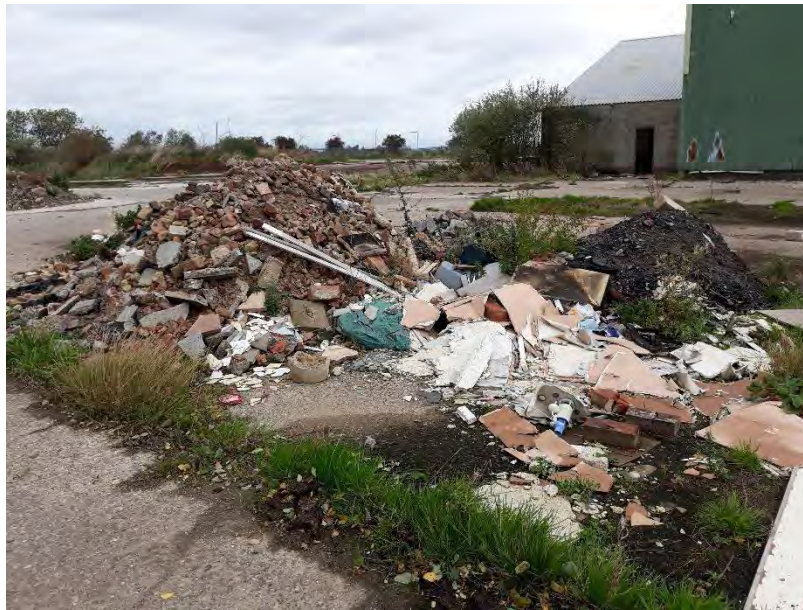
Figure 15 Concrete Apron – south west – significant fly tipping

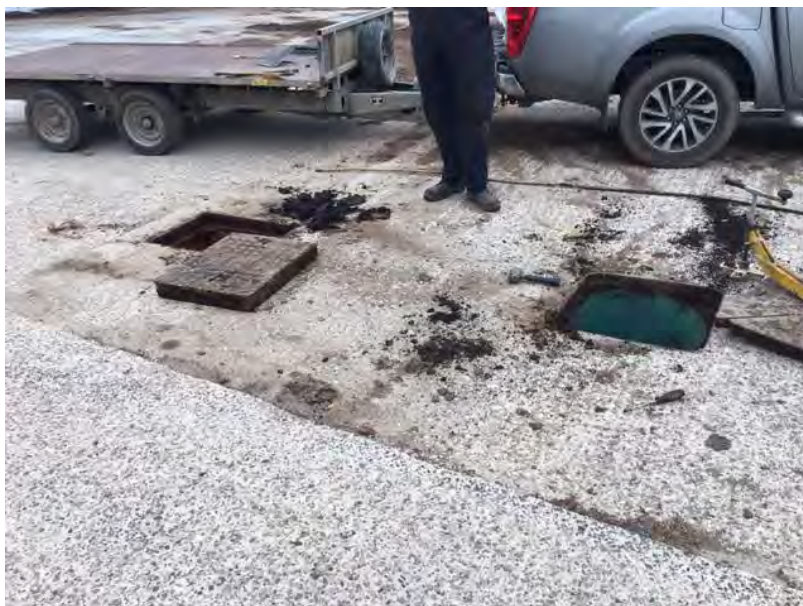
Most of the guttering and downpipes are missing from the building and channels of flow throughout the site could not be observed during the dry weather experienced during the visit. A number of covers over inspection chambers were removed using a manhole cover lifting tool (figure 16).

Figure 16 Removal of manhole covers with lifting tool

None of the drains are functioning to any significant degree. Without exception, chambers were found to be clogged with mud and debris including broken tiles, stone and bricks although once cleared and a few metres of the drain cleared with a drainage rod, some residual flow could be observed.

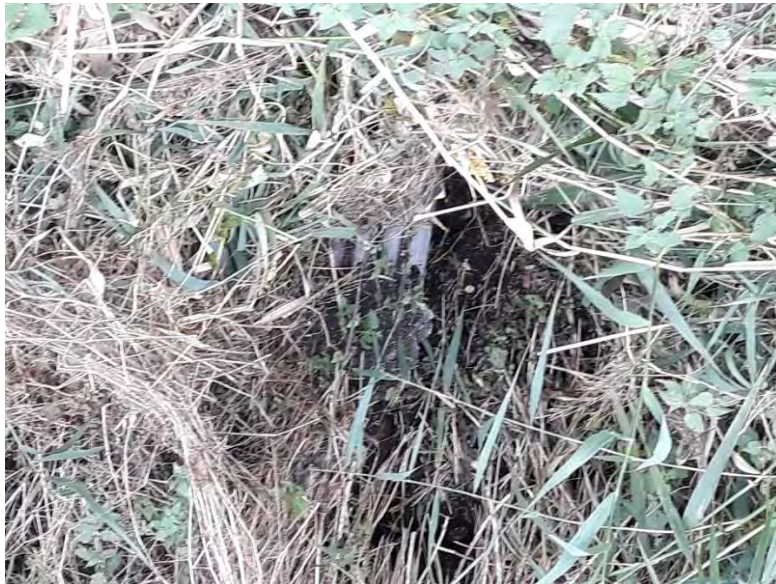
Clean water drainage from the site outfalls at two points (minimum) to a deep ditch (1.5m) running along the northern boundary from east to west. Outfalls are situated at each end of the building (figures 17 and 18) but neither were flowing although residue from previous flows could be observed

Figure 17 Drain outfall at eastern end of building

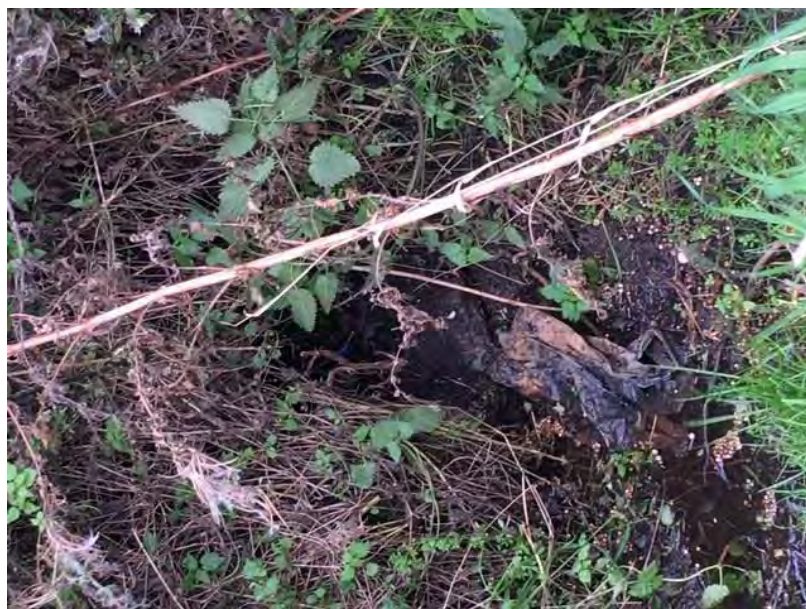
No organic contaminants, fuel or oils were noted but residue from organic runoff in the past was noted in a ditch at the western outfall (see figure 18) but this was not extensive. The site is surrounded by fields in arable cultivation. The vegetation along the boundary is as expected for the time of year, i.e. end of season senescence and yellowing is prevalent but no areas were particularly worse than others or obviously due to site emissions.

Figure 18 Drain outfall at western end of building

at the western outfall. The eastern outfall could not be seen but is assumed to be associated with a large pipe observed running along the bottom of the ditch. It is assumed that flow is diverted along the ditch to reduce risk of erosion at high flow rates, i.e. diverting water along rather than across the ditch at the point of outfall.

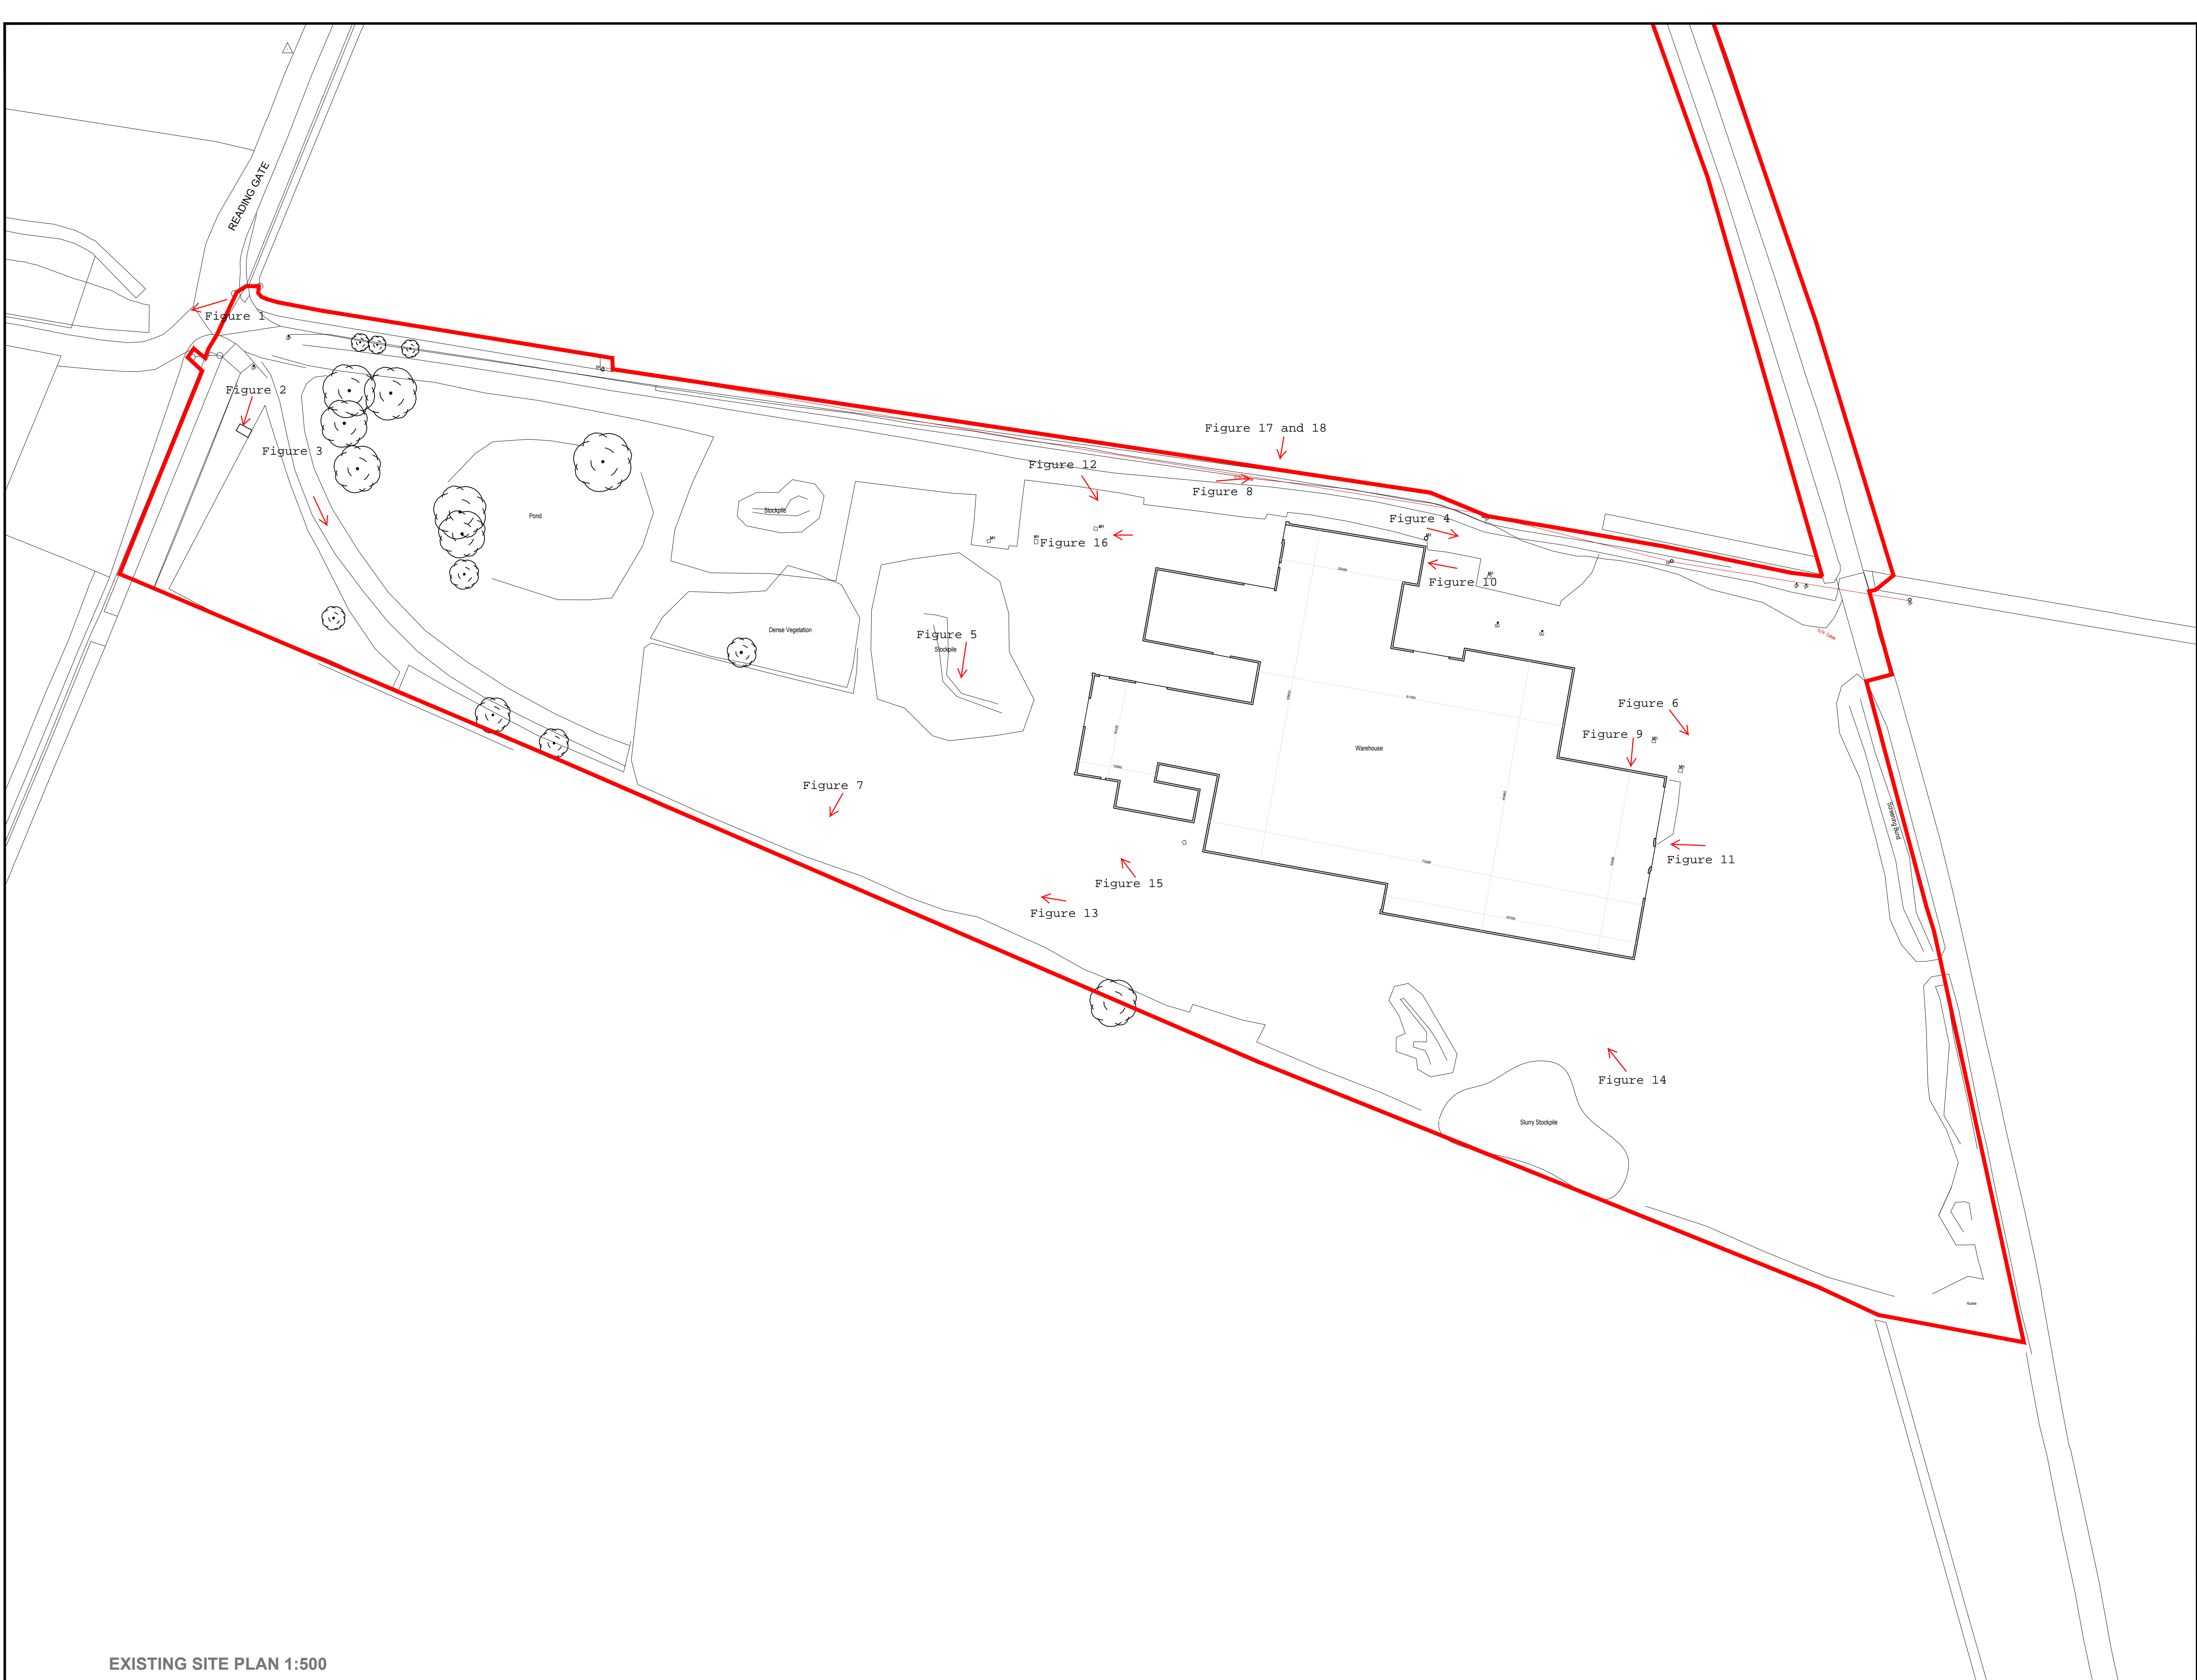
EXISTING SITE PLAN 1:500

As detailed on the plan, the majority of the site is mainly covered in concrete in variable states of repair. The western end of the site has two small areas of hardstanding, a pond and soil cover.
