ENVIRONMENTAL ASSESSMENT REPORT

**PROPOSED NEW COMMERCIAL/INDUSTRIAL DEVELOPMENT
AT
PLOT A
FOR
ELLGIA LTD**

GDP PROJECT NUMBER 1936-A

28 AUGUST 2019

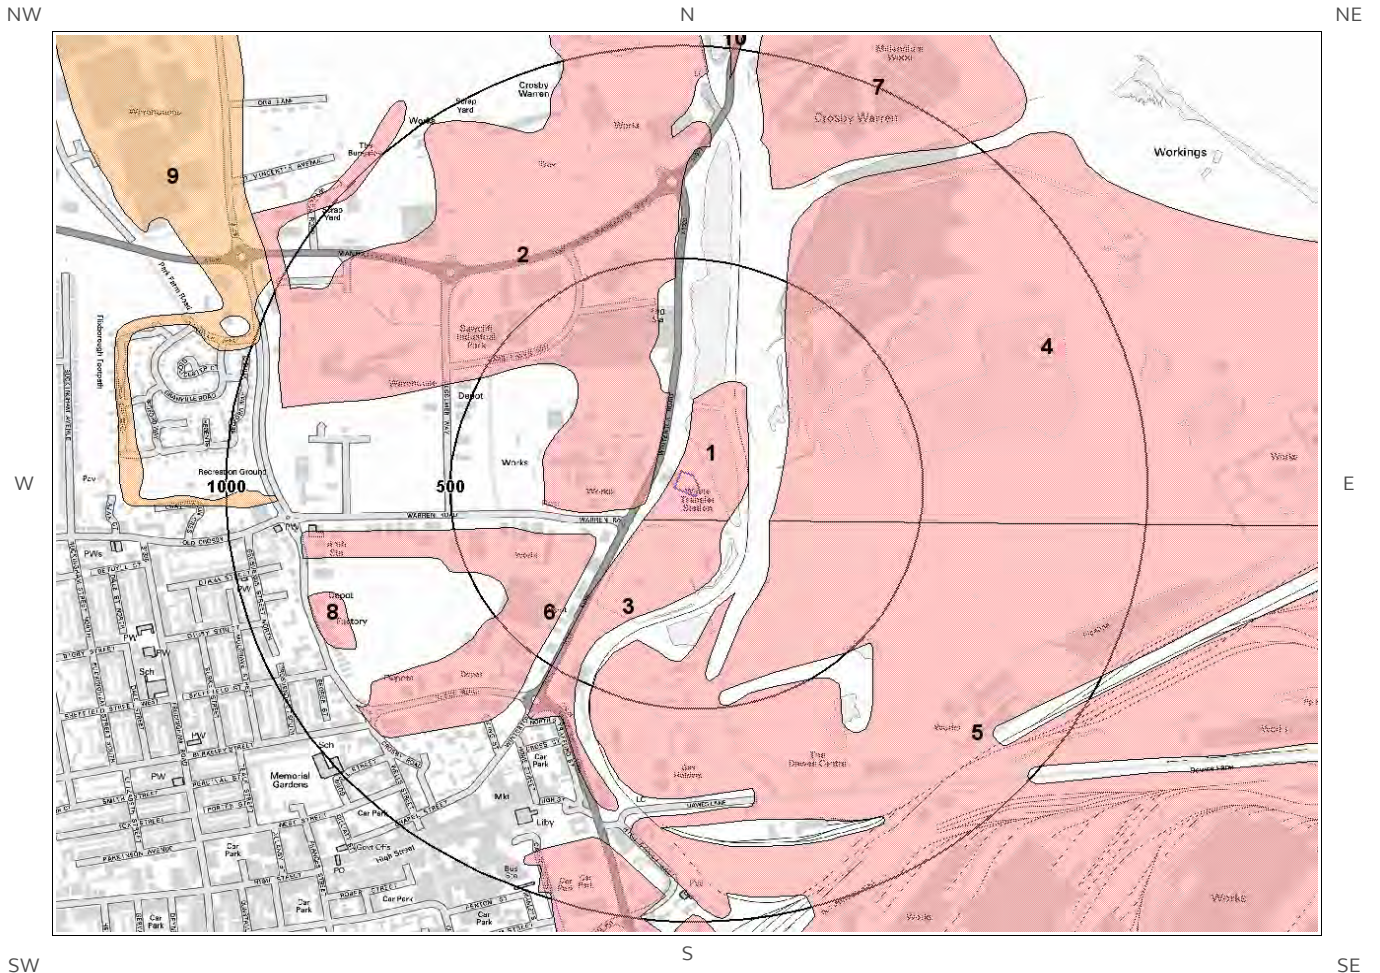
1.1 Artificial Ground Map

Distance (m)	Direction	Flow Type	Maximum Permeability	Minimum Permeability
0.0	On Site	Mixed	Very High	Low
