**Thorpe Marsh Green Energy Hub Limited**

# Thorpe Marsh Landfill (EPR/CP3091SC/V002)

Stability Risk Assessment

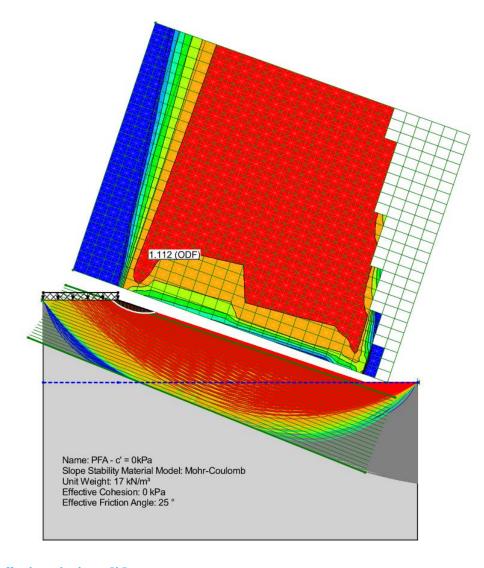
Figure 1 - Slope stability output, effective cohesion = 0kPa

Figure 1 shows stability output where effective cohesion is 0kPa. Figure 2 includes an effective cohesion of 1kPa and was carried out to assess the effect of minimal cohesion within the PFA due to the pozzolanic effects of the material.

It should be noted that the colour shading of the slip surfaces is graded from lowest (red) to highest (blue), but that red does not denote a failure. All over design factors are above 1.0 and as such, provide suitable factored resistance to slope failure.

Output from the analyses for PFA slope stability are included as Figure 1 and Figure 2.
