SITE CONDITION REPORT TEMPLATE

1.0 SITE DETAILS	
Name of the applicant	ENVA battery recycling Ltd
Activity address	Immingham Materials Recycling Facility, Unit 1-5 Pelham Industrial Estate, Manby Road. Immingham, Lincolnshire DN40 2LF.
National grid reference	518650, 415470

317213 Site Condition Report Appendix 1 – Baseline info

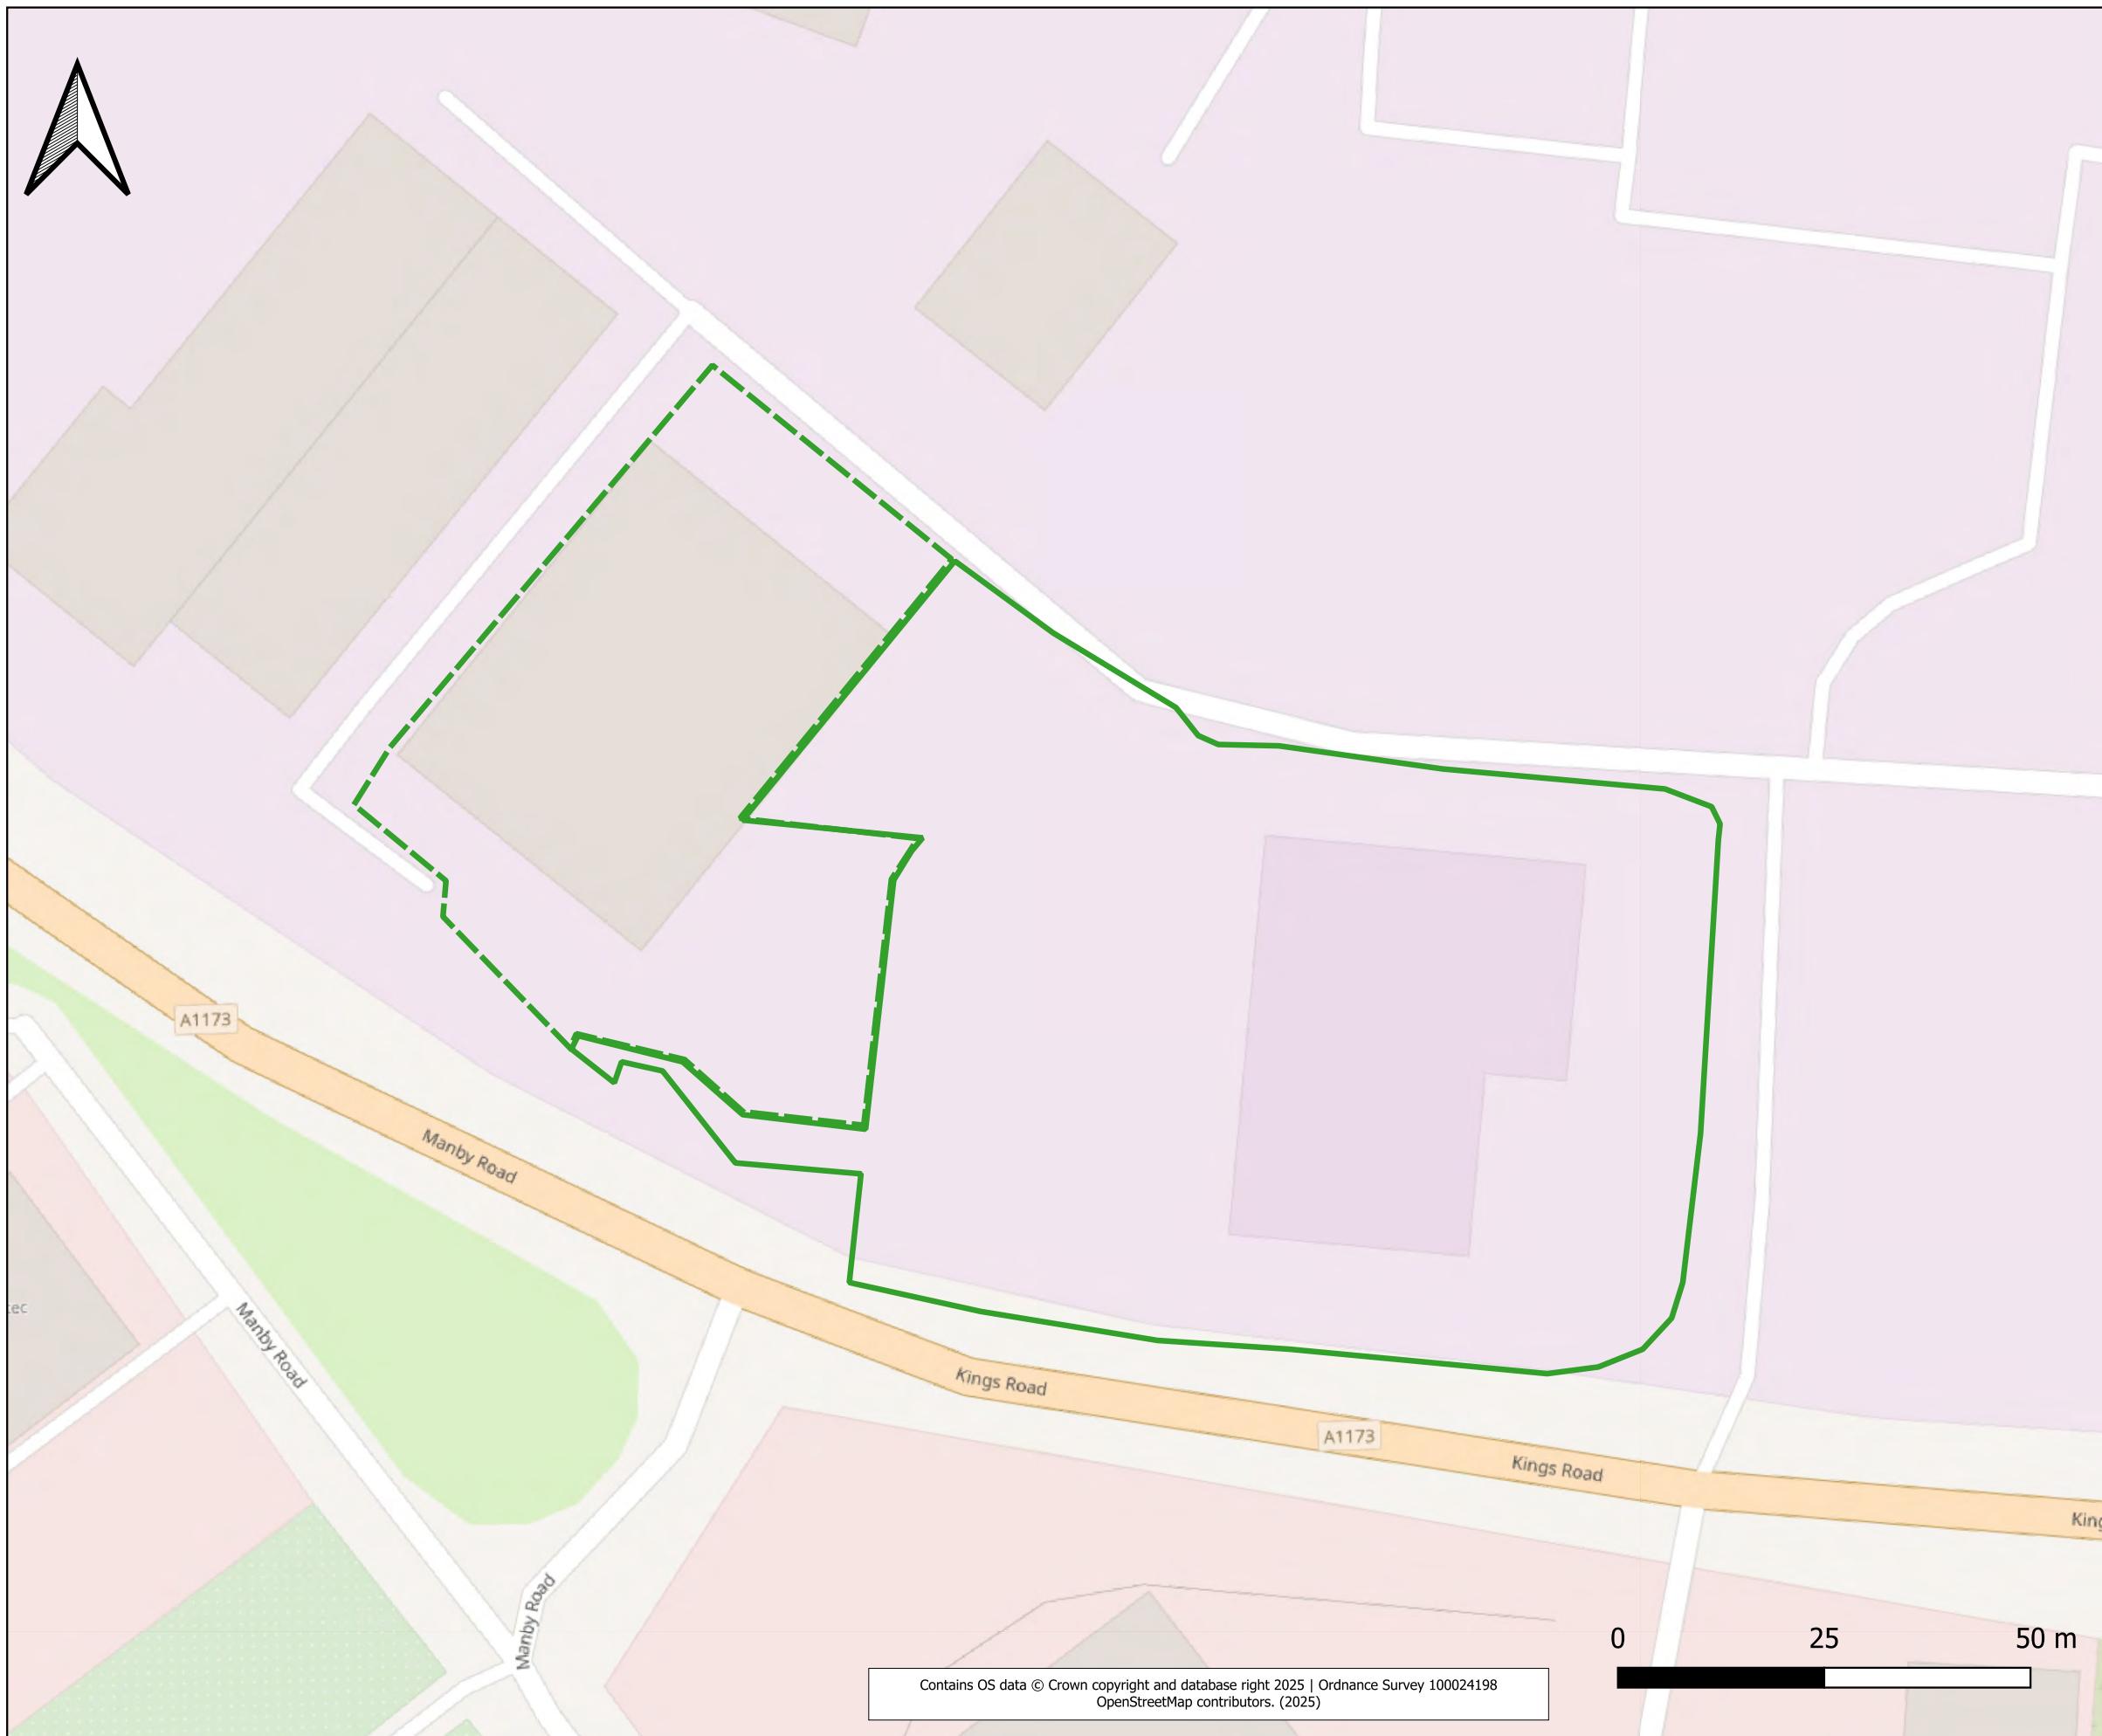
Drawing Ref: 317213 DW07 Drawing No: DW07

Legend:	
	Permit boundary (V012)
	Proposed permit boundary extension

It should be noted that ENVA's proposals include the use of an additional area of land to the northwest of the current permitted operation undertaken by ENVA. This area currently remains in the control of SAR Metals. We understand that this area is also controlled by a permit and that SARS metals are looking to surrender that permit as they exit that area. We have little detail on the current status of the surrender and whether the EA has any concerns over the potential for soil and groundwater contamination on that area. The operations undertaken by SAR Metals include catalytic convertor treatment to recover metals. SAR Metals have indicated that there are no relevant hazardous substances contained on their site only general cleaning materials and maintenance items along with some spray paints that are stocked in volumes that would not pose a credible risk to soil and groundwater. They have indicated that they do not stock oils and fuels on site. SAR Metals have also indicated that they have no records of any pollution incidents within the last 5 years. As there are understood to be no credible risks from relevant hazardous substances to soil and groundwater from this area it has not generally been considered further.

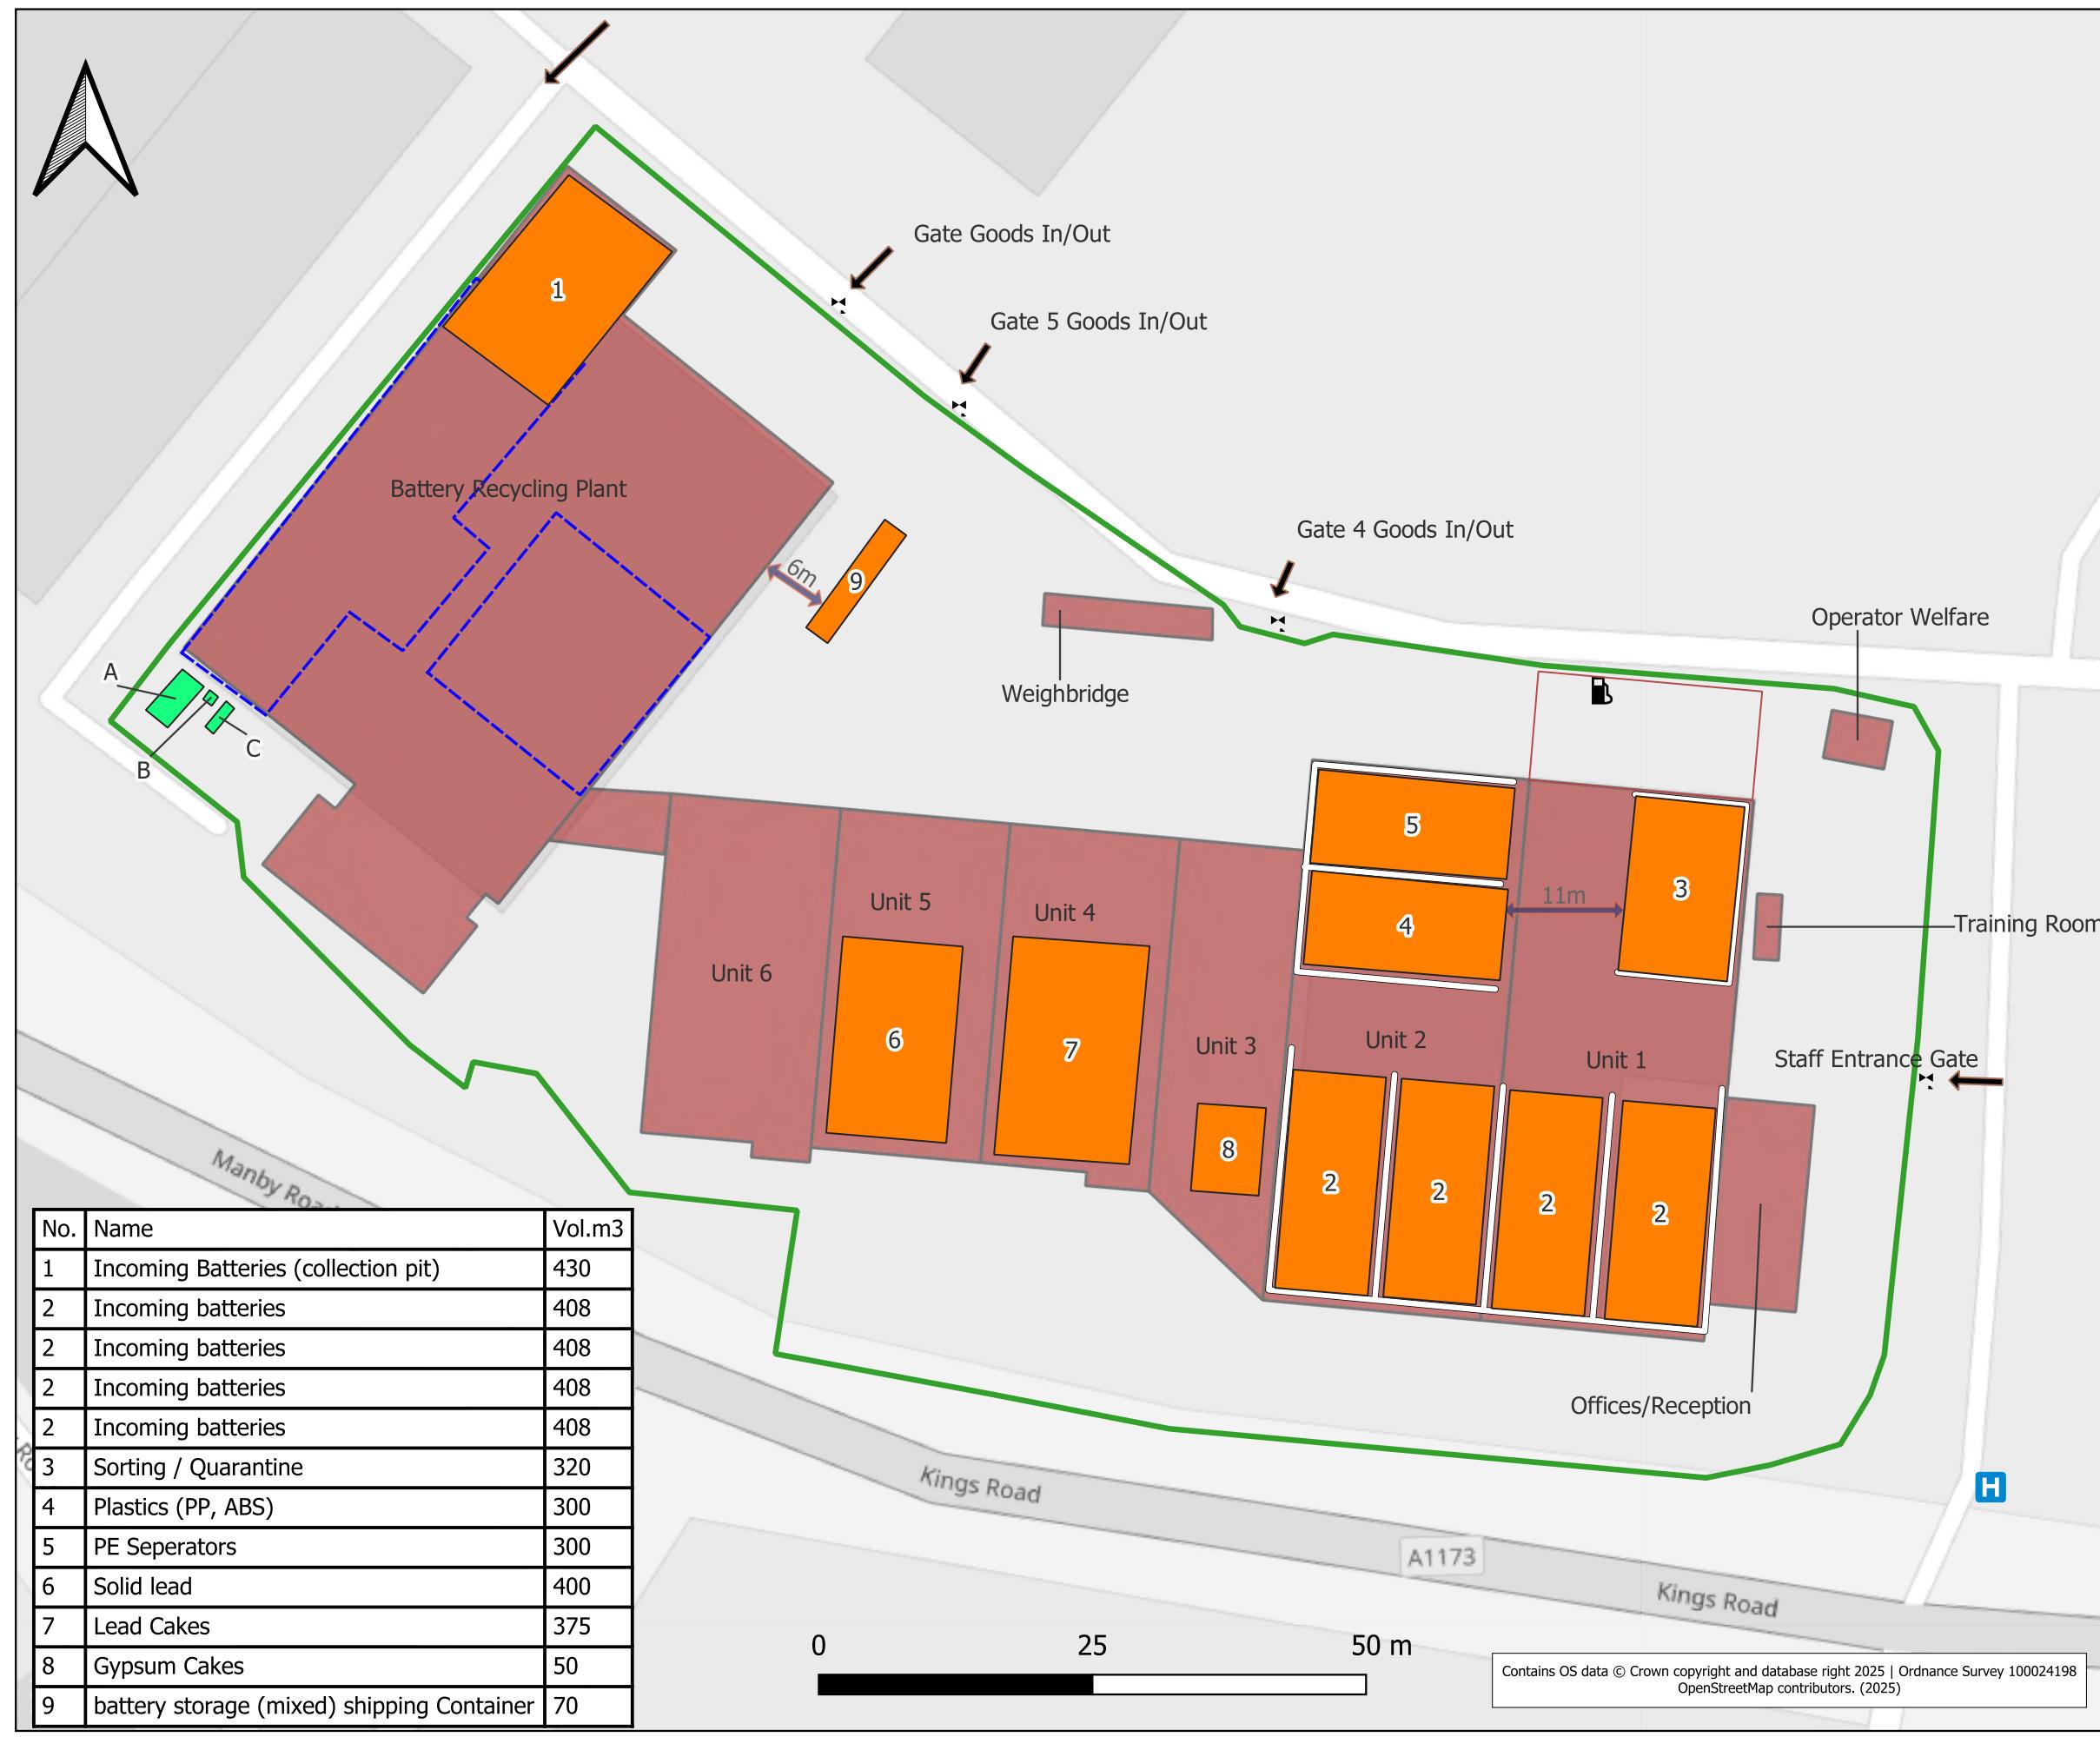
Legend:	
Permit Boundary	
Waste storage	
Raw materials	
Concrete bay	
Separation distances	
Access gates	
Fire engine access	
Bunding	
Hydrant	
Diesel	
Battery Recycling Plant	
Site:	Pelham Industrial Estate, Manby Road, Immingham, Lincolnshire, DN40 2LF
Drawing title:	Site Layout Plan
Date:	15/10/25
Scale:	1:600
Paper size:	A3 (420×297mm)
Drawn by:	RM
Checked by:	KB
Status:	Final
Final revision	-
Drawing Ref:	317213 DW02
Drawing No:	DW02

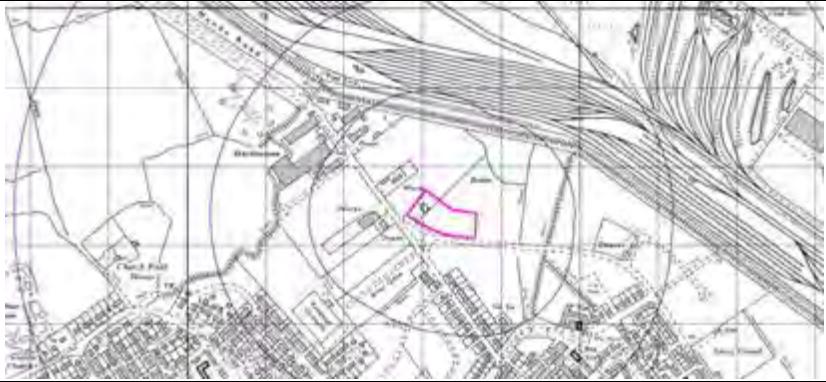
1974 1:10,000

The site history has already been summarised in the Site Condition Report (see also extracts from historic mapping below). The site was developed from approximately 1975 and is noted to have been used as a depot and warehouses. Prior to 1975 the site was undeveloped. As such, any impacts to soils or groundwater on the site will have occurred more recently or occurred from sources of contamination off-site e.g. the presence of potentially contaminated materials that could migrate in groundwater.

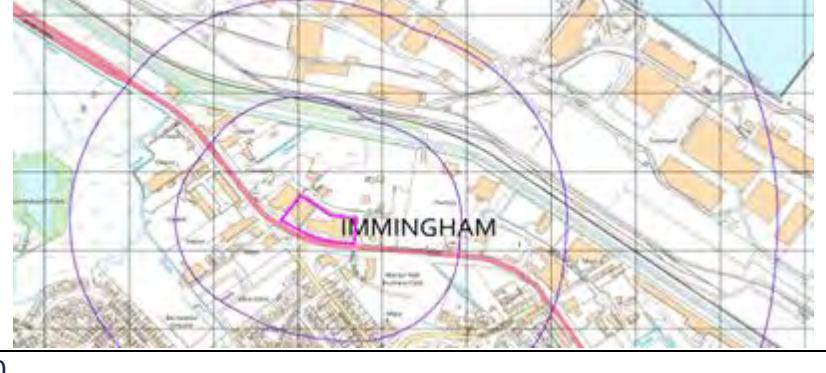
2025 1:10,000

ENVA took over operation of the site in 2021. Prior to this time the site had been used for similar purposes through the previous operator of the Site, SAR Metals, since the site was first permitted in 2009 (15/01/09). It is understood that similar relevant hazardous substances would have been present on the site since that time, ENVA having since taken on the operation of the site.

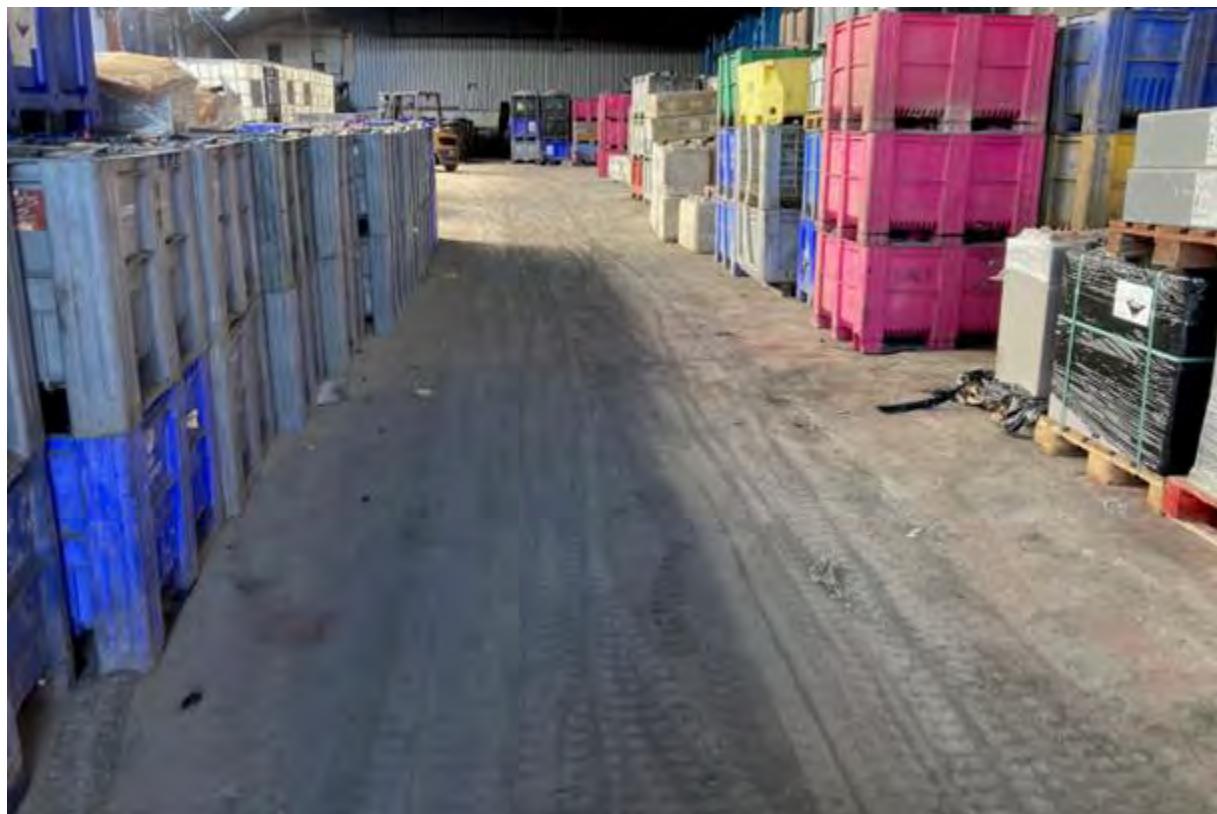
Photo 5: General view of internal impermeable surface

- Secondary containment is provided and is checked regularly to ensure it is in good condition.
- Site operations are undertaken on an impermeable surface, to which an acid-resistant coating has been applied, this was fully renovated in May/June 2024.

- There is an ongoing maintenance operation to ensure leaks and damage rectified, for instance, the oil water separator is serviced annually by a competent contractor, there are weekly visual checks of the site surface to determine if any repair is required.
