IMMINGHAM WASTE TO ENERGY PLANT

SITE CONDITION REPORT

DATE ISSUED: May 2023
JOB NUMBER: GM12772
REPORT NUMBER: 001
VERSION: V1.0
STATUS: Final

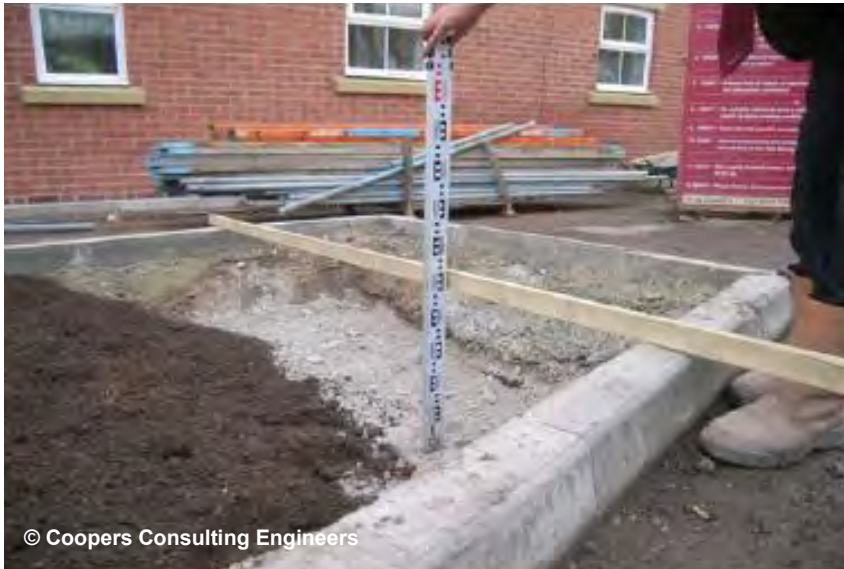
Photograph 1: Depth check of inert cover within area of public open space. Physical break layer and topsoil visible.

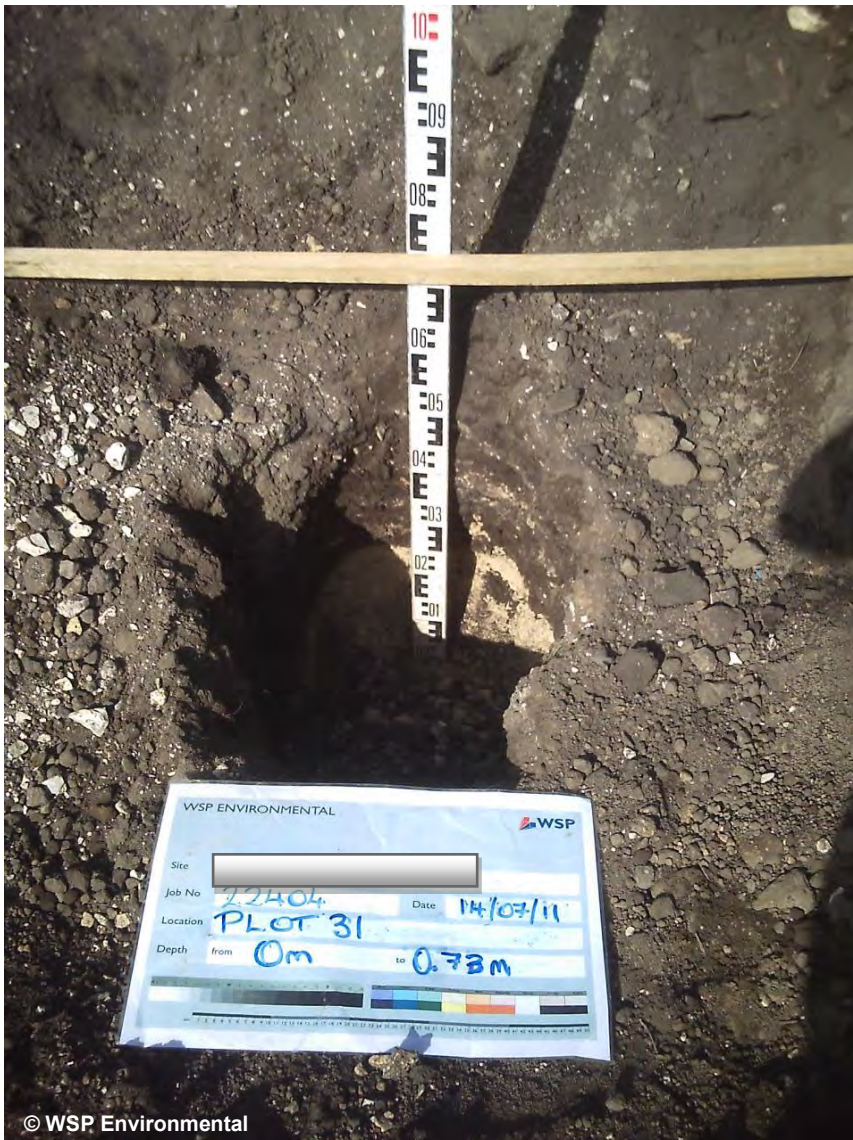
Photograph 2: Depth check of inert cover with Site & Location Information Board.

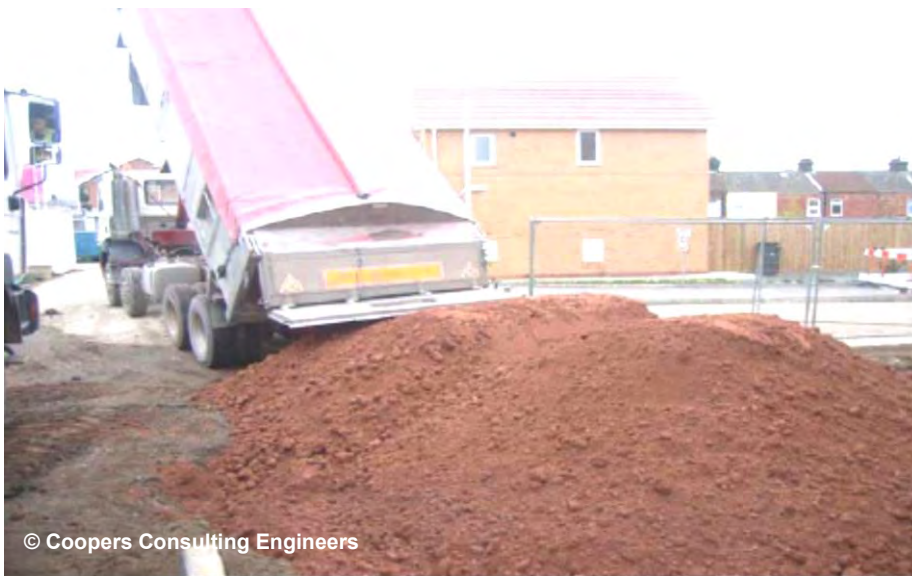
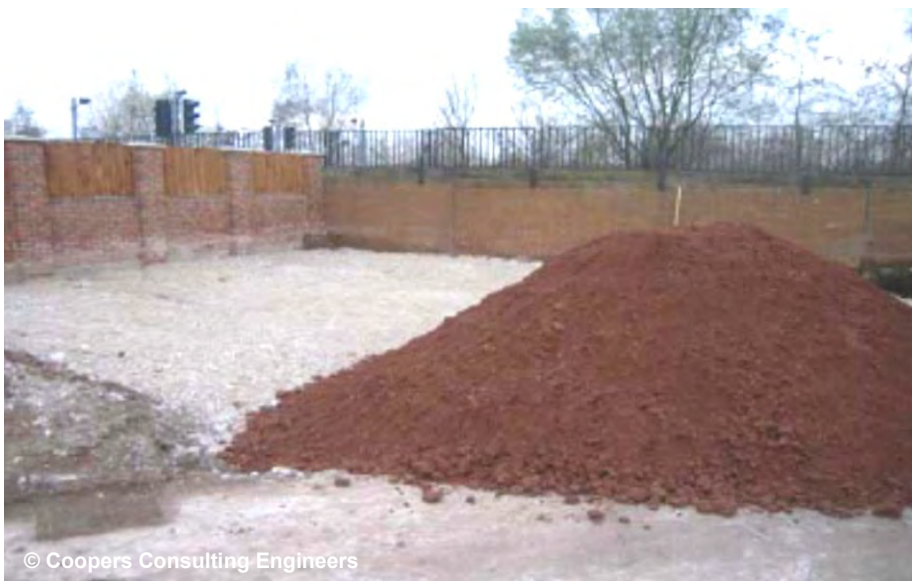
Photographs 9 and 10: Inert crushed sandstone being delivered with remediation break layer visible in Photograph 10. The spatial area of the remediation can be observed from these photographs (old terrace housing in Photograph 9 and traffic lights in photograph 10).

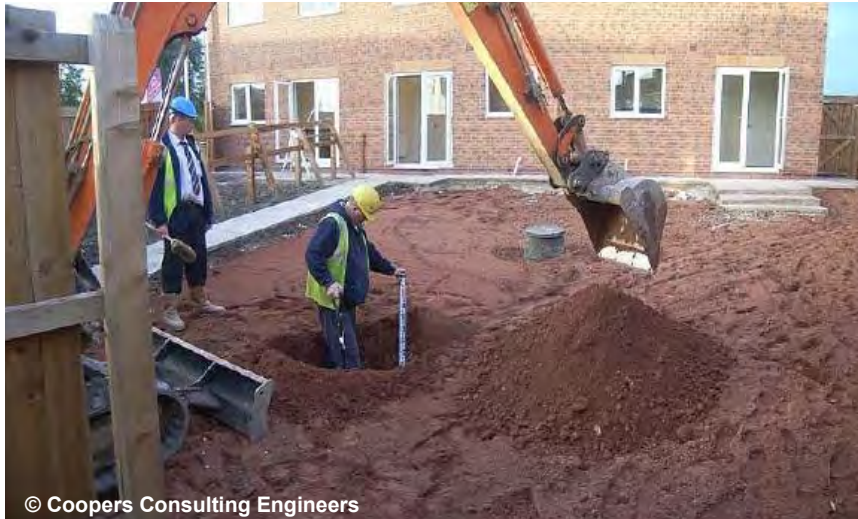
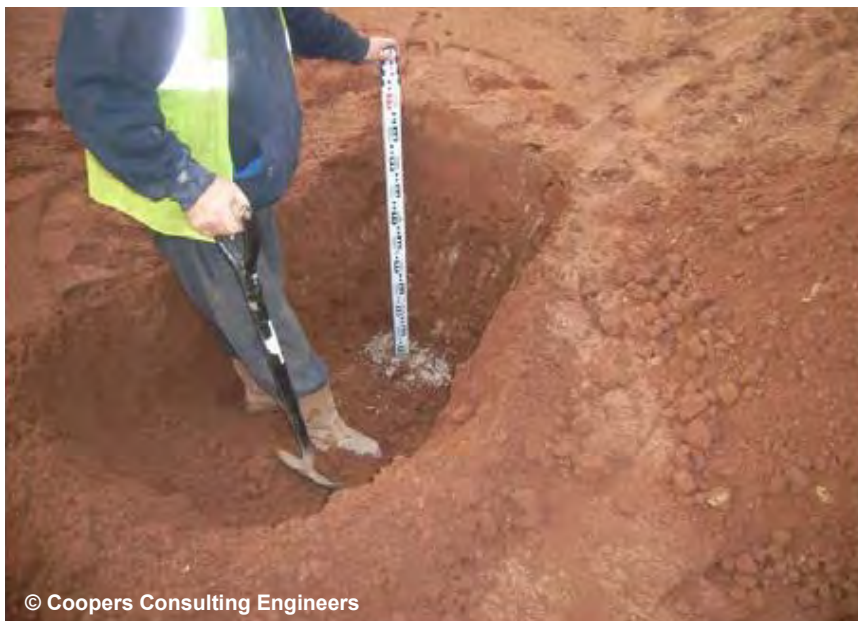
Photographs 11 and 12 show the remediation of the rear garden, with a significant depth (1.0m) of inert cover. Remediation break layer visible at the base of the excavation. Photograph 11 has been stitched to form a panoramic photograph and
