CONCEPTUAL SITE MODEL, ENVIRONMENTAL SETTING AND SITE DESIGN REPORT (ESSD)

**SKELBROOKE QUARRY EXTENSION AREA
STRAIGHT LANE
SKELBROOKE
DONCASTER
SOUTH YORKSHIRE
DN6 8LY**

**Document Reference: WR7640/05.R1
August 2022**

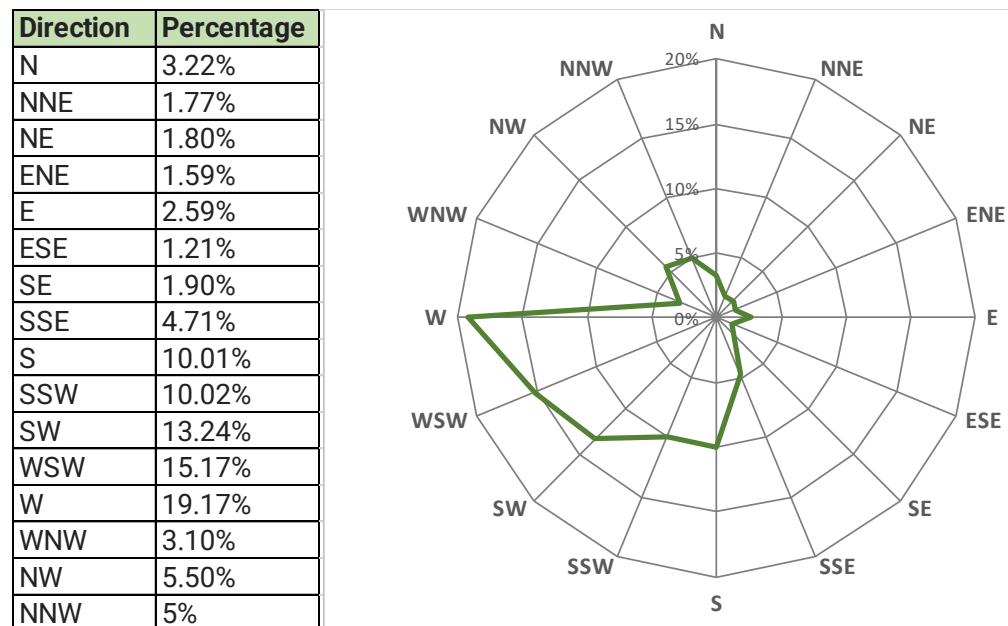
Figure ESSD1: Wind direction data and wind rose for Church Fenton meteorological recording station between 2000 - 2010 (inclusive)

3.1.4 The predominant local wind direction is from the western quadrant with the prevailing with significant contributions from the west-southwest / south-west, as seen in **Figure ESSD1**. Wind from the north-western quarter occurring relatively less frequently, with winds from the south-eastern and north-eastern, occurring very infrequently. Wind speeds remain below 5m/s for 65.44% of the time. Monthly wind speed averages throughout the year range from 3.8m/s to 5.27m/s.
