**ENVIRONMENTAL PERMIT VARIATION APPLICATION
WASTE RECOVERY PLAN**

**SKELBROOKE QUARRY EXTENSION AREA
STRAIGHT LANE
SKELBROOKE
DONCASTER**

**Document Reference: WR7640/09.R1
August 2022**

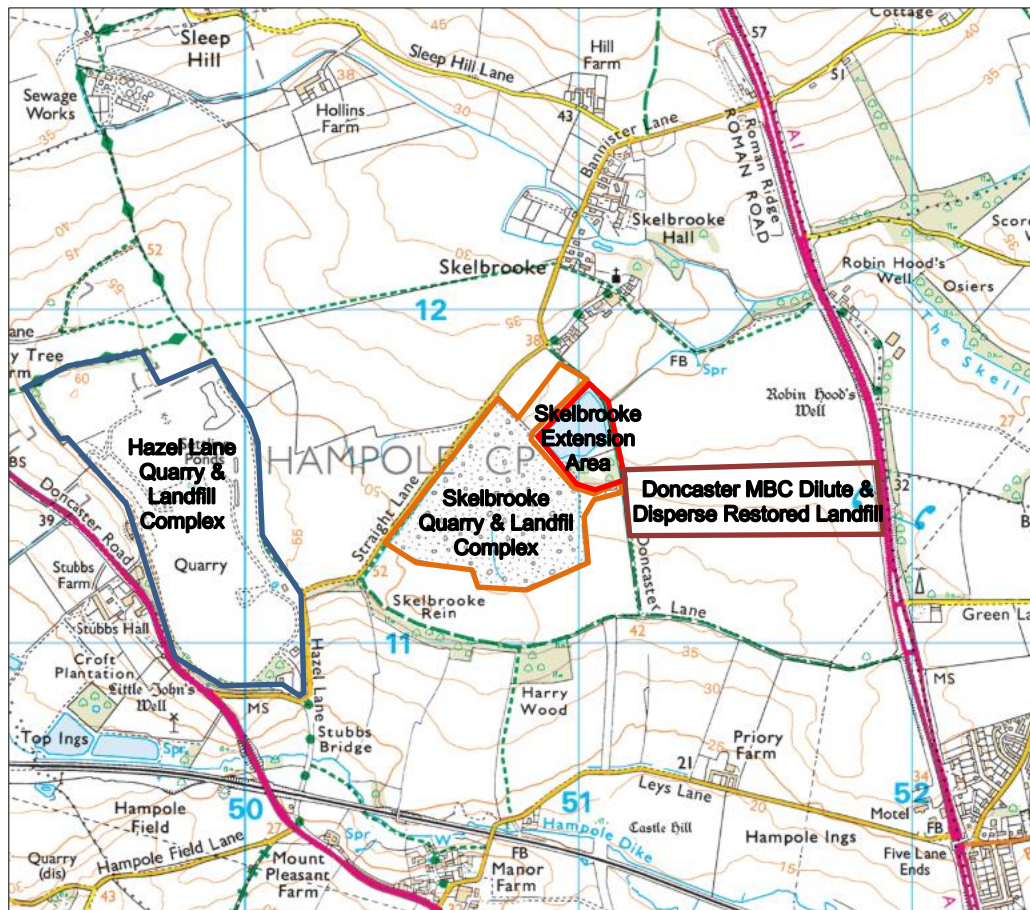
Figure 1: Site Location

- 2.1 Skelbrooke Quarry and Landfill is located 7.5 kilometres northwest of Doncaster, approximately 1km to the west of the A1(T) at National Grid Reference SE 510 116.

- 2.2 The area covered by the existing permit forms an (north-)eastern extension, of 4.5 hectares of the main quarry located to the south. The extension is bounded to the north and west by Straight Lane, to the north and east by Doncaster Lane, to the south by the quarry and landfill access road and to the southeast by restored landfill.

- 6.11 The northernmost section of the site depicted in **Drawing No SB450/D1** has already been restored to agricultural land using indigenous materials, as is evident from recent aerial imagery of the site presented in **Figure 1** below. The

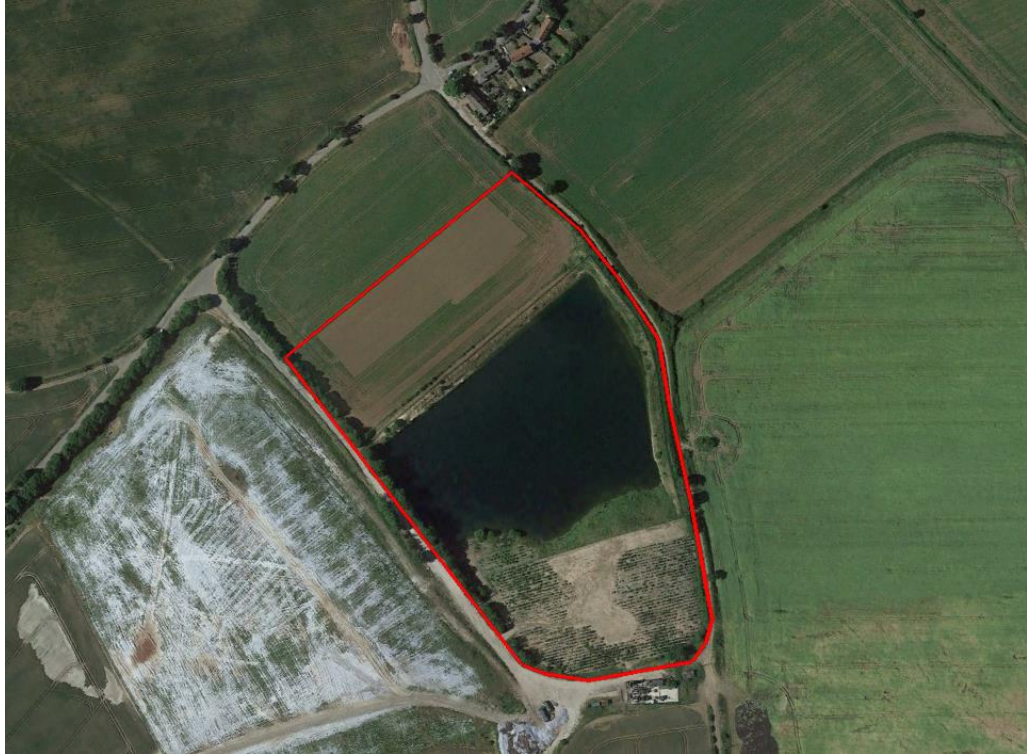
Figure 2: Restoration status of Skelbrooke Quarry Extension

Source: Google Earth (Imagery Date: June 2018)

use of imported materials is necessary to support the restoration of the flooded section of the site and a small portion of the south-eastern area; the extent of which is as indicated in **Drawing No. WR7640/10/WRP01**. The quantity of materials that need to be imported to site to achieve the final levels of the approved scheme of restoration has been modelled at 224,000m³. An additional 6,000 m³ of material will be deposited which will be site-won; making the total quantity of waste to be deposited a volume of 230,000 m³.
