**LKPHL 11 - SITE CONDITION REPORT FOR  
Blaxton Aggregates Limited  
Bank End Quarry  
Bank End Road  
Blaxton  
Doncaster  
South Yorkshire  
DN9 3AN**

1.0 SITE DETAILS	
Name of the applicant	Blaxton Aggregates Limited
Activity address	Bank End Quarry, Bank End Road, Blaxton, Doncaster, South Yorkshire DN9 3AN
National grid reference	SE 68332 00036

Document reference and dates for Site Condition Report at permit application and surrender	V2 25.05.2021
--	---------------

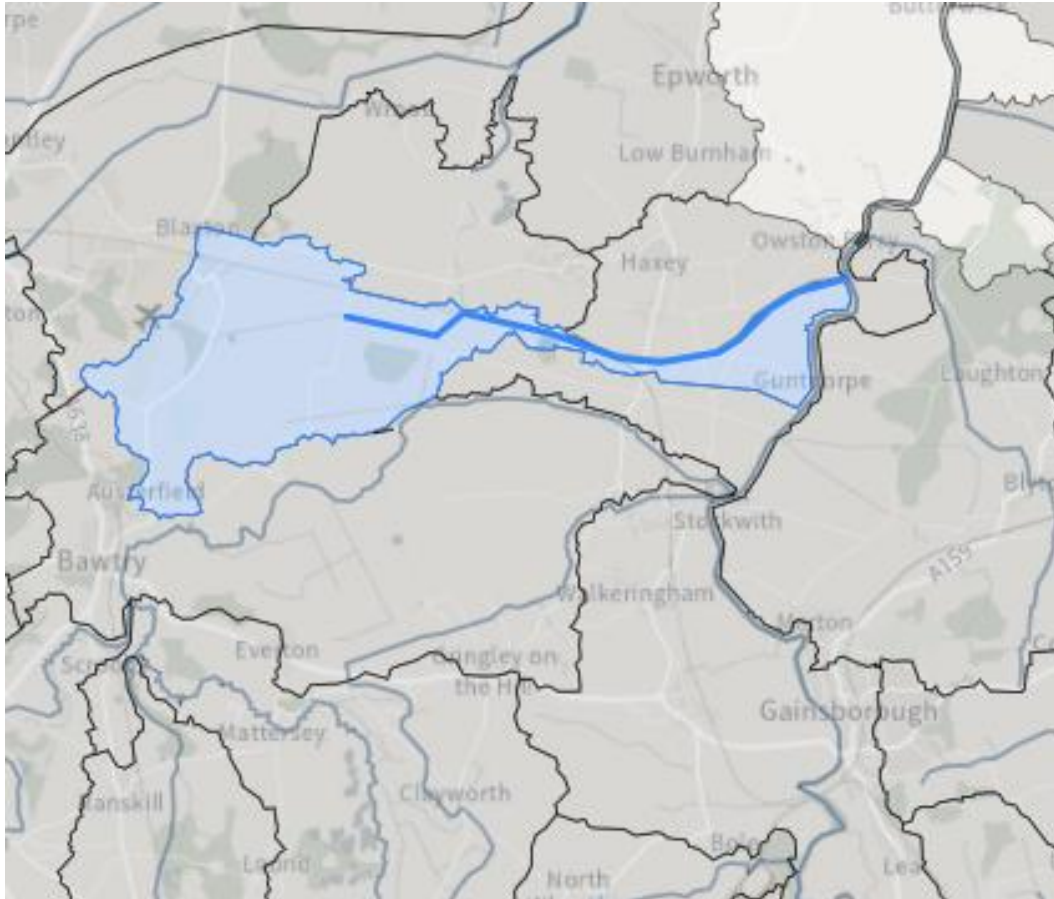
River catchment taken from Environment Agency catchment Data Explorer Site –  
(trib of Trent) Water Body

The site not connected to a local water course via surface water drains due to the lack of impermeable surfaces employed on the site.

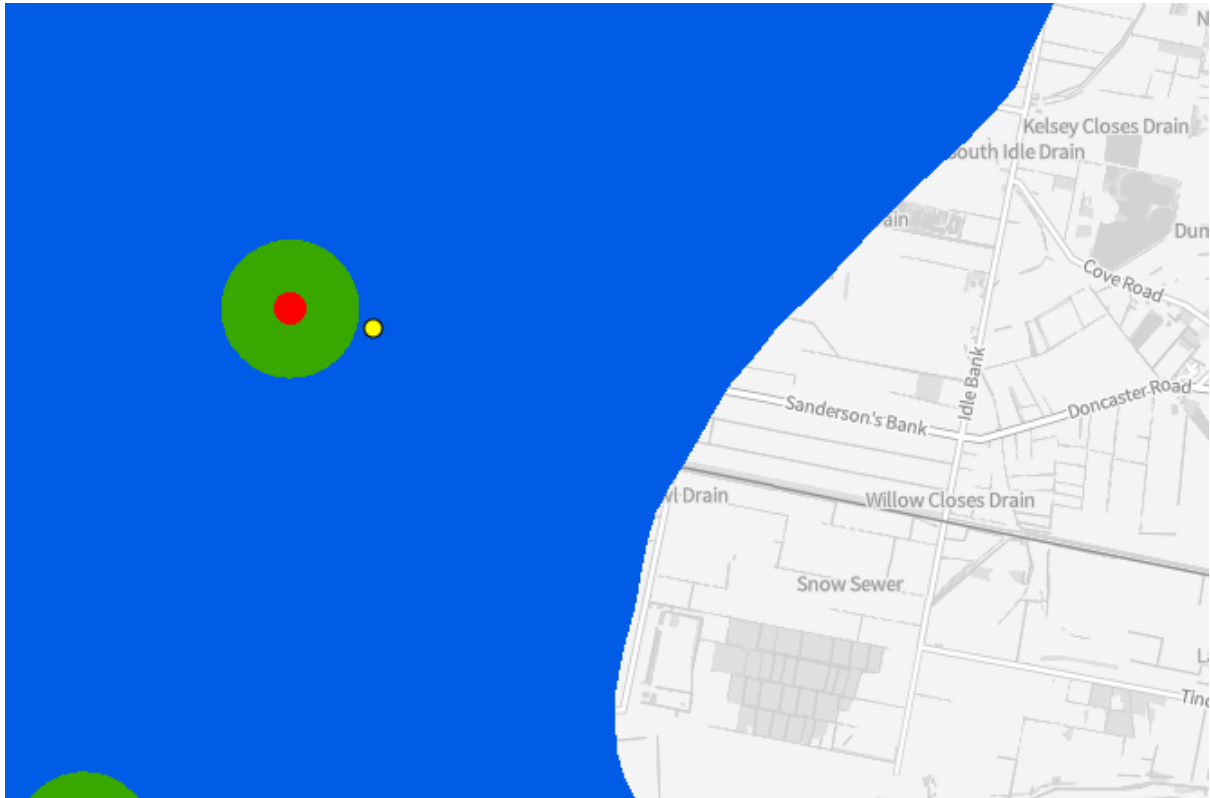
Map showing source protection zones, with the site being located within zone 3 total catchment.

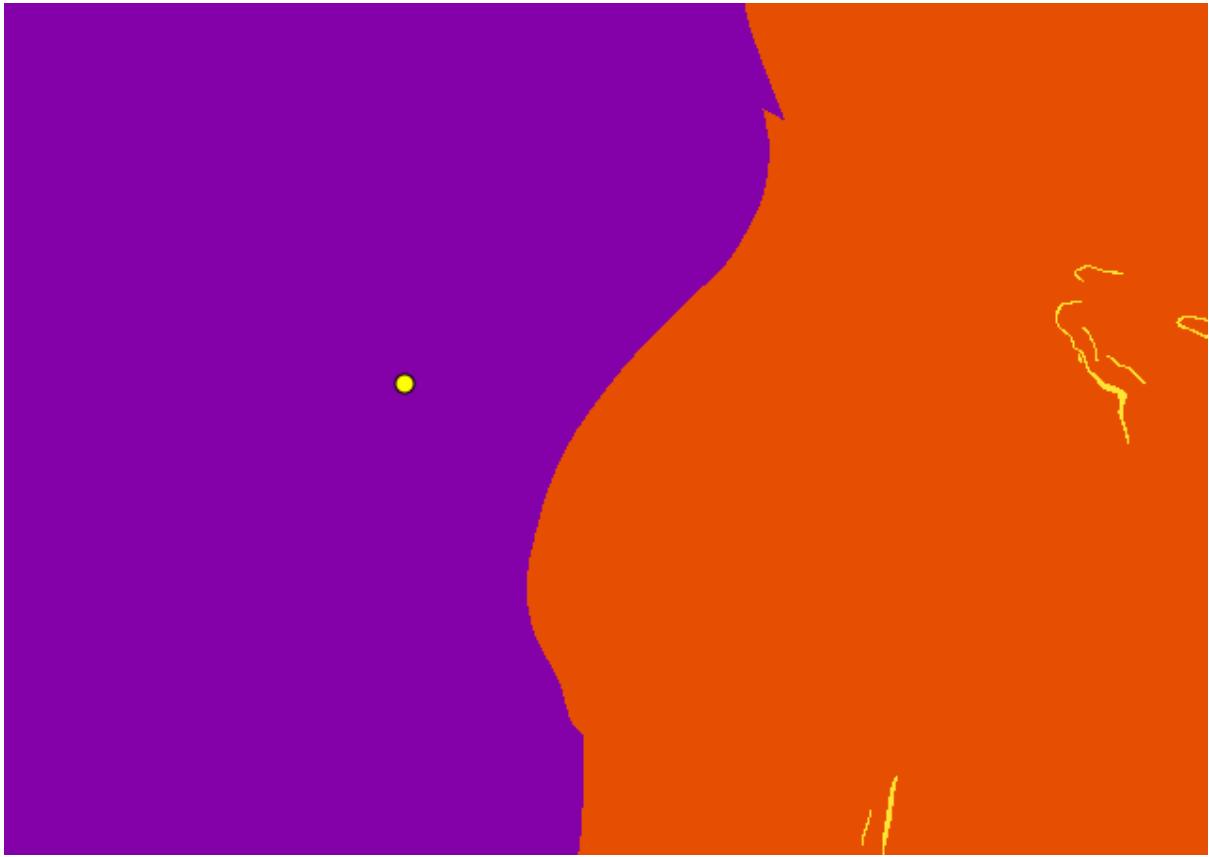
## Principal aquifer - Source Magic Map

The site is located within a principal aquifer.

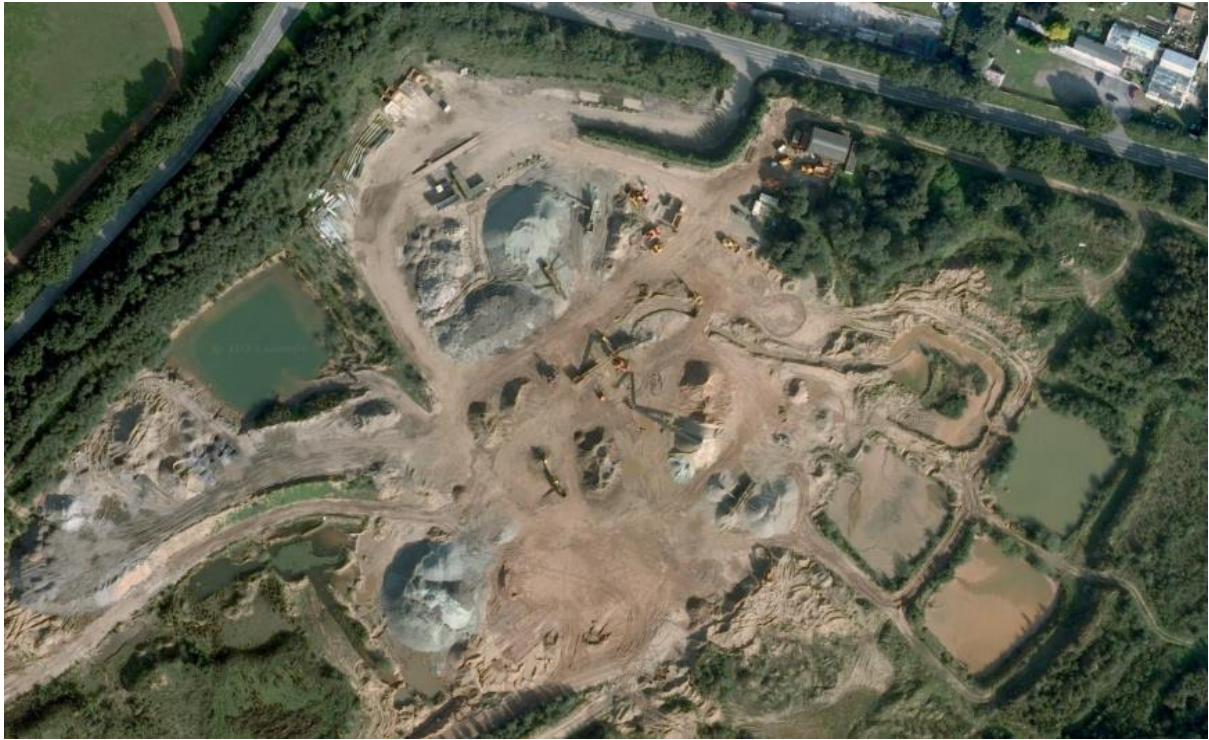
**Aerial photograph of the existing recycling and quarrying operation.**

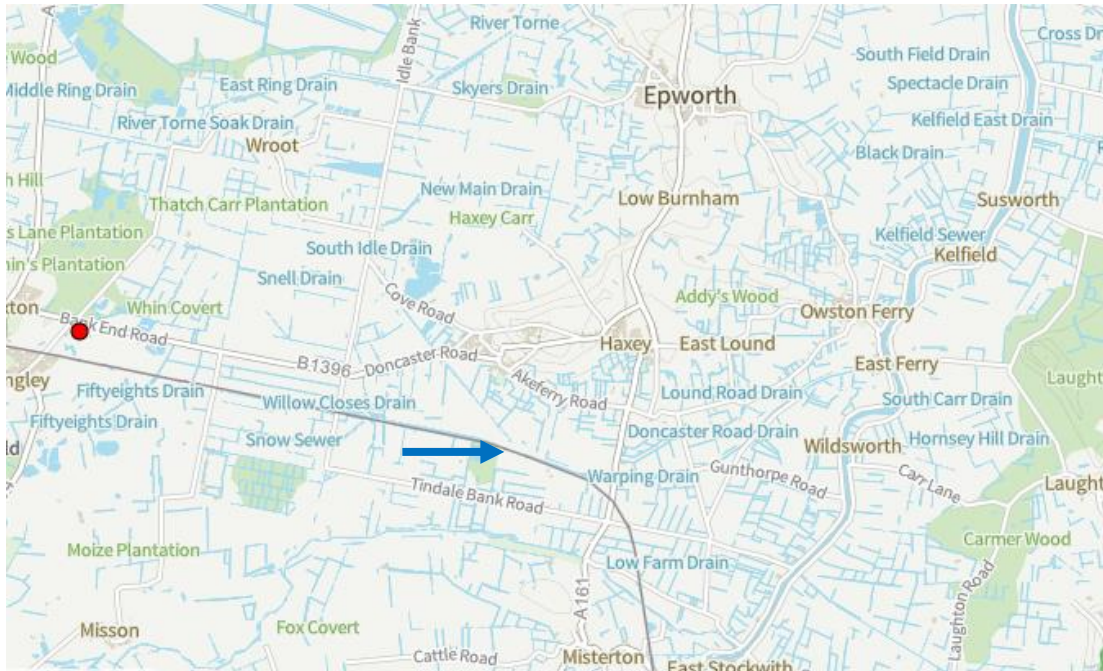
### Site location in proximity to the Warping Drain

Symbol	Item

Site

Warping Drain

The site is located within the Warping Drain catchment, which forms part of the River Trent catchment. The Warping Drain is fed in the locality by surface water drains and dykes such as. In the event of and containment or spill at the site without any pollution prevention measures that are explained within the Environmental Risk Assessment and highlighted in the Basic Conceptual Site Model (CSM) there would certainly be an impact on surface water from, however preventative measures have been taken.
