**CONSTRUCTION QUALITY
ASSURANCE VALIDATION REPORT**

**EARTHWORKS CONSTRUCTION FOR BASAL GEOLOGICAL
BARRIER PHASE 3**

REF:ARM/SCM/CLQ/CQA/1.00/2011

CHADWICH LANE QUARRY LANDFILL SITE

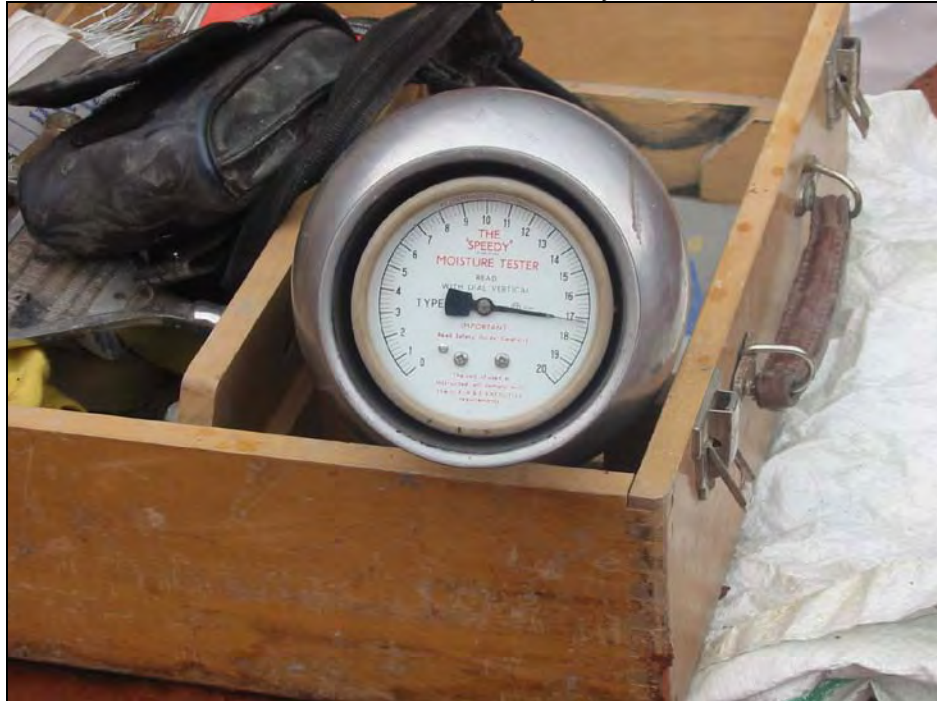
Plate 1:17% moisture on Ashworth Speedy Moisture Tester

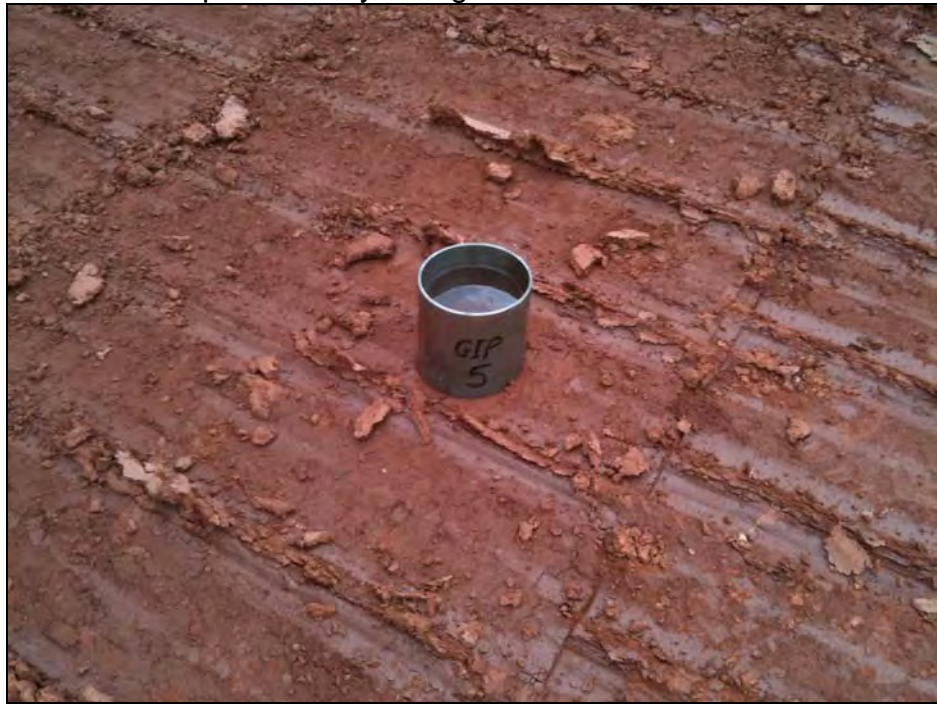
Plate 2: Core permeability falling head test on Phase 3

The permeability tests were carried out in accordance with the Environment Agency Guidance. Permeability test records are presented at Appendix 4.

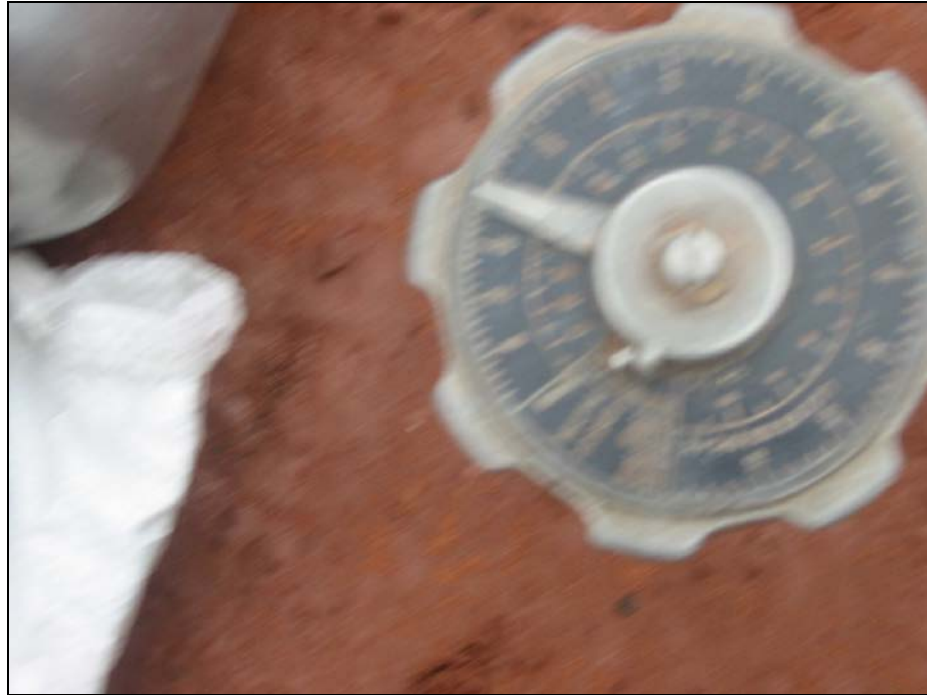
Plate 3: Hand shear vane result in excess of 100kPa

20 shear strength tests were undertaken at a rate of at least one test per 105m³ using an EDECO/Pilcon hand shear vane at random locations on the base and sides of each lift, within each section of geological barrier mineral liner placed, and are presented on summary sheets Appendix 5.

All of the results are well in excess of 50kPa.

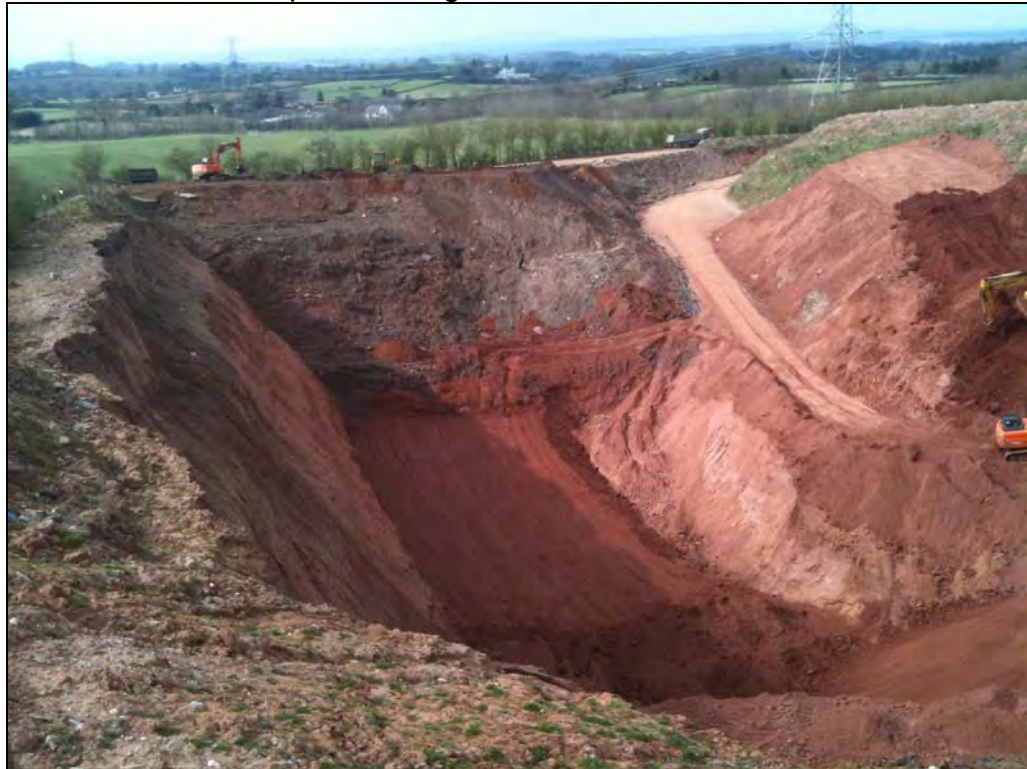
Plate 4:View of completed lining works for Phase 3

The mineral liner was over 1 metre in thickness as proved by physical measurements by the engineer on site.

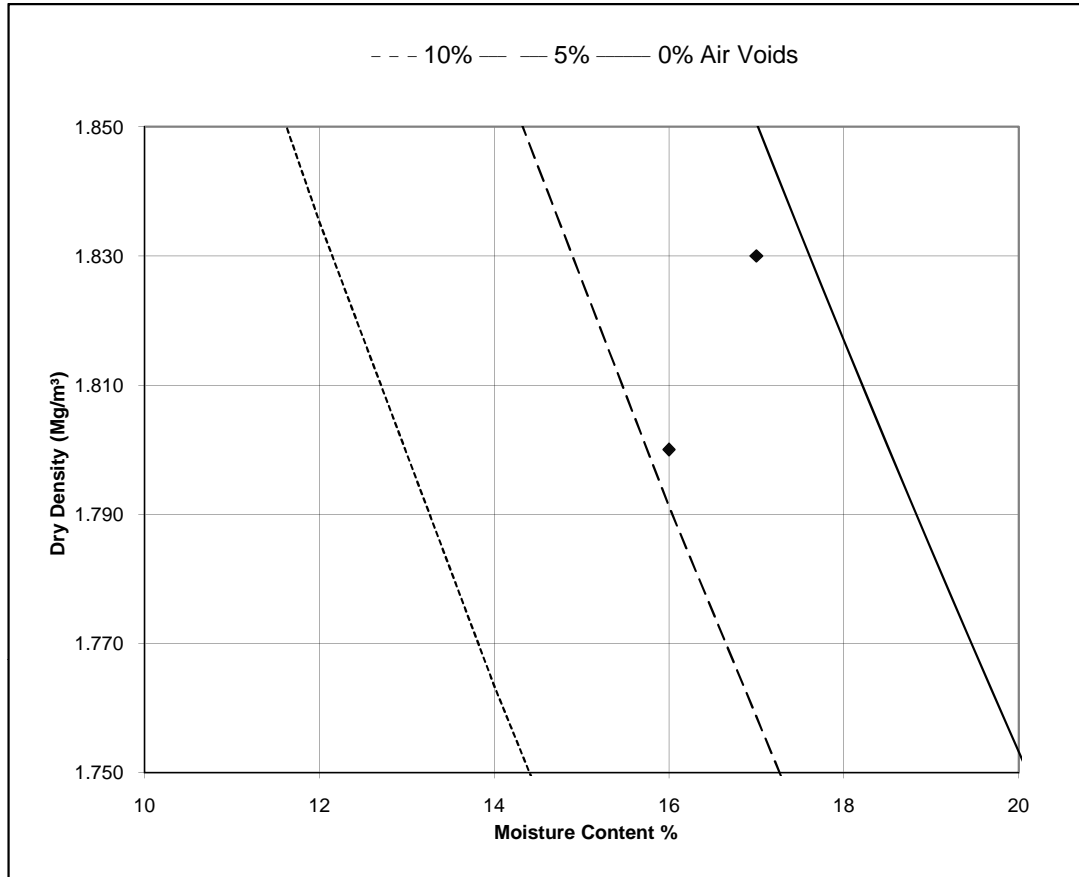
Graph 1 Base

MC	Density
16	1.800
17	1.830
0	0.000
0	0.000
0	0.000
0	0.000
0	0.000
0	0.000
0	0.000
0	0.000
0	0.000

Particle density 2.700

All of the plots were above the 5% air voids line.

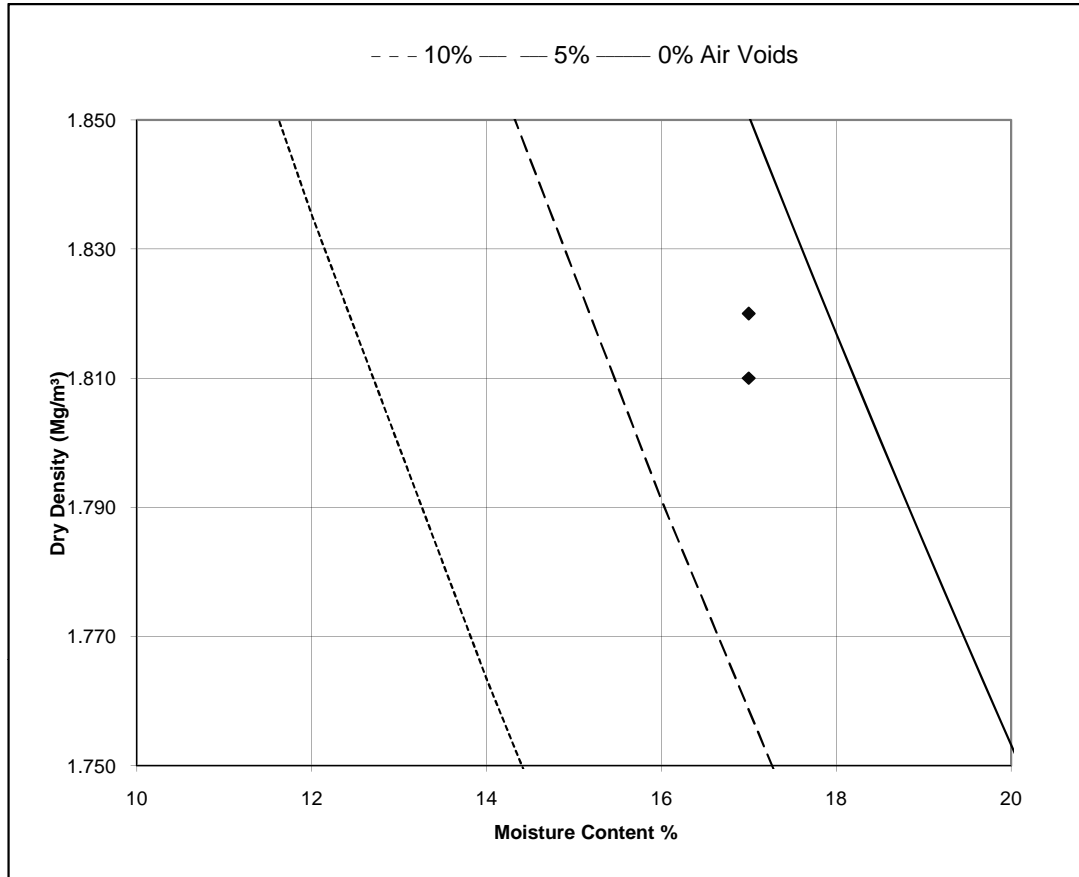
Graph 1 Base

MC	Density
17	1.810
17	1.820
0	0.000
0	0.000
0	0.000
0	0.000
0	0.000
0	0.000
0	0.000
0	0.000
0	0.000

Particle density 2.700

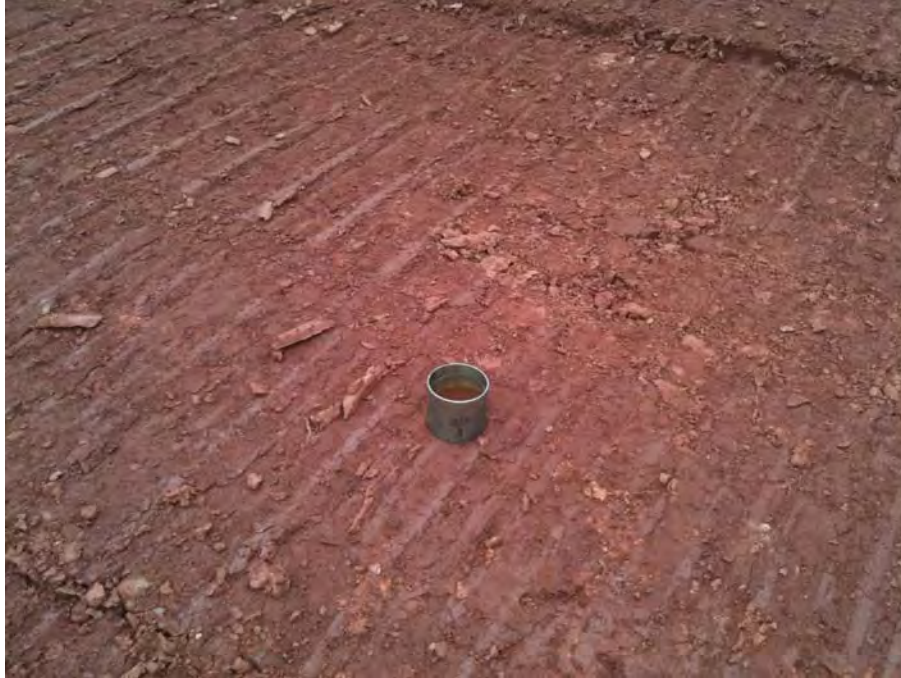
Phase 3 Section 1: Falling Head Permeability 21/03/2011

Placement of the clay was carried out in four lifts between 21st March and 6th May in two phases. The plastic limit was reported at 17% and had a natural moisture content of 16% to 17%. The permeability falling head test carried out in 21st March still had lost no water on 23 March.

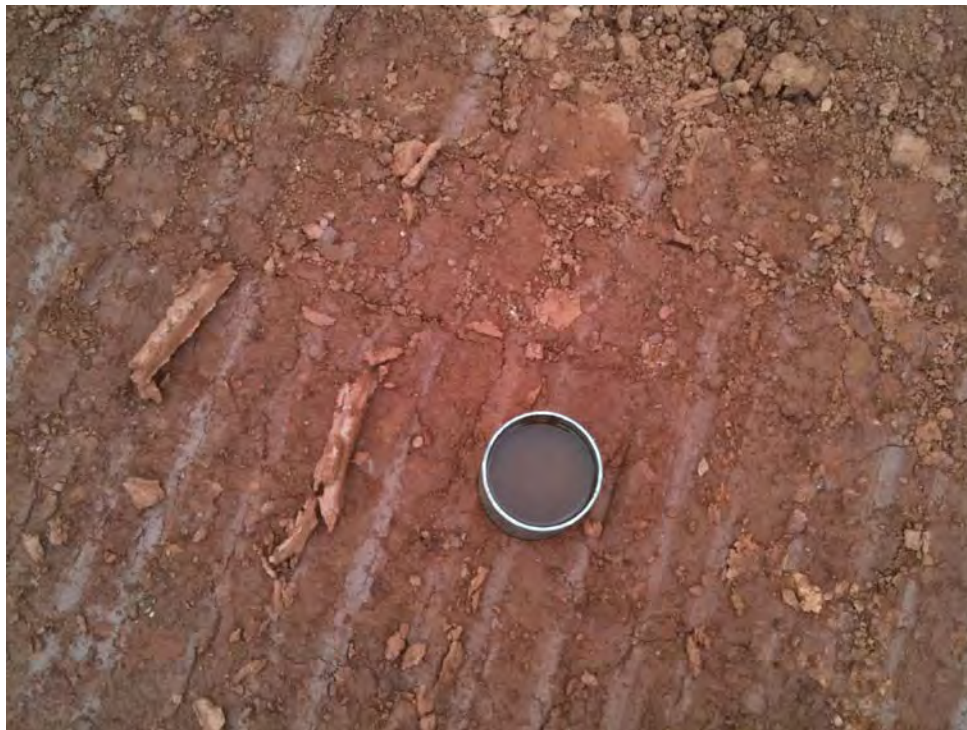
Phase 3 Section 1: Falling Head Permeability 23/03/2011

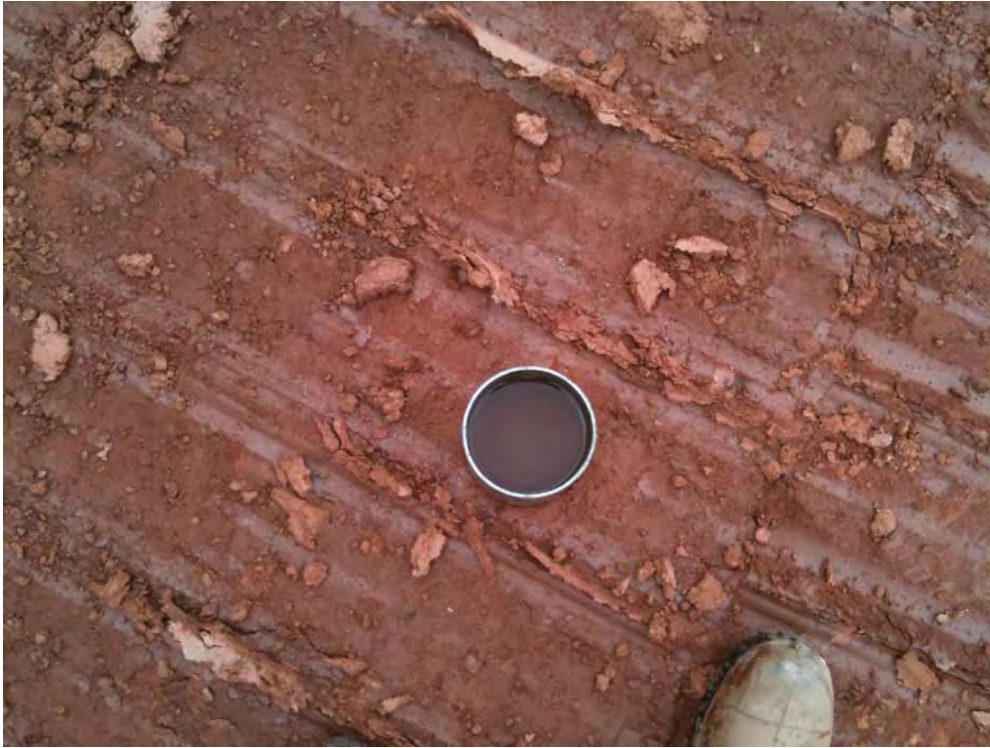
Permeability Test Phase 3 Section 2 4th May 2011

Section 2 moisture values were at 17%. The cores did not lose any water from 29th April to 2nd May. The Phase 3 Section 2 basal lining works were completed on the 6th May 2011.

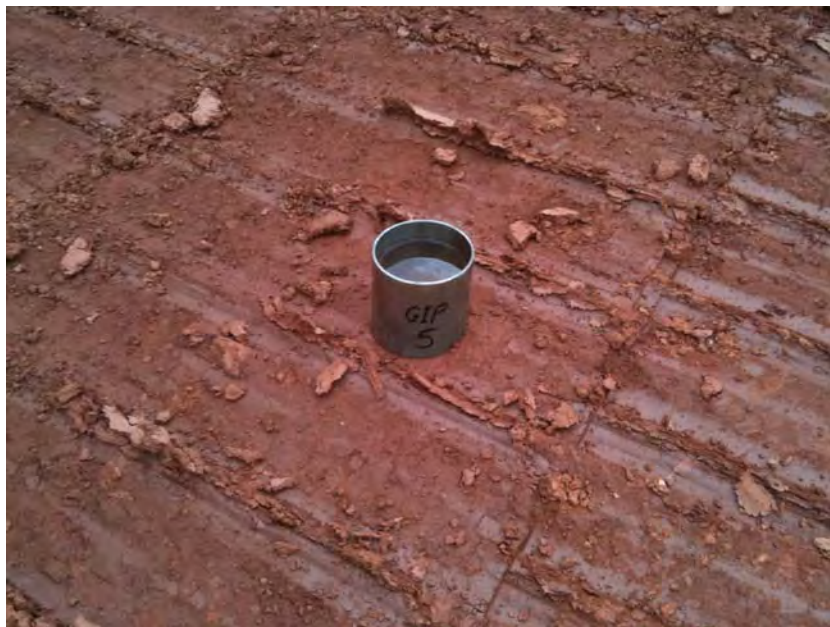
Permeability Test Phase 3 Section 2 6th May 2011
