Depot Wet Waste Bay Site Condition Report

South Molton Depot

South Molton Highways Depot, Pathfields Industrial Estate, South Molton, EX36 3LH

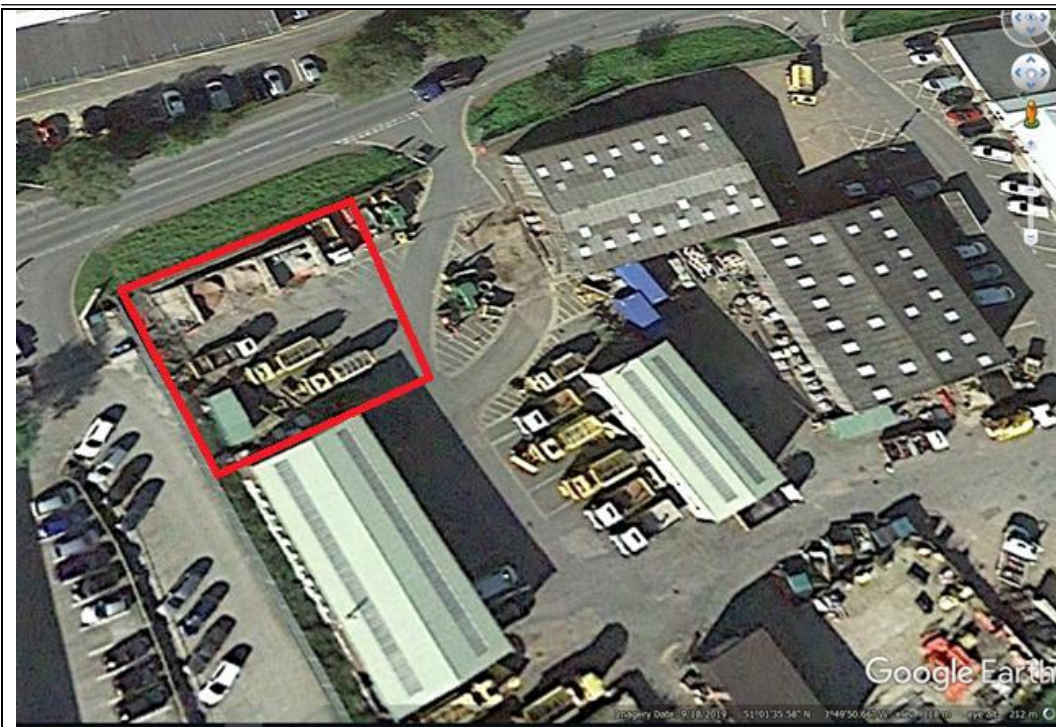
Figure (i) - Site photos

Aerial view taken during site walkover on 18 September 2019
Data source: Google Earth

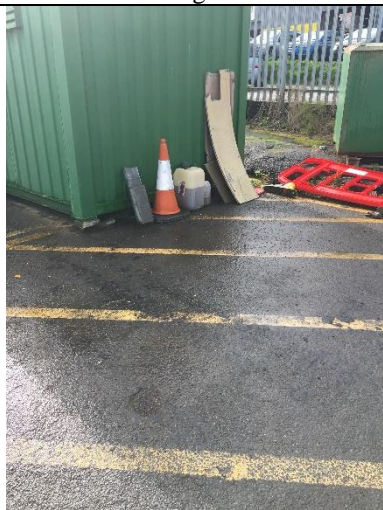
Photo shows existing tarmac surface and location of cabin and perimeter fence. (Note the container was moved into the COSHH store)
