## Depot Wet Waste Bay Site Condition Report

### South Molton Depot

*South Molton Highways Depot, Pathfields Industrial Estate, South Molton, EX36 3LH*

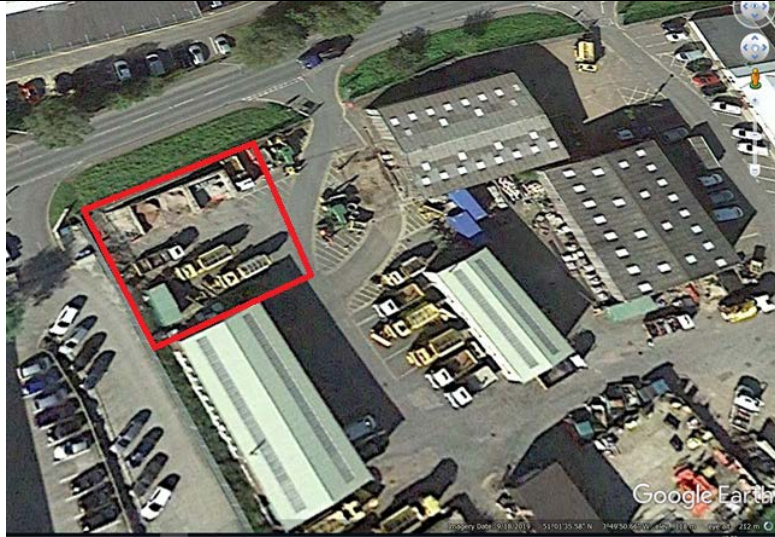
**Figure (i)** - Site photos

Aerial view taken during site walkover on 18 September 2019  
Data source: Google Earth

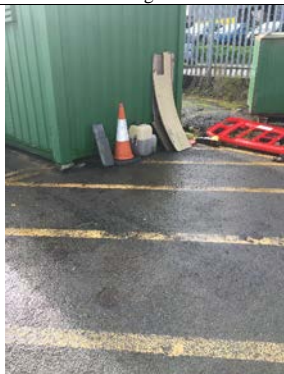
Photo shows existing tarmac surface and location of cabin and perimeter fence. (Note the container was moved into the COSHH store)
