**Coastal Recycling
Deep Moor
Waste Transfer and Composting
Facility
Site Condition Report**

June 2024

Report Number: 2095-R003

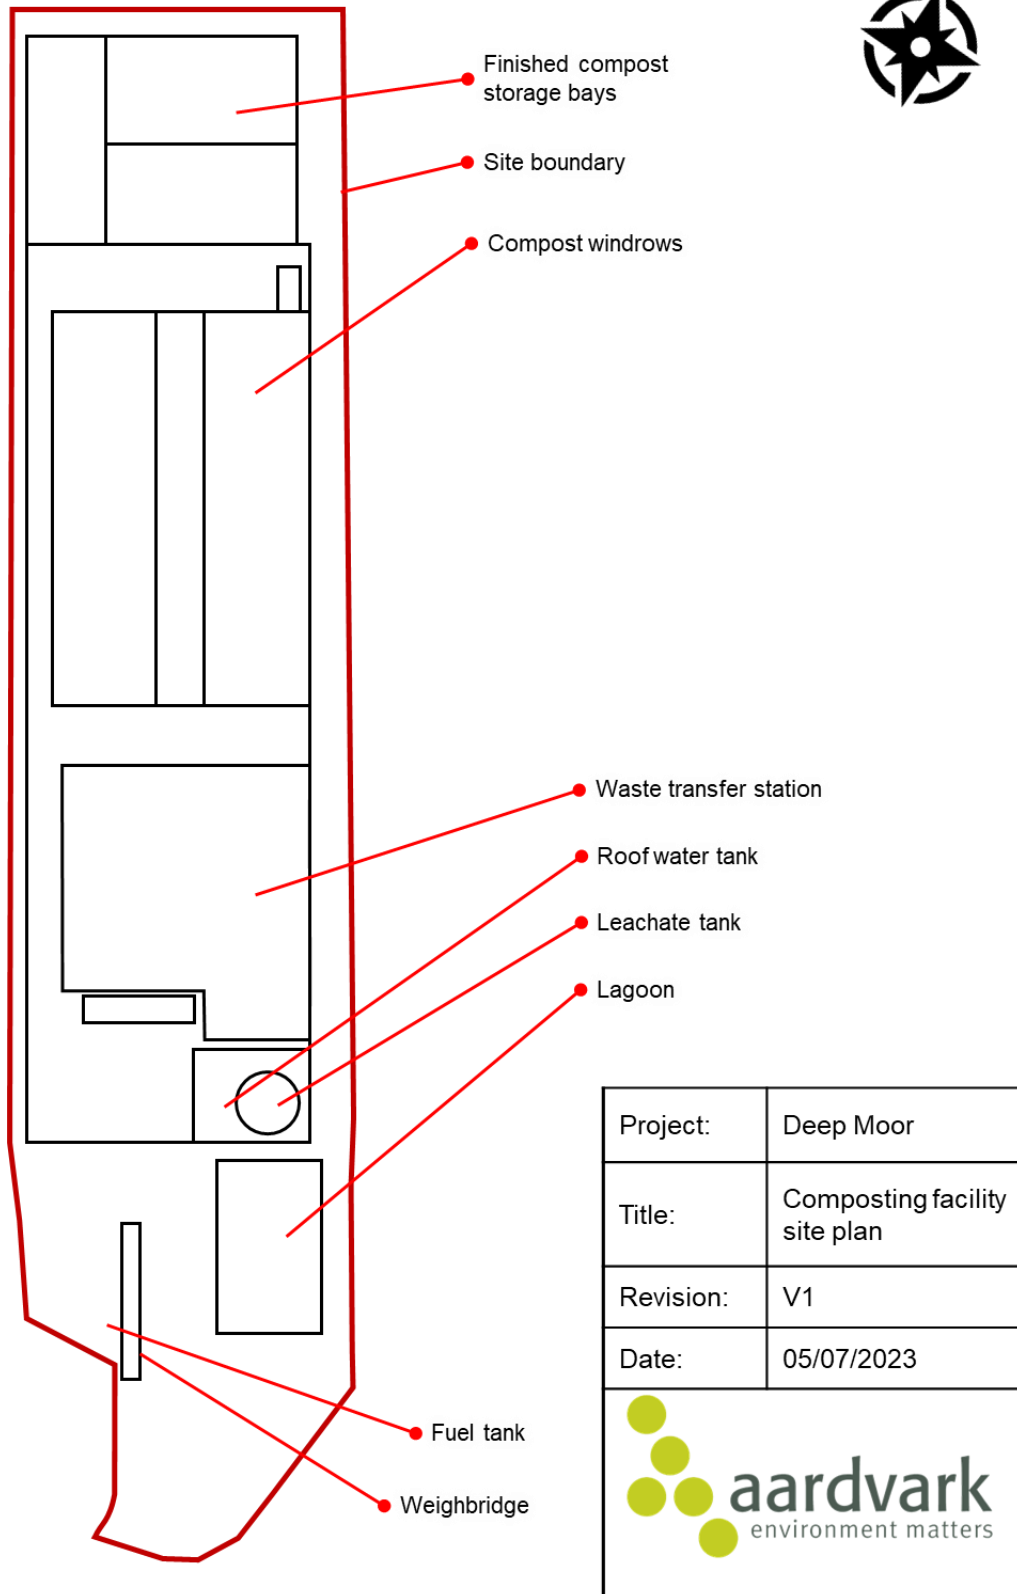
Figure 2: Deep Moor Composting and Waste Transfer Station Site Layout

The site layout is displayed below in figure 2 and 3.

Project:	Deep Moor
Title:	Composting facility site plan
Revision:	V1
Date:	05/07/2023

Materials enter the site via the site entrance, heading North towards the Waste Transfer and Composting Site entrance. Before entering the site they pass over the weighbridge where waste acceptance checks are completed, including waste transfer notes and weighbridge tickets. No public vehicles will access this area of the site. Please see figure 2 which displays the permitted area.

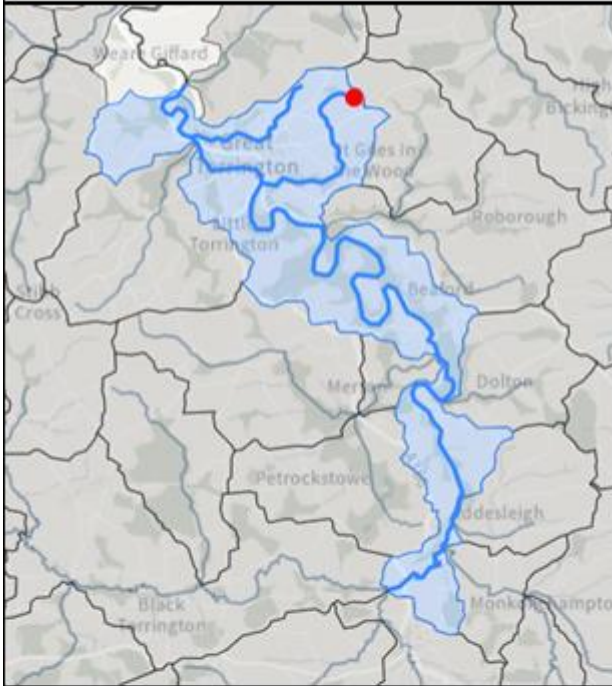
Torrige (Lew to Estuary) Water Body

Located within the Torridge (Lew to Estuary) Water Body, within the Torridge Operational Catchment, North Devon Management Catchment and the South West River Basin District.
