STABILITY RISK ASSESSMENT LOWER HARE FARM WHITESTONE, EXETER

Prepared for: AA Environmental Limited

ASL Report No. 167-22-696-13Rev1

July 2022

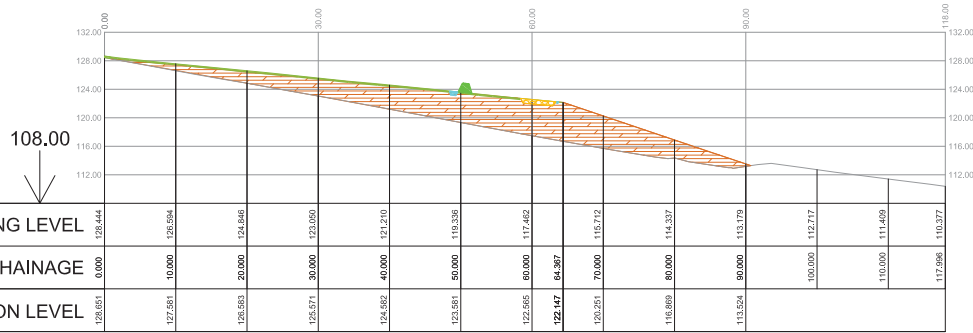
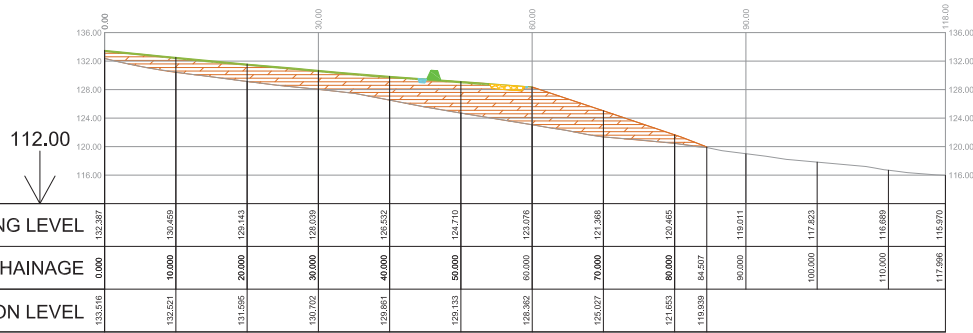
A-AA
 Horiz. 1:500
 Vert. 1:500

B-BB
 Horiz. 1:500
 Vert. 1:500

C-CC
 Horiz. 1:500
 Vert. 1:500

D-DD
 Horiz. 1:500
 Vert. 1:500

- Key:**
- Existing Ground Level
 - Reinstated Soils
 - Engineering Fill
 - Devon Hedgebank
 - Drainage Swale
 - Haul Route
 - Surface Water Grip

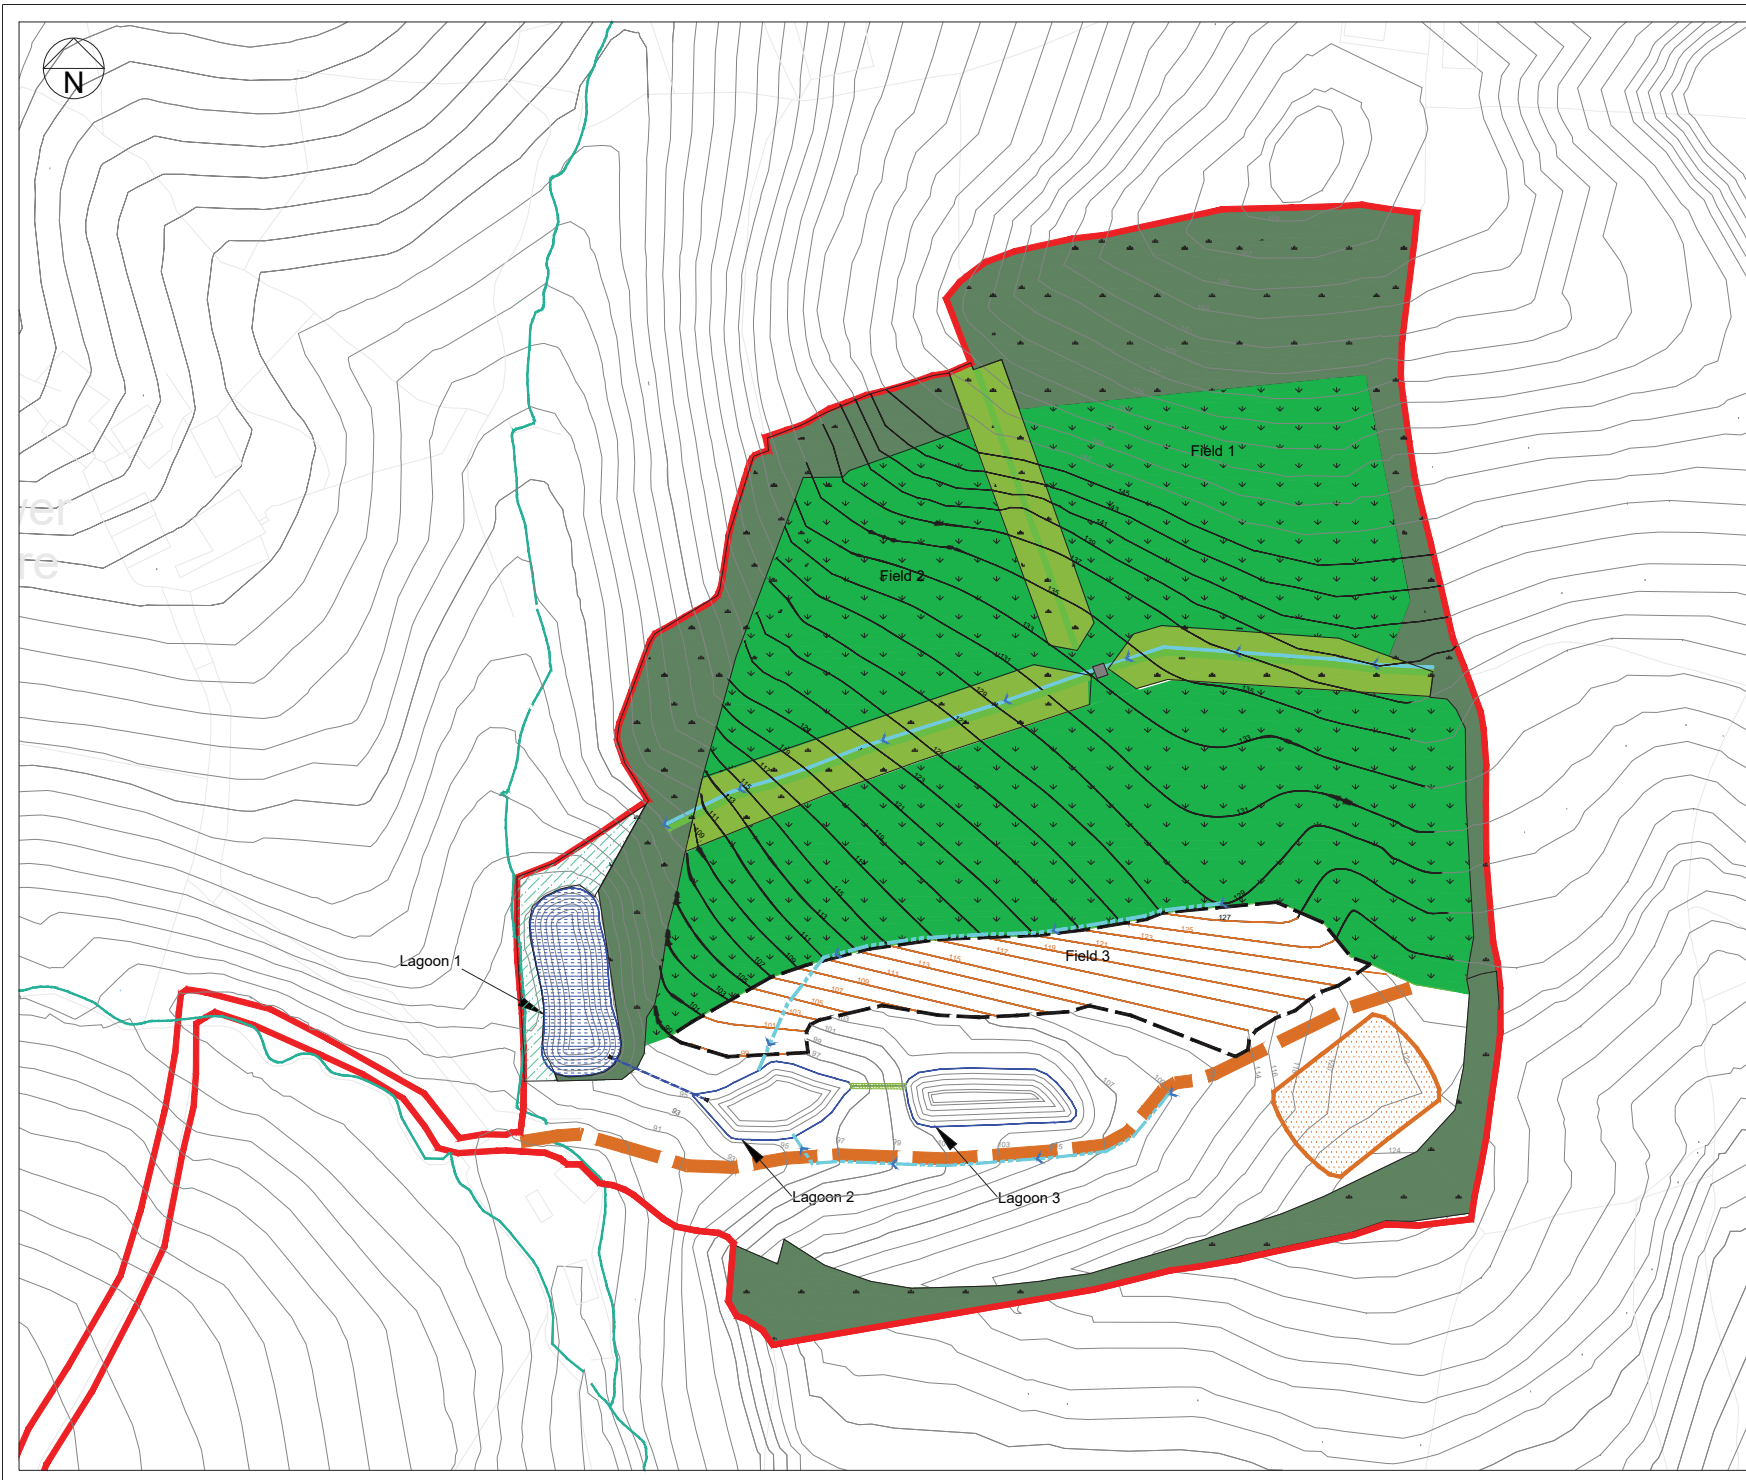
Scale	Date	Apr'22	Drg. No.	Rev.
1:2,000@A3	Drawn	KW	Chkd.	ML
			213189/D/PH2/001B

- Key:**
- Site Boundary
 - Area of overlap of Phase 2 & 3 Earthworks
 - Existing ground level contours
 - Restoration contours
 - Contours in area of P2 and P3 overlap
 - Headland (Lowland Meadow Habitat) Buffer Zone
 - Headland (Neutral Grassland Habitat) Buffer Zone
 - Restored Agricultural Field
 - Retained existing trees
 - Devon Hedgebank
 - Permanent Drainage Swale
 - Temporary Drainage Ditch
 - Haul Route
 - Temporary Drainage Swale
 - Surface Water Feature
 - Topsoil Stockpile
 - Attenuation Pond
 - Culvert
 - DN450 Twinwall Pipe

- Notes:**
1. Total site area: 115,385 m²
 Site area fully restored in Phase 2: 78,091 m²
 Percentage of site fully restored in Phase 2: 67%
 2. Phase 2 volume of engineering fill / geological barrier: 23,260 cu m.
 3. Phase 2 volume of restoration soils: 13,180 cu m.
 4. Phase 2 volume of inert waste: 55,820 cu m.
