HYDROGEOLOGICAL RISK ASSESSMENT

COLSTERWORTH TRIANGLE QUARRY

Report Reference: 3601/HRA

December 2024

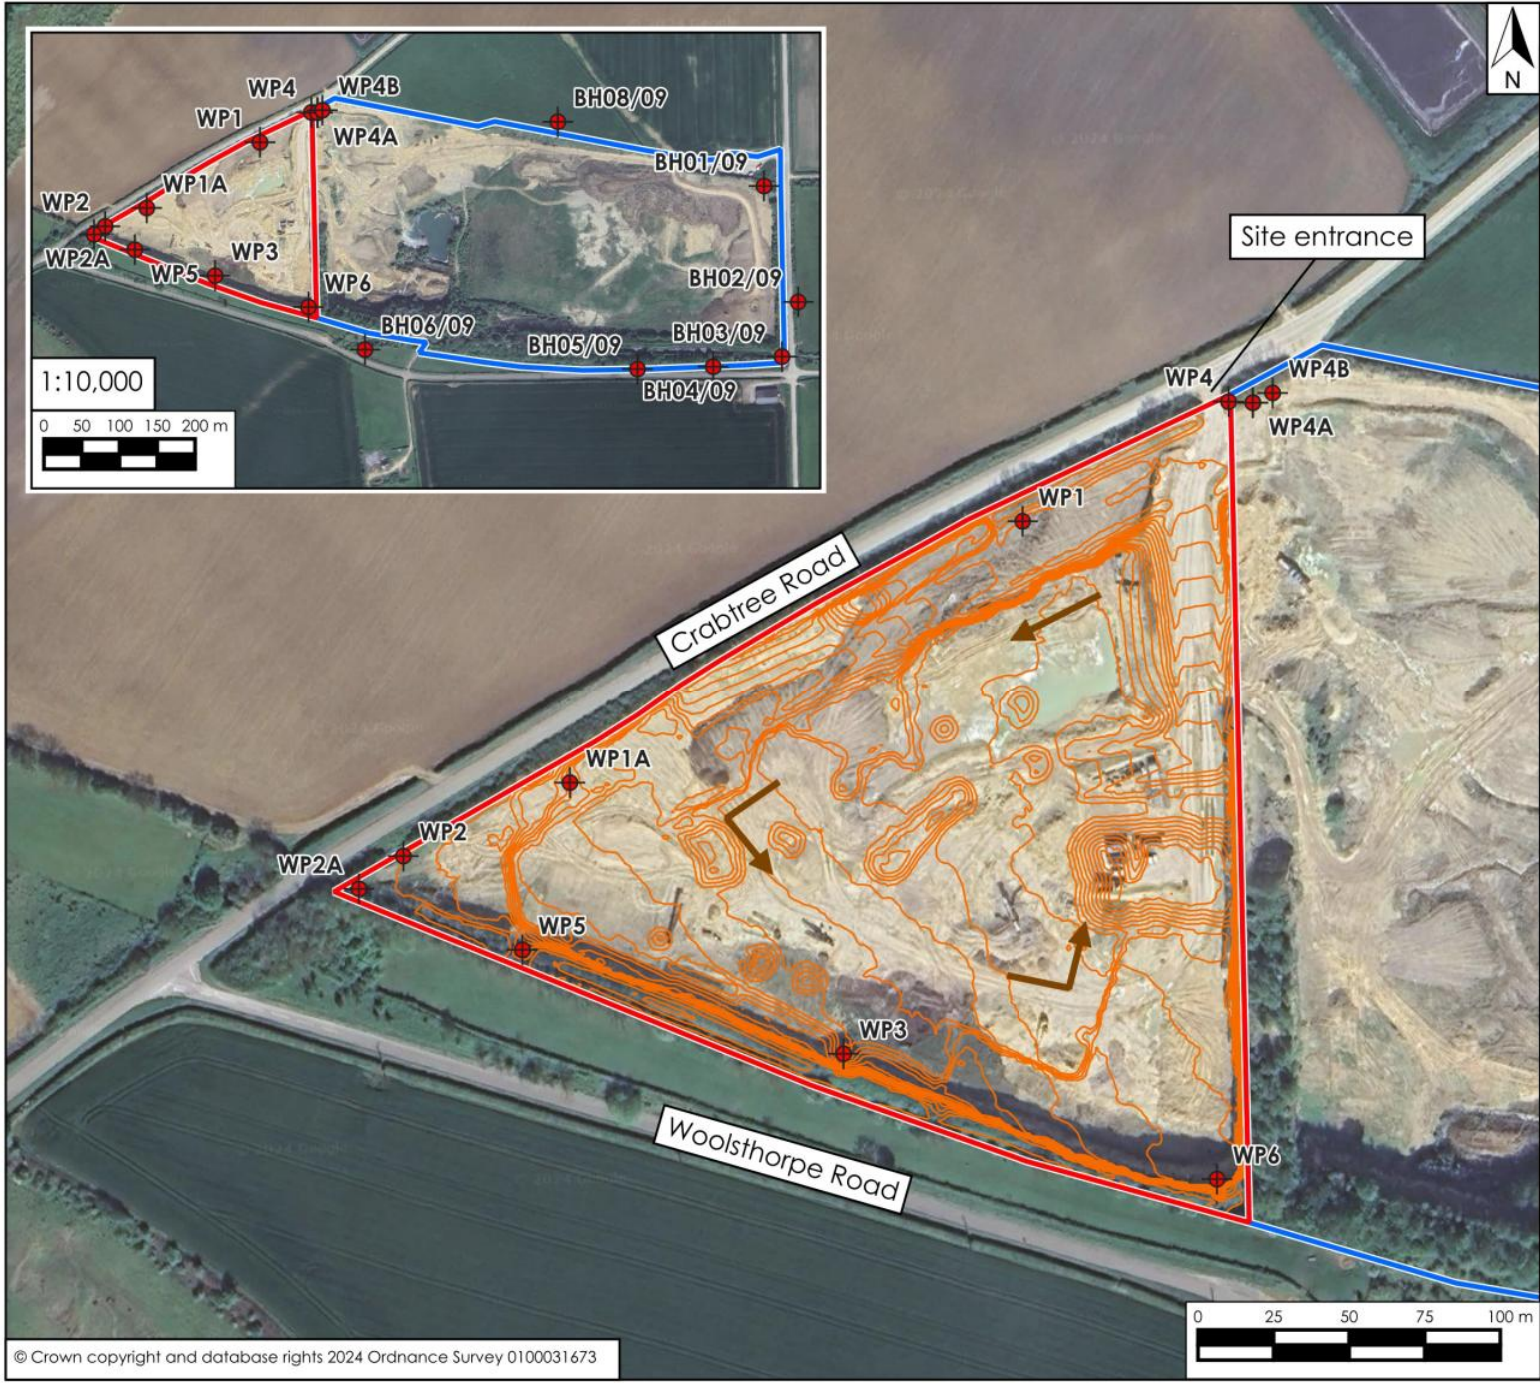
- Key
- Application boundary
 - FCC Colsterworth Landfill
 - 1m contour (mAOD)
 - Monitoring borehole (id)
 - ➔ Proposed direction of infilling

The site layout and proposed direction of working is shown on *Drawing 3601/HRA/02*. The proposed permit boundary covers the worked-out area west of the FCC Landfill and totals approximately 4.3 hectares (ha). The site is accessed off Crabtree Road to its northeast.
