Stability Risk Assessment for
STAINBY QUARRY
nr Colsterworth, Lincolnshire

ref. CES/STQ/101 v4
December 2024

Project Name: Stability Risk Assessment for STAINBY QUARRY,
nr Colsterworth, Lincolnshire

Project No.: CES/STQ/101 v4

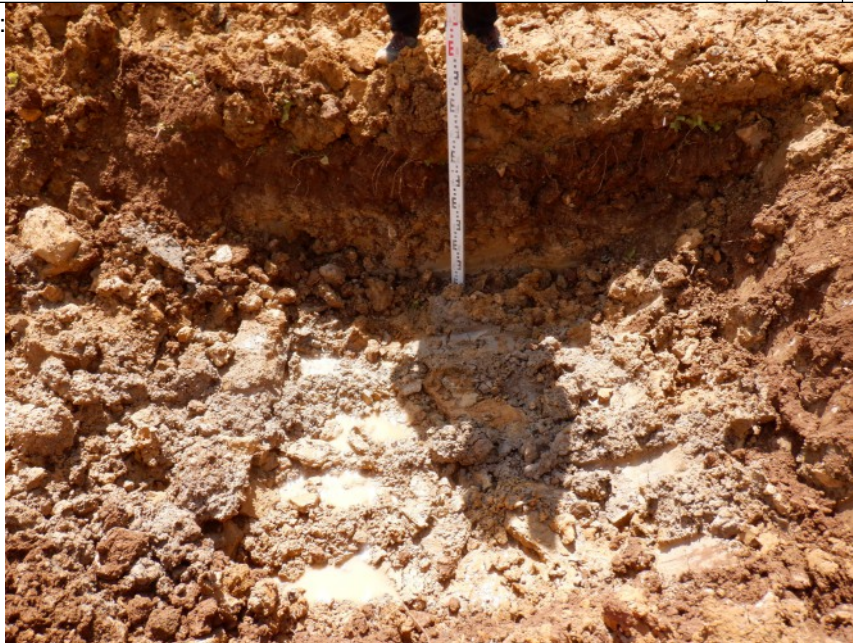
TRIAL PIT PHOTOS:

STRATA		SAMPLES & TESTS			
Legend	Depth (elev)	DESCRIPTION	Depth	No	Remarks/Tests
		OVERBURDEN CLAY - Soft orangish brown mottled with light orange, silty slightly sandy CLAY. Gravel sized fragments of buff limestone. Colour of the clay lightens with depth. Overburden storage material has been tipped onto limestone after extraction.	0		
	0.60 (132.38)	LIMESTONE - Buff yellow LIMESTONE. Strongly bedded.			
	0.70 (132.28)	CLAY - Light bluish grey silty, slightly sandy CLAY. Silt occurs in laminated bands in the clay. Clay is soft to firm with rare gravel observed.	0.70-1.00	B1 D1 B2	
	1.00 (131.98)		1

Pit stable, no groundwater encountered.

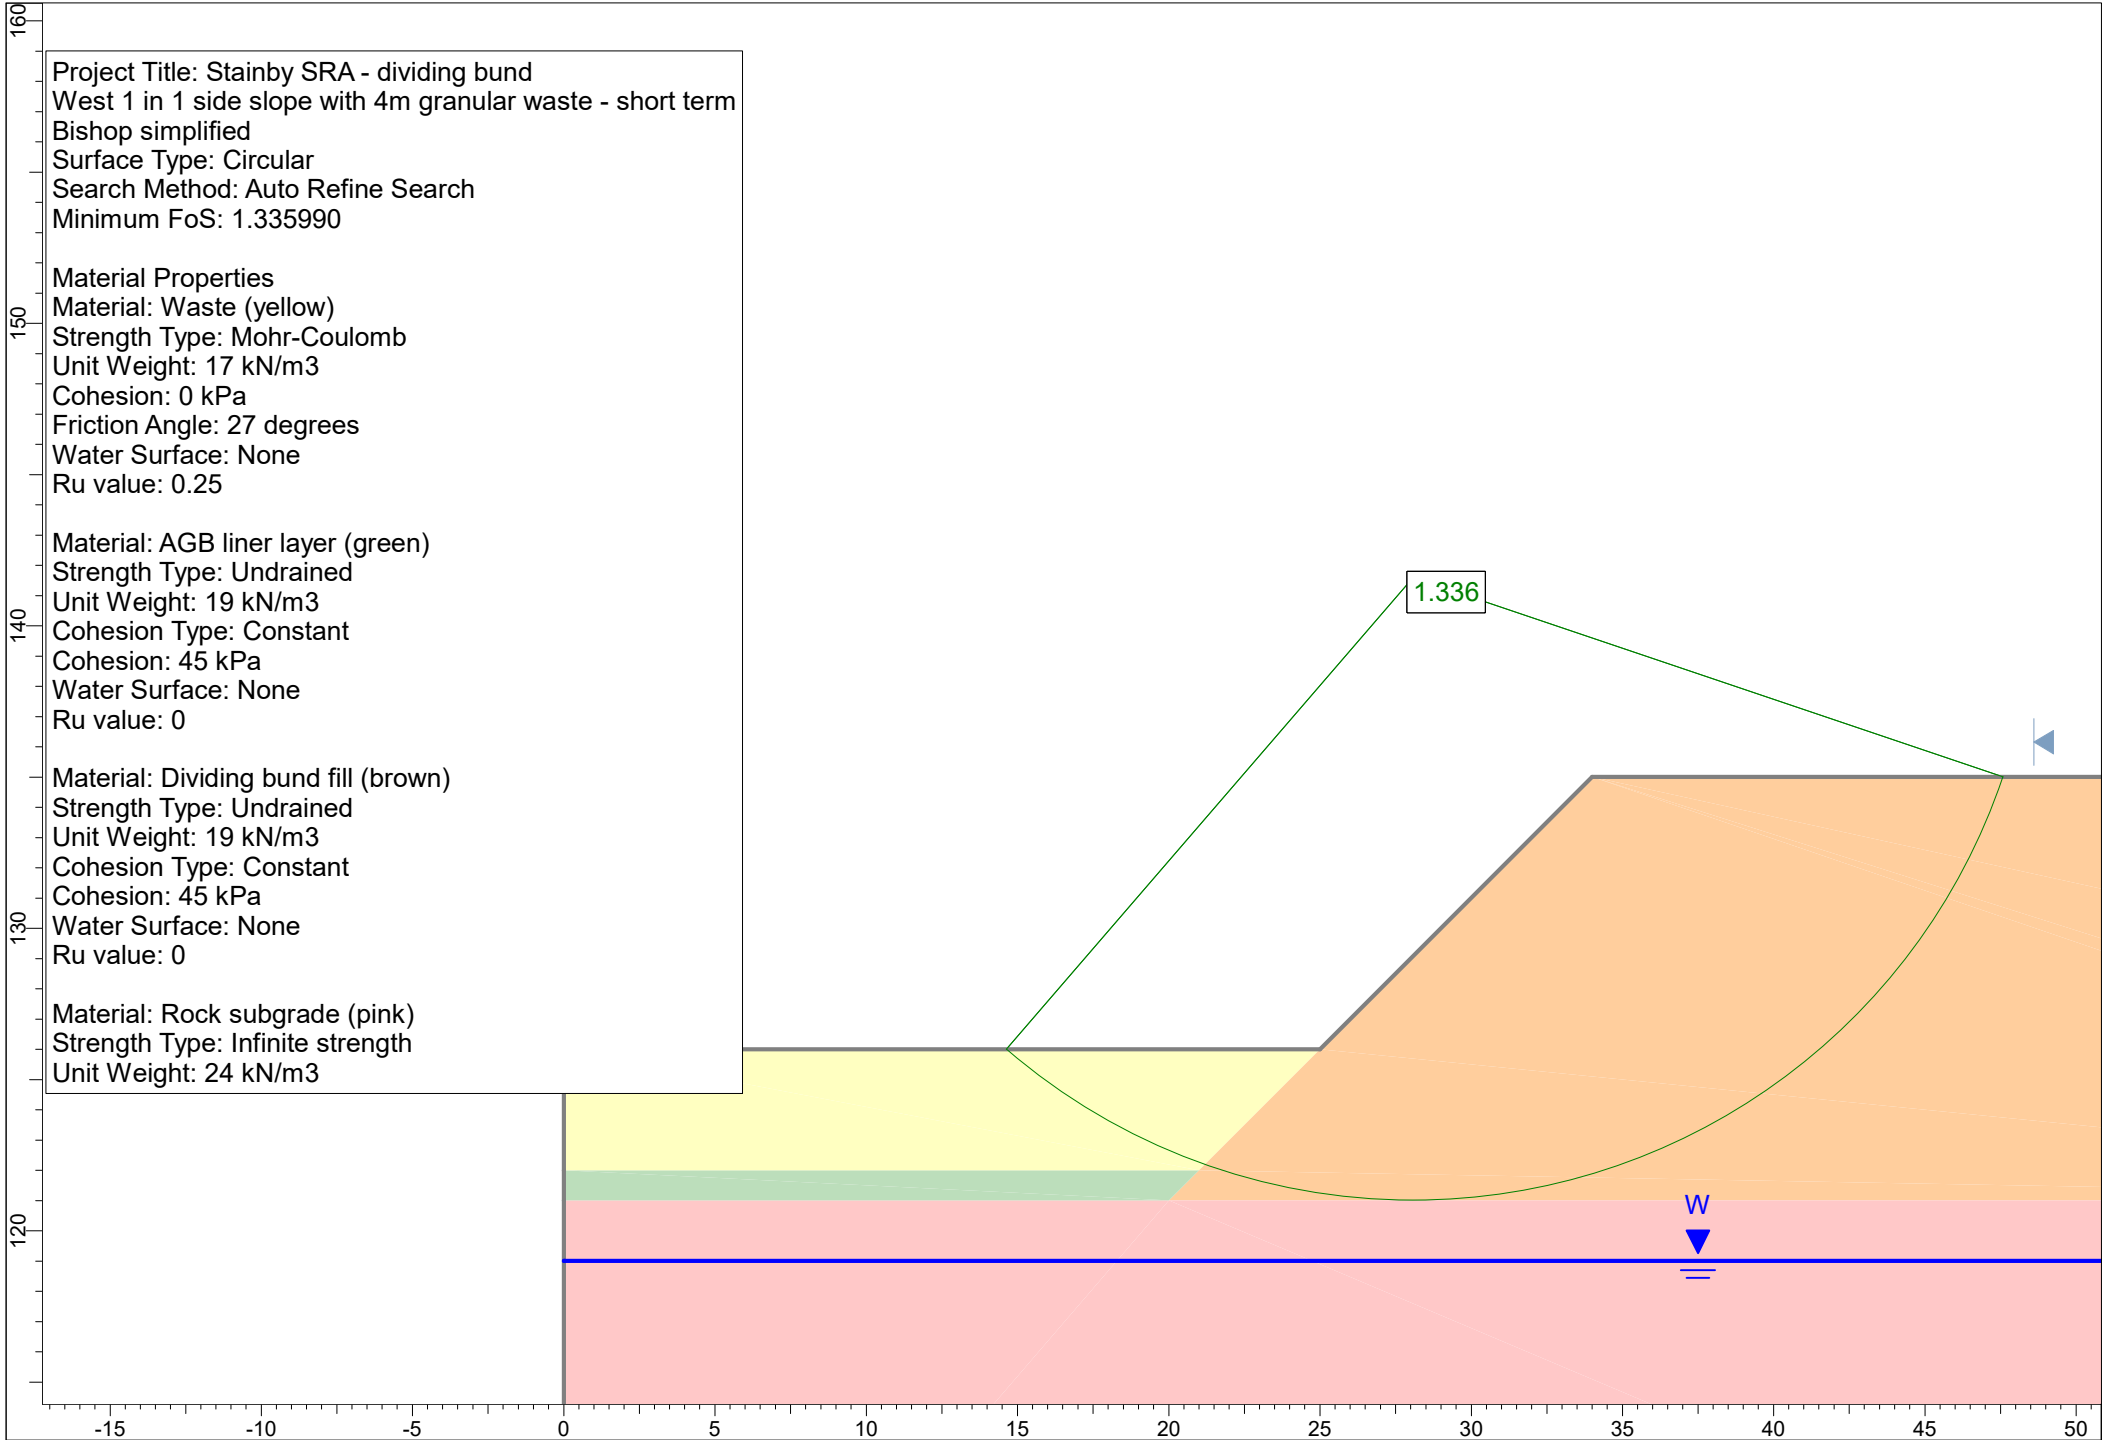
File Name: Stainby 1in1 dividing bund sideslope 3m waste ST.sli

Project Title: Stainby SRA - dividing bund W 1 in 1 side slope with 4m granular waste - short term

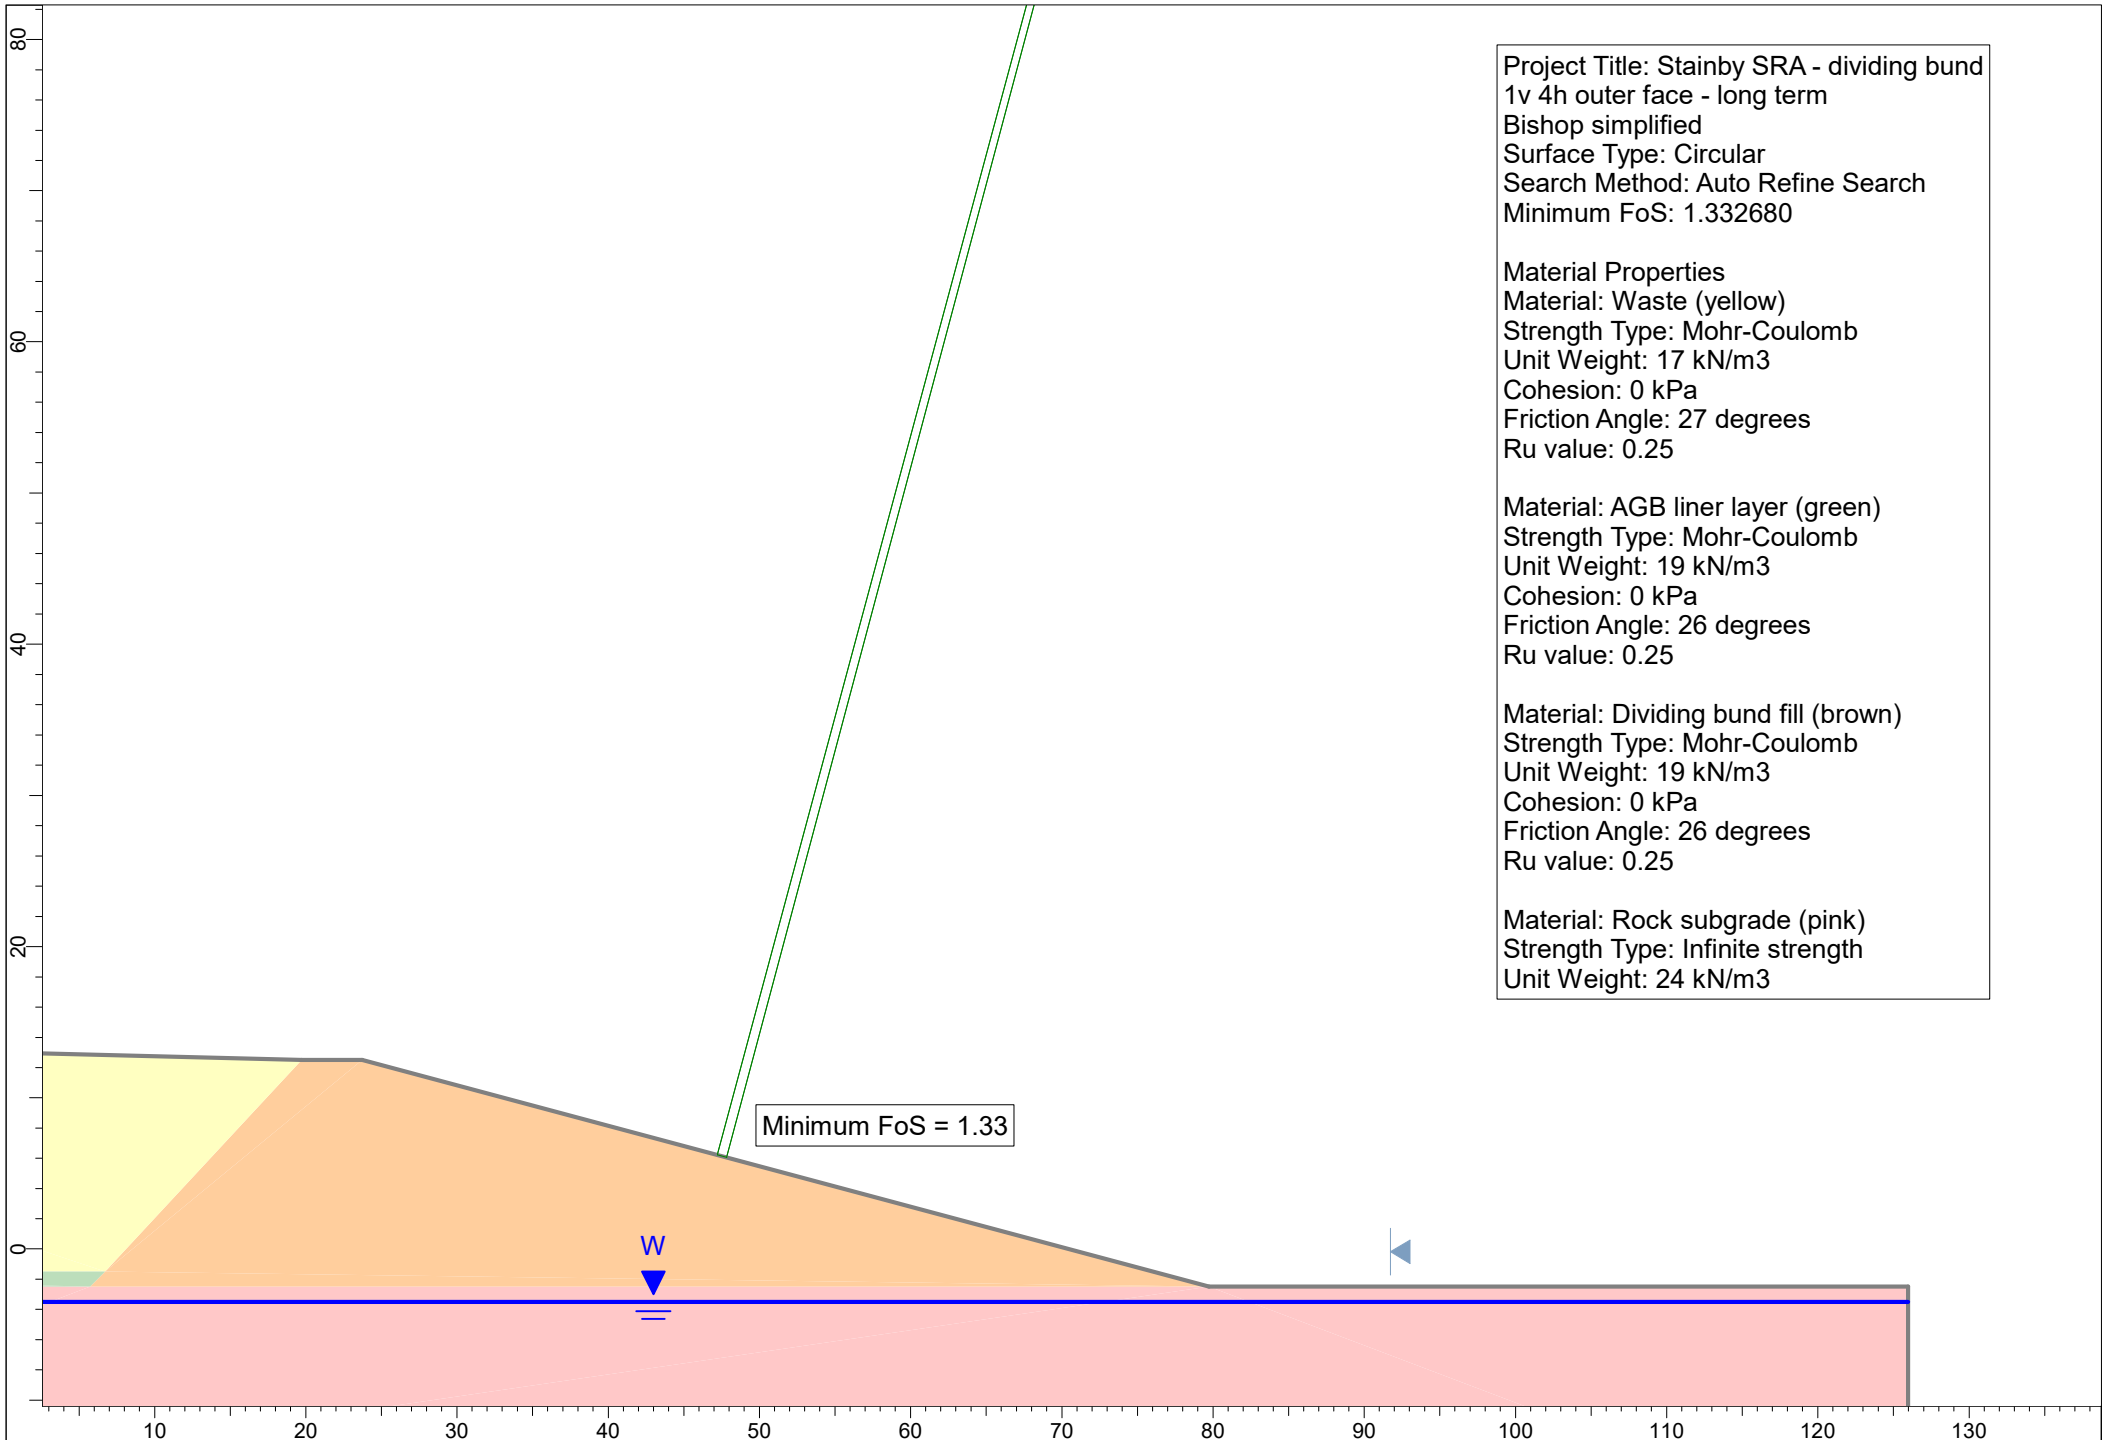
File Name: Stainby dividing bund LT target FoS 1.3 phi25 ru 0.25 1in3 inner 1in4 outer.sli

Project Title: Stainby SRA - dividing bund
 1v 4h outer face - long term
 Bishop simplified
 Surface Type: Circular
 Search Method: Auto Refine Search
 Minimum FoS: 1.332680

Material Properties
 Material: Waste (yellow)
 Strength Type: Mohr-Coulomb
 Unit Weight: 17 kN/m³
 Cohesion: 0 kPa
 Friction Angle: 27 degrees
 Ru value: 0.25

4.3.16 If a very long time gap is anticipated on the FCC side, where the dividing bund is built up to 14m full height and the clay fill drains to long-term conditions, analysis using an outer face angle of 1v in 4h would provide a FoS of 1.33, which complies with the target of 1.30 but is a very shallow angle. Other options might be to construct the bund to an outer face of 1 in 1 and place temporary fill against it to ensure support until such time as placing of waste occurs. In practice, it is anticipated that the liaison between CES Ltd and FCC over the timing of the placing of waste against the dividing bund will be such that the dividing bund can be constructed with outer face angles of 1 in 1 with waste placed to ensure the unsupported height is less than 10m at all times during construction.
