PROPOSED INERT WASTE
RECOVERY

PEACE WOOD QUARRY,
SHELLEY, WEST YORKSHIRE

HYDROGEOLOGICAL RISK
ASSESSMENT

Naylor Industries Limited

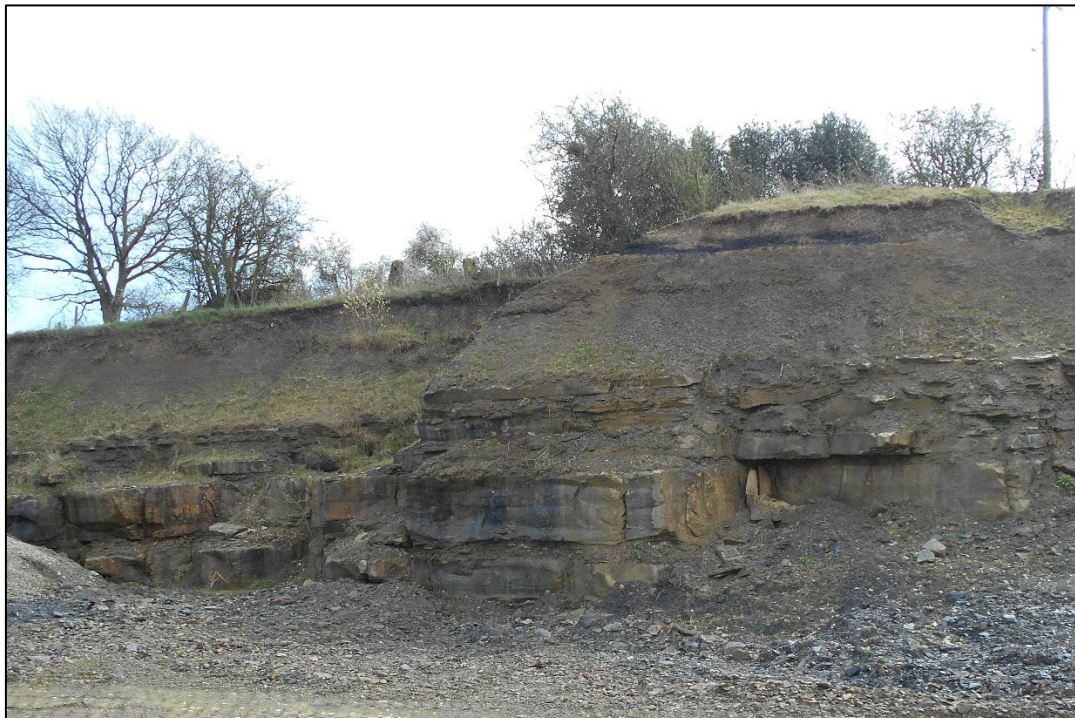
The geological sequence is characterised by the presence of two sandstone units separated by a thicker mudstone/fireclay unit. Only one borehole penetrated the lower sandstone and proved mudstone beneath. The lower sandstone thickness was 1.70m. The upper Penistone Flag Sandstone is an orthogonally jointed blocky sandstone with average thickness of approximately 4m. Figure 5 presents a view of the upper sandstone in the south western quarry face.

Figure 5: Penistone Flag Sandstone in the south western face of Peace Wood Quarry

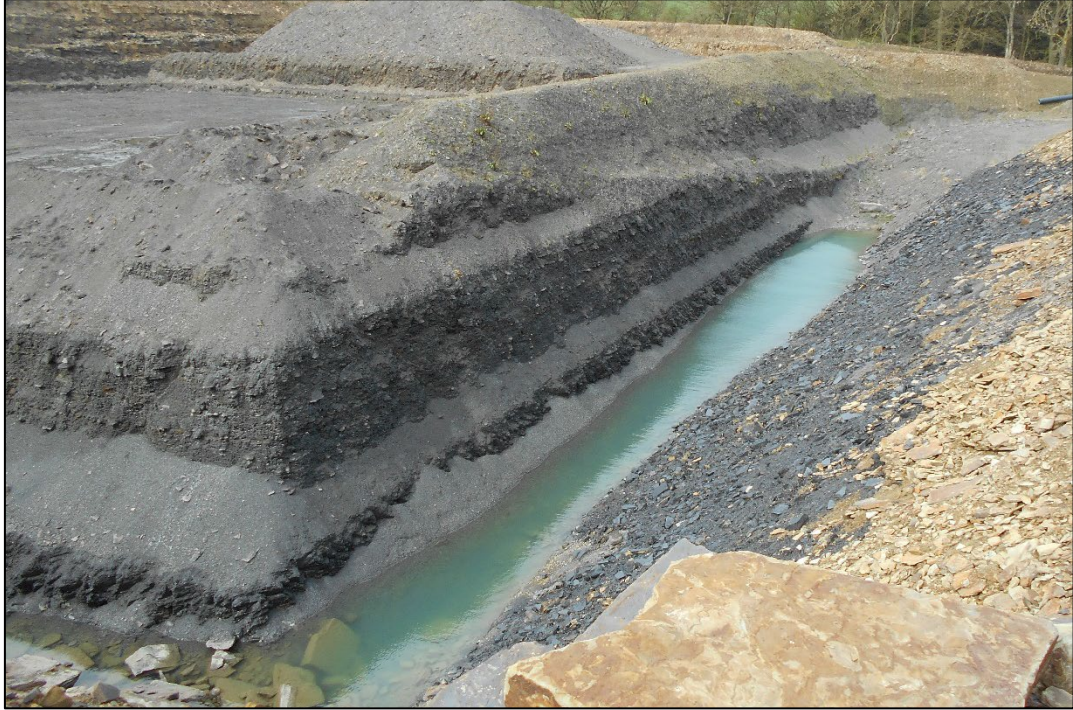
Mudstone units between the upper and lower sandstone formations consist of a sequence of thinly bedded brown mudstone, a shaley blue grey mudstone and basal horizon of black carbonaceous mudstone with underlying fireclay. The mudstone sequence is shown in Figure 6 which presents a view of the western quarry excavation below the upper sandstone.

Figure 6: Mudstone sequence at the western side of Peace Wood Quarry

Although the two sandstone units are the main water bearing units in the geological sequence encountered at Peace Wood Quarry, groundwater seepage from mudstone horizons has also been observed. During a site hydrological survey undertaken in April 2023, groundwater was observed seeping from the carbonaceous mudstone, above the fireclay, towards the base of the mudstone sequence. Accumulated groundwater can be observed around the periphery of the excavation, as shown in Figure 6.

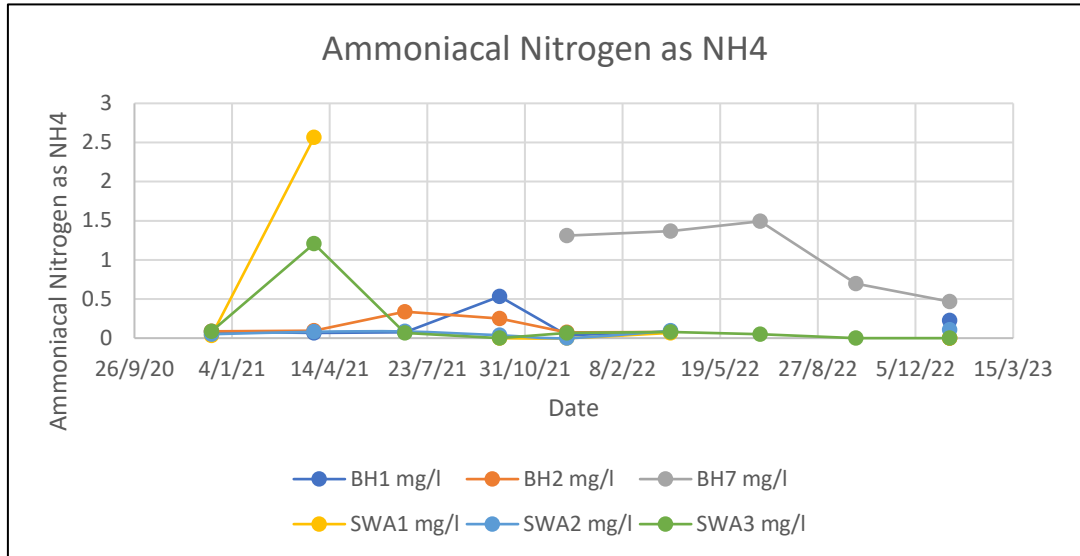
Figure 8: Ammoniacal nitrogen concentration at monitoring points

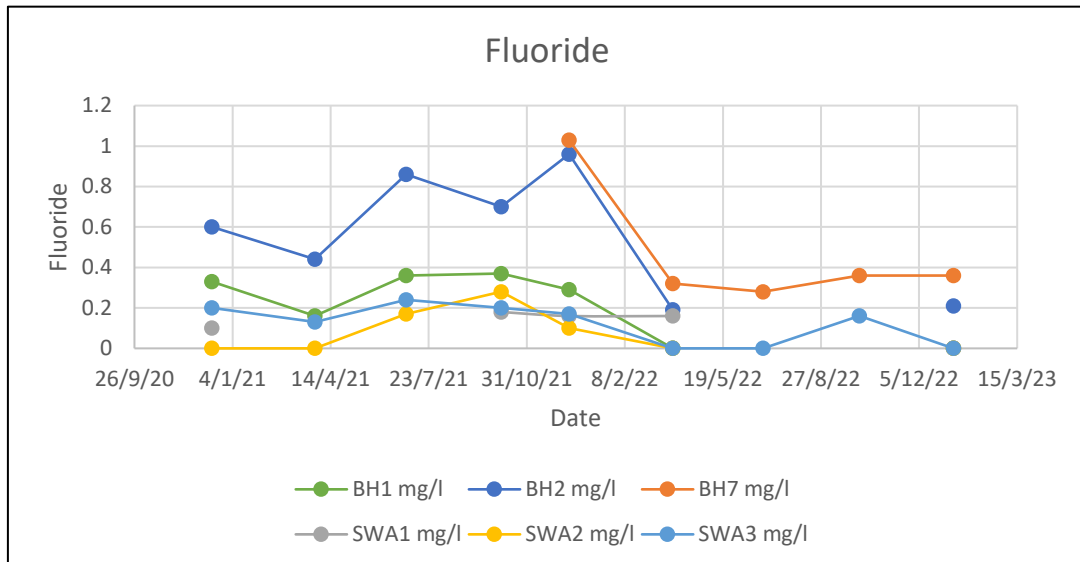
Figure 9: Fluoride concentration at monitoring points

The concentration of fluoride in groundwater and surface water samples remained below the UKDWS of 1.5 mg/l throughout the monitoring period. With the exception of a single sample from BH1 in October 2021, the concentration of nickel in groundwater and surface water remained below the UKDWS of 0.02 mg/l. The single exceedance is uncharacteristically high given previous and subsequent values and is considered likely to be erroneous.
