**HAW LANE, SAUNDERTON,  
BUCKINGHAMSHIRE, HP14 4JD  
PHASE I AND PHASE II  
GEOTECHNICAL INVESTIGATION  
VIRTUS DATA CENTRES  
28<sup>TH</sup> APRIL 2025  
LS8055**

| <b>Title:</b> | PHASE I AND PHASE II GEOTECHNICAL INVESTIGATION | |
| <b>Project:</b> | NEW DATA CENTRE | |
| <b>Client:</b> | VIRTUS DATA CENTRES | |

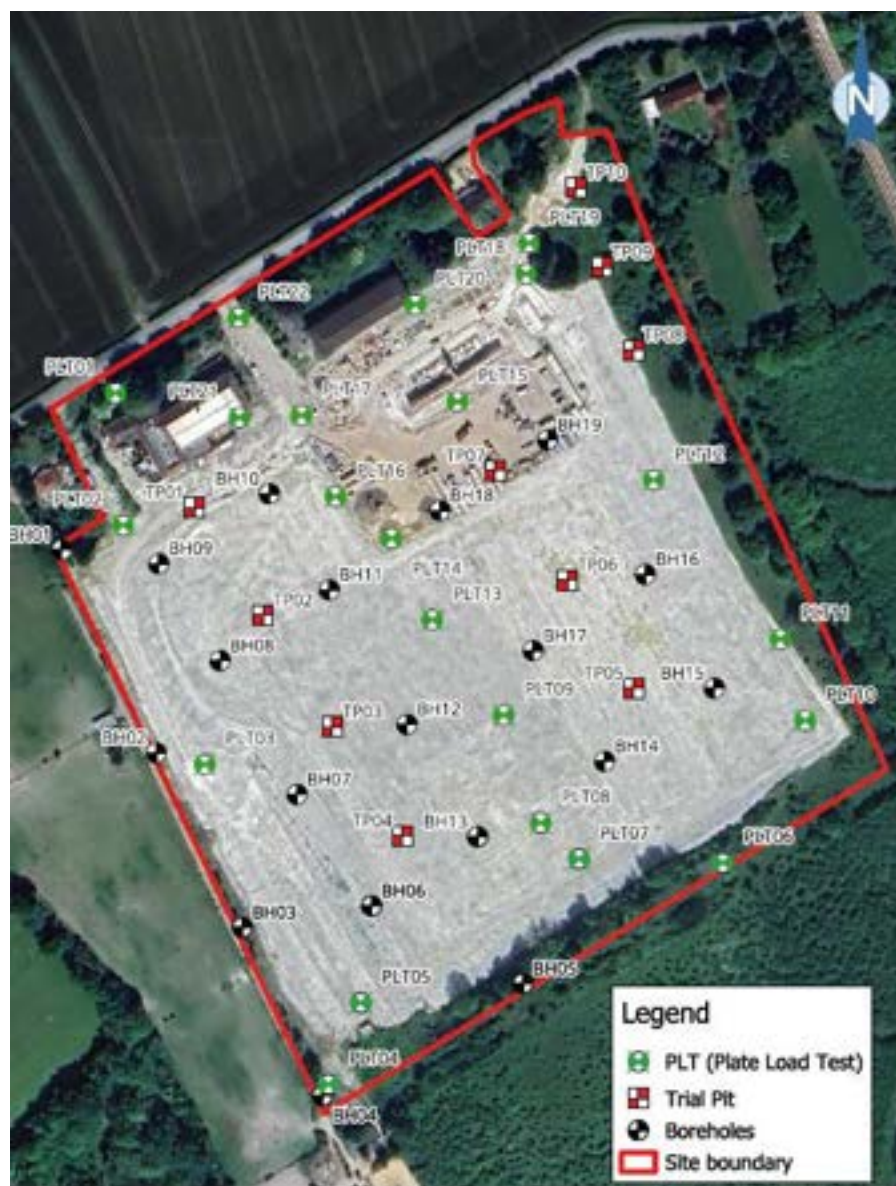
In summary, the area under investigation comprised a roughly square shaped area with site offices and welfare units in the north, and a chalk pit covers the rest of the site.

At the time of the walkover, the area was an active construction site with workers present and heavy machinery was often in use. Access was via *Haw Lane* from the north, through a metal gate. The point of access was through temporary, security-controlled Heras fencing adjacent to the security offices to the west. Either side of the access point were two derelict buildings associated with the old Molins factory, with asbestos warning signs present on the Heras fencing forming a perimeter around the buildings.
