Intended for  
**Avalon DC Limited**

# **FORMER MOLINS SITE, SAUNDERTON REMEDIATION VERIFICATION REPORT**

Project No. **16200011947-004**  
Issue No. **01**  
Date **09 December 2022**  
Made by **Sophie Davies**  
Checked by **Charles Collins**  
Approved by **Andy Mcvey**

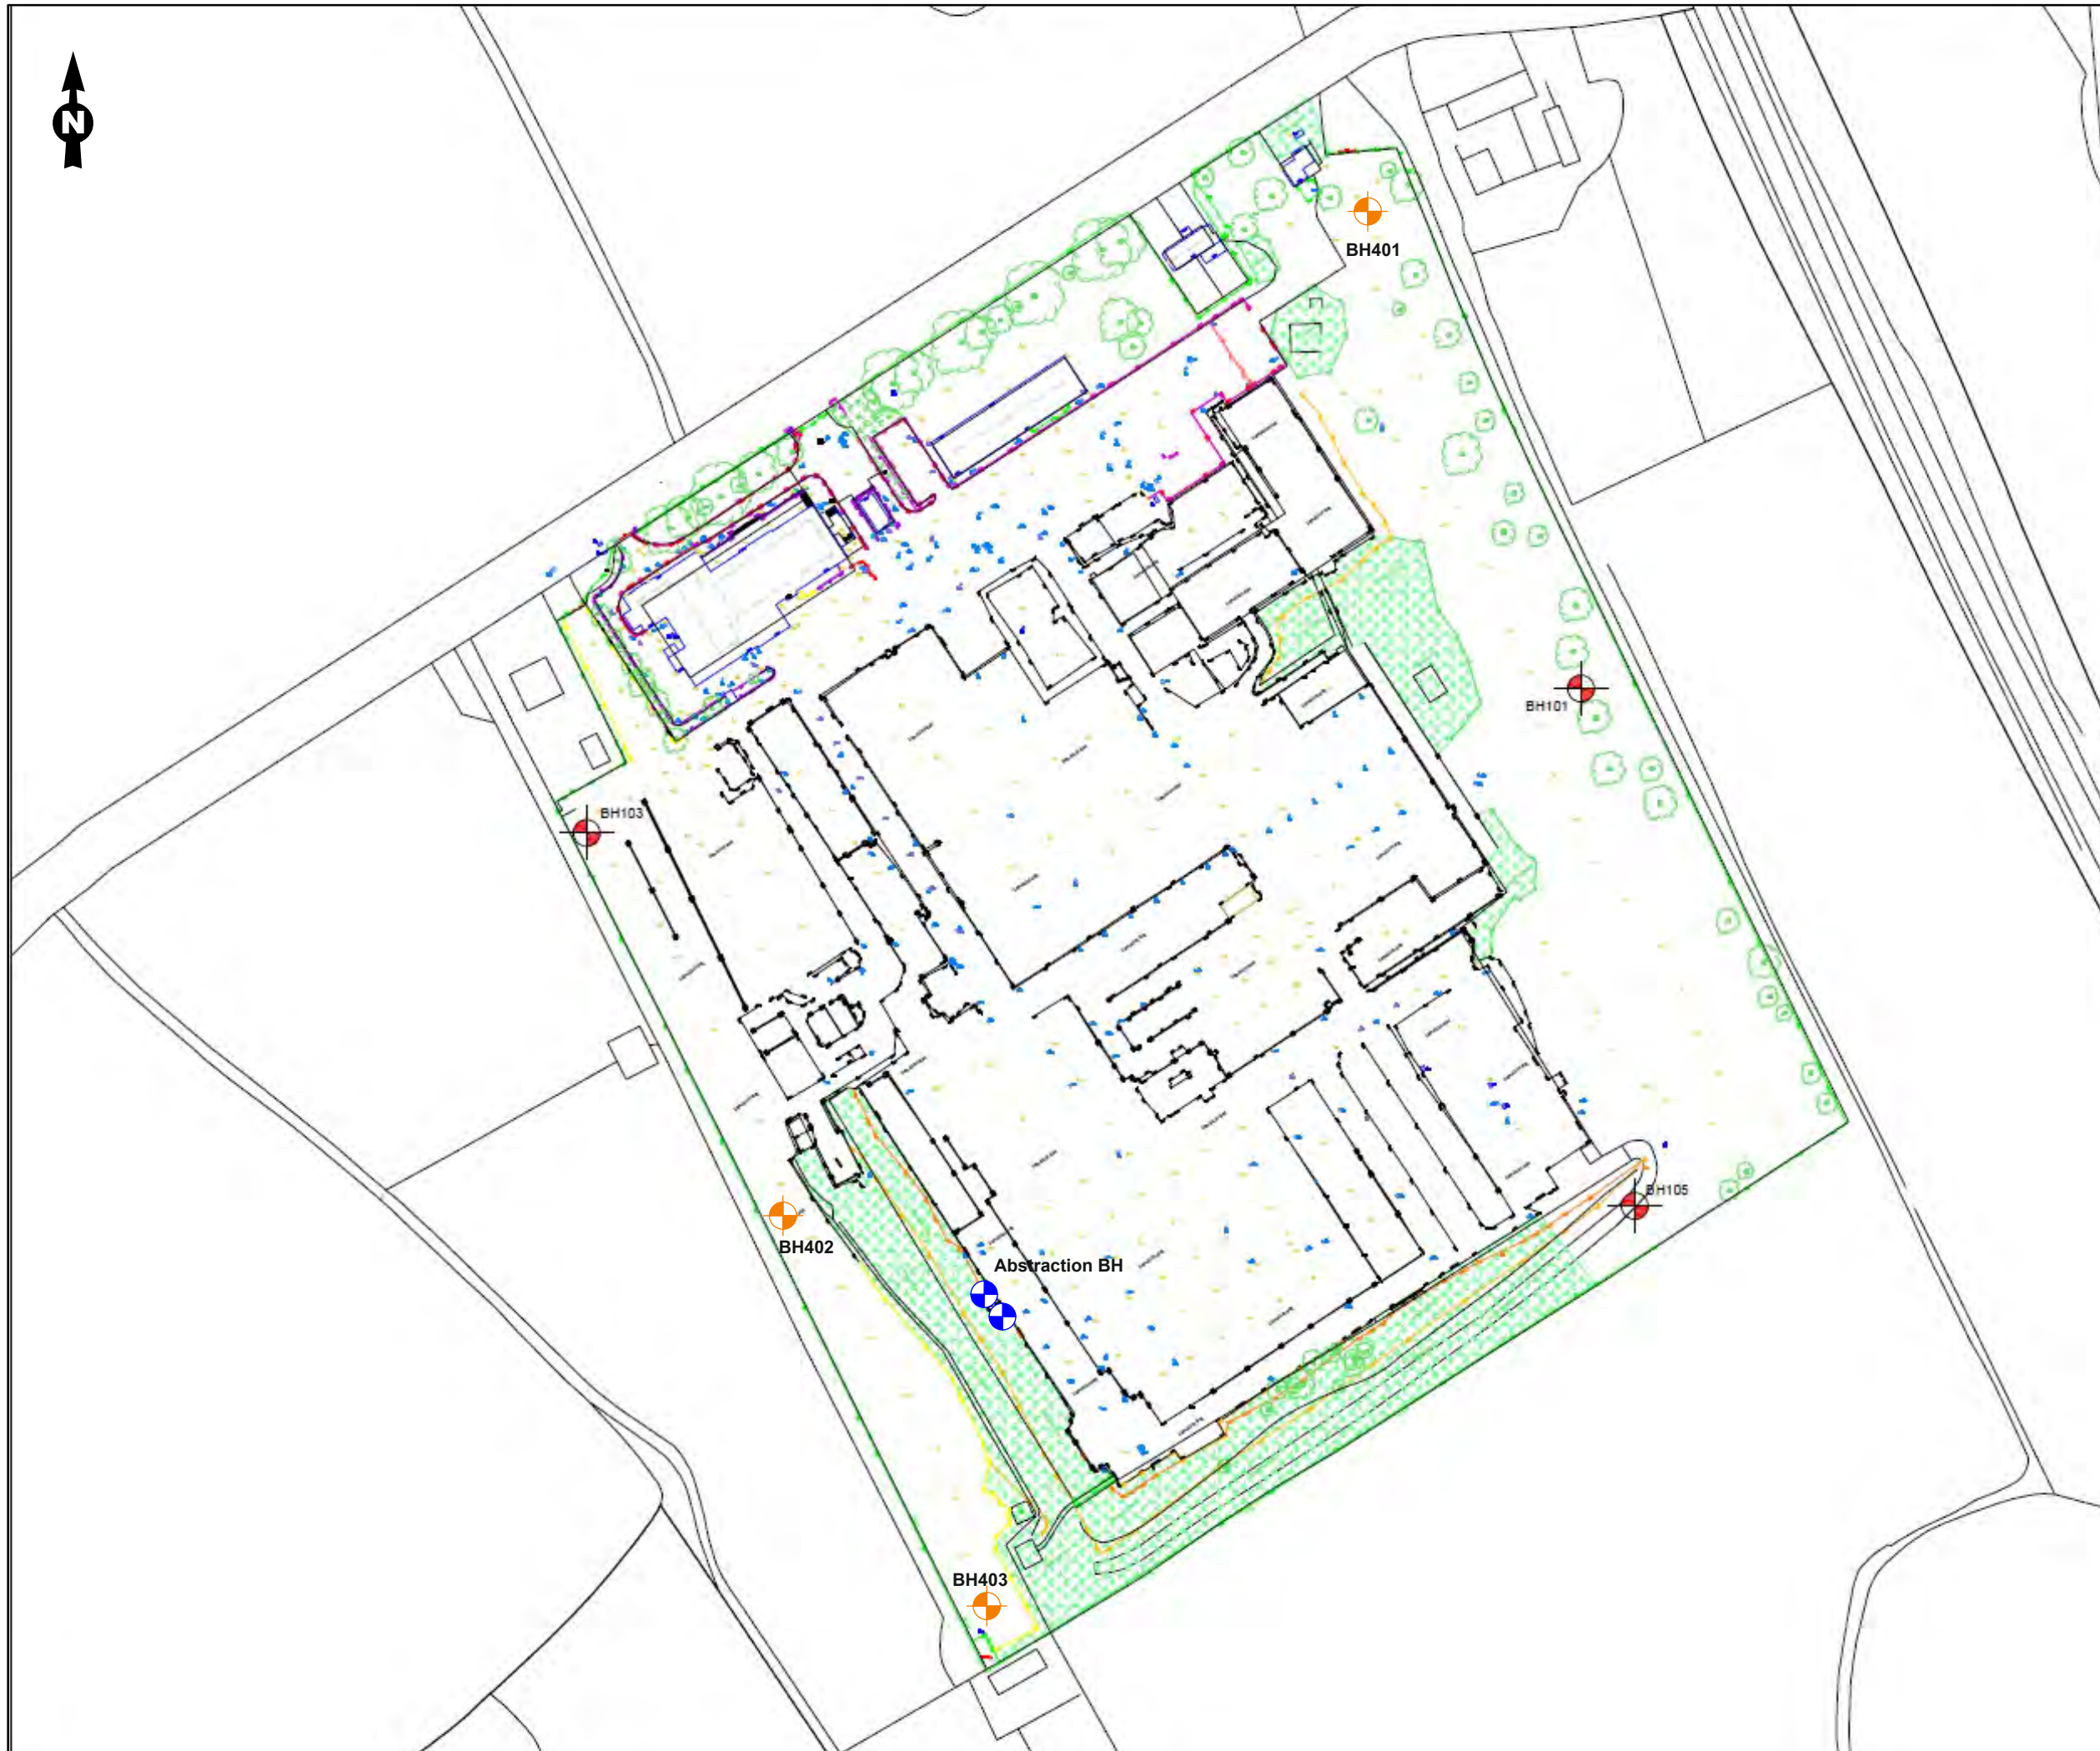
- Site Boundary
- Newly Installed Monitoring Wells (2022)
- Existing Abstraction Well
- Pre-existing Groundwater Monitoring Wells

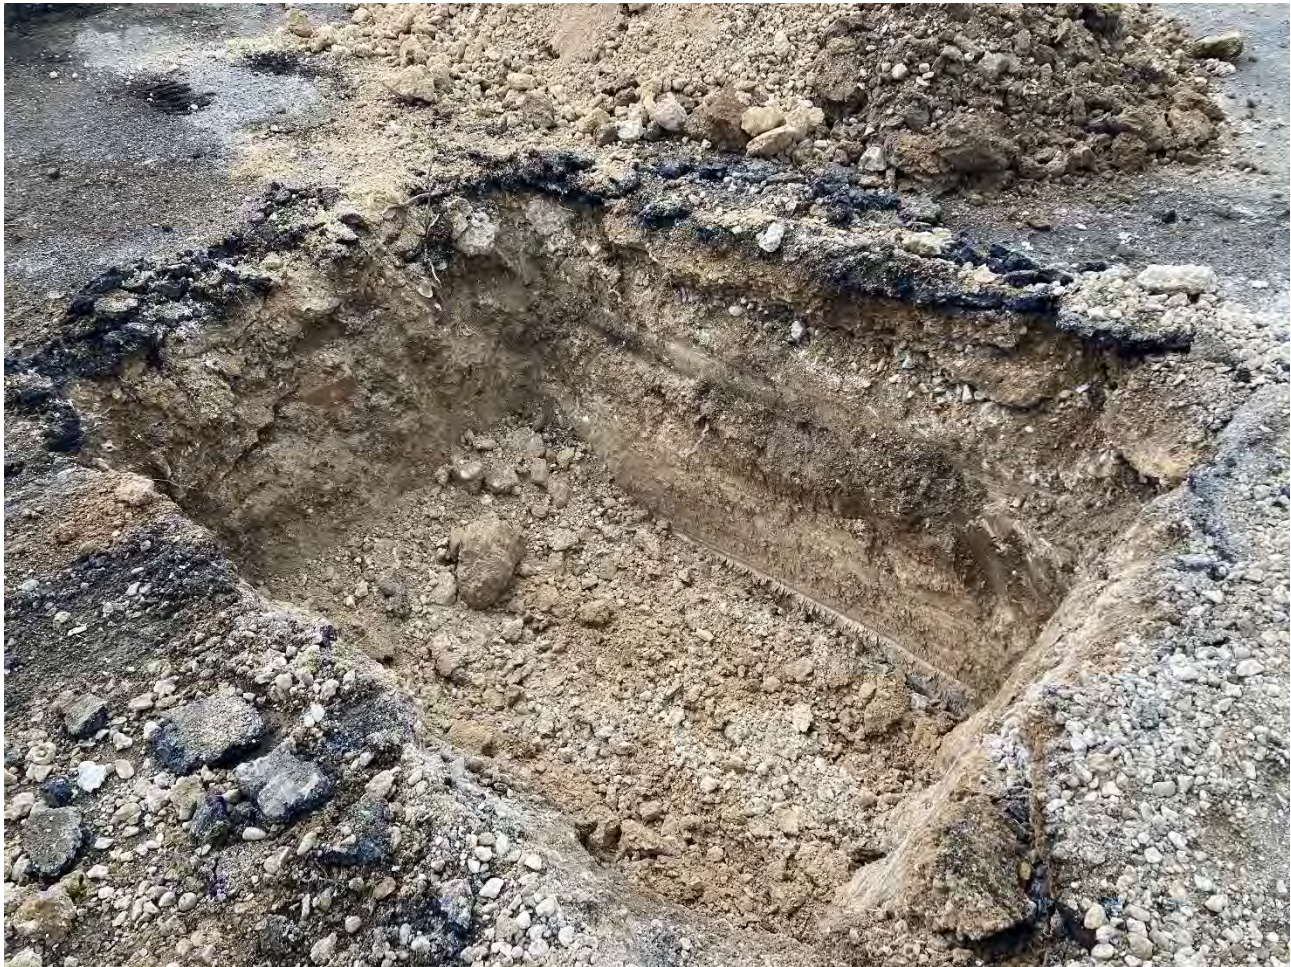
| <b>Comment</b><br><br>Trial pit D1/TP01, excavated to 1.30 m Below Ground Level (m BGL). | <b>Project</b><br>223159 - Sauderton |

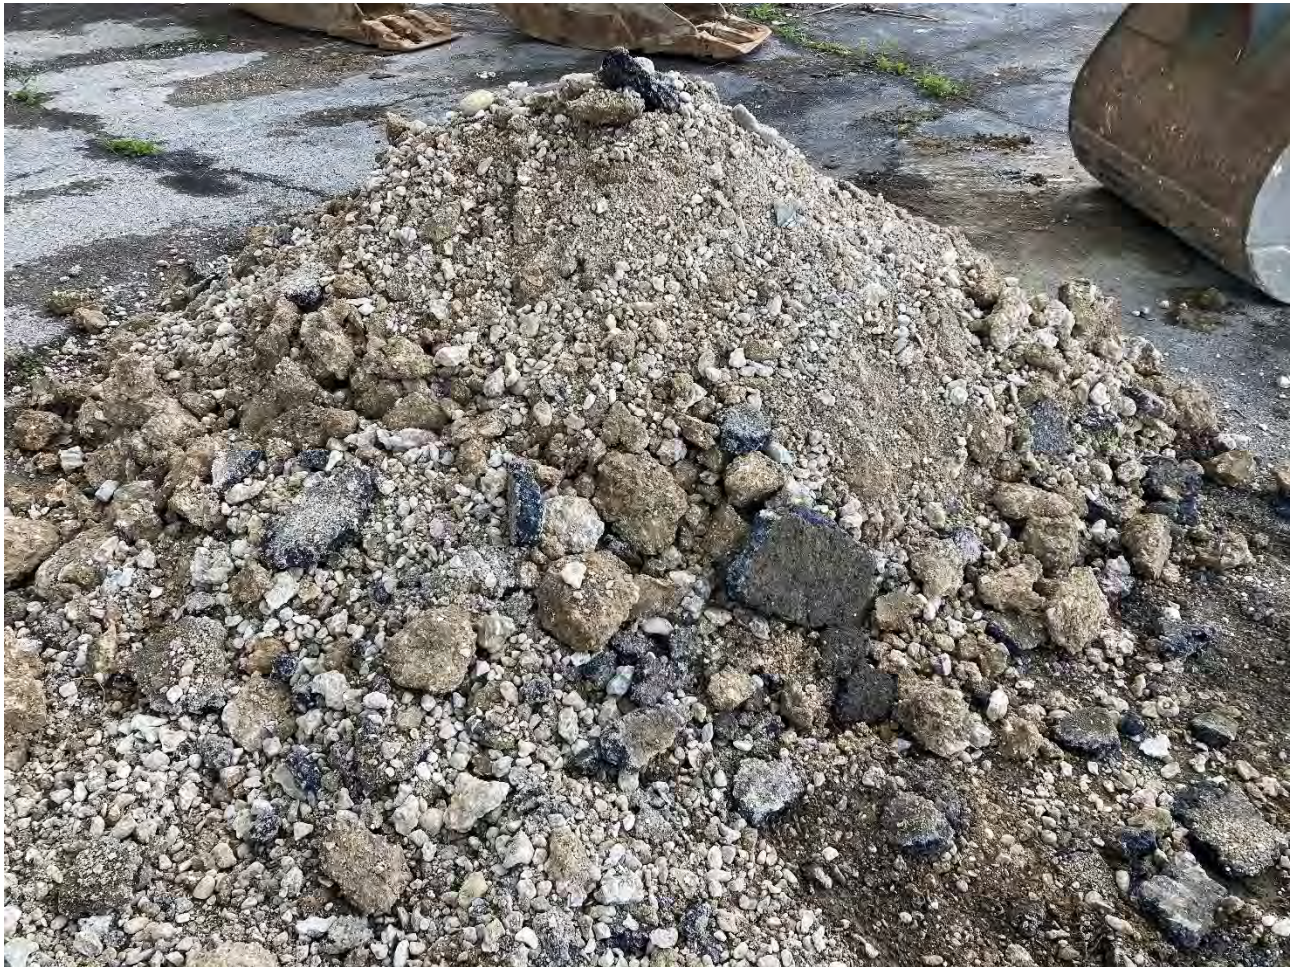
| <b>Comment</b><br><br>D1/TP01 Made Ground arisings. | <b>Project</b><br>223159 - Sauderton |

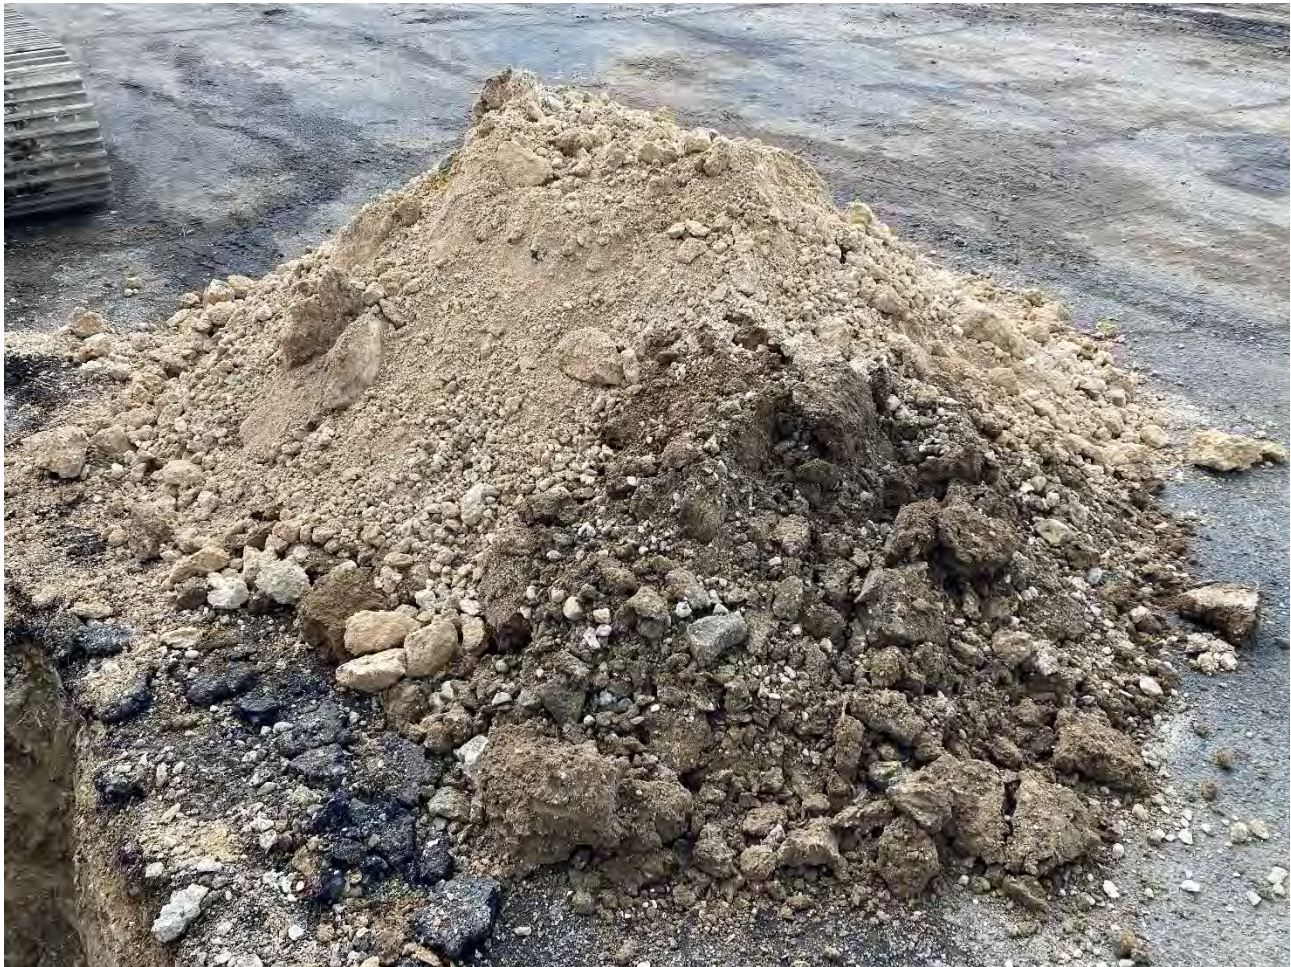
| <b>Comment</b><br><br>D1/TP01 Made Ground arisings<br>(foreground) and natural arisings<br>(background). | <b>Project</b><br>223159 – Saunderton |

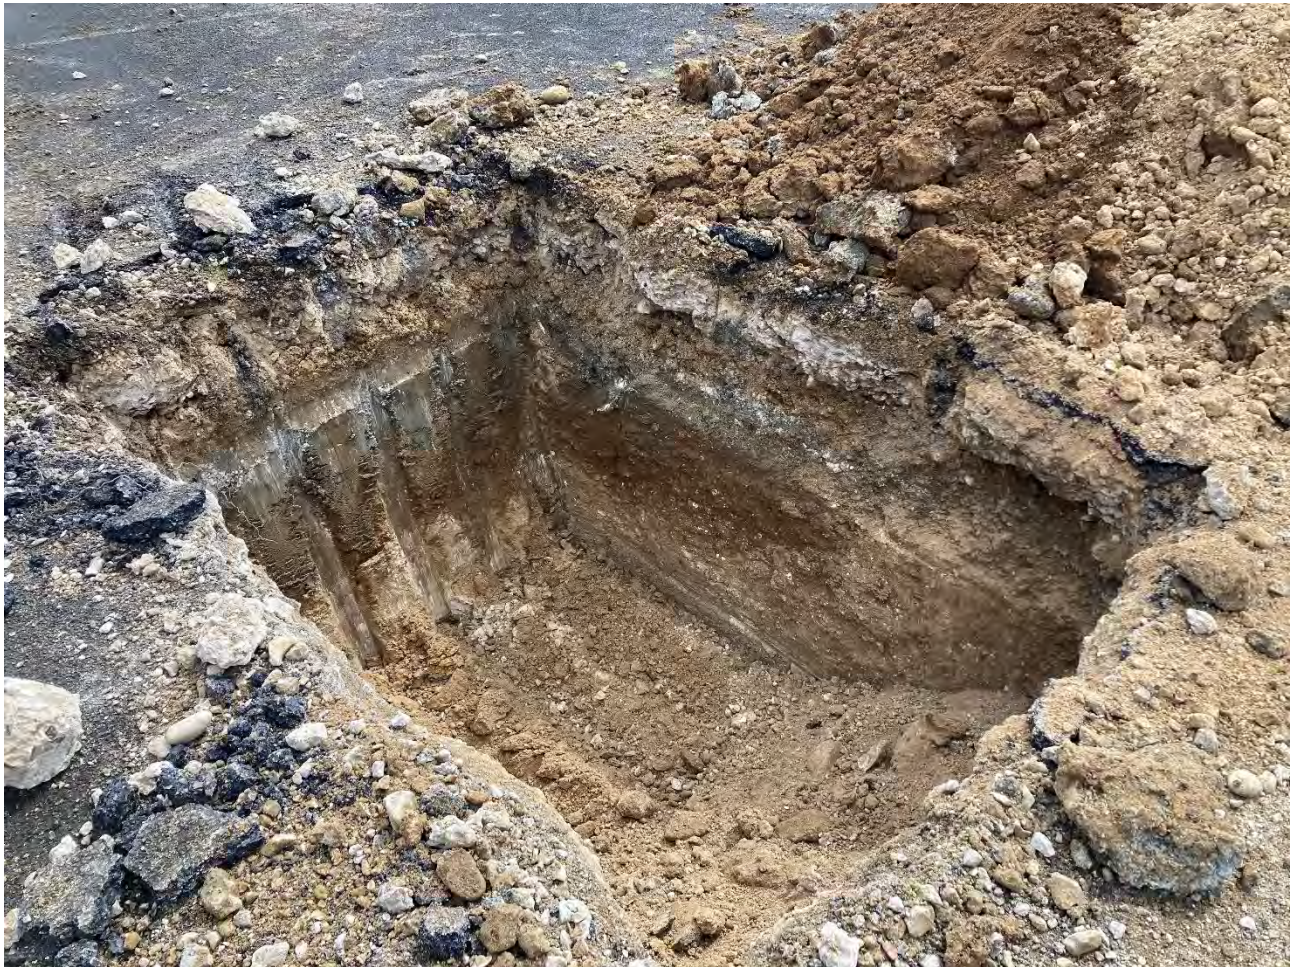
| <b>Comment</b><br><br>Trial pit D1/TP02, excavated to 1.40 m BGL. | <b>Project</b><br>223159 – Saunderton |

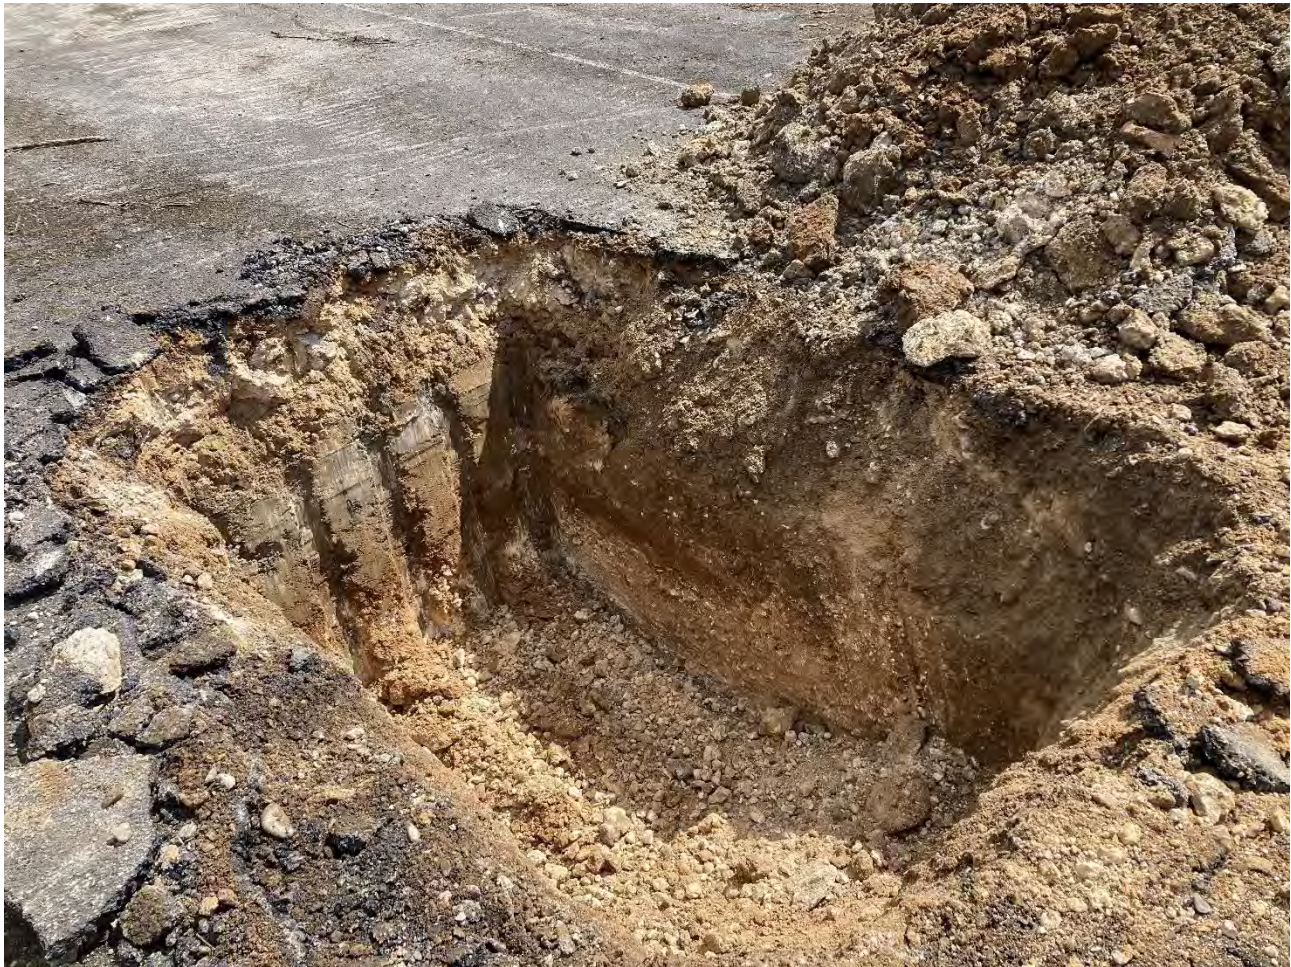
| <b>Comment</b><br><br>Trial pit E1/TP01, excavated to 1.45 m BGL. | <b>Project</b><br>223159 – Saunderton |

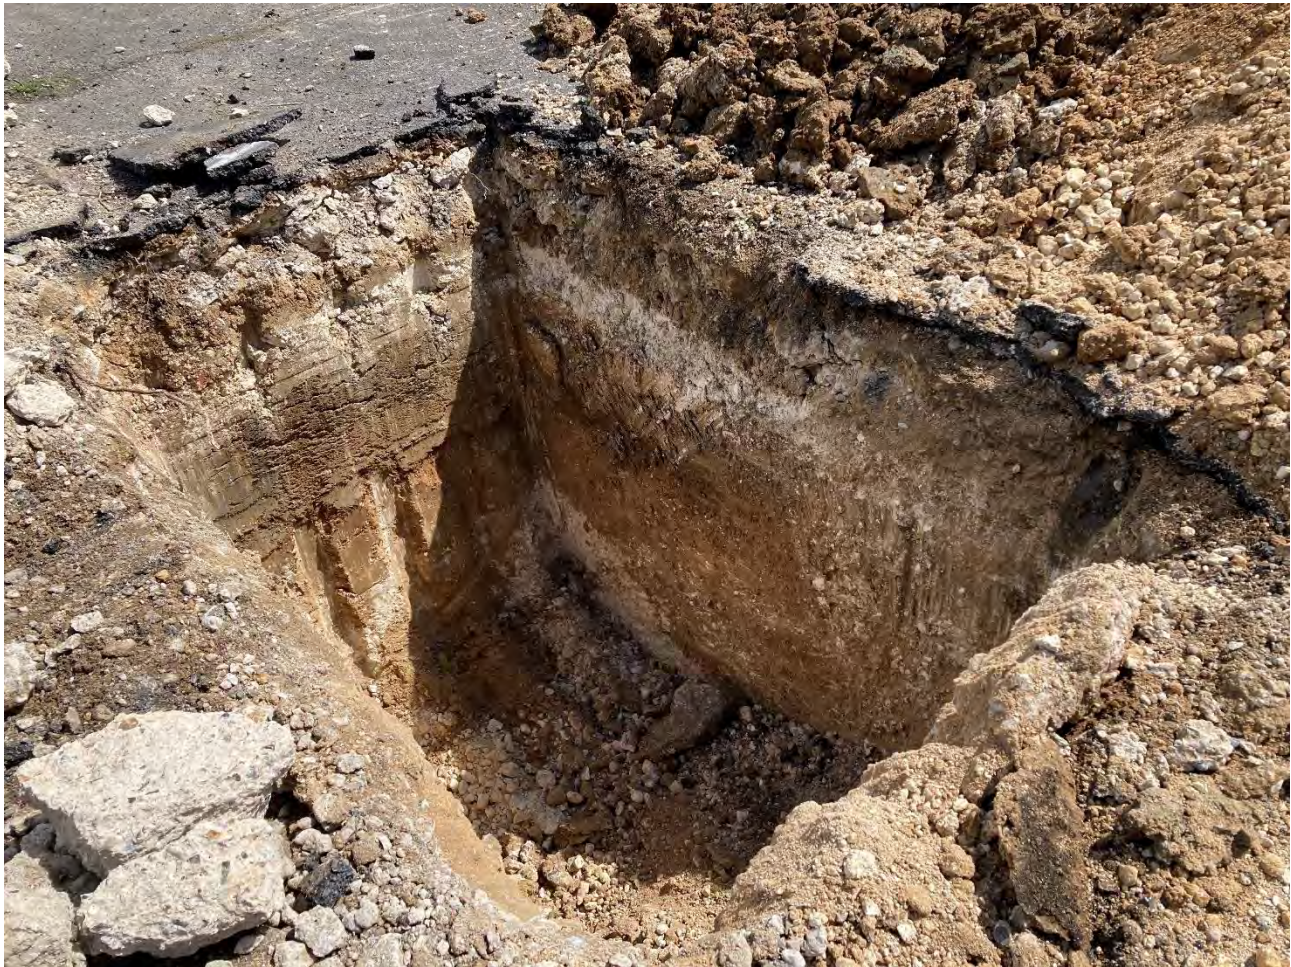
| <b>Comment</b><br><br>Trial pit E1/TP02, excavated to 1.80 m BGL. | <b>Project</b><br>223159 – Saunderton |

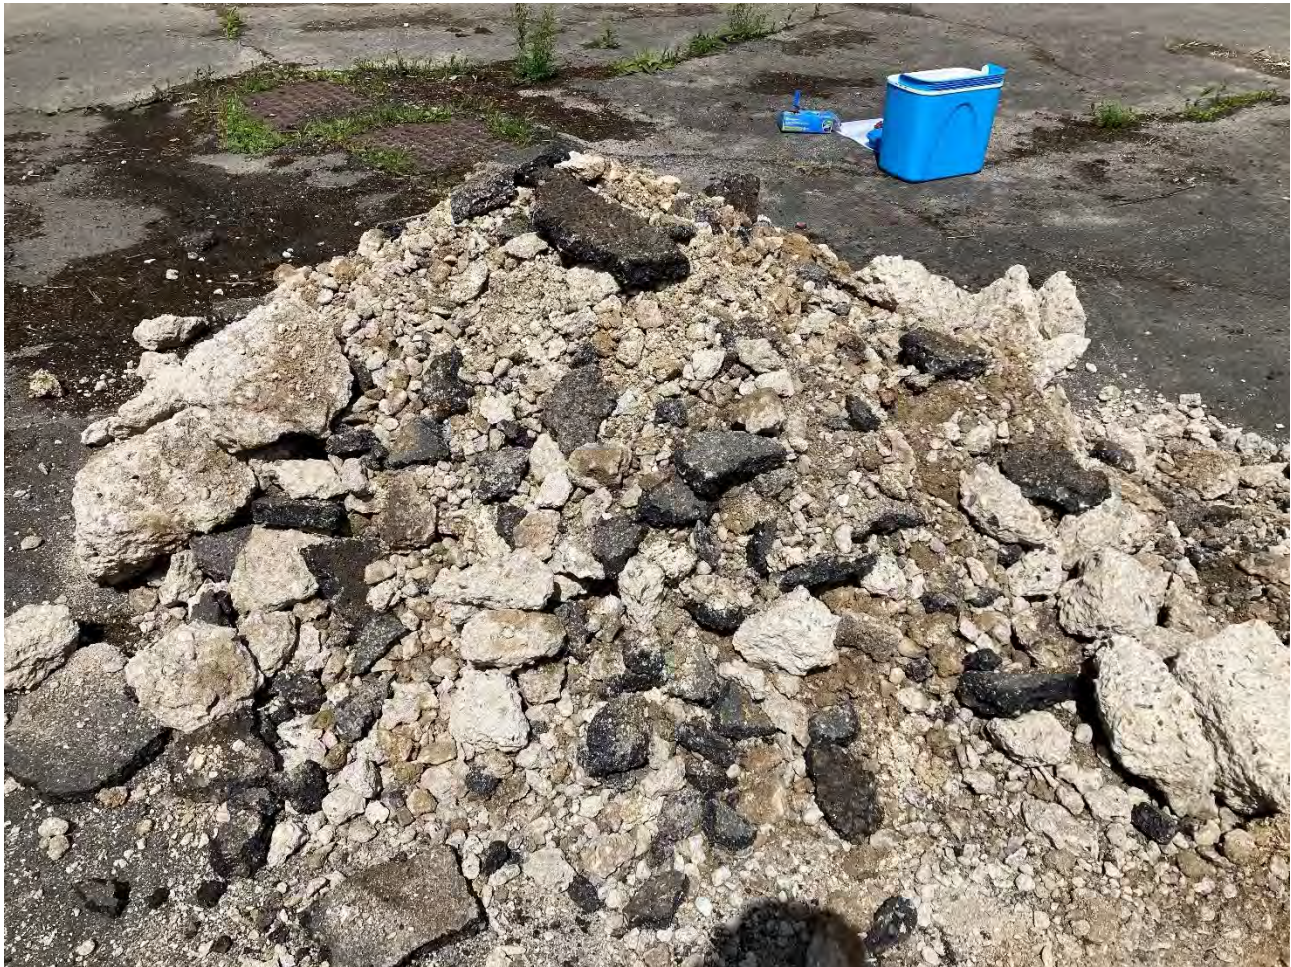
| <b>Comment</b><br><br>E1/TP02 Made Ground arisings. | <b>Project</b><br>223159 – Saunderton |

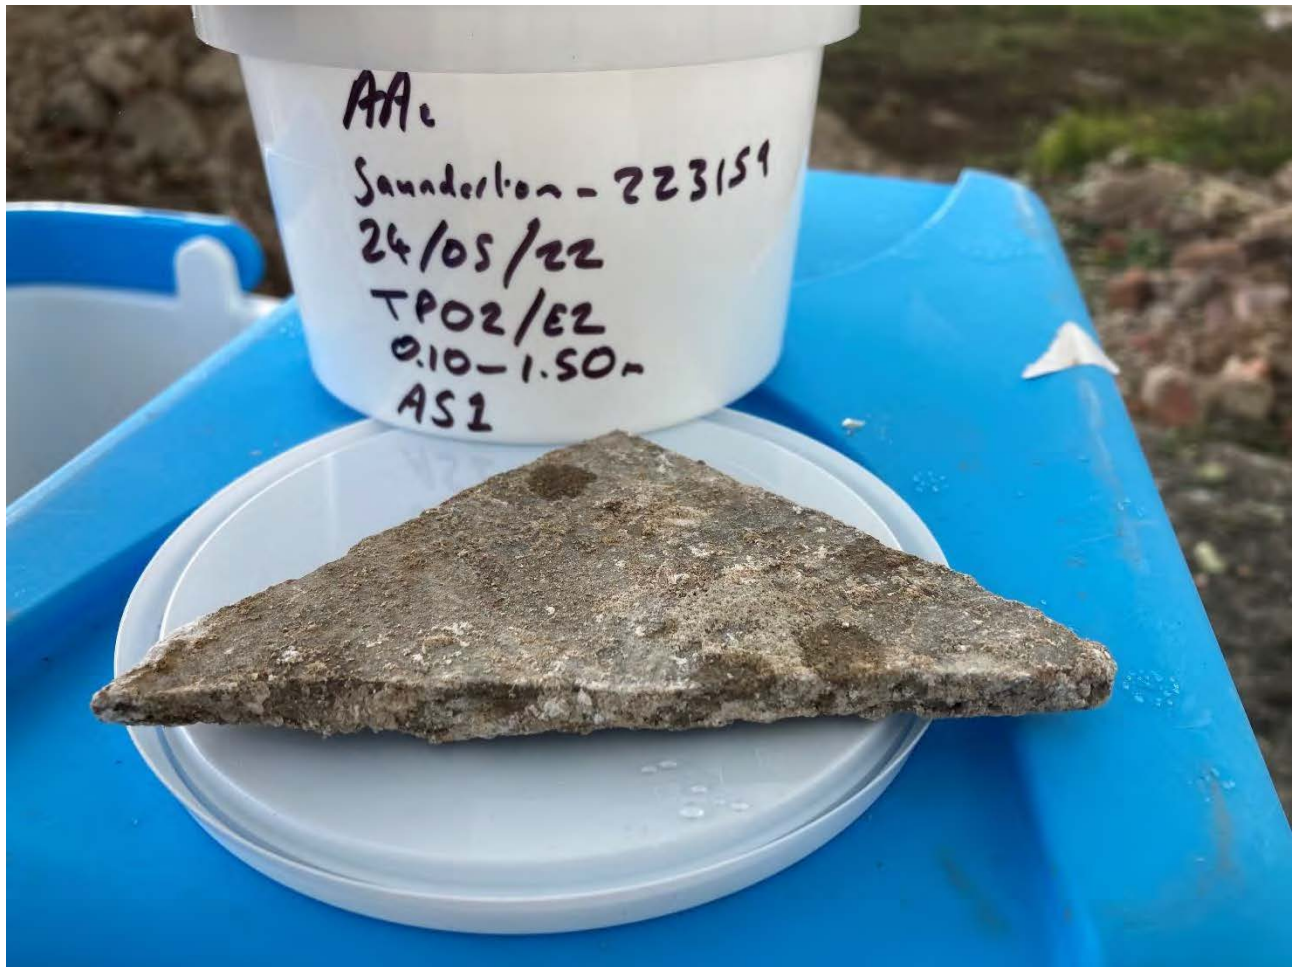
| <b>Comment</b><br><br>Fragment of suspected Asbestos Containing Material (ACM) encountered in E2/TP02. | <b>Project</b><br>223159 – Saunderton |

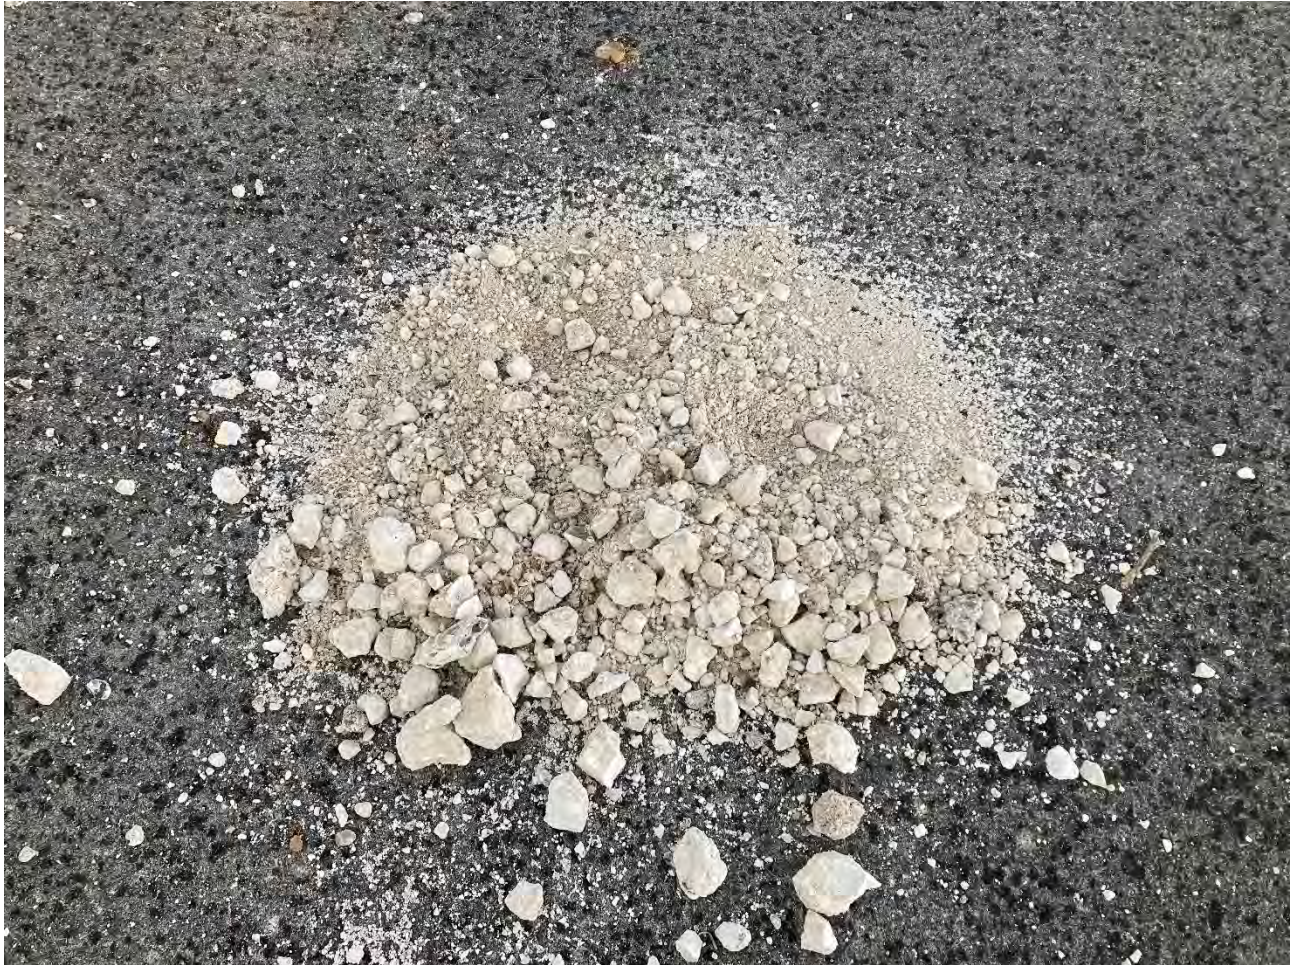
| <b>Comment</b><br><br>E2/TP02 natural arisings. | <b>Project</b><br>223159 – Saunderton |

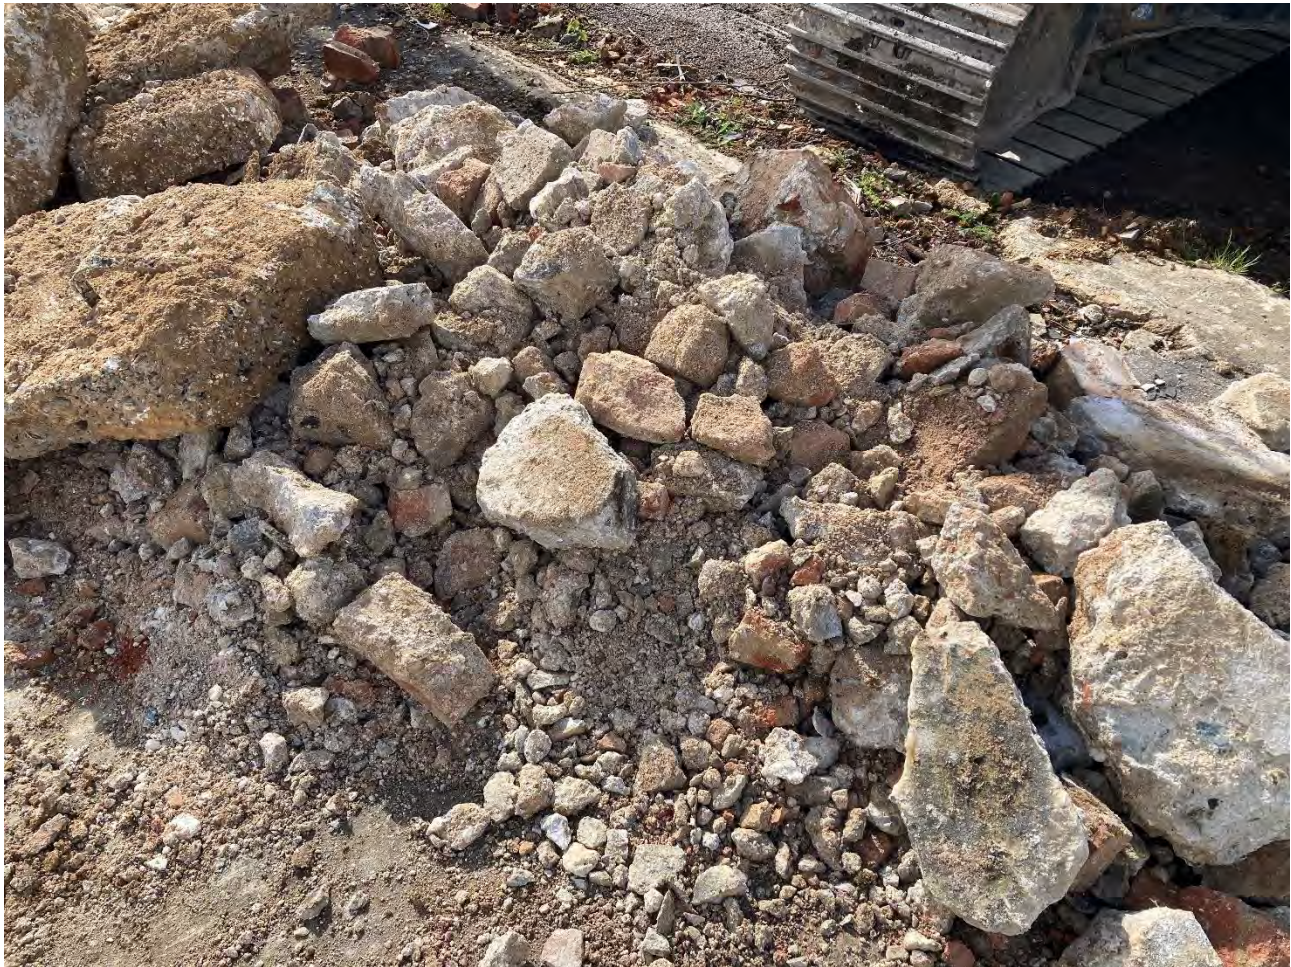
| <b>Comment</b><br><br>D2/TP02 Made Ground arisings. | <b>Project</b><br>223159 – Saunderton |

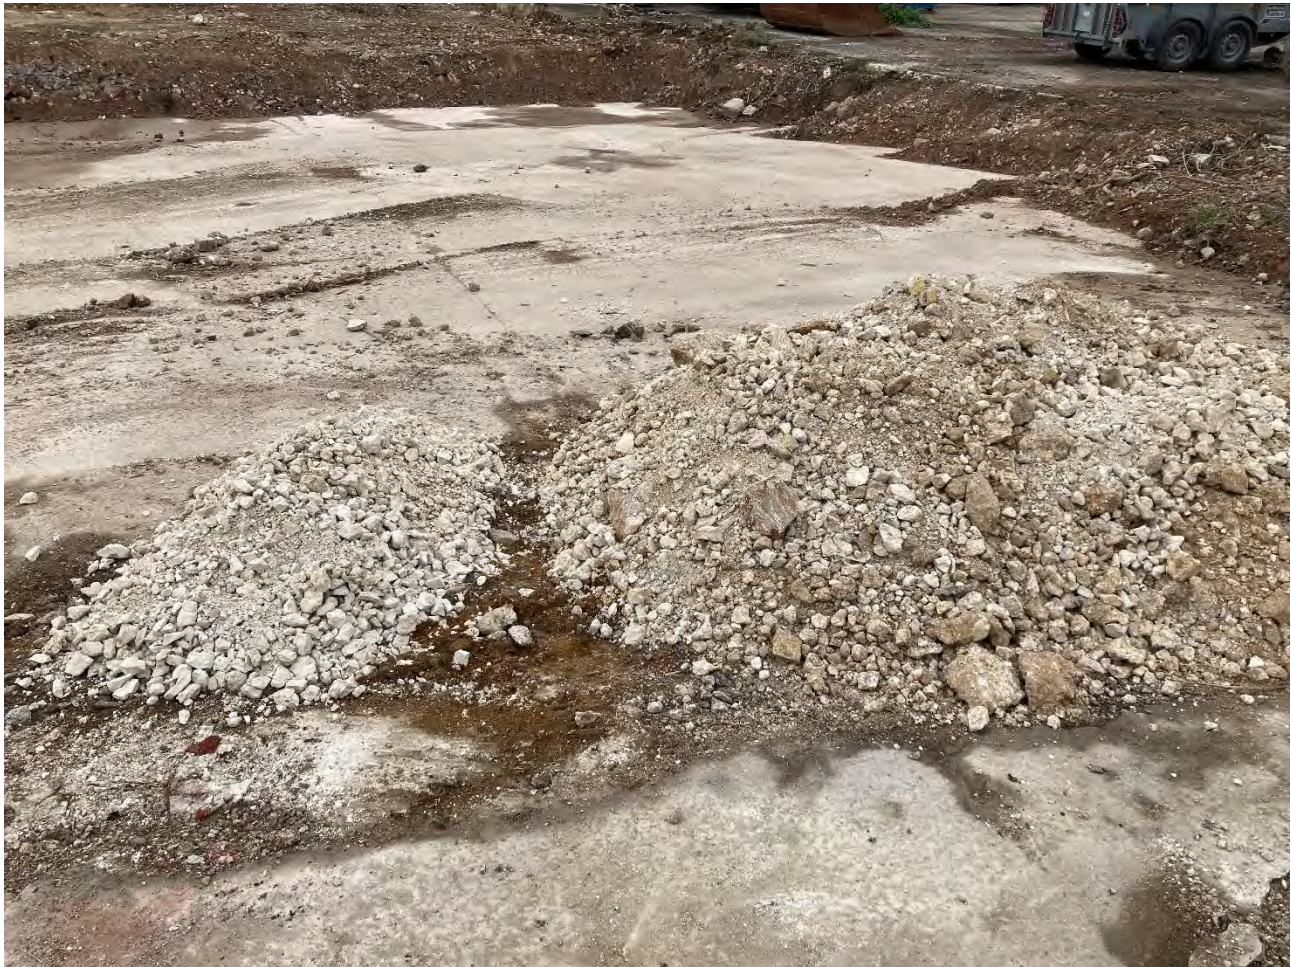
| <b>Comment</b><br><br>D2/TP01 natural arisings (left) and Made Ground arisings (right). | <b>Project</b><br>223159 – Saunderton |

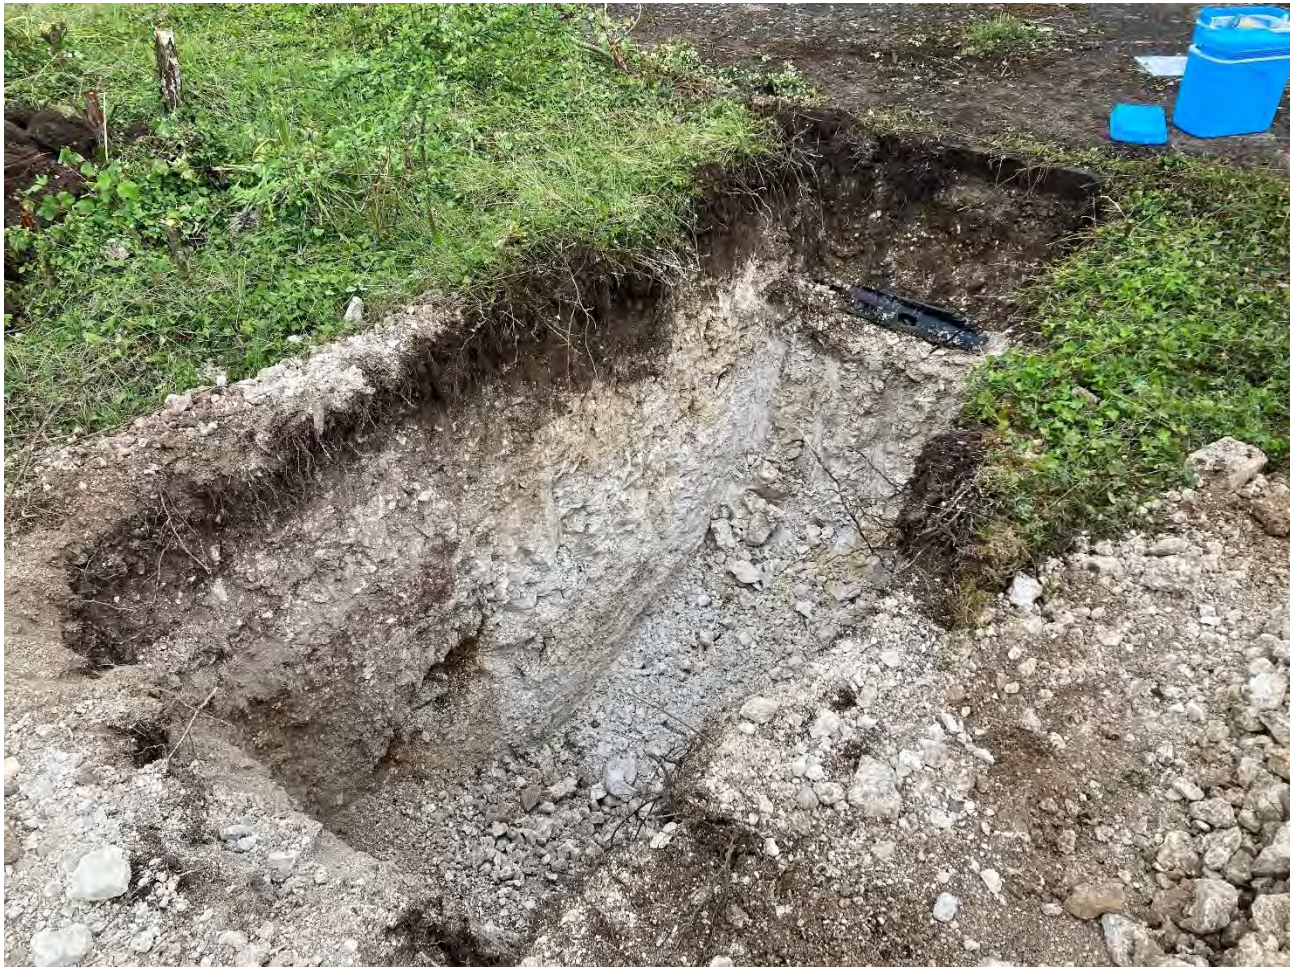
| <b>Comment</b><br><br>Trial pit D2/TP03, excavated to 1.85 m BGL. | <b>Project</b><br>223159 – Saunderton |

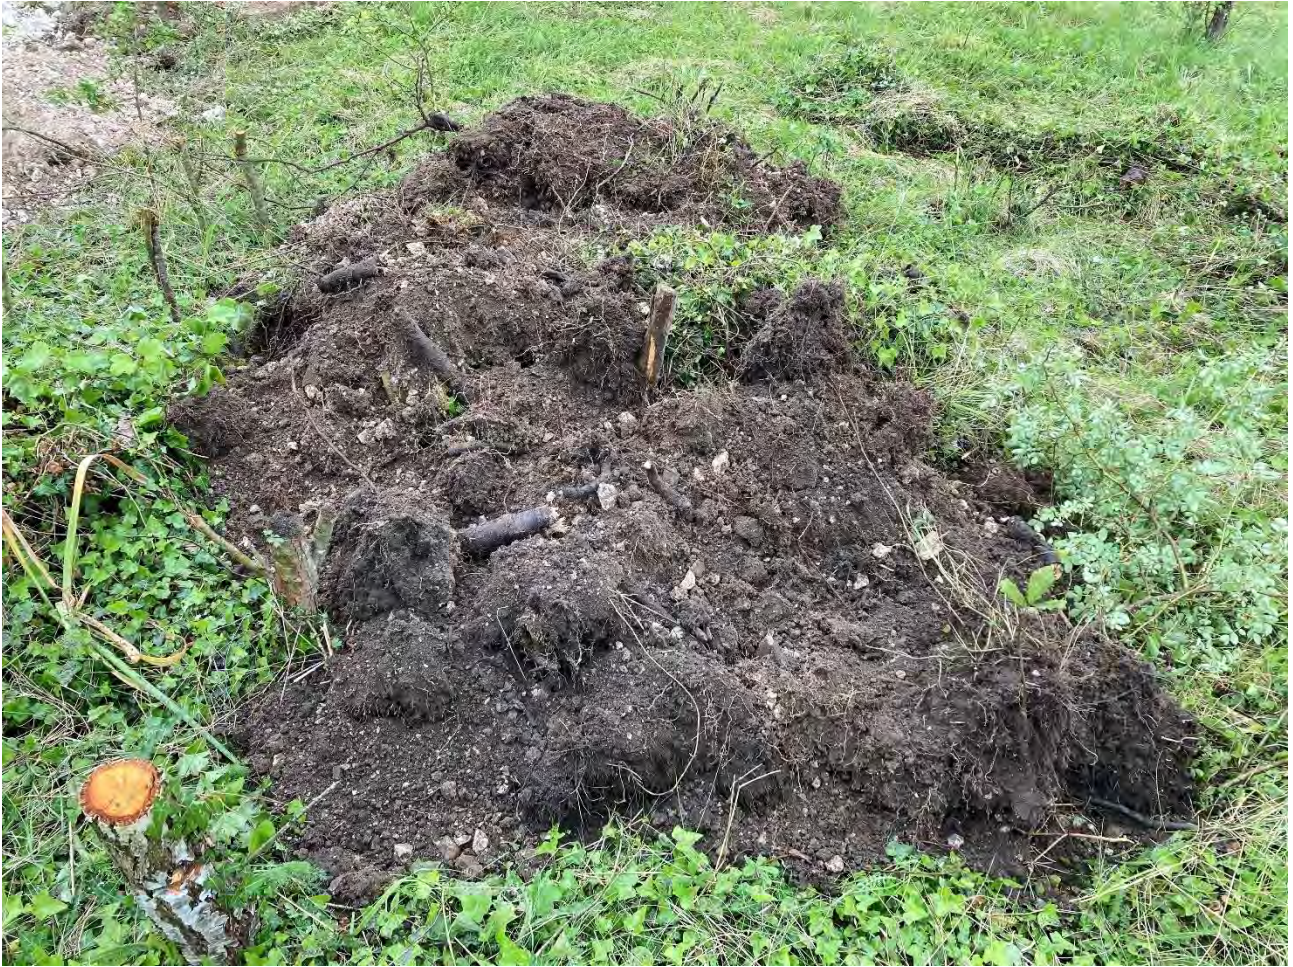
| <b>Comment</b><br><br>D2/TP03 topsoil/Made Ground arisings. | <b>Project</b><br>223159 – Saunderton |

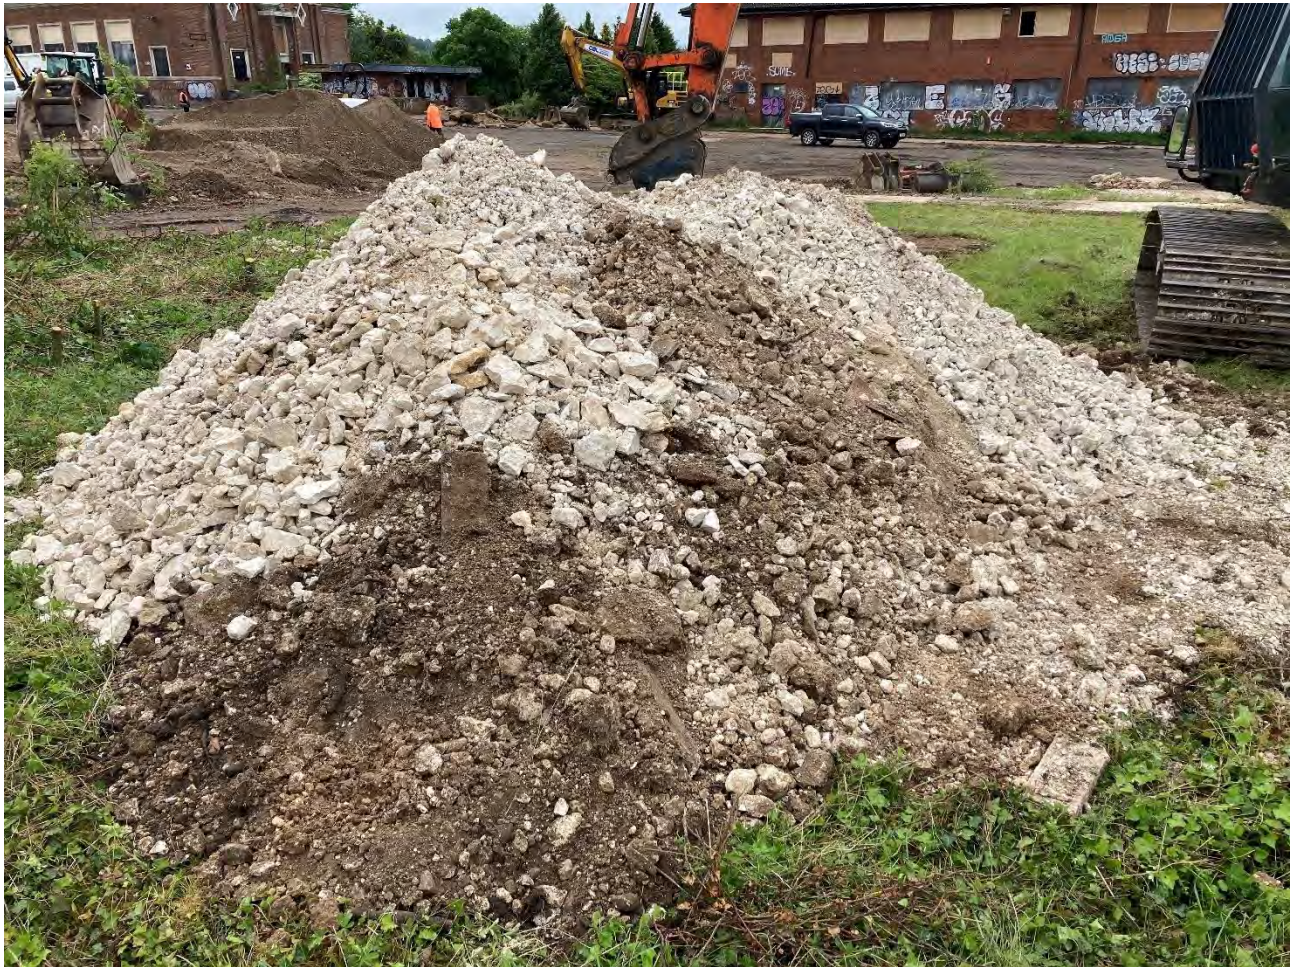
| <b>Comment</b><br><br>D2/TP03 Made Ground arisings<br>(foreground) and natural arisings<br>(background). | <b>Project</b><br>223159 – Saunderton |

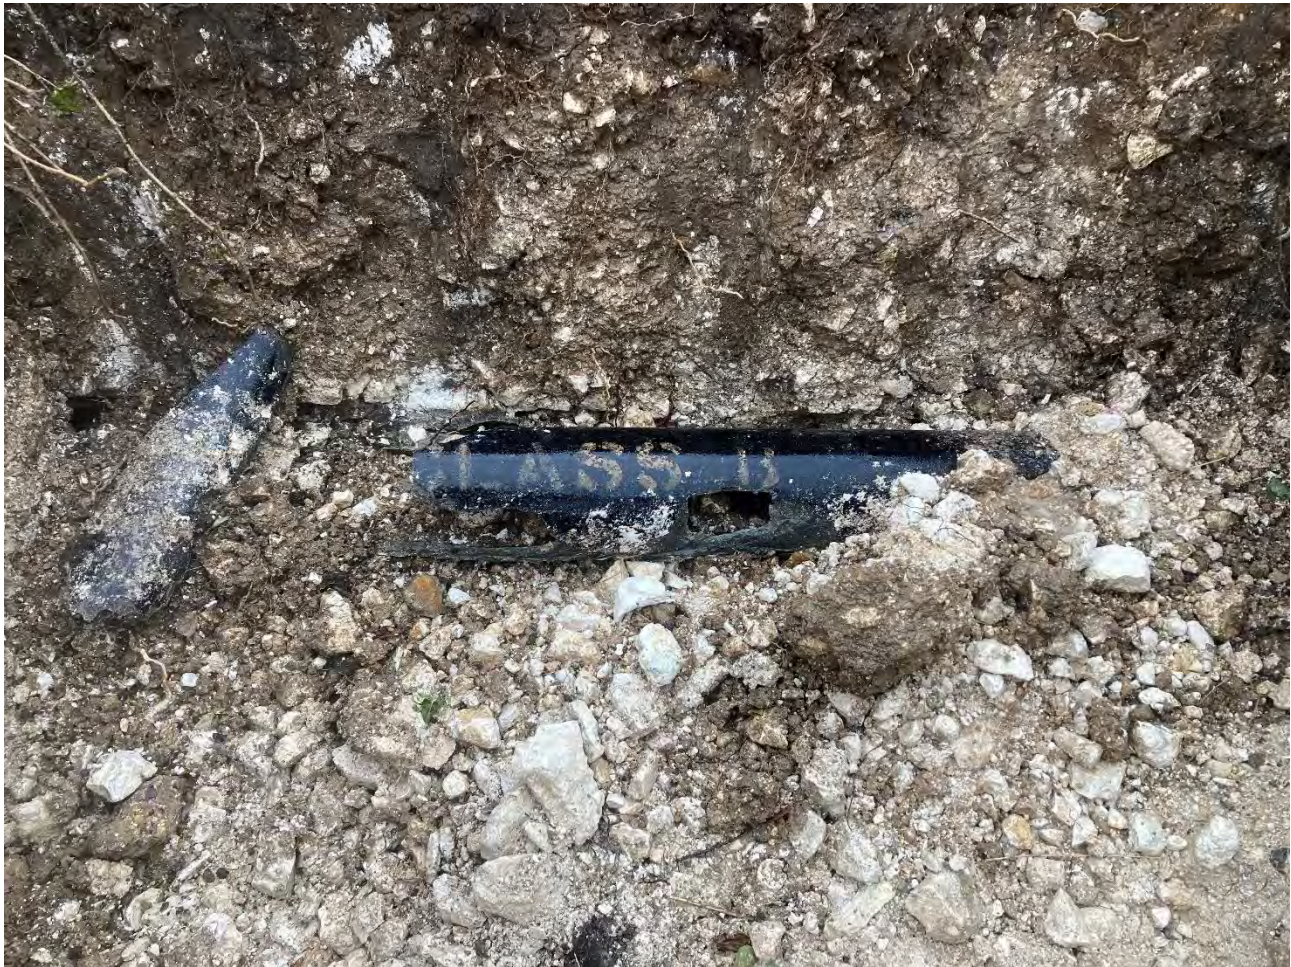
| <b>Comment</b><br><br>Suspected asbestos containing pipe encountered at 0.60 m BGL in D2/TP03. | <b>Project</b><br>223159 – Saunderton |
