Intended for  
**Avalon DC Limited**

# **FORMER MOLINS SITE, SAUNDERTON REMEDIATION VERIFICATION REPORT**

Project No. **16200011947-004**  
Issue No. **01**  
Date **09 December 2022**  
Made by **Sophie Davies**  
Checked by **Charles Collins**  
Approved by **Andy Mcvey**

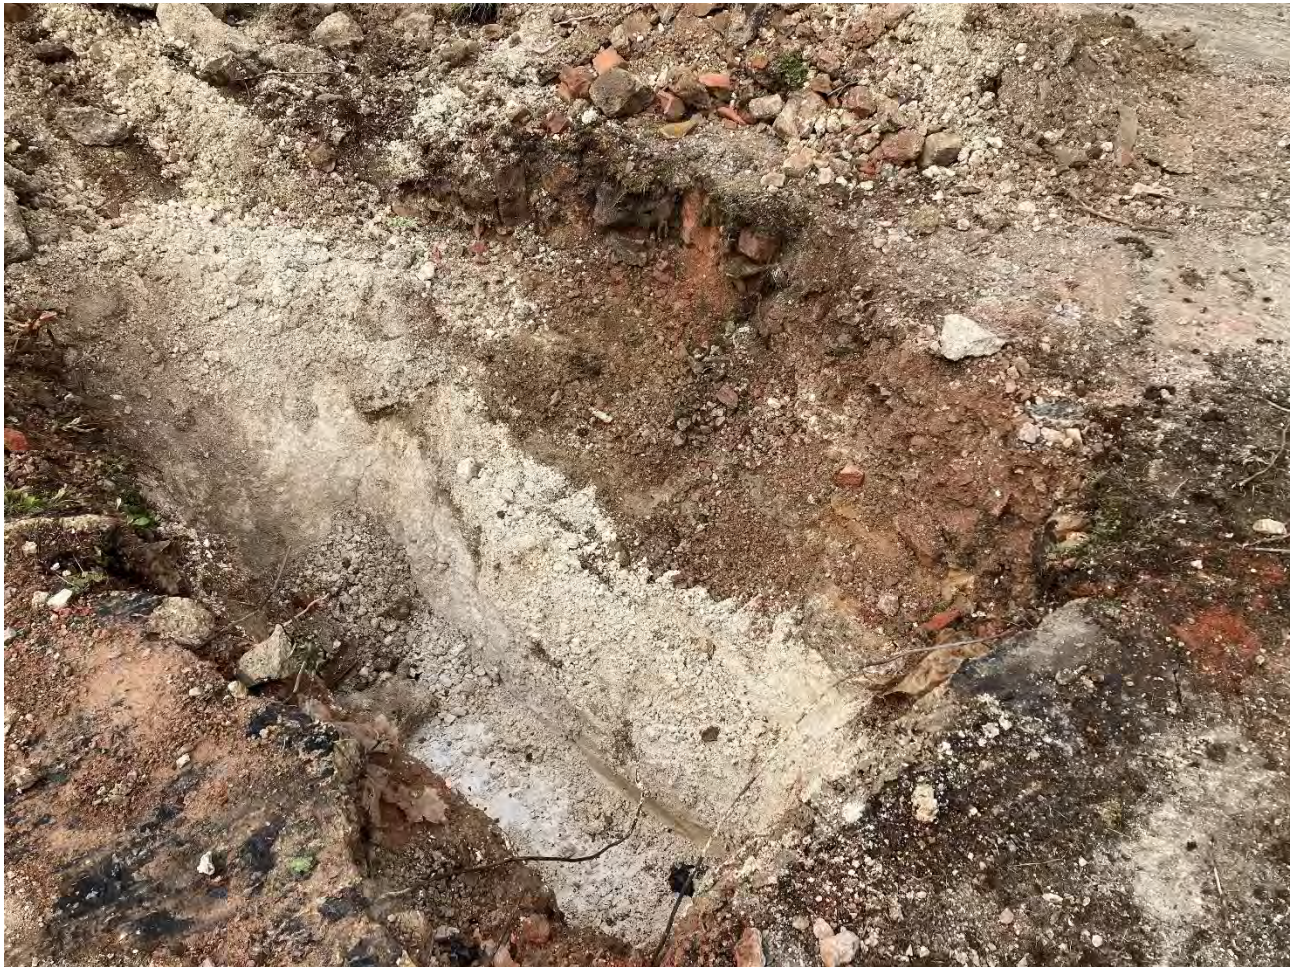
| <b>Comment</b><br><br>Trial pit E2/TP03, excavated to 1.60 m BGL. | <b>Project</b><br>223159 – Saunderton |

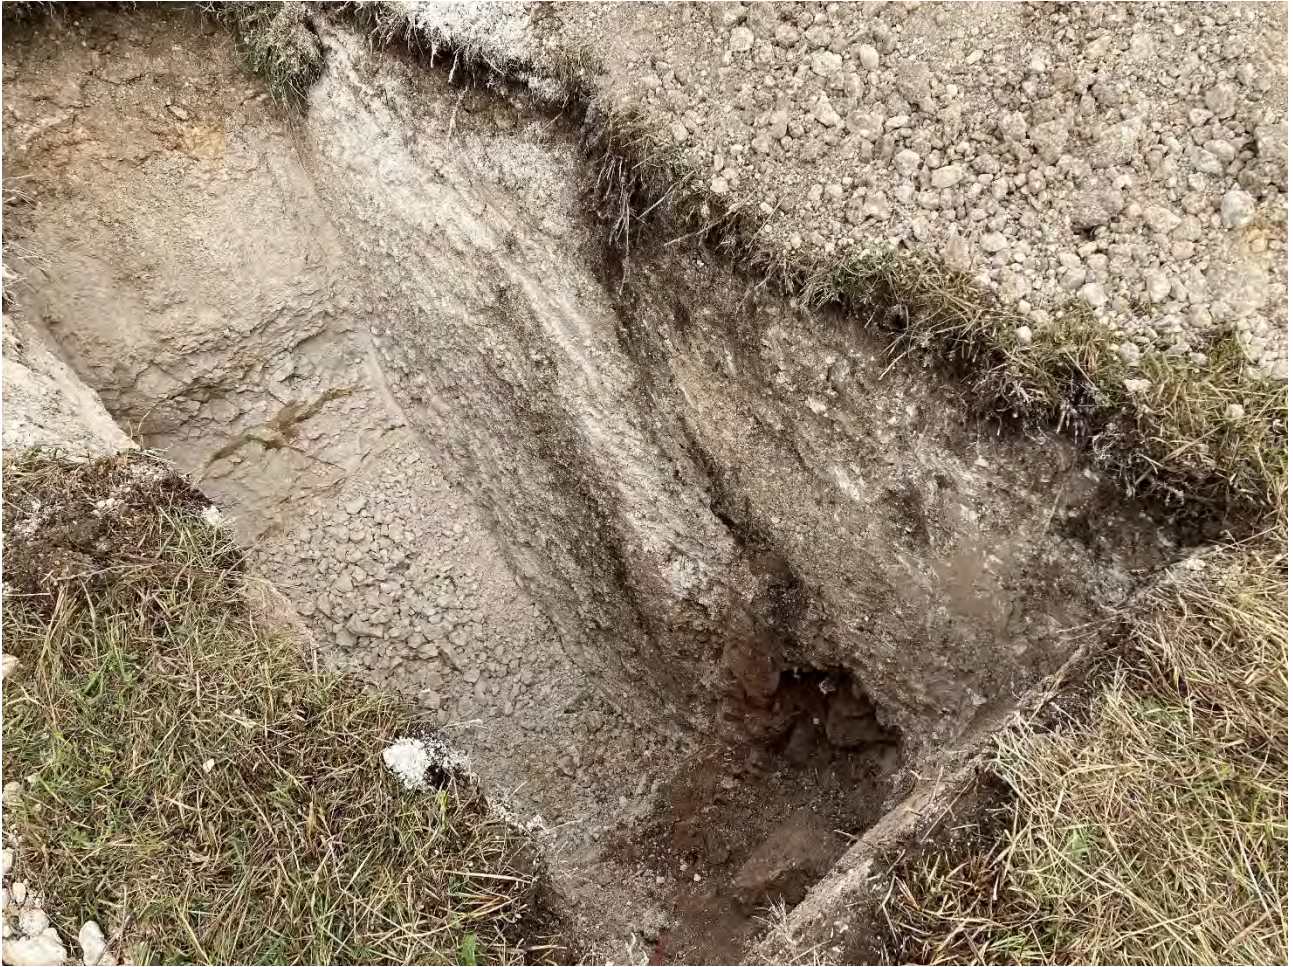
| <b>Comment</b><br><br>Trial pit E2/TP05, excavated to 3.00 m BGL. | <b>Project</b><br>223159 – Saunderton |

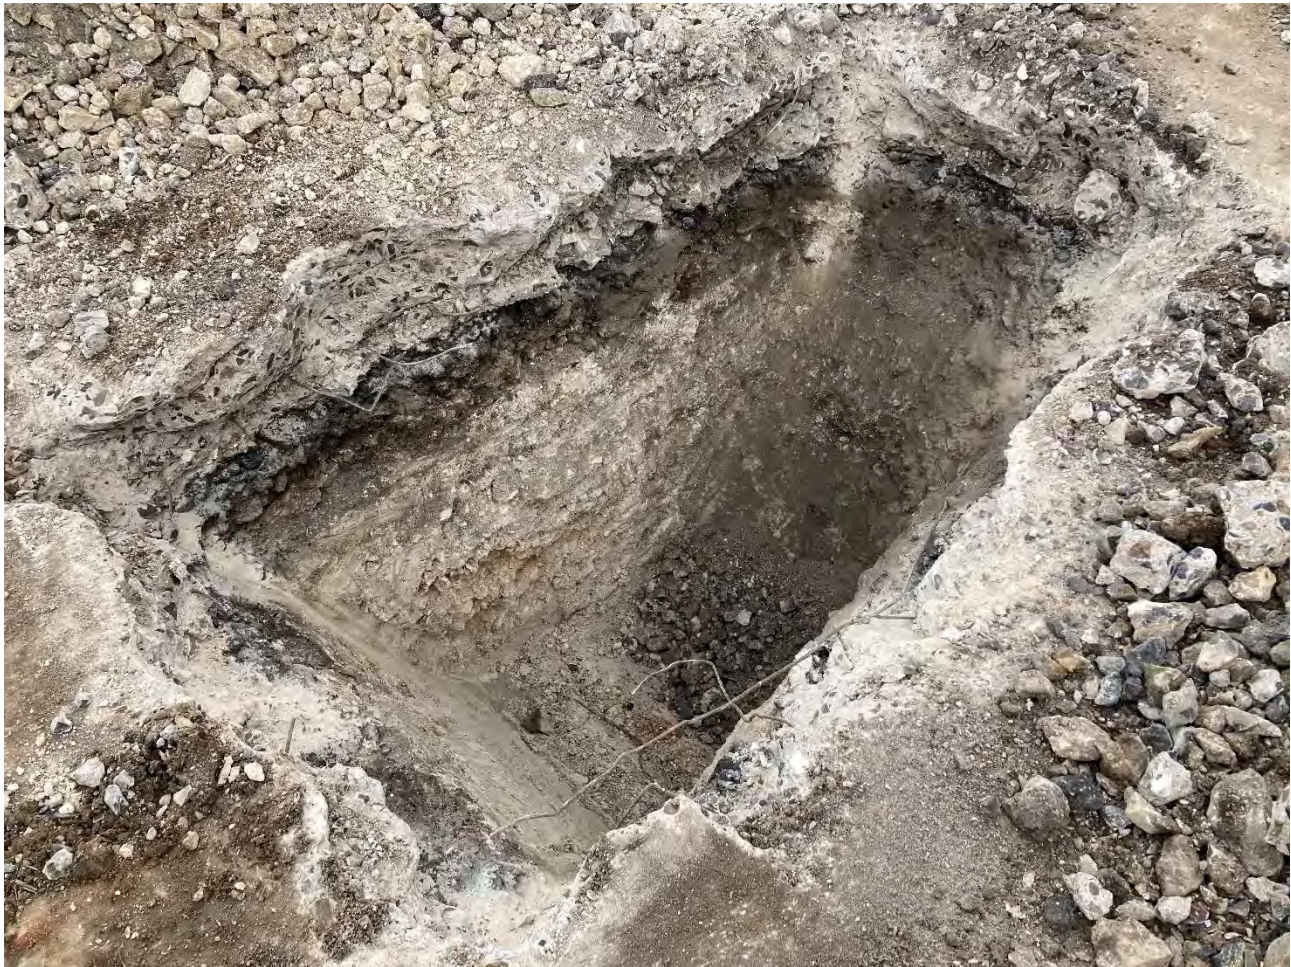
| <b>Comment</b><br><br>Trial pit D2/TP05, excavated to 1.60 m BGL. | <b>Project</b><br>223159 – Saunderton |

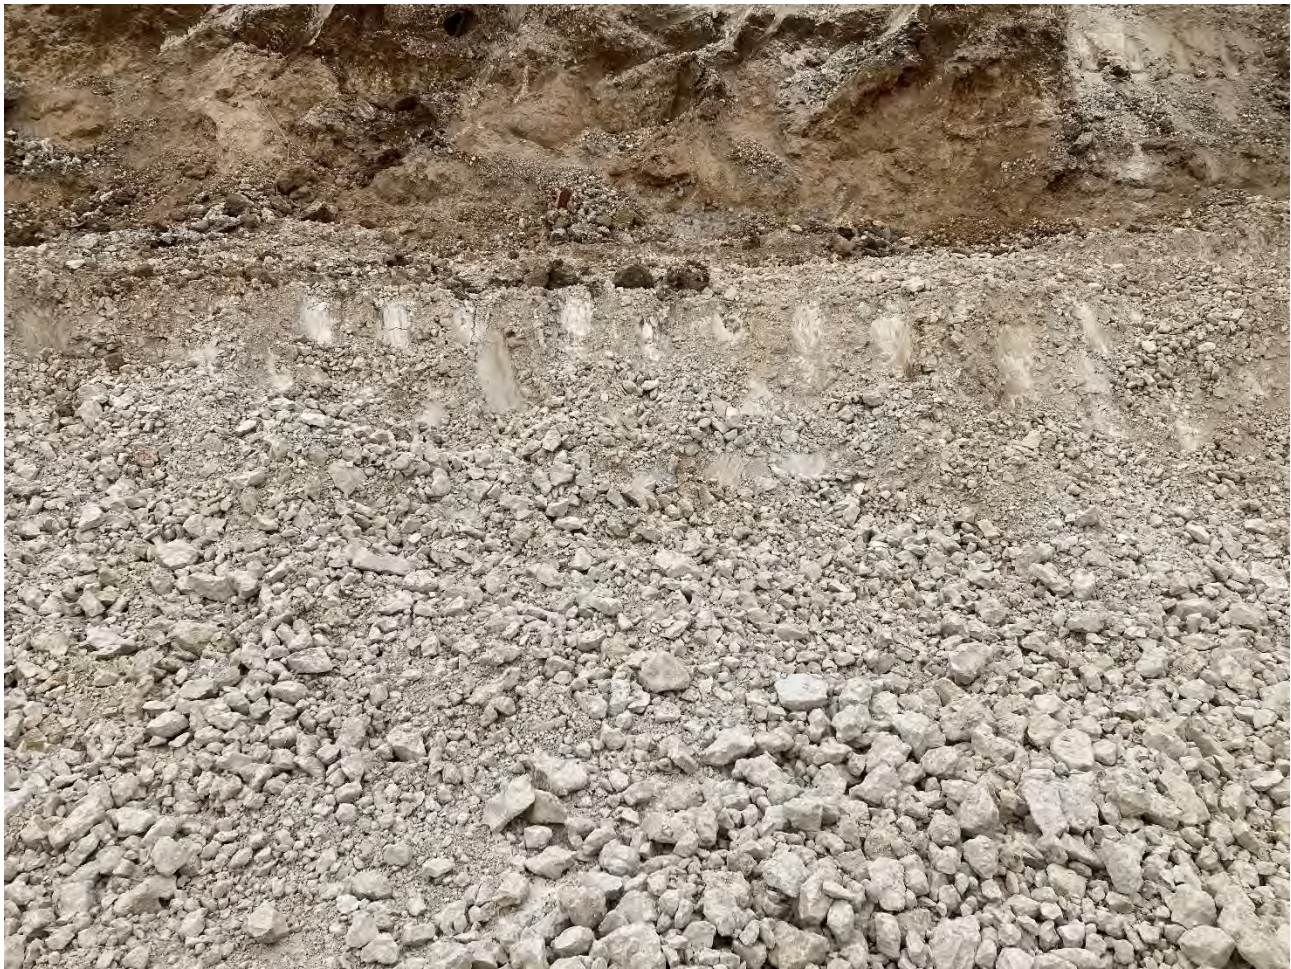
| <b>Comment</b><br><br>D1/TP02 V/N1. | <b>Project</b><br>223159 - Sauderton |

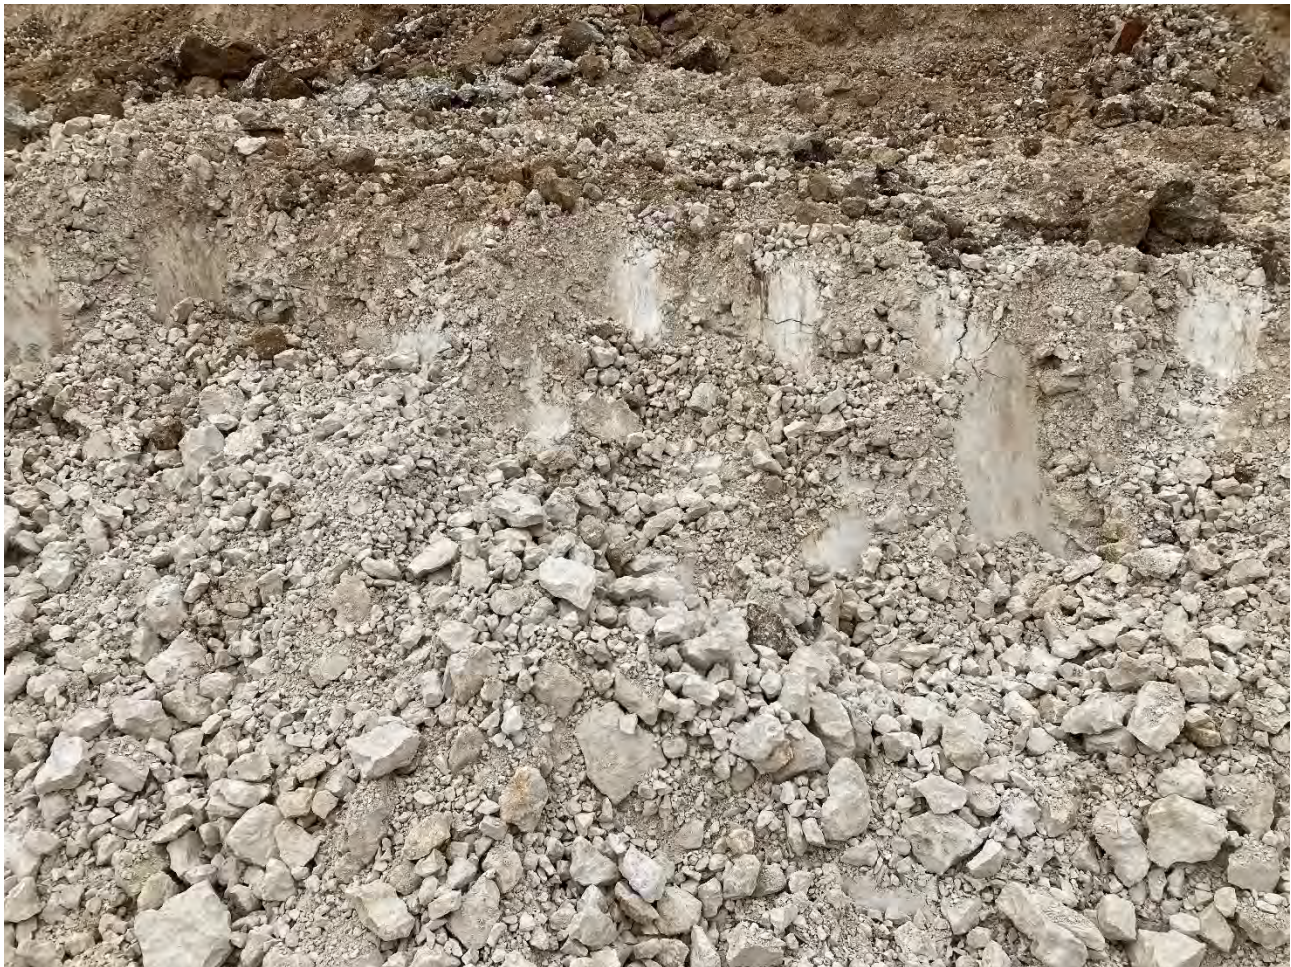
| <b>Comment</b><br><br>D1/TP02 V/N1 – natural material close up. | <b>Project</b><br>223159 – Saunderton |

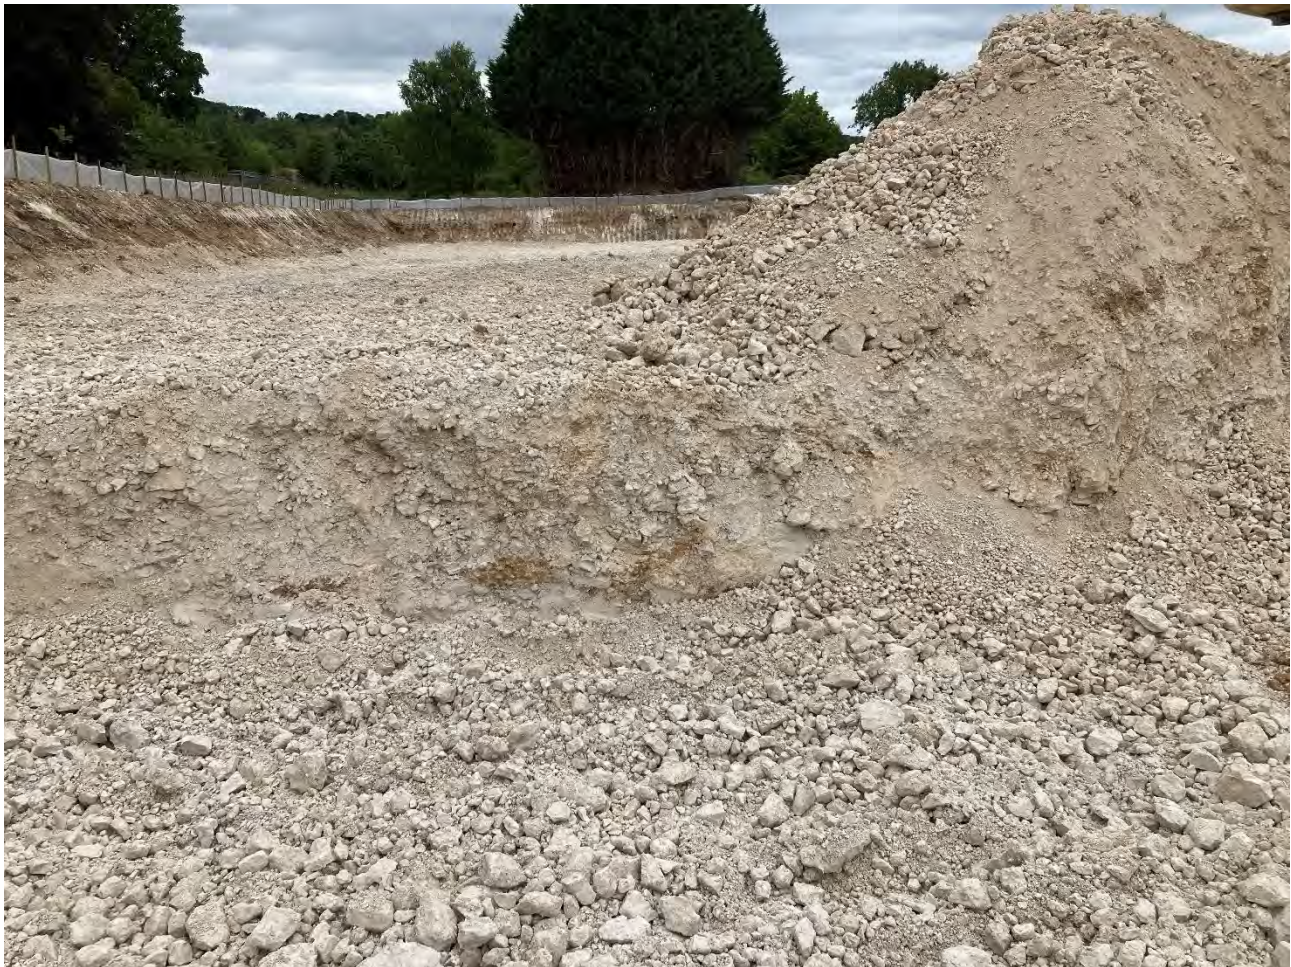
| <b>Comment</b><br><br>D1/TP02 V/E1. | <b>Project</b><br>223159 – Saunderton |

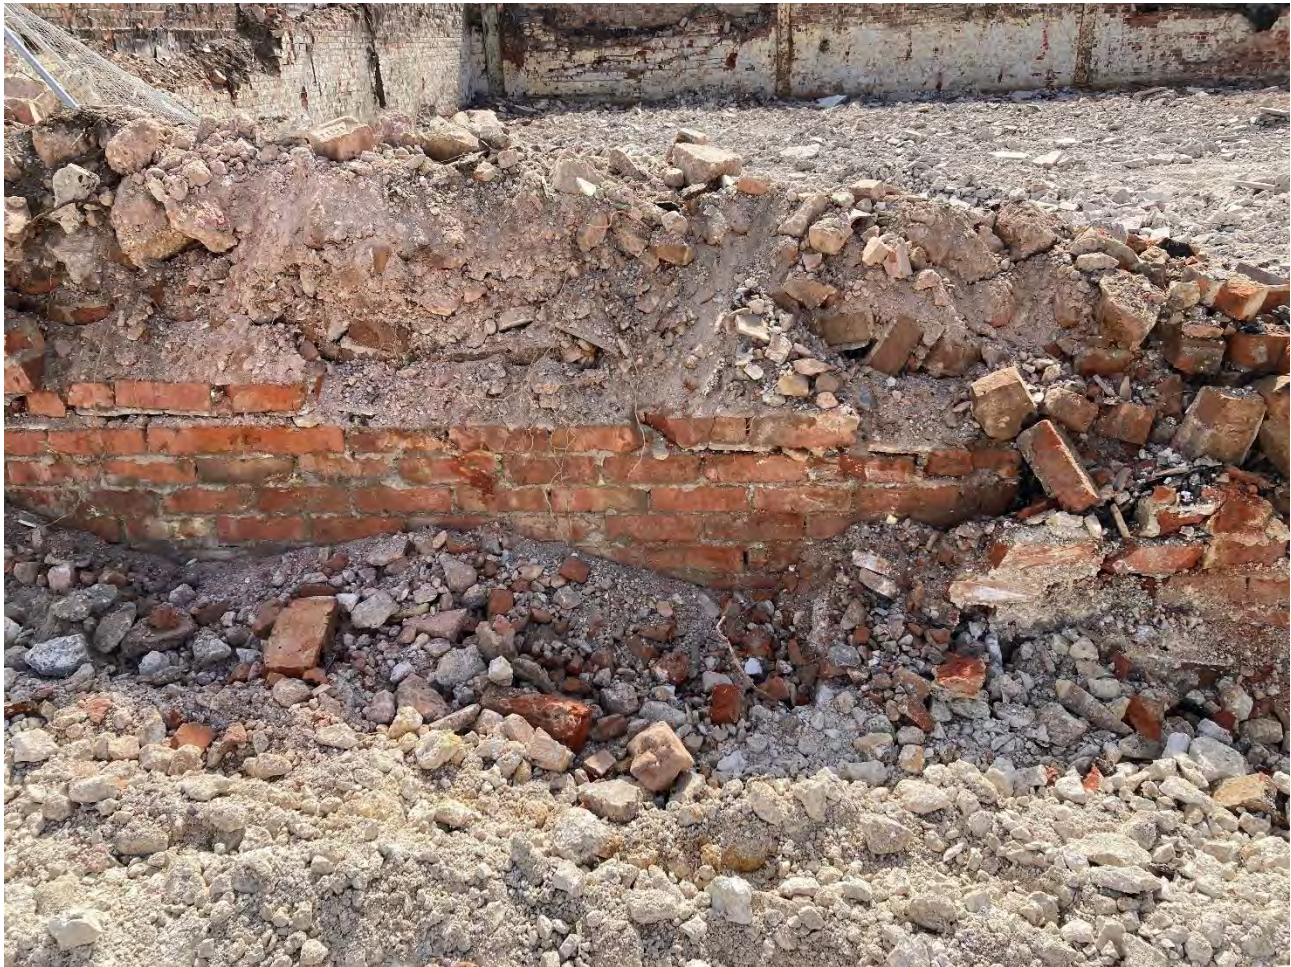
| <b>Comment</b><br><br>D2/TP05 V/W3 excavated to 0.60 m BGL. | <b>Project</b><br>223159 – Saunderton |

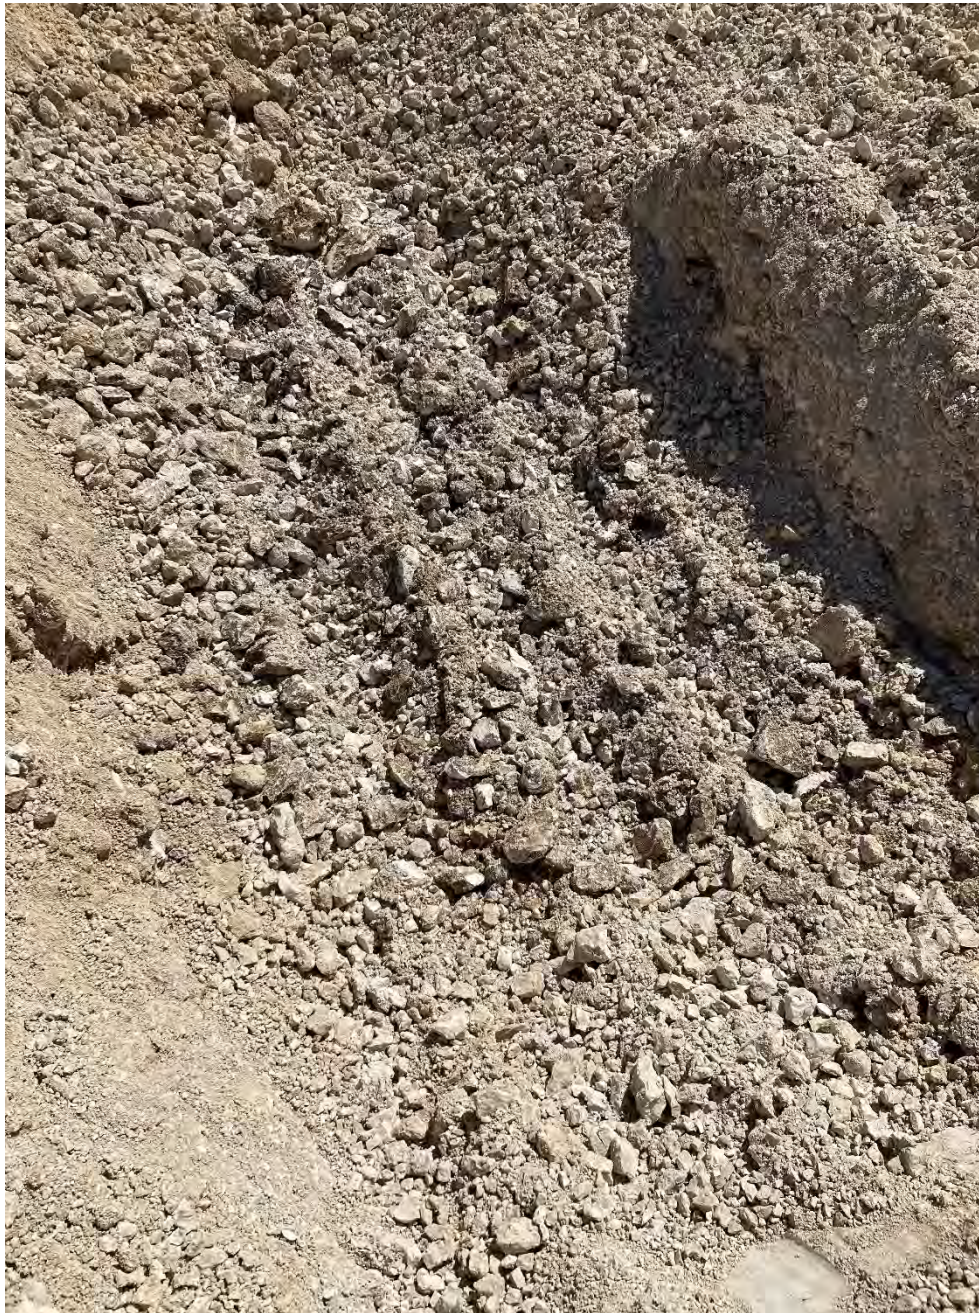
| <b>Comment</b><br><br>D2/TP05 V/B4 - initial excavation where potential hydrocarbon / organic contamination was observed. | <b>Project</b><br>223159 – Saunderton |
