## Hemel Hempstead Data Centre – Emergency Back-up Generation Facility

Site Condition Report - Environmental Permit Application

Reference: 284474-EP-SCR

Issue | 6 May 2022

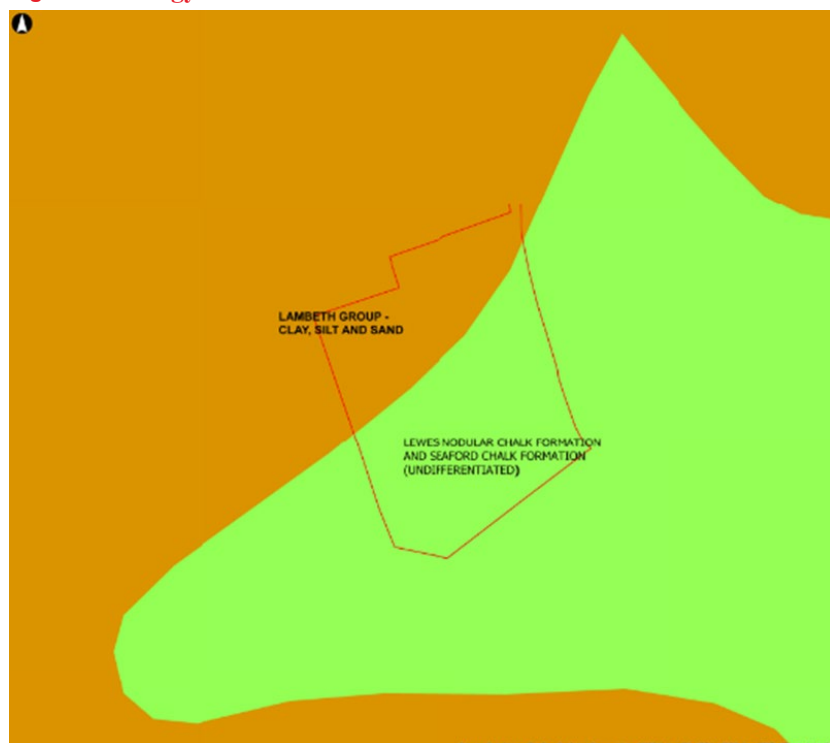
**Figure 1 Geology – Bedrock**

The British Geological Survey (BGS) mapping the geological succession at the site is as indicated in the table below, with mapped extents of outcrop as shown on the figures below. However, ground investigations at the site have shown that the Lambeth Group appears to be generally absent on this site, but the Clay with Flints encountered as the uppermost layer of bedrock geology across the whole of the site. Made Ground was also encountered across the whole site during the ground investigations.

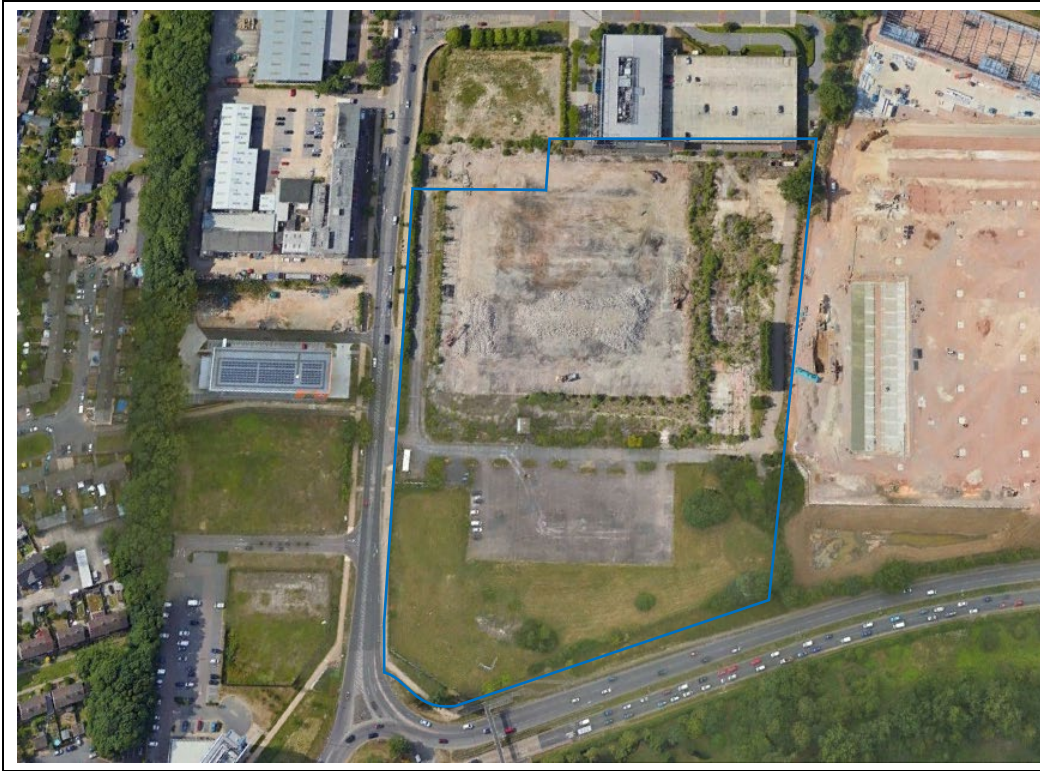
**Figure 6 2018 Google Earth Pro imagery**

The operation of the factory ceased in around 2000 when the company relocated to a new site in Tring, Hertfordshire. The factory was demolished around the year 2002 and the land remained vacant until 2018 when works were initiated to prepare the land for future development (removal of slabs and creation of stockpiles) (Figure 6).

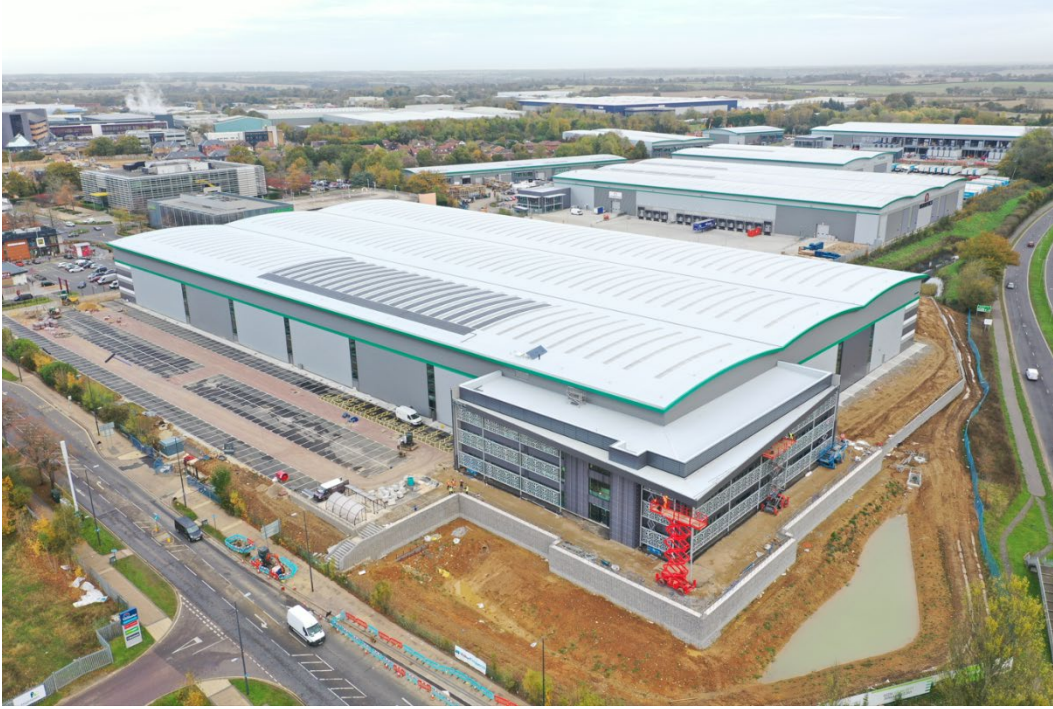
**Figure 7 Aerial view from above Maylands Avenue; Source: Prologis**

Construction of the consented scheme commenced in January 2021 and is at an advanced stage of construction. Figure 7 shows a recent aerial photograph. This shows the progress made in construction from January 2021, with site development works and the building on the site substantially complete.
