WINVIC CONSTRUCTION LIMITED

MAYLANDS GATEWAY, HEMEL HEMPSTEAD, HERTFORDSHIRE

SUPPLEMENTARY GROUND INVESTIGATION REPORT

April 2017
Report No. CCL02935.CD47

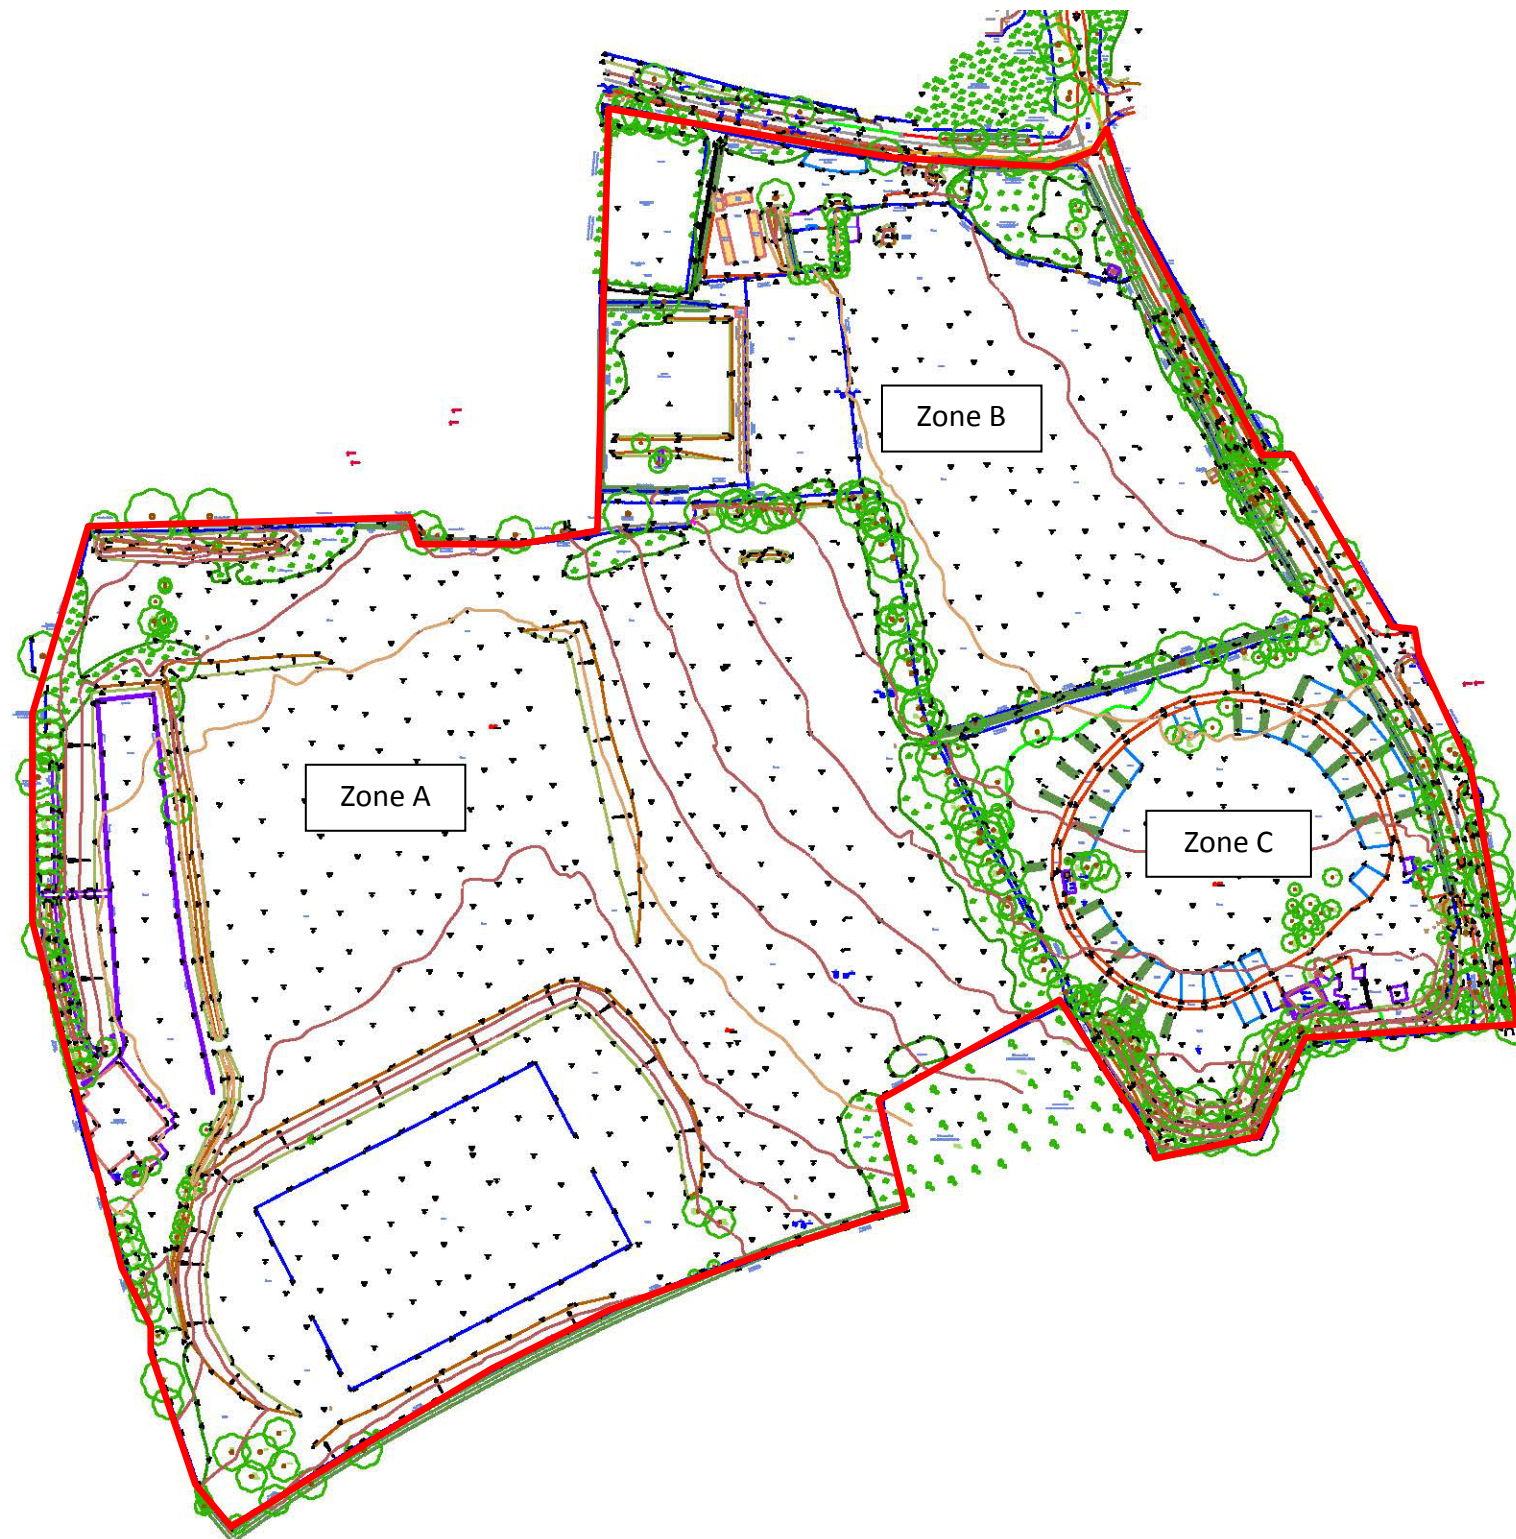
TOPOGRAPHICAL SITE SURVEY
Scale 1:2500

Plan based on the Topographical Survey drawing by Greenhatch Group, dated January 2016. Drawing No. 22846_T. Rev. 1

This site description is based on observations made during a supplementary ground investigation in March 2017. Reference should also be made to the topographical survey, presented as Figure 3.

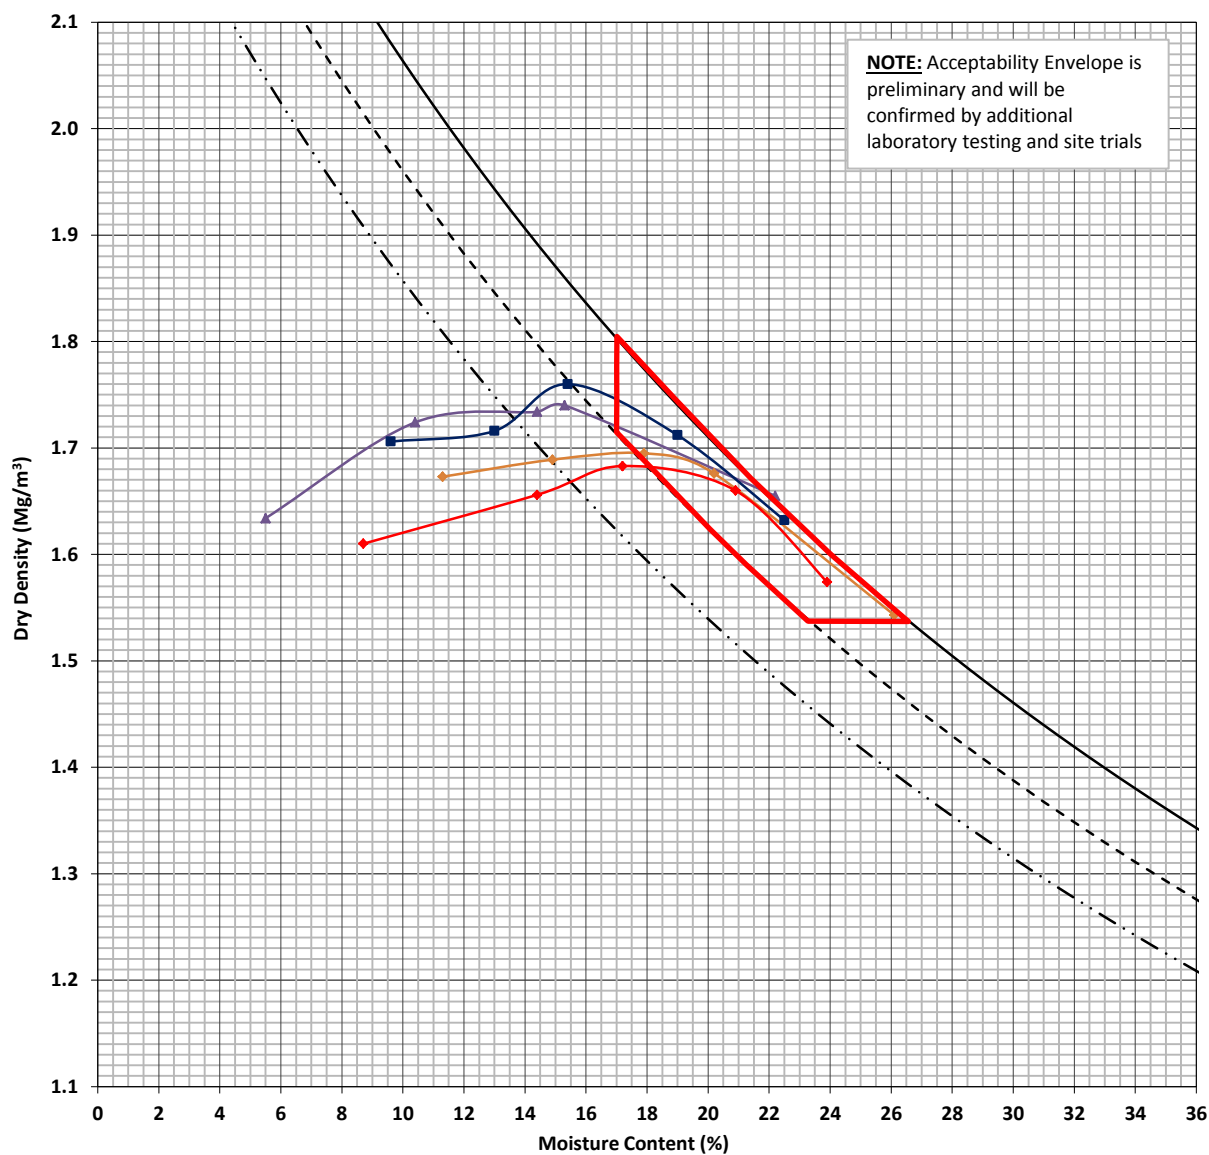
FIGURE 9

—	0%	- - -	5%	- · - · -	10%
—	Envelope	—▲—	TP CCL08 0.7-0.8 m LM MG	—◆—	TP CCL08 2.0-2.2 m LM MG
—◆—	TP CCL19 1.1-1.2 m LM MG	—■—	TP CCL41 0.2-0.4 m LM MG/RW

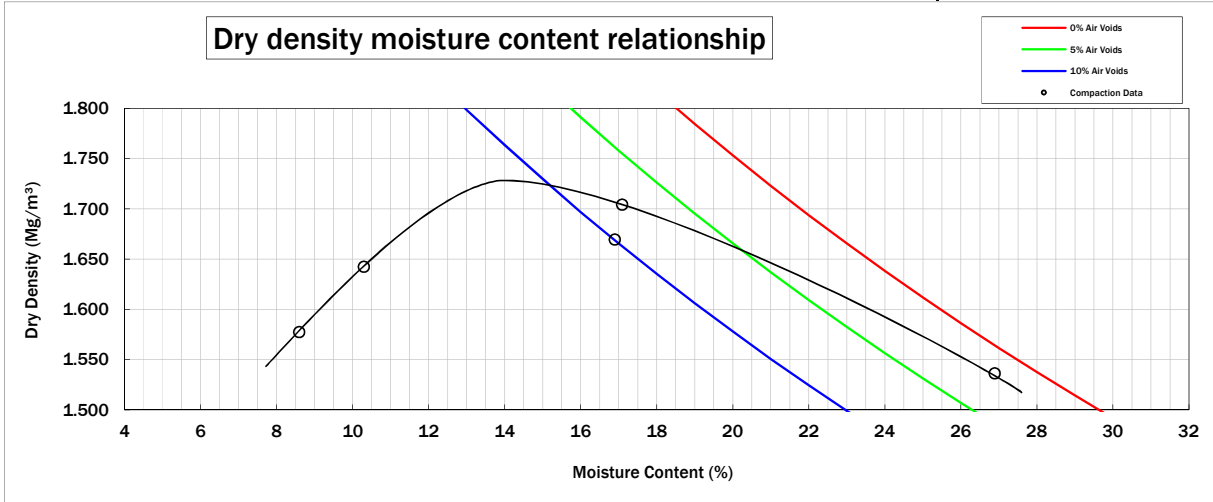
<p>The graph plots Dry Density (Mg/m³) on the y-axis (1.500 to 1.800) against Moisture Content (%) on the x-axis (4 to 32). It shows compaction data points (circles) and three theoretical air void curves: 0% (red), 5% (green), and 10% (blue). The peak of the compaction curve is at approximately 14% moisture content and 1.74 Mg/m³ dry density.</p>

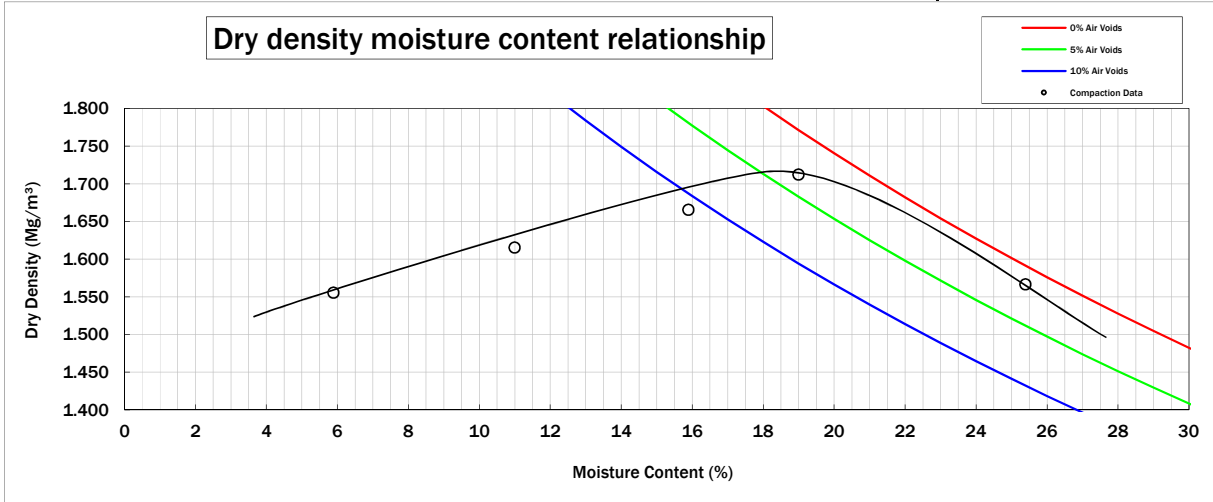
<p>The graph plots Dry Density (Mg/m³) on the y-axis (1.400 to 1.800) against Moisture Content (%) on the x-axis (0 to 30). It features three theoretical curves for 0% (red), 5% (green), and 10% (blue) air voids. Compaction data points are shown as open circles, with a smooth curve fitted through them. The optimum moisture content is 19% and the maximum dry density is 1.71 Mg/m³.</p>

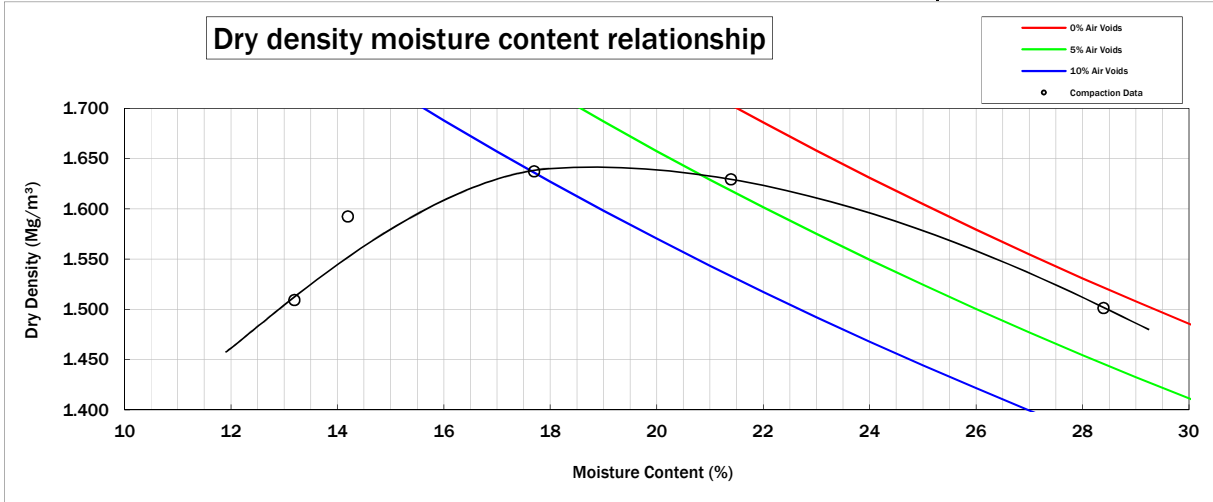
<p>The graph plots Dry Density (Mg/m³) on the y-axis (1.40 to 1.70) against Moisture Content (%) on the x-axis (10 to 30). It shows four compaction data points (open circles) and three theoretical air void curves (0%, 5%, and 10% air voids). The peak of the compaction curve is at 18% moisture content and 1.64 Mg/m³ dry density.</p>

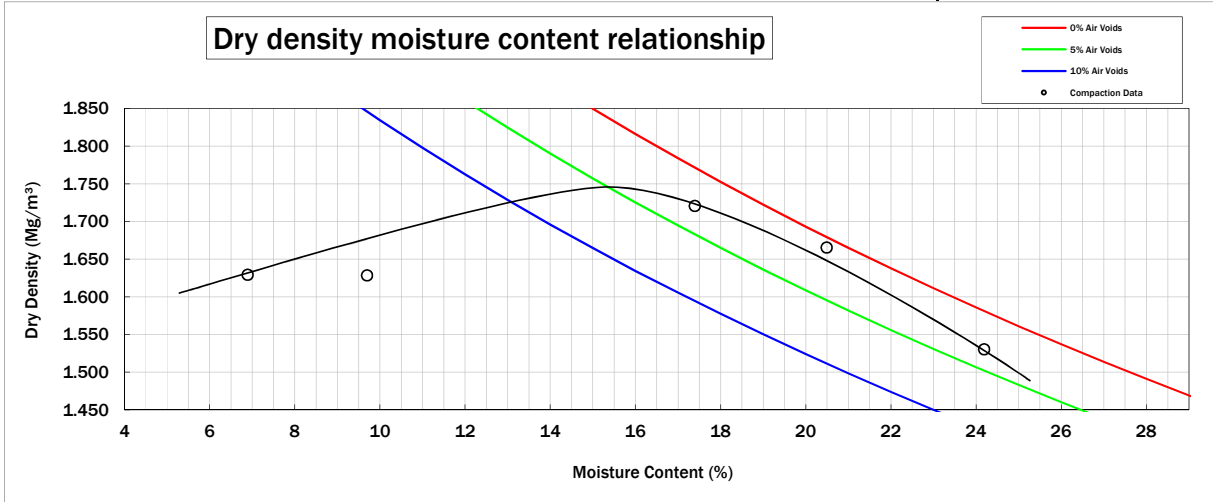
<p>The graph plots Dry Density (Mg/m³) on the y-axis (1.450 to 1.850) against Moisture Content (%) on the x-axis (4 to 28). Three curves represent 0% (red), 5% (green), and 10% (blue) air voids. Compaction data points are shown as open circles. The maximum dry density is 1.75 Mg/m³ at 16% moisture content.</p>

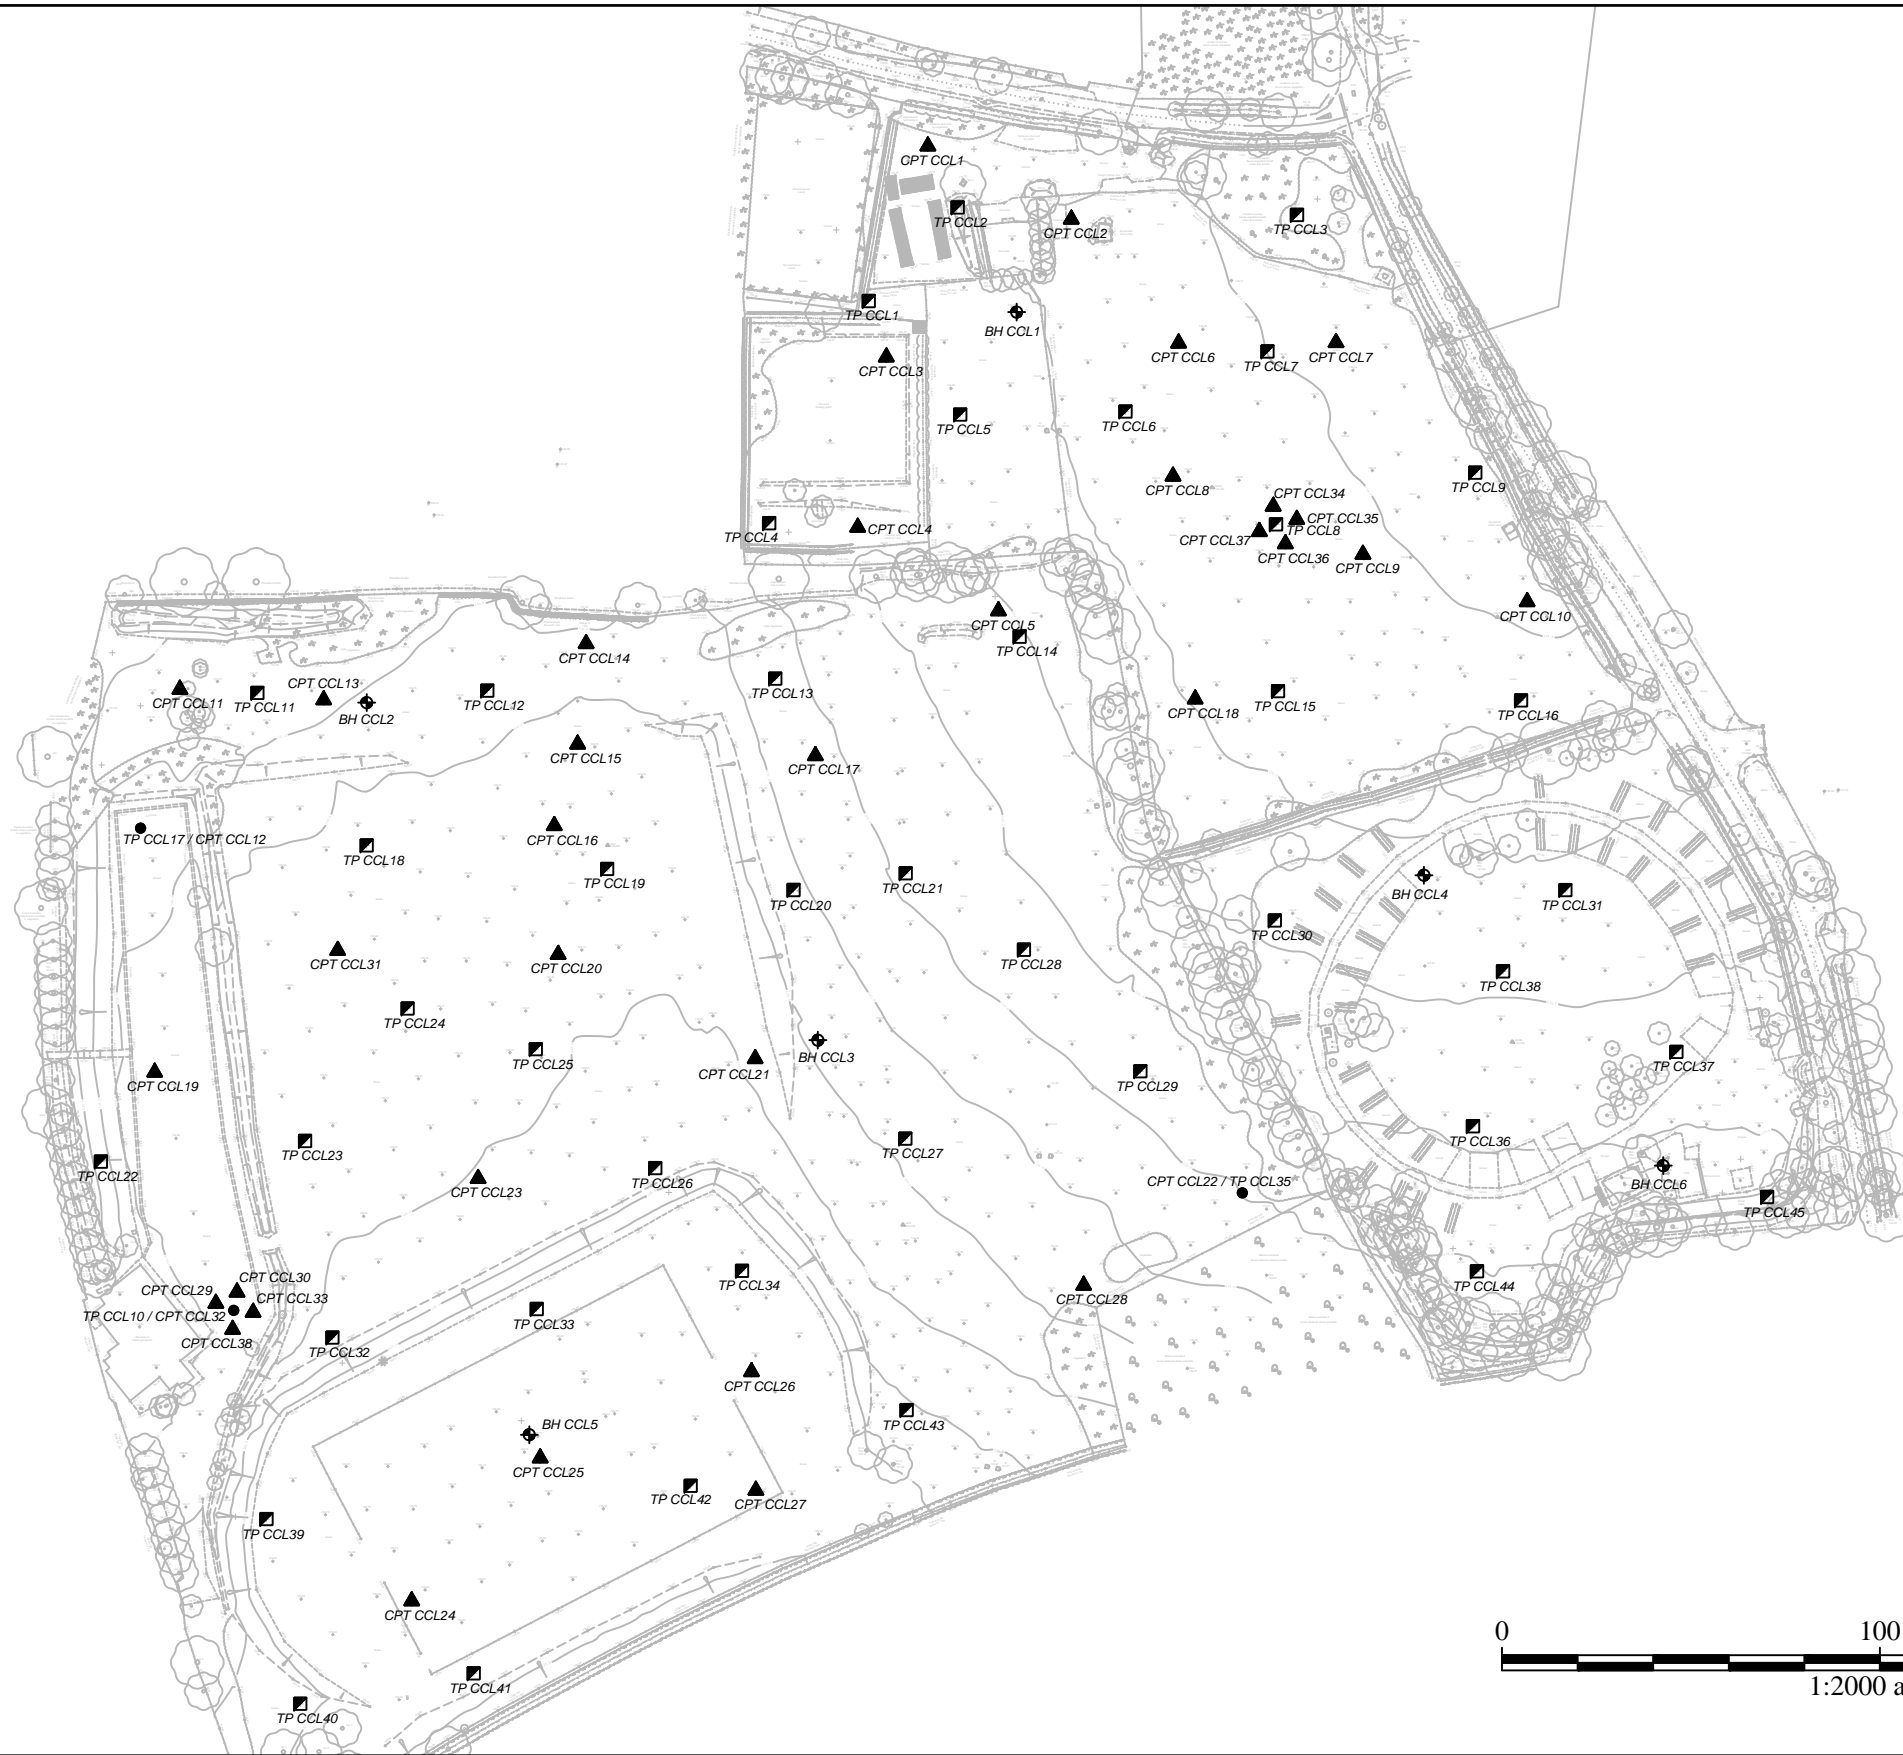
Plan based on the Topographical Survey drawing by Greenhatch Group, dated January 2016, Drawing No. 22846_T. Rev 1

EXPLORATORY HOLE LOCATION PLAN
