WINVIC CONSTRUCTION LIMITED

MAYLANDS GATEWAY, HEMEL HEMPSTEAD, HERTFORDSHIRE

PHASE II SUPPLEMENTARY GROUND INVESTIGATION REPORT

December 2017
Report No. CCL02935.CF12

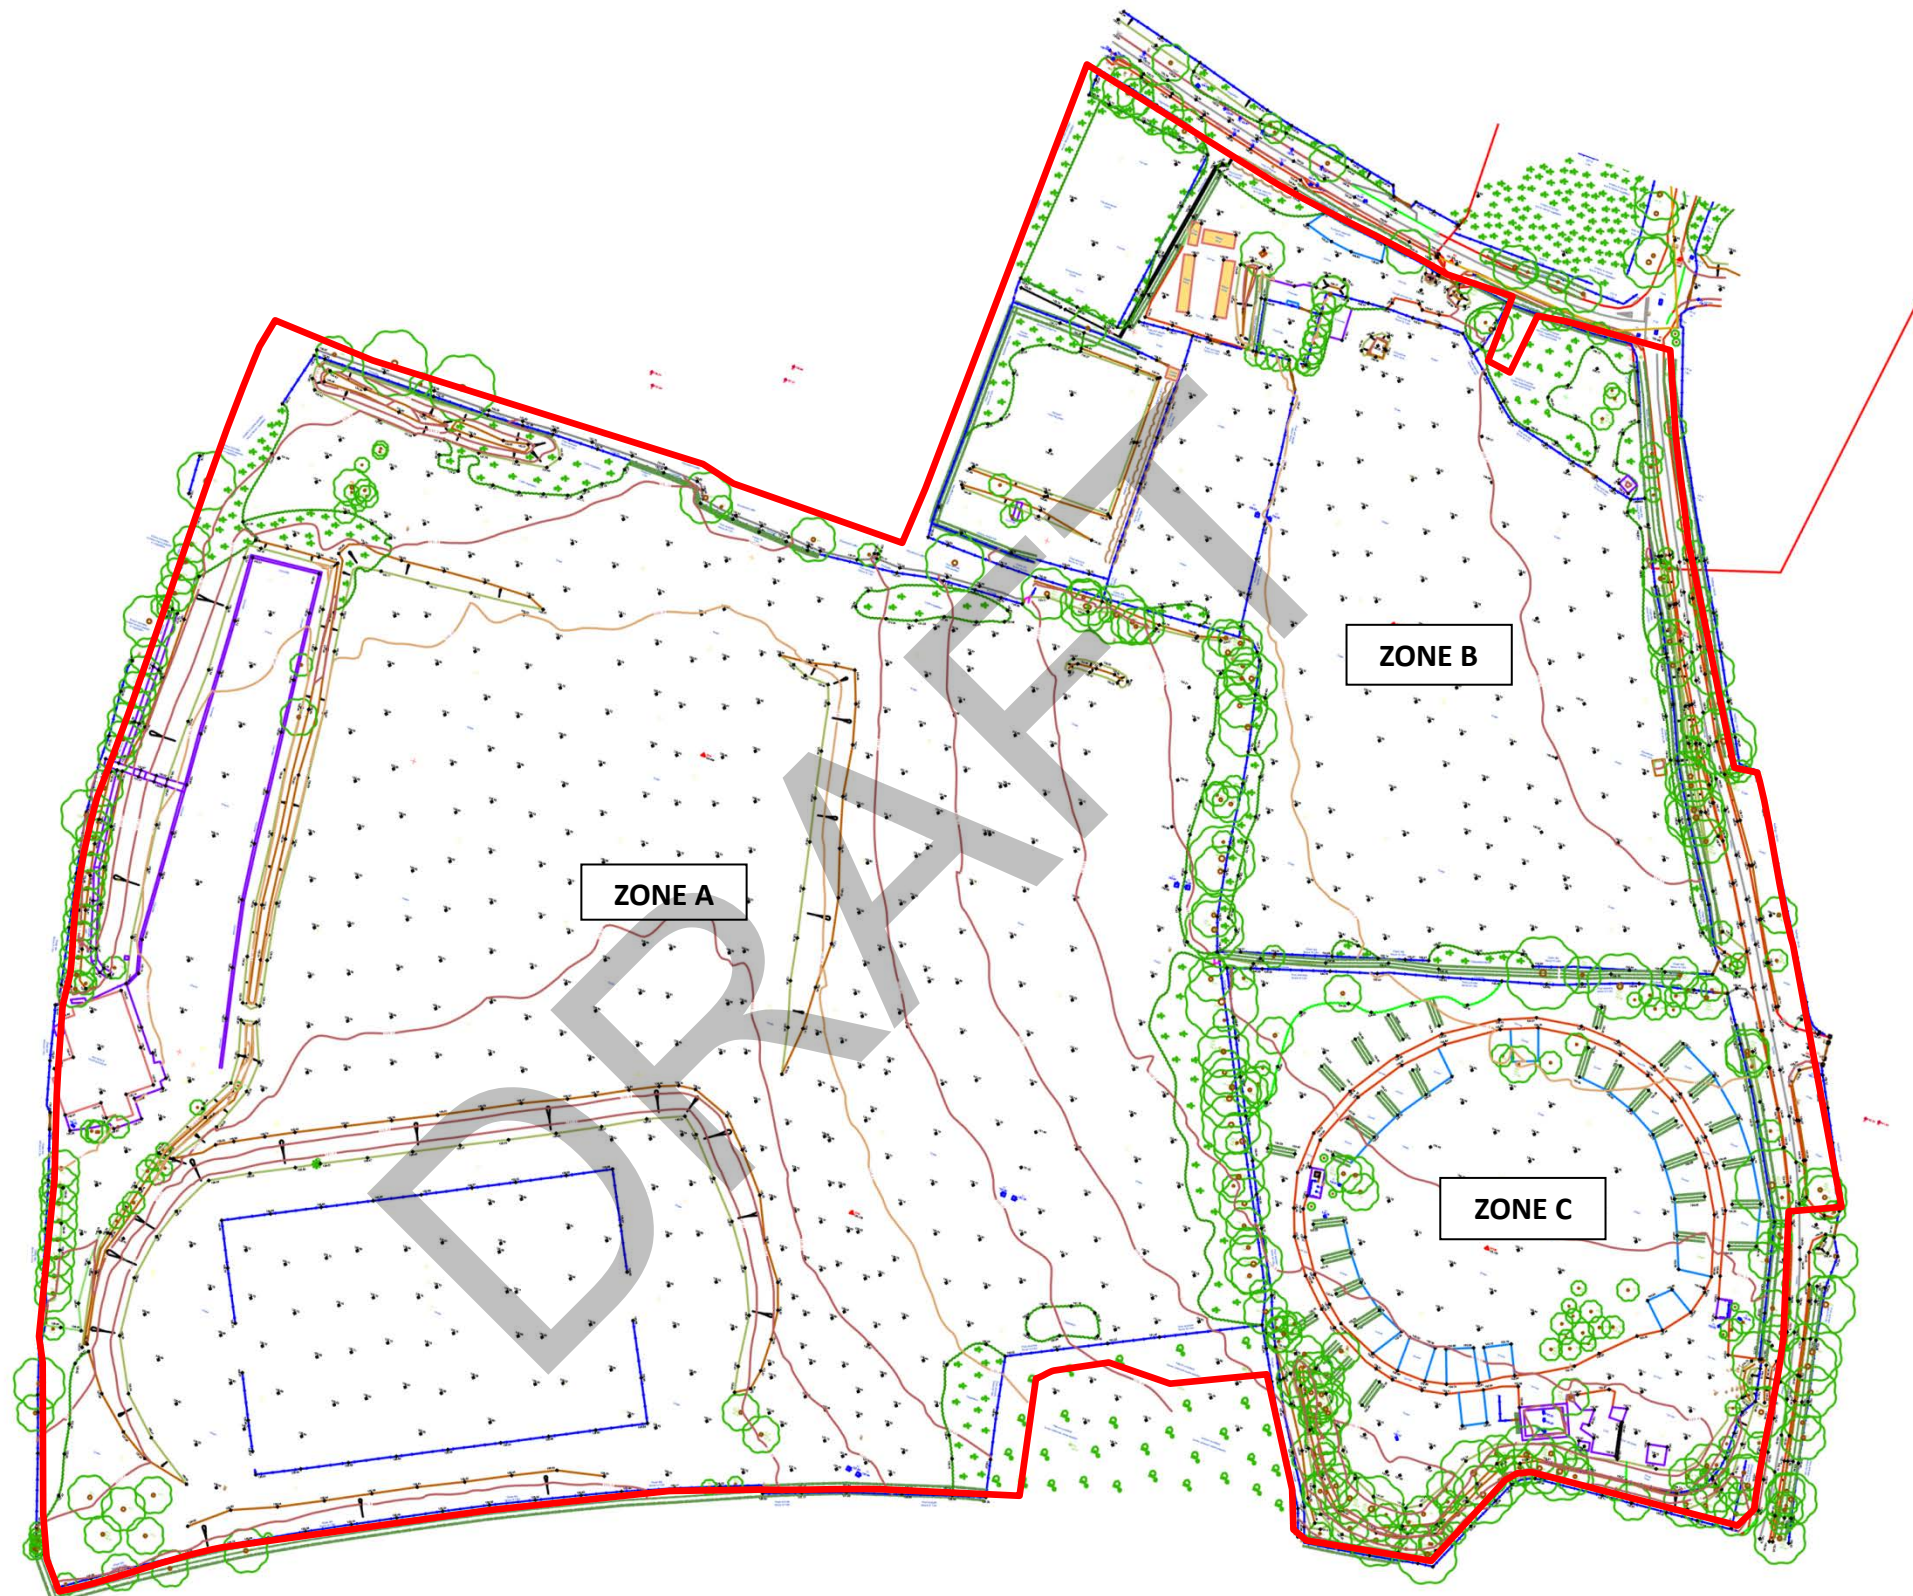
TOPOGRAPHICAL SITE SURVEY
Scale 1:2000

Plan based on the Topographical Survey drawing by Greenhatch Group, dated January 2016. Drawing No. 22846_T. Rev. 1
