# High Speed 2 - 1MC06 - Stage One C2 - MWCC – North Portal of Chiltern Tunnels to Brackley

## Historical Hartwell Landfill Geoenvironmental Assessment Report

### 1MC06-CEK-EV-REP-CS04\_CL18-000001

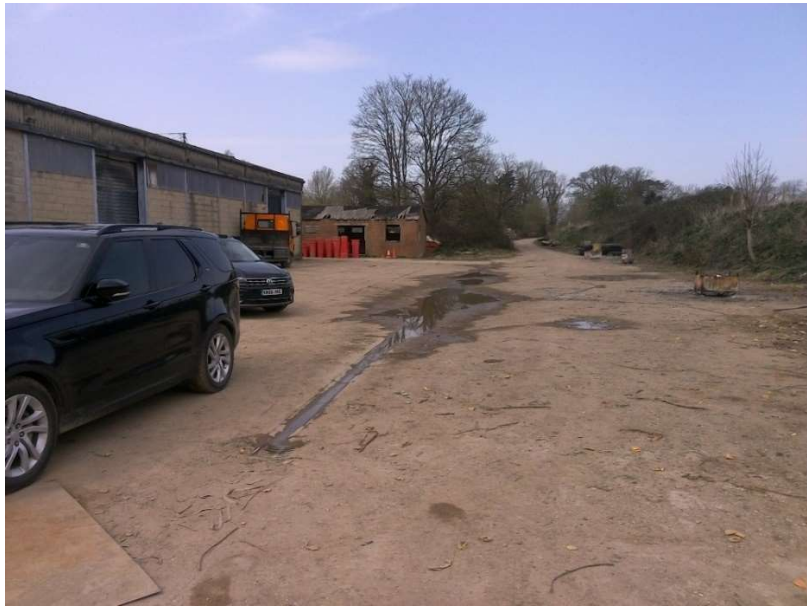
| Photograph | Description |
|---|---|
| | <p><b>Plate 1</b> – Scaffolding Yard, Warehouse and smaller associated buildings in the centre of the Former Hartwell Clay, Old Brick and Tile Works (LQ 11.03) covered with hard standing.</p> |

A scaffolding yard, warehouse, and several smaller associated buildings (known as Hartwell Depot) were present within a small area in the centre of the Historic Brickworks Area / Former Hartwell Clay, Old Brick and Tile works and Landfill (LQ 11-03). The Scaffolding Yard is accessed from the A418 Road by a concrete road and is covered by concrete hardstanding. Overflowing skips were noted at the scaffolding yard, along with scattered waste materials (pallets, roof sheeting, plastics, gas canisters and drums) (Plates 1 to 4).

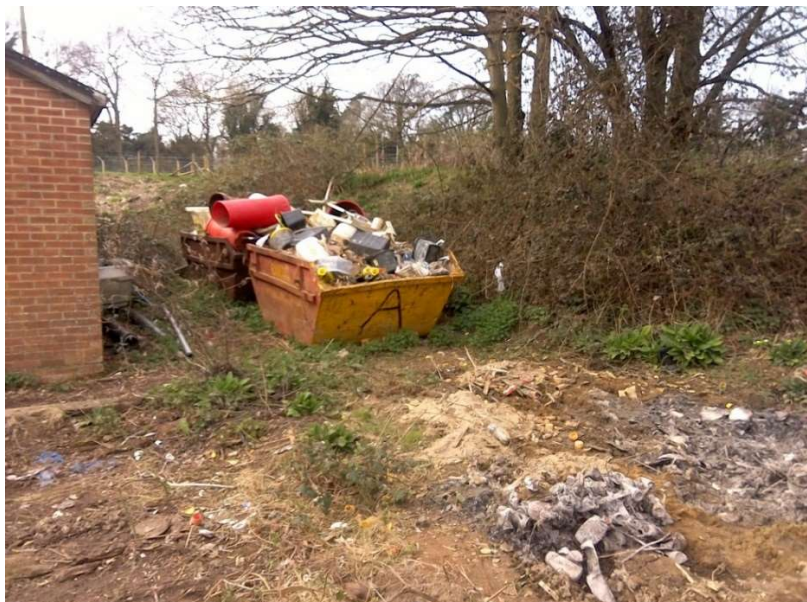
| Photograph | Description |
|---|---|
| | <p><b>Plate 2</b> – Overflowing skips and scattered waste materials within the Scaffolding Yard within LQ 11.03.</p> |

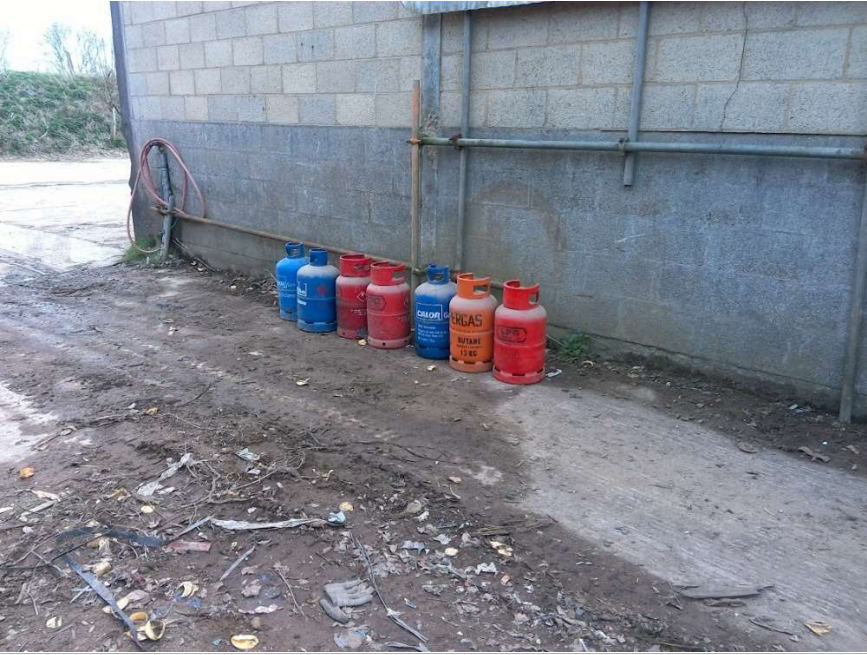
| Photograph | Description |
|---|---|
| | <b>Plate 3</b> – Gas canisters located within the Scaffolding Yard within LQ 11.03. |

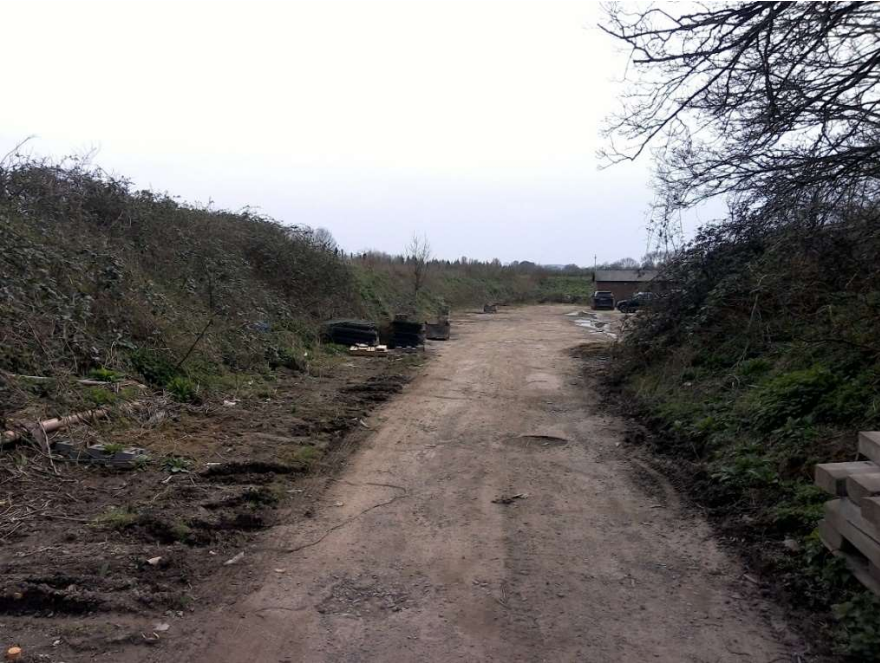
| Photograph | Description |
|---|---|
| | <b>Plate 4</b> – Concrete access road to the Scaffolding Yard within LQ 11.03. Raised area of landfill noted either side of the road. |

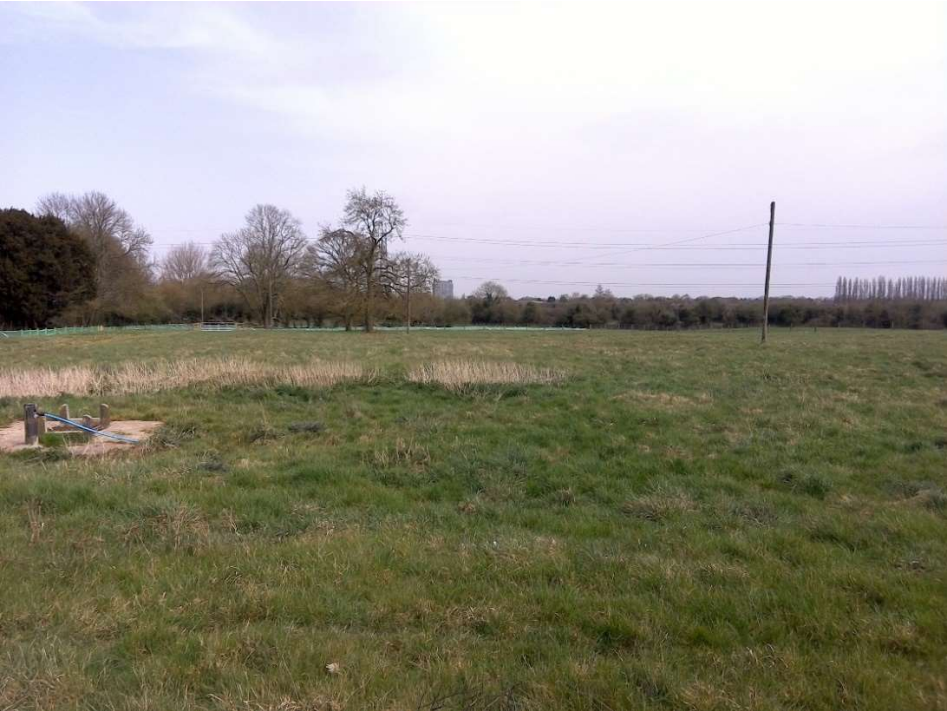
| Photograph | Description |
|---|---|
| | <b>Plate 5</b> – Former Hartwell Clay, Old Brick and Tile Works and Landfill (LQ 11.03) comprising rough grassland on higher land than the Scaffolding Yard. |

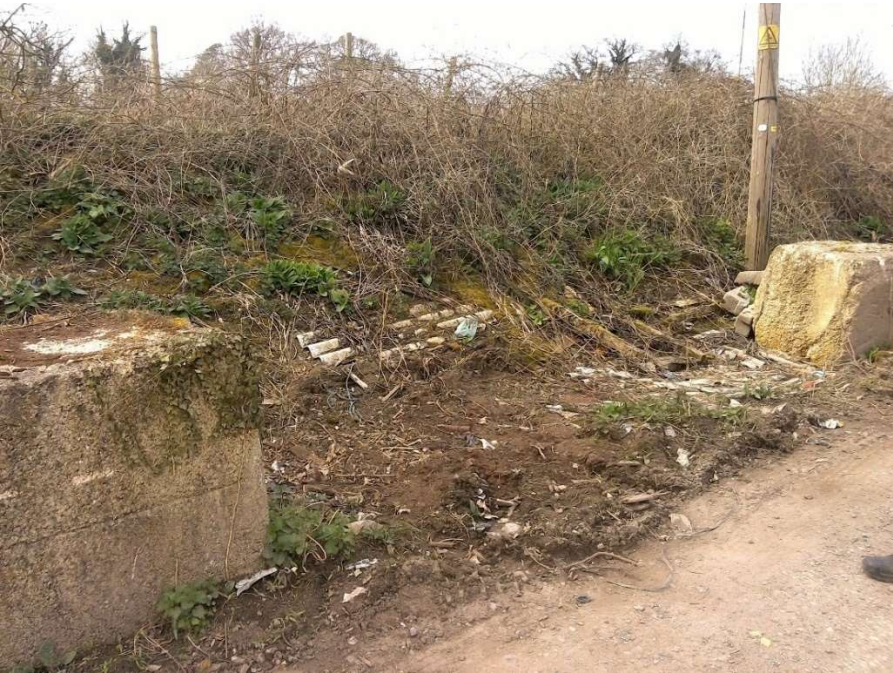
| Photograph | Description |
|---|---|
| | <b>Plate 6</b> – Exposed area of Made Ground/ landfill within the Historic Brickworks Area/ former Hartwell Clay, Old Brick and Tile Works and Landfill (LQ 11.03) |

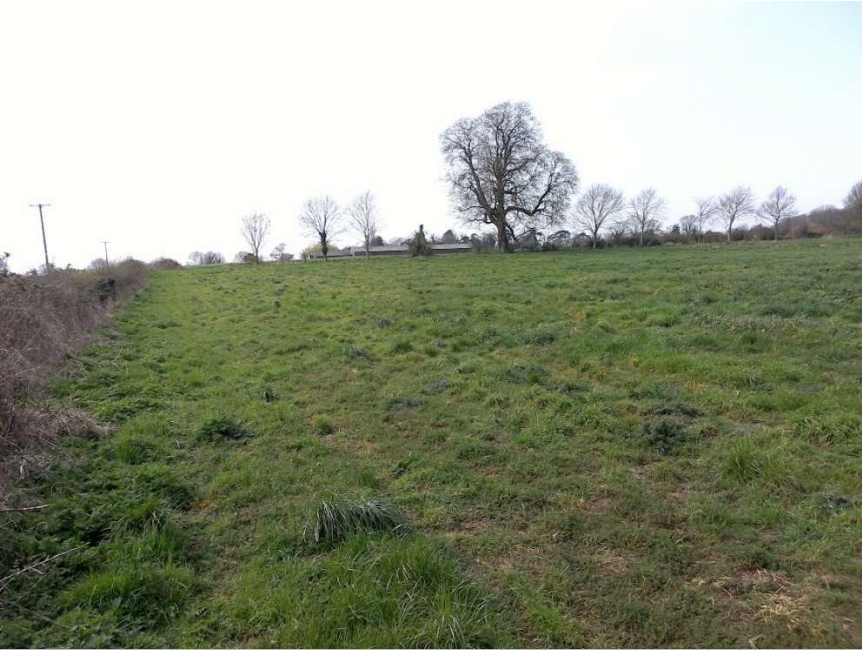
| Photograph | Description |
|---|---|
| | <b>Plate 7</b> – Hartwell Landfill (LQ 11.04) with the derelict residential dwelling (Glebe House) in the background. |

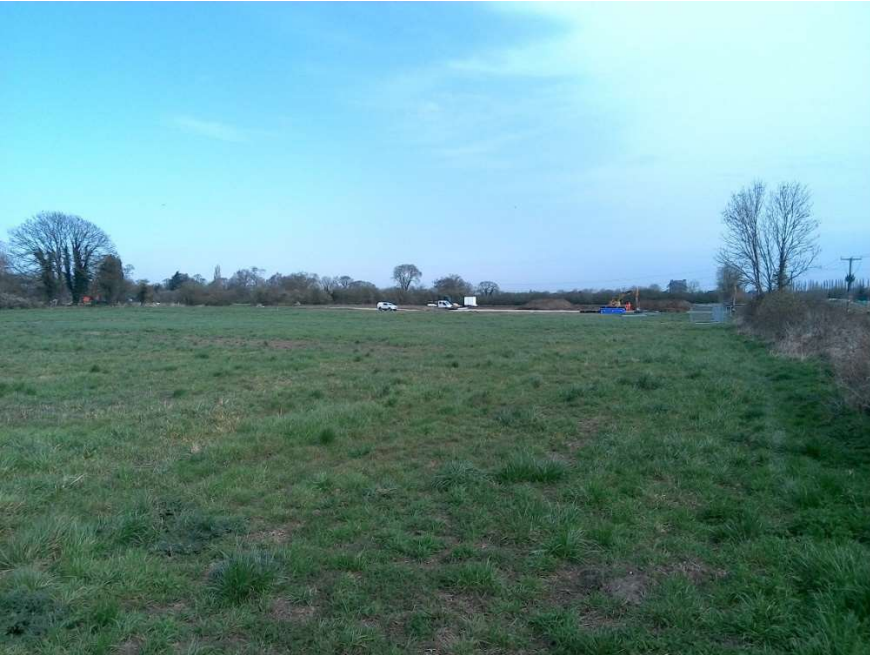
| Photograph | Description |
|---|---|
| | <b>Plate 8</b> – Historical Hartwell Landfill (LQ 11.04) comprising grassland /agricultural fields. |
